Agenda
for
64th PCC meeting

EASTERN REGIONAL POWER COMMITTEE

AGENDA FOR 64TH PROTECTION SUB-COMMITTEE MEETING TO BE HELD AT ERPC, KOLKATA ON 22.02.2018 (THURSDAY) AT 11:00 HOURS

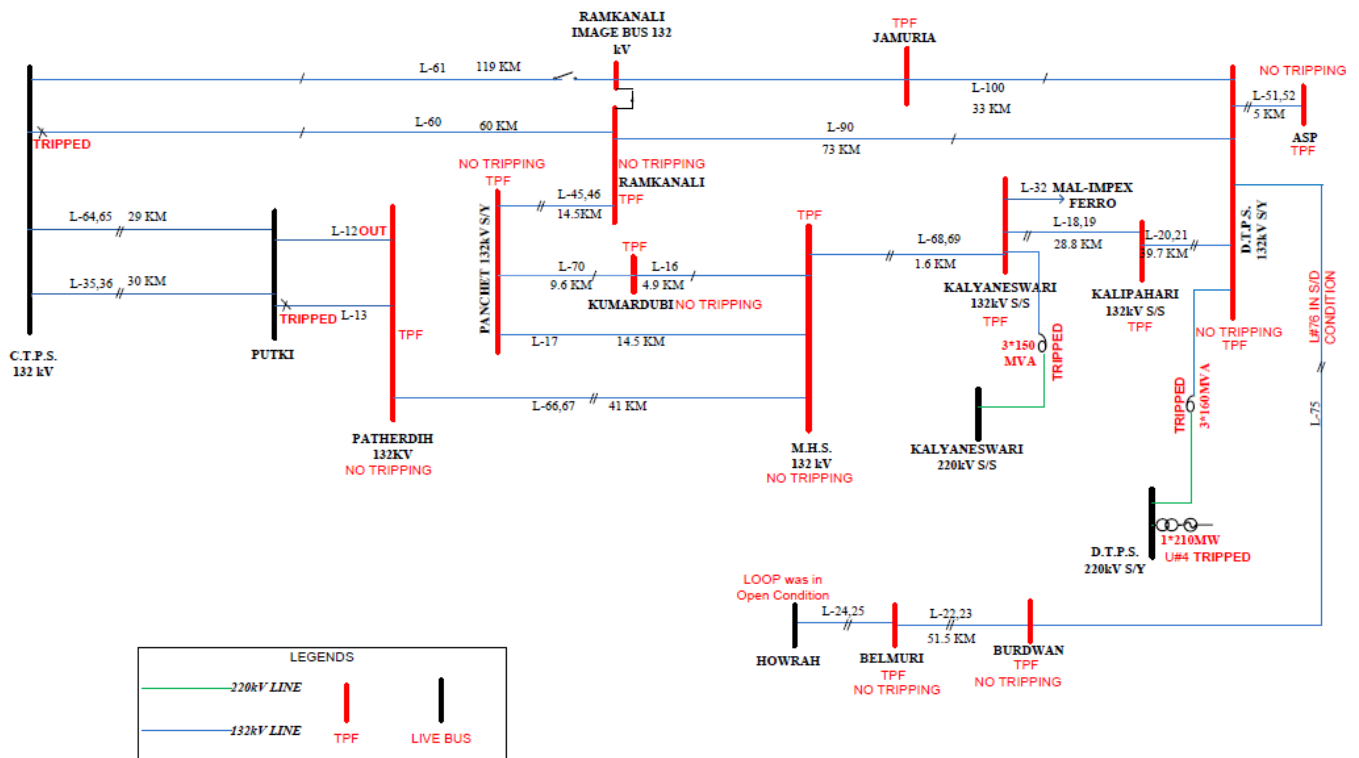
On 19.01.18 at around 12.25 Hrs a wide spread total power failure occurred in 132kV DVC system due to outage of 220kV Bus-1 in Kalyaneswari S/stn and subsequent outage of Three ATRs, U#4 in DTPS, Line#60 from CTPS and Line #13 from Putki end. The other affected 132kV S/Stns are Kalipahari, Kumardhubi, Burdwan Patherdih, Sindri, MHS, Ramkanali, PHS, Jamuria, Belmuri, ASP.

1. After completion of maintenance of 220 kV Main Bus-2; the Lines, ATRs and Power Transformers are distributed in both the Buses. Bus Differential Protection was put into service through switches. The sequence of putting Bus bar in service was Check zone

2. After putting all the switches in service, it was observed that Main Zone-1 (i.e Bus-1) Busbar protection relay had operated. However, as the Check Zone did not operate, no tripping took place.
3. Thereafter, the Bus bar switches were made off again. The Busbar Relay flags were made reset and again it was tried to put the Bus Bar protection in service. As far as the operator could recall, the same sequence was followed this time also for putting Bus Bar Switches in service.

However, in this case Bus Bar protection again operated for MainBus-1, but this time tripping took place for the Bays connected to Main Bus-1.

4. In Main Bus-1, Two ATRs were connected and with the outage of these two ATRs third ATR which was connected to Main Bus-2 also tripped due to overloading.

5. With the outage of Kalyaneswari 132 kV Bus, the loading of Kalyaneswari S/S which was around 1550 A at that instant (as per last available records) was started being fed by DTPS ATRs through Line 20, L#21, L#90 and L#100 as the Howrah loops were open. The DTPS ATRs were already feeding a load of around 1400A. This additional load caused tripping of DTPS ATRs through O/C Protection (P.U value 1000A). This causes outage of auxiliary power of U#4 (running at 180 MW) which ultimately led to the tripping of U#4.

6. With outage of Kalyaneswari and DTPS 132 kV system; L#60 from CTPS end and Line #13 from Putki end also tripped through D/O/C due to overload which finally causes TPF at Kalipahari, Kumardhubi, Burdwan Patherdih, Sindri, MHS, Ramkanali, PHS, and Jamuria, Belmuri, ASP.

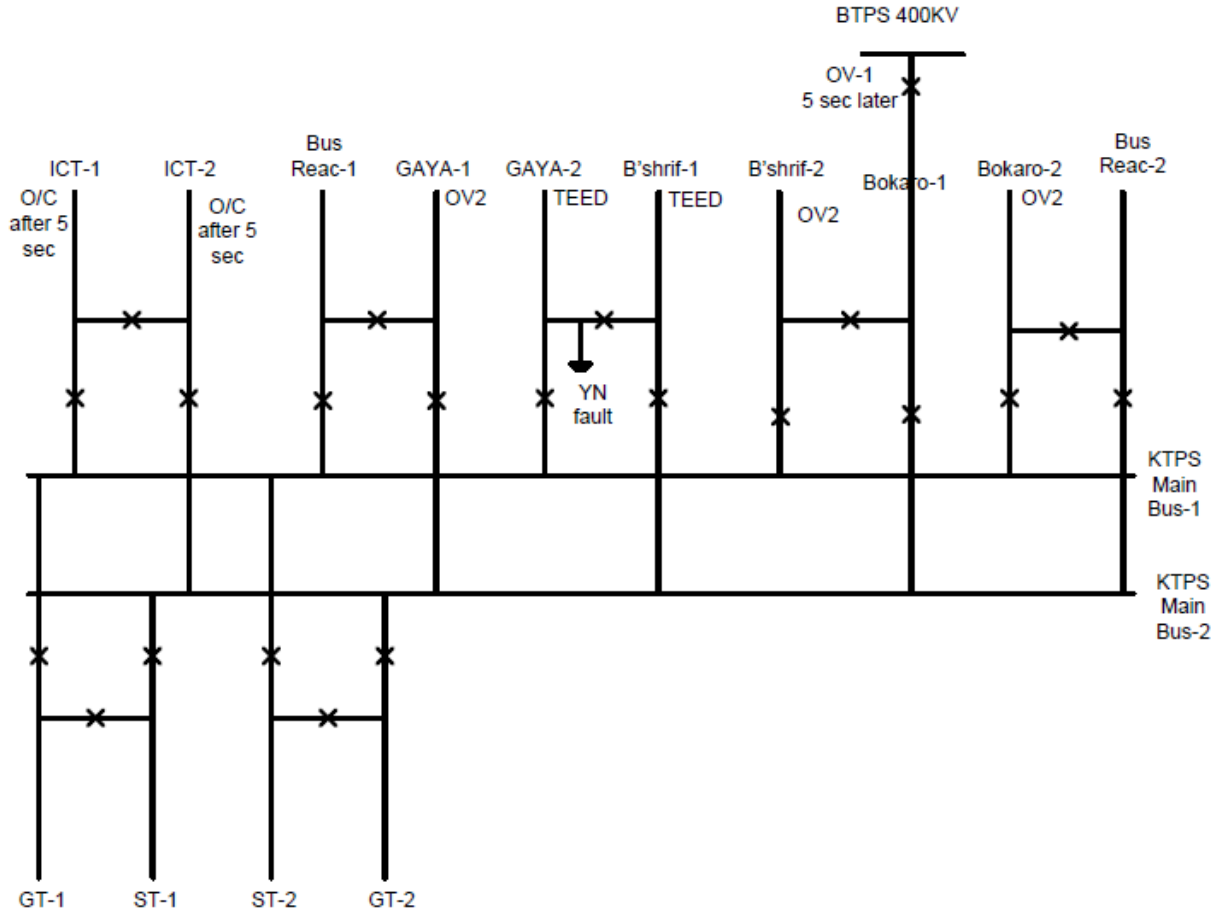
Due to problem in tie CB of 400 kV Koderma - Gaya - II and 400 kV Koderma - Biharshariff - II, all 400 kV lines i.e. 400 kV Koderma - Biharshariff D/C, 400 kV Koderma - Gaya D/C & 400 kV Koderma - Bokaro A D/C along with all 400/220 kV ICTs at Bokaro A & Koderma tripped resulting loss of total power supply at Koderma and Bokaro A and running units at Koderma & Bokaro A.

At 400KV Koderma, tie breaker to GAYA line-2 and BIHARSHARIF line-1 was under maintenance to attend leakage in hydraulic mechanism and to replace it's damaged Trip Coil. During normalisation of Tie breaker after maintenance work, Isolator 14-89B didn't CLOSE from REMOTE, the said isolator was checked for closing in LOCAL Mode. As the isolator got engaged, heavy flashing was observed in Y-pole of Tie breaker assembly (414), consequently both the units got tripped due to CLASS A protection along with tripping of all 400KV lines and ICT # 1 & 2 resulting in total power failure in 400KV switchyard.

1. GAYA-2 (413) TEED & BIHARSHARIF-1(415) TEED protection operated.
2. GAYA 1, BOKARO 2, BIHARSHARIFF 2 O/V Stage 2 operated instantaneously.
3. BOKARO-1(421): DT received due to O/V at BTPS A due to power evacuation problem.
4. ICT 1 & 2 trip through O/C.
5. ST#1 & 2: Through under voltage in LV side.

1. Gaya 2 & BiharShariff 1 tripped through TEED Differential to clear the fault within about 80ms.
2. During appearance of the YN fault, all the DRs show temporary rise in BN and RN voltages with BN voltage rising above 140% i.e. O/V stage 2. Thus O/V stage 2 appears in all the lines causing all power to be fed through BTPS 1.
3. After BTPS 1 trips through O/V Stage 1(5 sec later) at BTPS end, ICTs of KTPS trips through O/C due to overloading.
