Minutes  
of  
**64<sup>th</sup> PCC meeting**

**Date: 12.03.2018**  
**Eastern Regional Power Committee**  
**14, Golf Club Road, Tollygunge**  
**Kolkata: 700 033**

## MINUTES OF 64<sup>TH</sup> PROTECTION SUB-COMMITTEE MEETING HELD AT ERPC, KOLKATA ON 22.02.2018 (THURSDAY) AT 11:00 HOURS

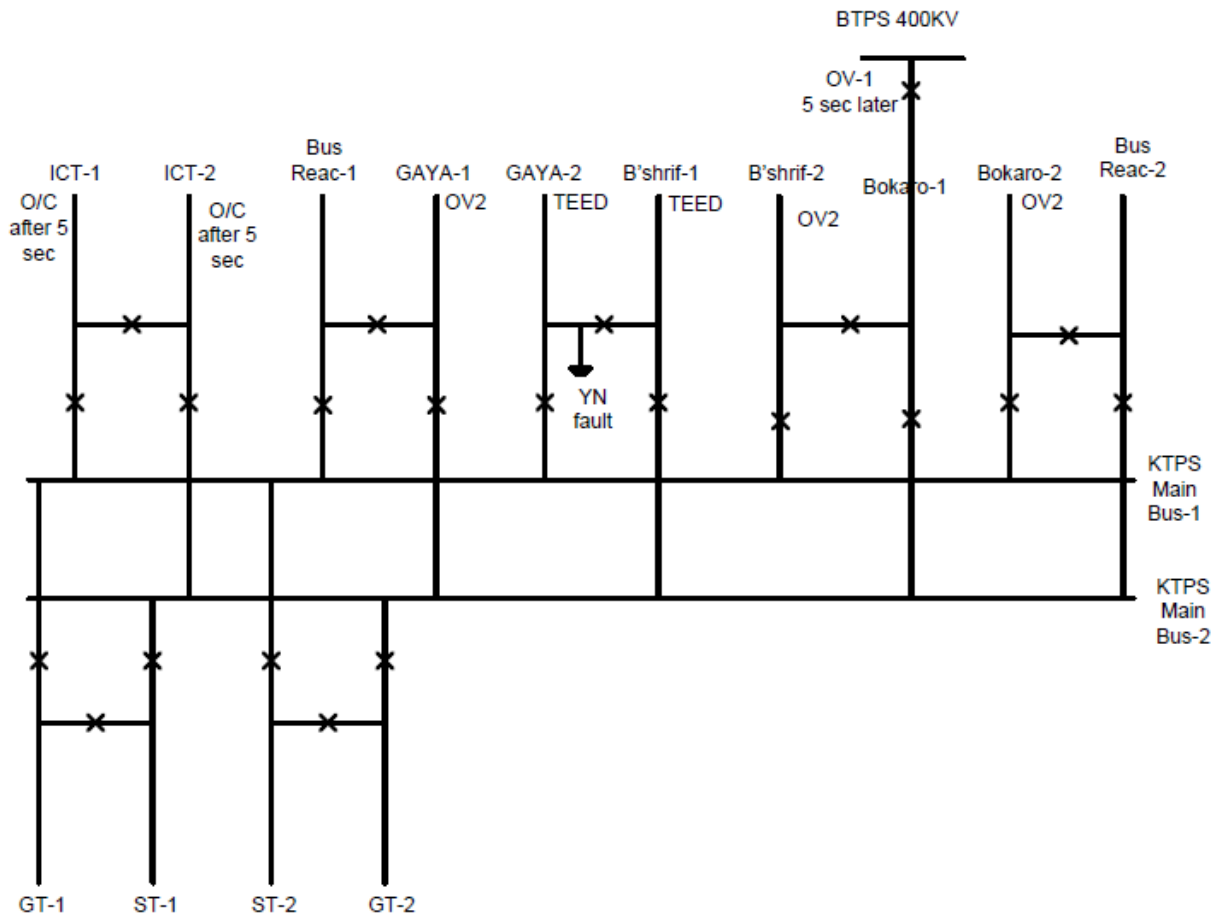
At 400KV Koderma, tie breaker to GAYA line-2 and BIHARSHARIF line-1 was under maintenance to attend leakage in hydraulic mechanism and to replace it's damaged Trip Coil. During normalisation of Tie breaker after maintenance work, Isolator 14-89B didn't CLOSE from REMOTE, the said isolator was checked for closing in LOCAL Mode. As the isolator got engaged, heavy flashing was observed in Y-pole of Tie breaker assembly (414), consequently both the units got tripped due to CLASS A protection along with tripping of all 400KV lines and ICT # 1 & 2 resulting in total power failure in 400KV switchyard.

1. Gaya 2 & BiharShariff 1 tripped through TEED Differential to clear the fault within about 80ms.
2. During appearance of the YN fault, all the DRs show temporary rise in BN and RN voltages with BN voltage rising above 140% i.e. O/V stage 2. Thus O/V stage 2 appears in all the lines causing all power to be fed through BTPS 1.

3. After BTPS 1 trips through O/V Stage 1(5 sec later) at BTPS end, ICTs of KTPS trips through O/C due to overloading.

DVC explained that heavy flashing was observed in Y-pole of Tie breaker assembly (414) during normalization of Tie breaker after maintenance work.

- TEED protection of GAYA-2 (413) TEED & BIHARSHARIF-1(415) had operated and tripped the respective lines.
- Over voltage Stage 2 had operated for GAYA 1, BOKARO 2, BIHARSHARIFF 2 lines and the lines tripped instantaneously.
- DT received at Koderma end due to O/V stage I operation at BTPS A.
- As a result, ICTs of KTPS end were tripped through O/C protection due to overloading.

DVC informed that over voltage was not observed in Bus CVT but the line CVTs were observed the over voltage in B and R phases during the Y-N fault as per the DR plot.

- All over voltage settings have been revised.
- All stage 1 settings revised to 110% and 5 sec. In case of Double Ckt lines the second line now has the setting 112% and 8sec.
- Over voltage Stage 2 is revised to 140% for both the lines with a time delay of 100ms.

PCC opined that voltage of healthy phases may rise if CVT neutral earthing is not proper and advised DVC to check the line CVTs neutral earthing.
