Agenda
for
65th PCC meeting

EASTERN REGIONAL POWER COMMITTEE

AGENDA FOR 65TH PROTECTION SUB-COMMITTEE MEETING TO BE HELD AT ERPC, KOLKATA ON 28.03.2018 (WEDNESDAY) AT 11:00 HOURS

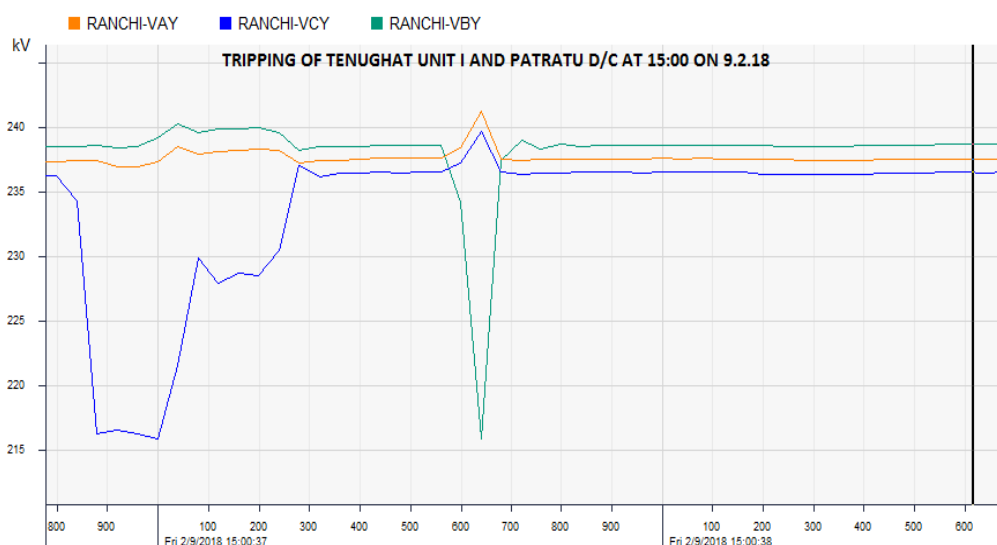
Analysis of PMU plots:

There was a fault at 220 KV Patratu-Hatia ckt II as jumper and insulator disc puncture has been found in this circuit. As per PMU data, fault was not cleared within the specified time which may results in cascaded tripping in nearby region.

In PMU data, two faults have been observed. First fault was in B phase at 15:00:36.800 hrs which was cleared in 500 ms. 300 ms after clearing the first fault, another fault was observed in Y phase which was cleared within 100 ms.
