ERLDC Agenda Items for 65th PCC Meeting

Agenda 1: Low Frequency Oscillation (LFO) observed in Pan India grid on 17th March 2018 from 02:43 Hrs. to 02:48 Hrs.

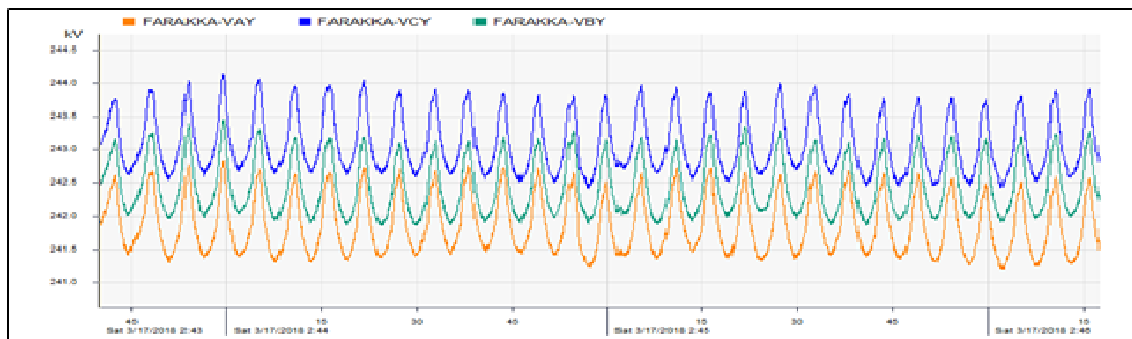
Low frequency oscillation of 0.37 Hz was observed in the pan-India grid on 17th March 2018 from 02:43 hrs. to 02:48 hrs. Based on the synchrophasor data analysis for the Indian grid, it is noted that oscillation was more prominent in the Eastern region near Farakka STPS. Oscillations of Farakka bus voltage as recorded by the PMU installed there is given in the figure below. Based on analysis of all India SCADA data, it was found that there were large variations in the MW and MVAR generation of the Kahalagaon Unit 6 during the same time period. On inquiry with KhSTPS, it was reported that there was some issue with the Kahalgaon unit 6 turbine Electro-hydraulic governor (EHG) due to which its control valves oscillated causing Unit generation to fluctuate from 40 MW to 470 MW, as can be seen from the MW and MVAR plot received from NTPC. The time of LFO initiation in the grid as recorded by PMUs, and that of Kahalgaon MW/MVAR fluctuations matched with each other. Further, on examining the all India SCADA data of generating units obtained from NLDC it was observed that no other unit has experienced such severe oscillation in its MW/MVAR during the period. So, it can be inferred from the analysis that oscillation was excited in the grid due to the malfunctioning of turbine EHG of Kahalgaon Unit 6.

Fig 1: Farakka Bus Voltage from PMU.

1. NTPC Kahalgaon may kindly explain the issue with the turbine EHG governor of their U-6 and the remedial action taken so that such event does not reappear in near future as these have an adverse impact on the entire the Indian Grid.

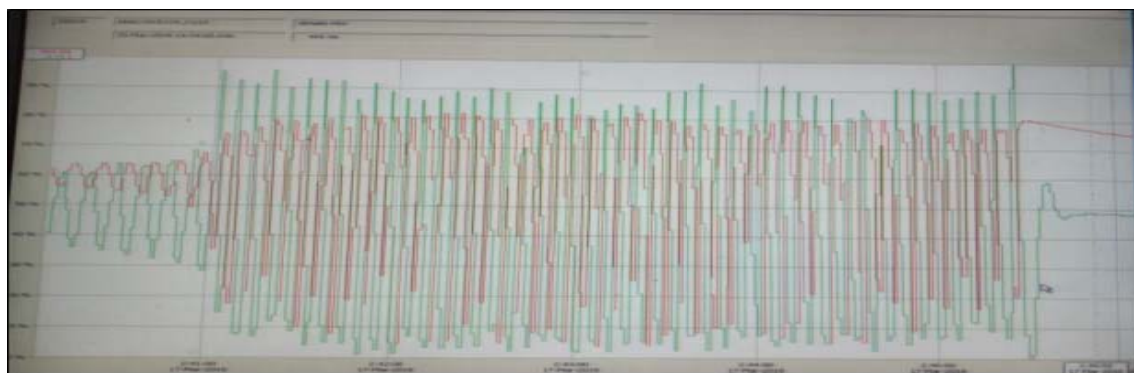
Fig 2: MW and MVAR of Kahalgaon Unit 6 received from NTPC.
