# Minutes of **65<sup>th</sup> PCC meeting**

# EASTERN REGIONAL POWER COMMITTEE

## MINUTES OF 65<sup>TH</sup> PROTECTION SUB-COMMITTEE MEETING HELD AT ERPC, KOLKATA ON 28.03.2018 (WEDNESDAY) AT 11:00 HOURS

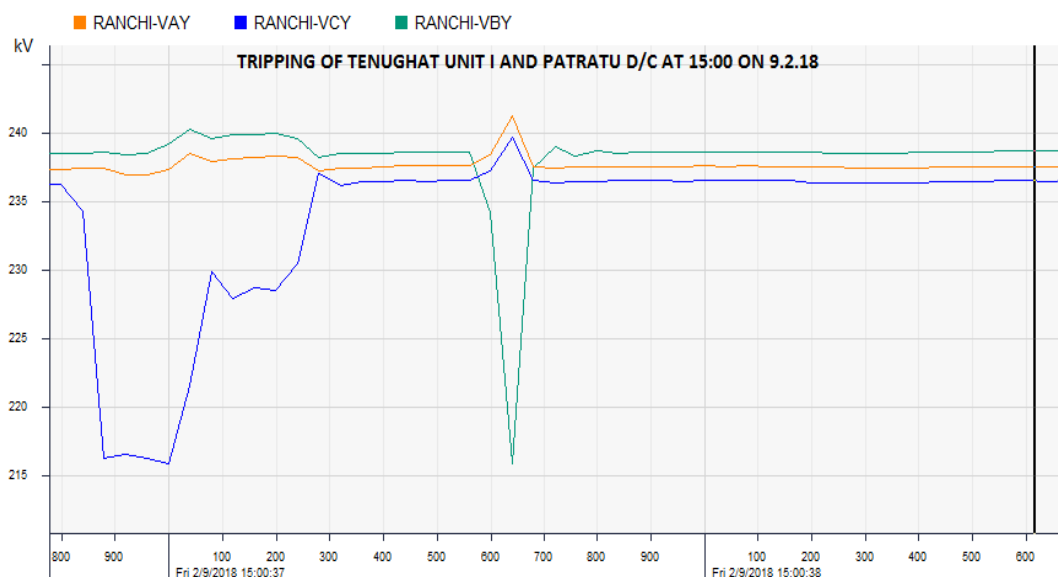
## Analysis of PMU plots:

In PMU data, two faults have been observed. First fault was in B phase at 15:00:36.800 hrs which was cleared in 500 ms. 300 ms after clearing the first fault, another fault was observed in Y phase which was cleared within 100 ms.

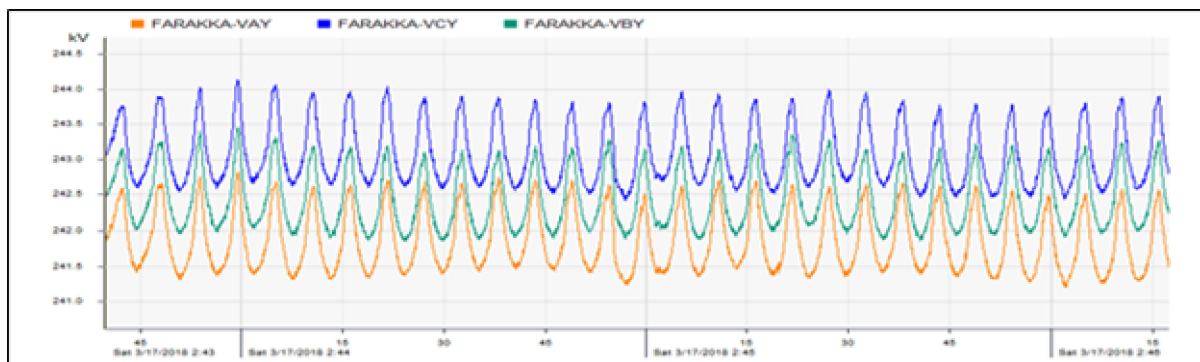
**Fig 1: Farakka Bus Voltage from PMU.**

Low frequency oscillation of 0.37 Hz was observed in the pan-India grid on 17<sup>th</sup> March 2018 from 02:43 hrs. to 02:48 hrs. Based on the synchrophasor data analysis for the Indian grid, it is noted that oscillation was more prominent in the Eastern region near Farakka STPS. Oscillation of Farakka bus voltage as recorded by the PMU installed there is given in the figure below. Based on analysis of all India SCADA data, it was found that there were large variations in the MW and MVAR generation of the Kahalgaon Unit 6 during the same time period. On inquiry with KhSTPS, it was reported that there was some issue with the Kahalgaon unit 6 turbine Electro-hydraulic governor (EHG) due to which its control valves oscillated causing Unit generation to fluctuate from 40 MW to 470 MW, as can be seen from the MW and MVAR plot received from NTPC. The time of LFO initiation in the grid as recorded by PMUs, and that of Kahalgaon MW/MVAR fluctuations matched with each other. Further, on examining the all India SCADA data of generating units obtained from NLDC it was observed that no other unit has experienced such severe oscillation in its MW/MVAR during the period. So, it can be inferred from the analysis that oscillation was excited in the grid due to the malfunctioning of turbine EHG of Kahalgaon Unit 6.

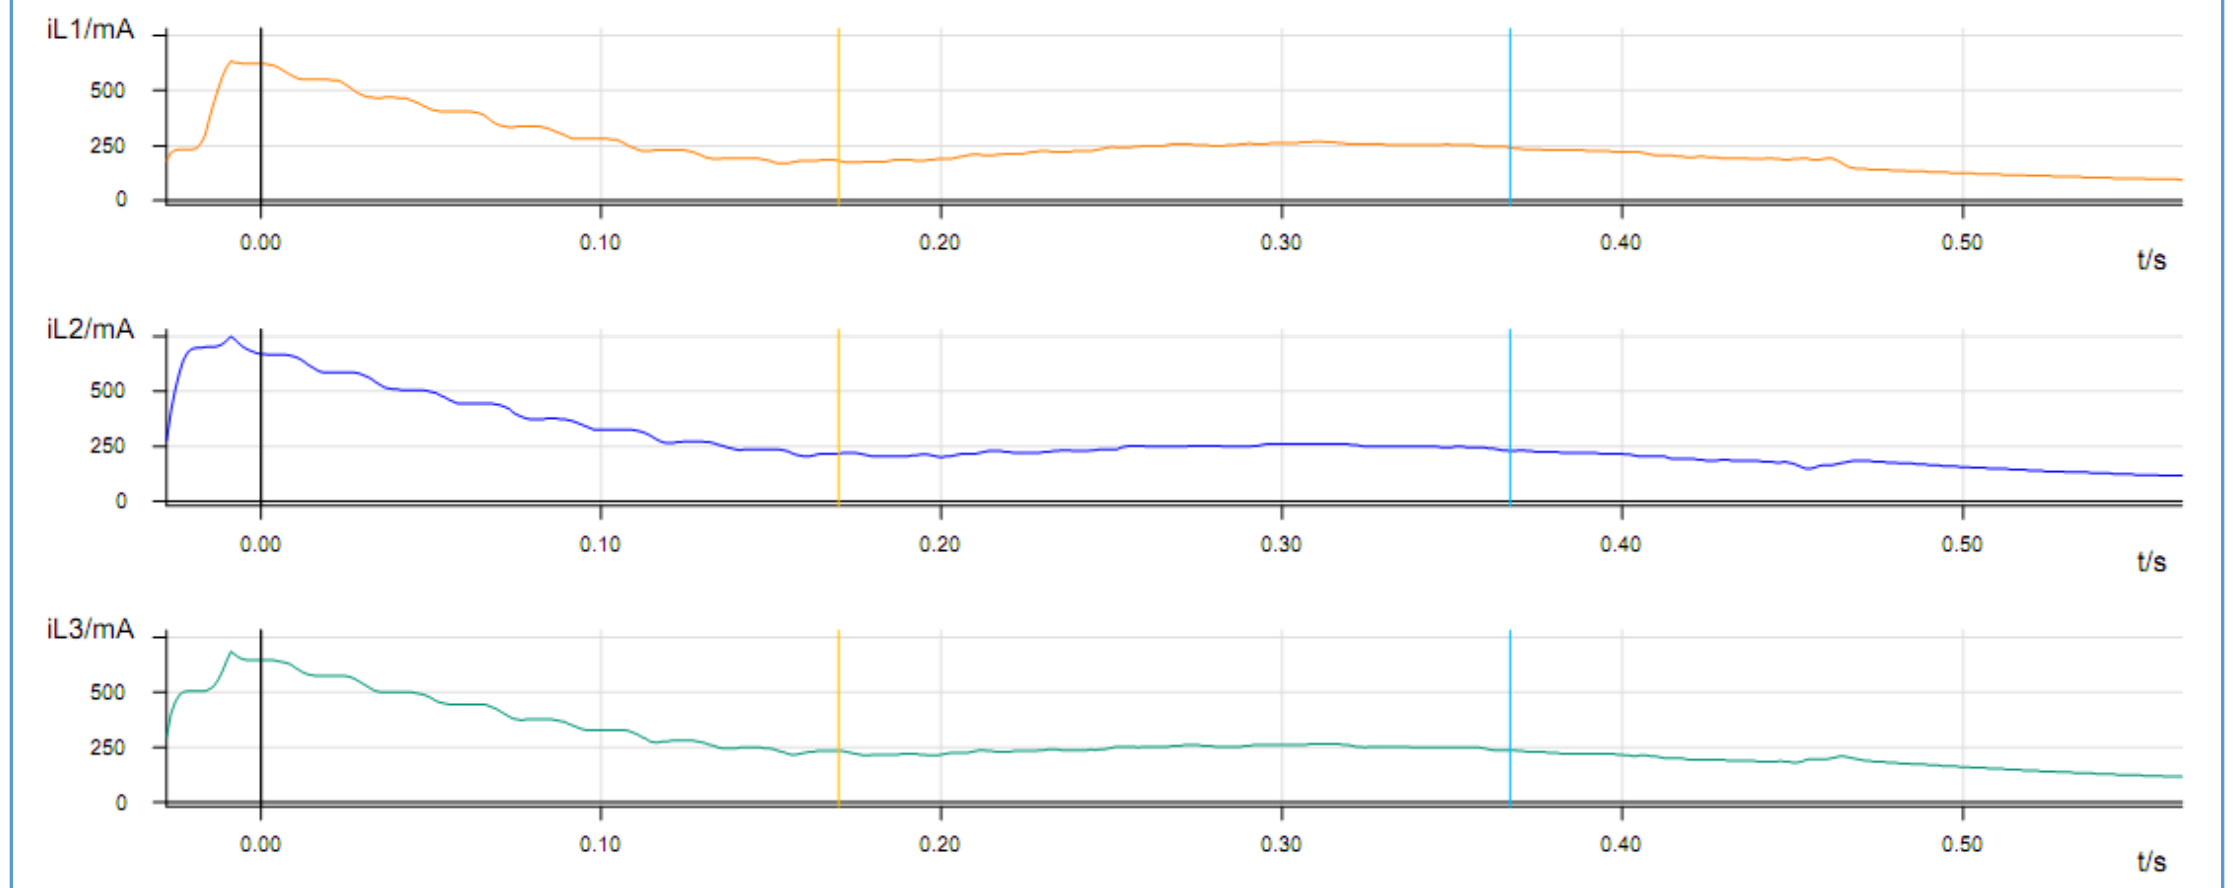
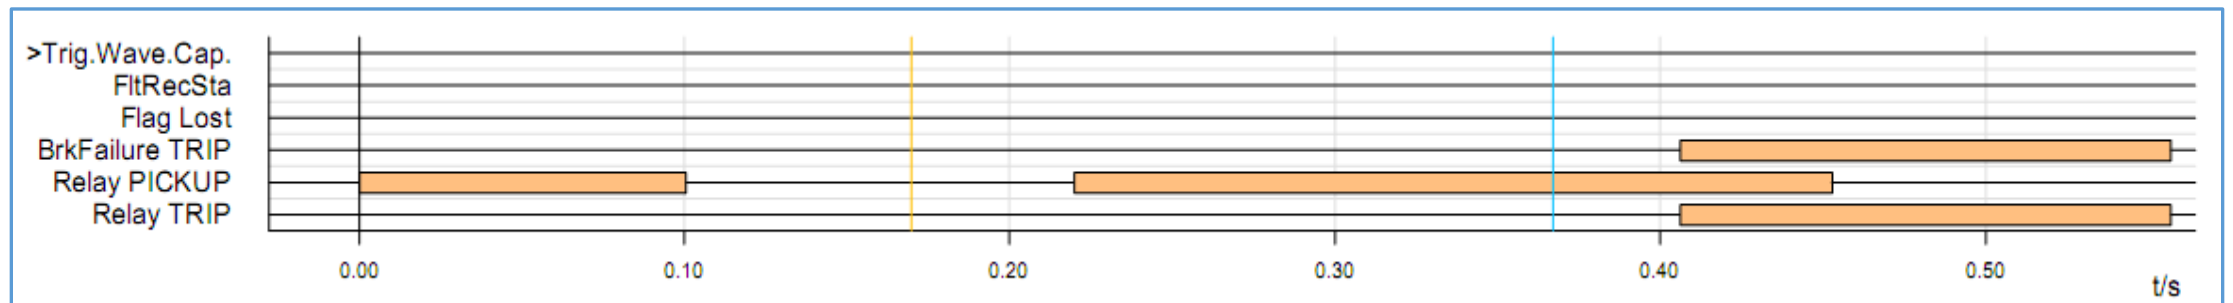
# UNIT # 4 LBB DR

- On 19.02.18 at around 18.10 Hrs U#4 was going to be synchronised through Main Bus-1. But, as soon as the Breaker Close pulse was provided, LBB protection operated and all the Bays connected to Main Bus-1 and Bus Section 1-3 Breaker tripped through 96 Relays.
- With the failure of Main Bus-1, SST – A tripped leading to failure of Emergency Boards of U # 2 which caused failure of AVR Thyristor cooling fan. This initiated a Class-A tripping for U#2 which was on Main Bus-2.
- With operation of Class-A Lock-out of U#2, trip pulse was issued to GT#2 Breaker. But GT#2 LBB operated as Y and B-Pole had delayed opening.

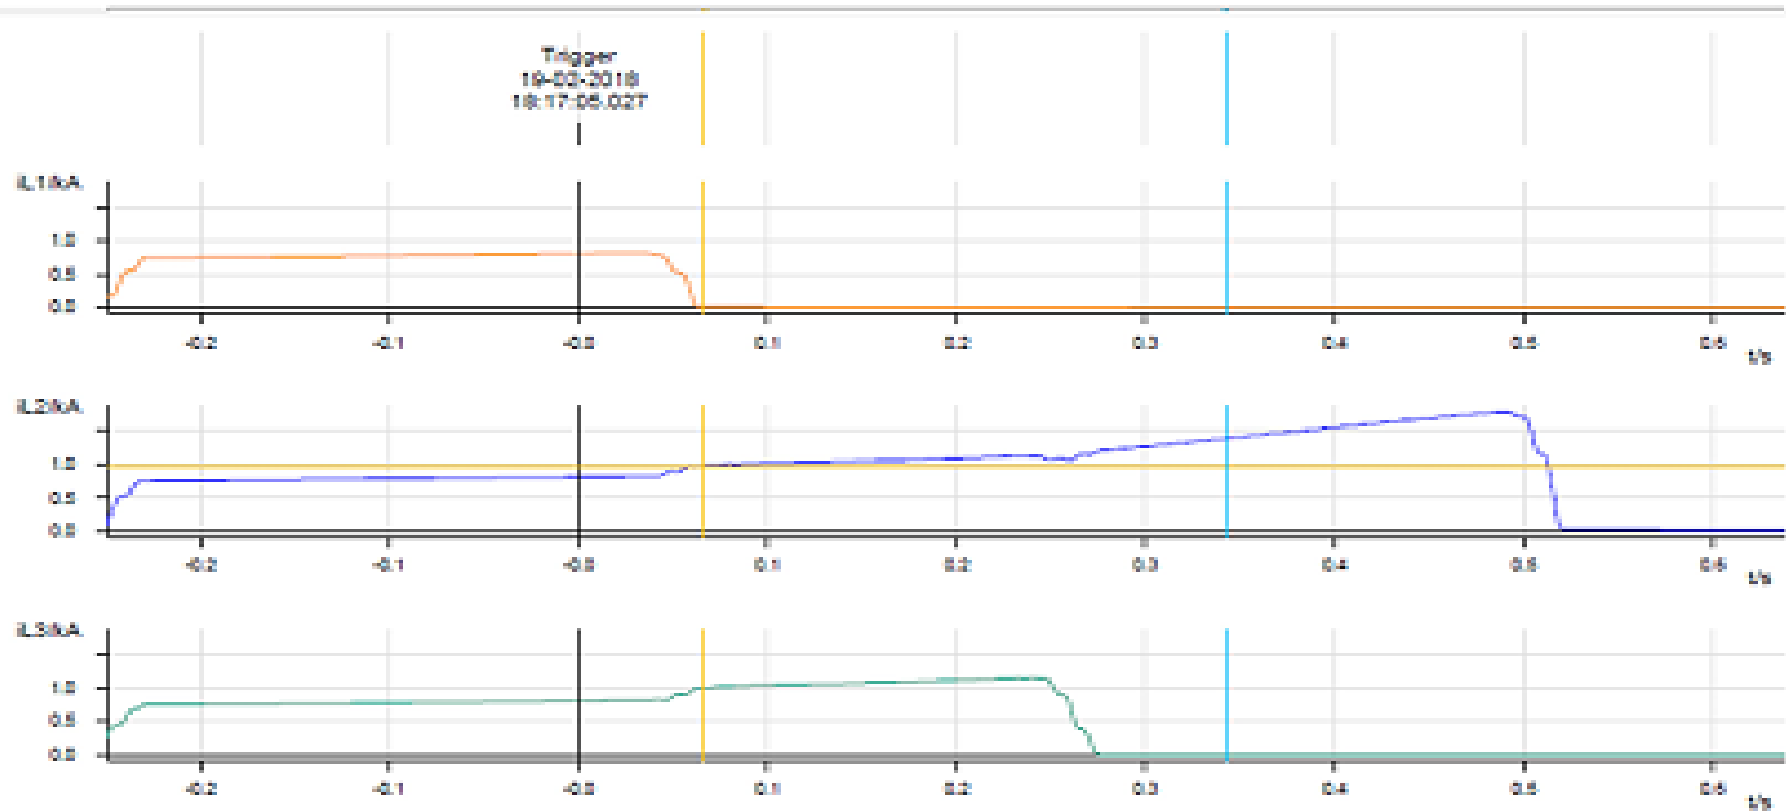
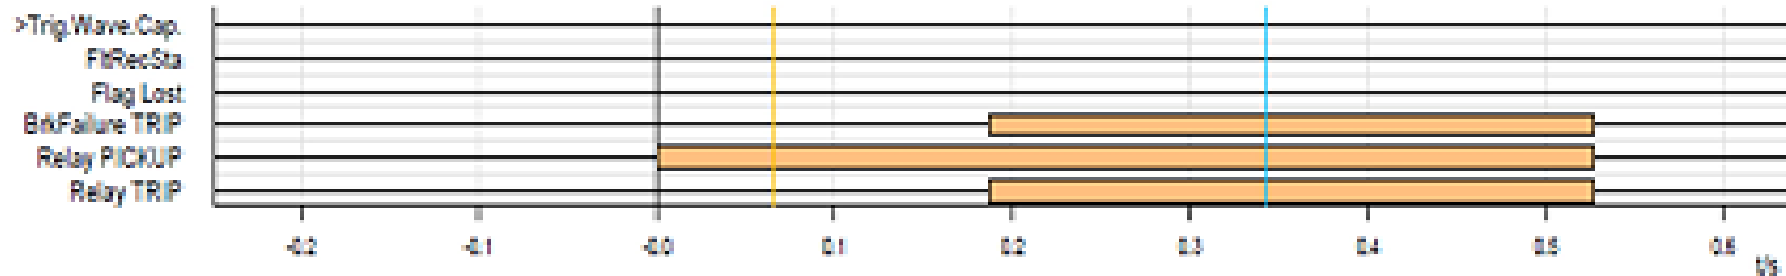
# LBB UNIT # 2 DR

Fault Record obtained from LBB relay of Unit#2

- With the initiation of GT#2 LBB protection, 96 Lock-out Relays of all the bays of Main Bus #2 and Bus Section 2-4 operated.
- However, Bus section 2-4 Breaker failed to trip . In this Breaker Y pole got stuck and initiated LBB protection of Bus Section 2-4 which resulted in tripping of all the bays associated with Main Bus-4.
- This ultimately results in failure of Main Bus-1, 2 and 4 causing outage of U # 2, 3 and 6.
