Minutes of **68th PCC meeting**

Date: 05.07.2018
Eastern Regional Power Committee
14, Golf Club Road, Tollygunge
Kolkata: 700 033

MINUTES OF 68TH PROTECTION SUB-COMMITTEE MEETING HELD AT ERPC, KOLKATA ON 18.06.2018 (MONDAY) AT 10:30 HOURS

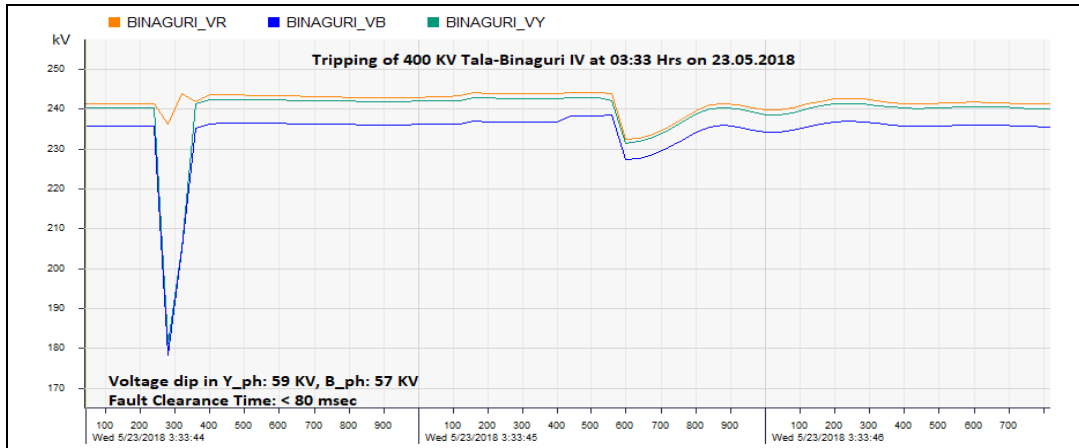
On 23rd May At 03:33 Hrs: 400 kV Binaguri-Talackt 4 tripped on Y-B phase to earth fault (Fault distance was 147.10 km from Binaguri end). At the same time 400 kV, Binaguri-Malbase ckt also tripped on B phase to earth fault however, it got successfully reclosed from Binaguri end. The circuit seems to have tripped from Malbase end. It can be seen that fault were located in the Bhutan side however details are not shared with ERLDC. The associated PMU plot is given.

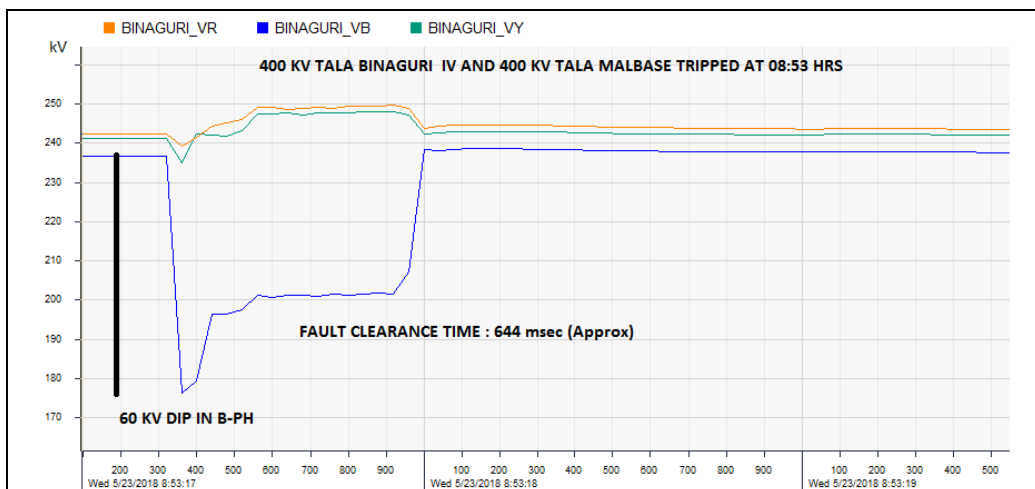
- 400 kV Binaguri-Talackt 4 tripped from Binaguri end on B phase to E/F in zone 2 (location of fault was 124.5 km from Binaguri end). Initially carrier signal was received due to which only B phase opened and A/R function and timer has started. However, within the next 133 ms direct trip was received at Binaguri from Tala causing three-phase tripping at Binaguri end.
- It was observed that the 400 kV Binaguri-tala 4 circuit did not trip from Tala end resulting in fault feeding on this circuit from 400 kV Binaguri-Malbase circuit. 400 kV Binaguri-Malbase circuit has first fed the fault in zone 3 from Binaguri end however, with tripping of 400 kV Binaguri-Tala 4 from Binaguri end, sensed the same in zone 2 and tripped in next 500 ms. The fault location observed for this circuit from Binaguri end was 145 km indicating the fault of 400 kV Binaguri-Tala 4 ckt.

This led to blackout of 400 kV Tala substation causing loss of 447 MW generation. The tripping of 400 kV Malbase-Tala circuit is not shared with ERLDC as this circuit might also have tripped during the blackout of Tala generation.

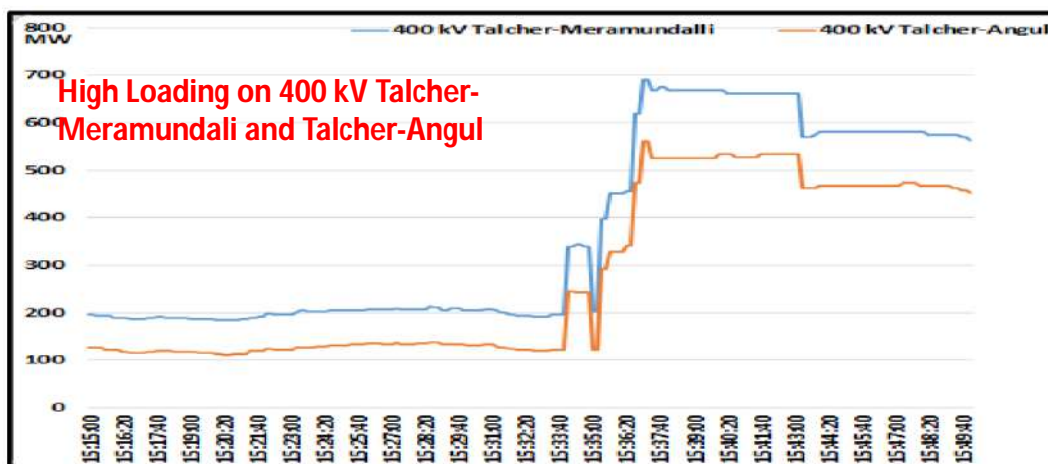
1. Severe loading on 400 kV Talcher-Meramundali and Talcher-Angul circuit (Refer Figure)
2. High loading on the 765/400 kV Vemagiri ICTs (Refer Figure).
3. Due to inadequate generation reduction at Talcher in eastern region the loading on 400 kV Talcher Stage 1 and 2 Interconnector were more than 1400 MW for 6 minutes (Refer Figure).

Figure: Loading of 400kV Talcher-Meramundali and Talcher-Angul on 16th may 2018

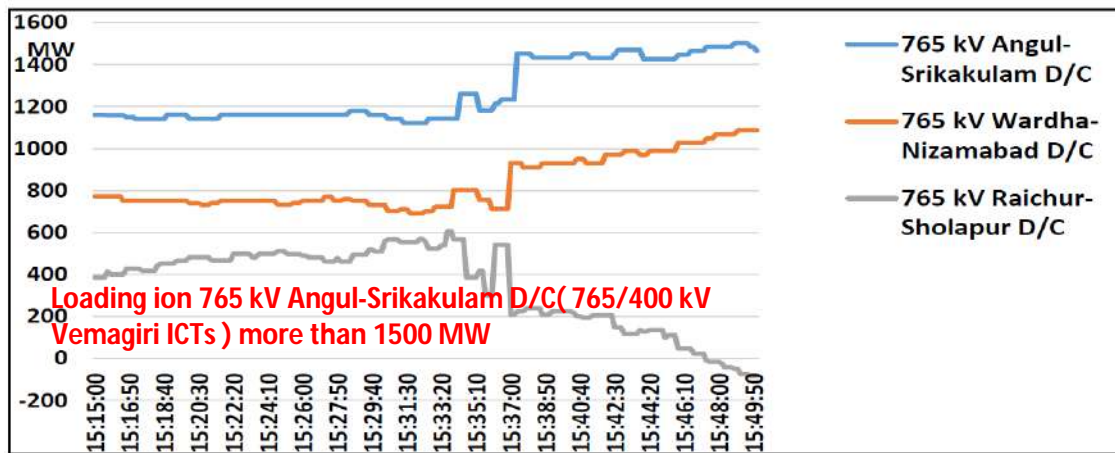
Figure: 2 X 1500 MVA Vemagiri ICTs loading (Same as 765 kV Angul-Srikakulam D/C power flows as no anchoring of 400 kV at Srikakulam) on 16th May 2018

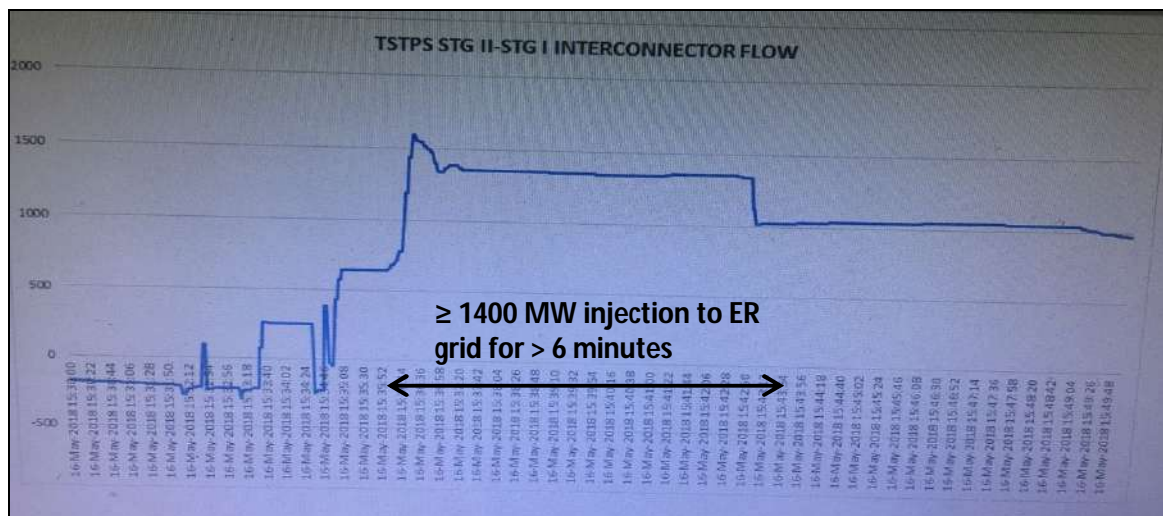
Figure: Loading of 400 kV Talcher stage 2- Stage 1 interconnectors on 16th May 2018

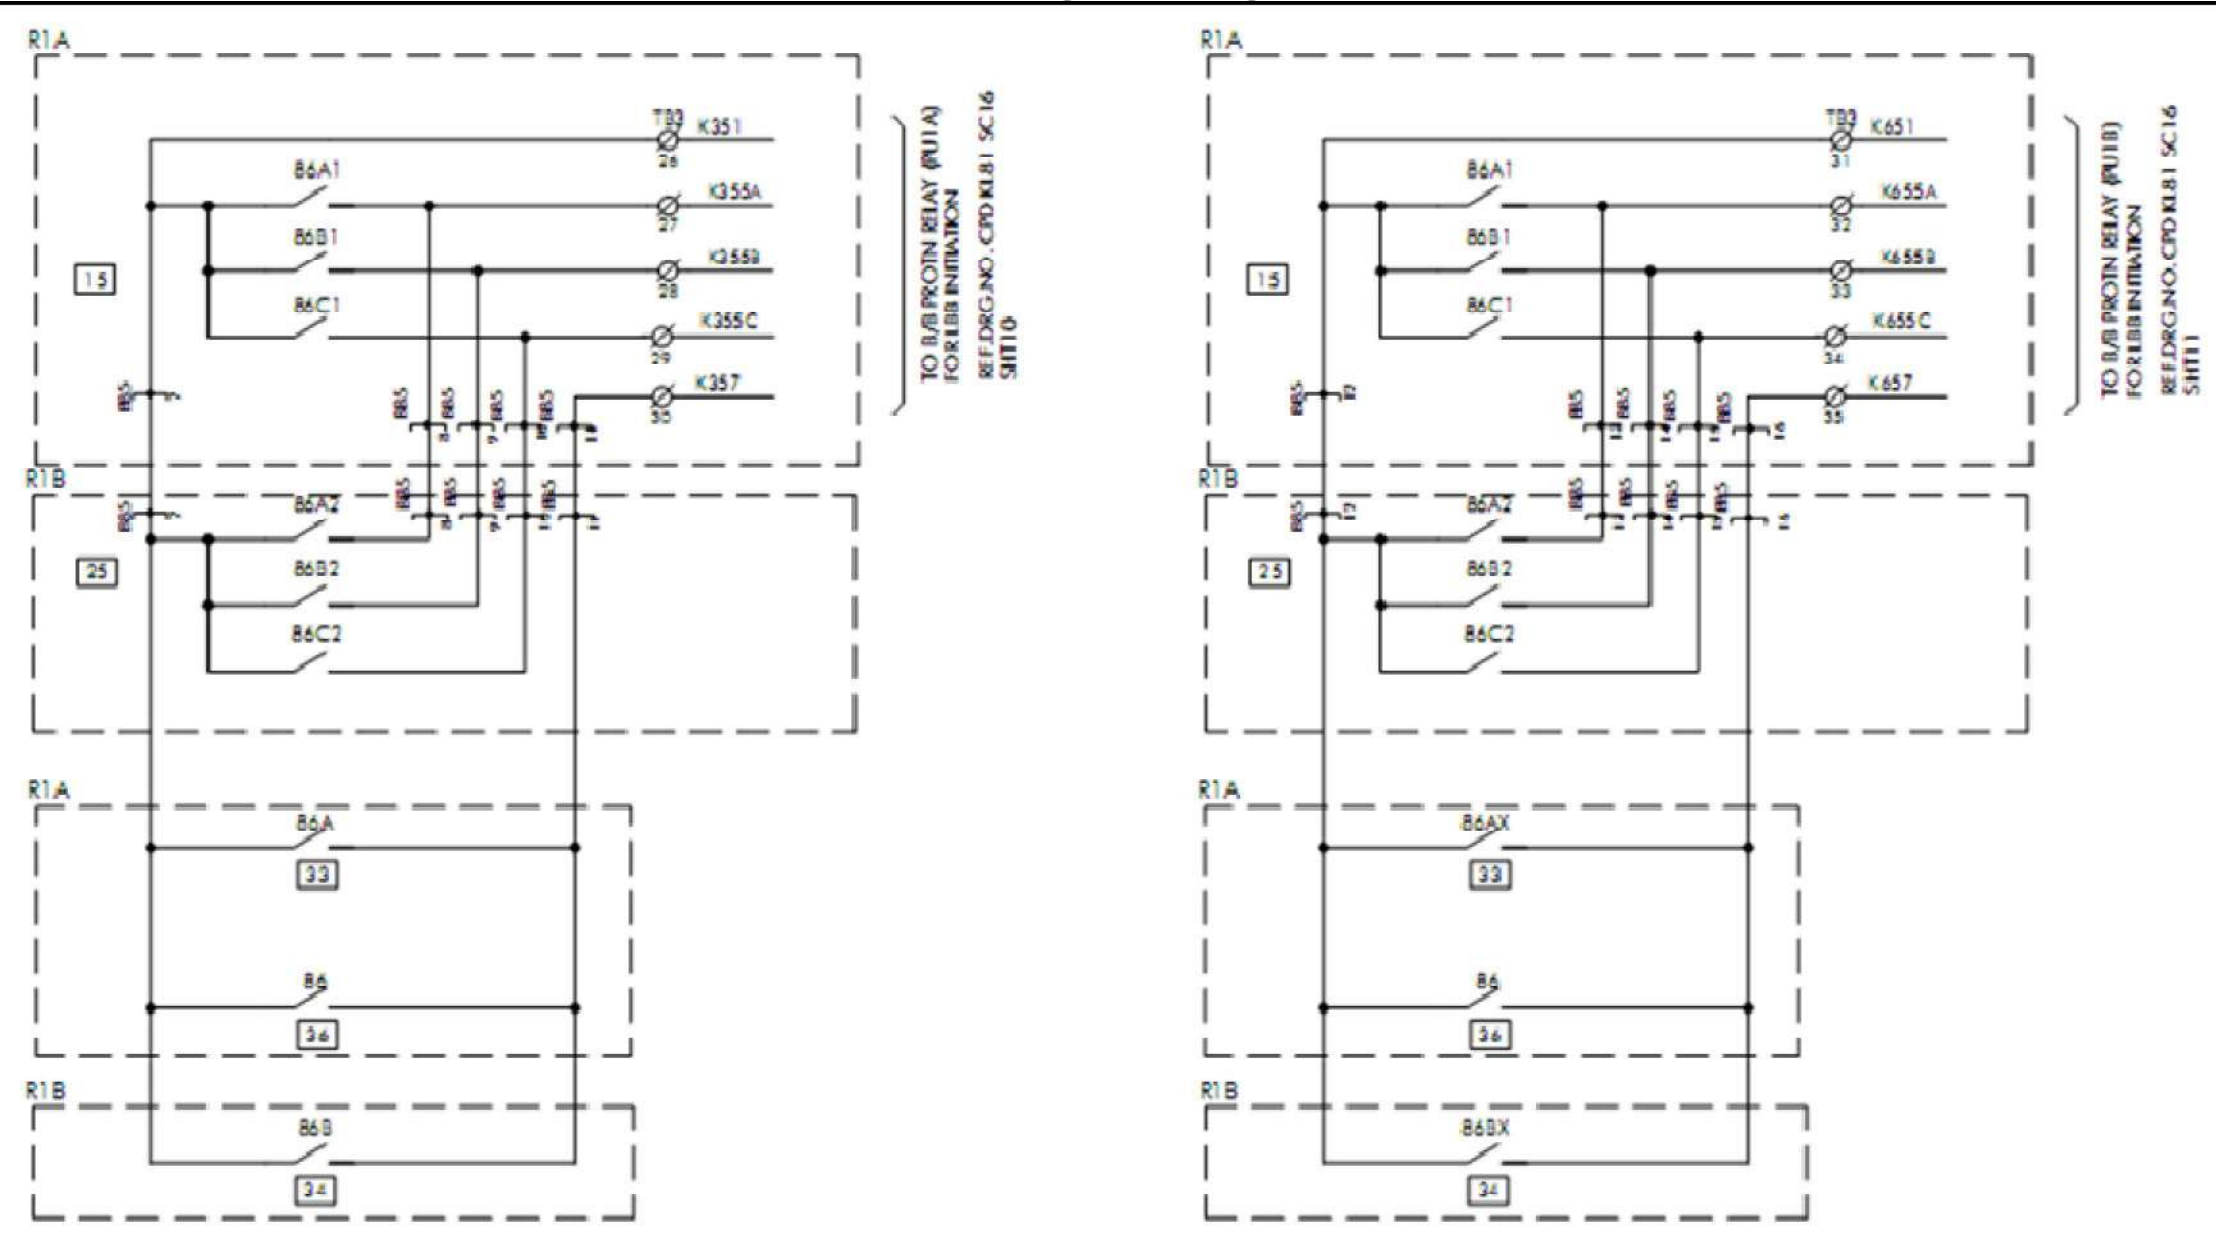
86 contacts going to LBB INI

- During checking of protection circuit of RTPS Line # 1, +ve wire for initiation of LBB in both PU1A & PU2A was found open in the TB3 26 & 31 respectively in R1A. This had resulted in non-appearance of LBB protection in RTPS # 1 leading to TPF at DSTPS 400KV.
- The opened LBB initiation DC +ve wire was reconnected as per drawing.

- The LED for LBB initiation present in Busbar Peripheral Units of each bays appears whenever there is any lockout operation in any bay.
- Shift personnel have been advised to note the appearance of this LED following any tripping before resetting the lockout relays. In case there is no appearance of LBB initiation LED in any bay after appearance lockout relays leading to three pole trip during any tripping the same must be noted and reported.
- Maintenance and testing of all HV Circuit Breakers needs to be carried out at least once in a year which is currently the normal practice.

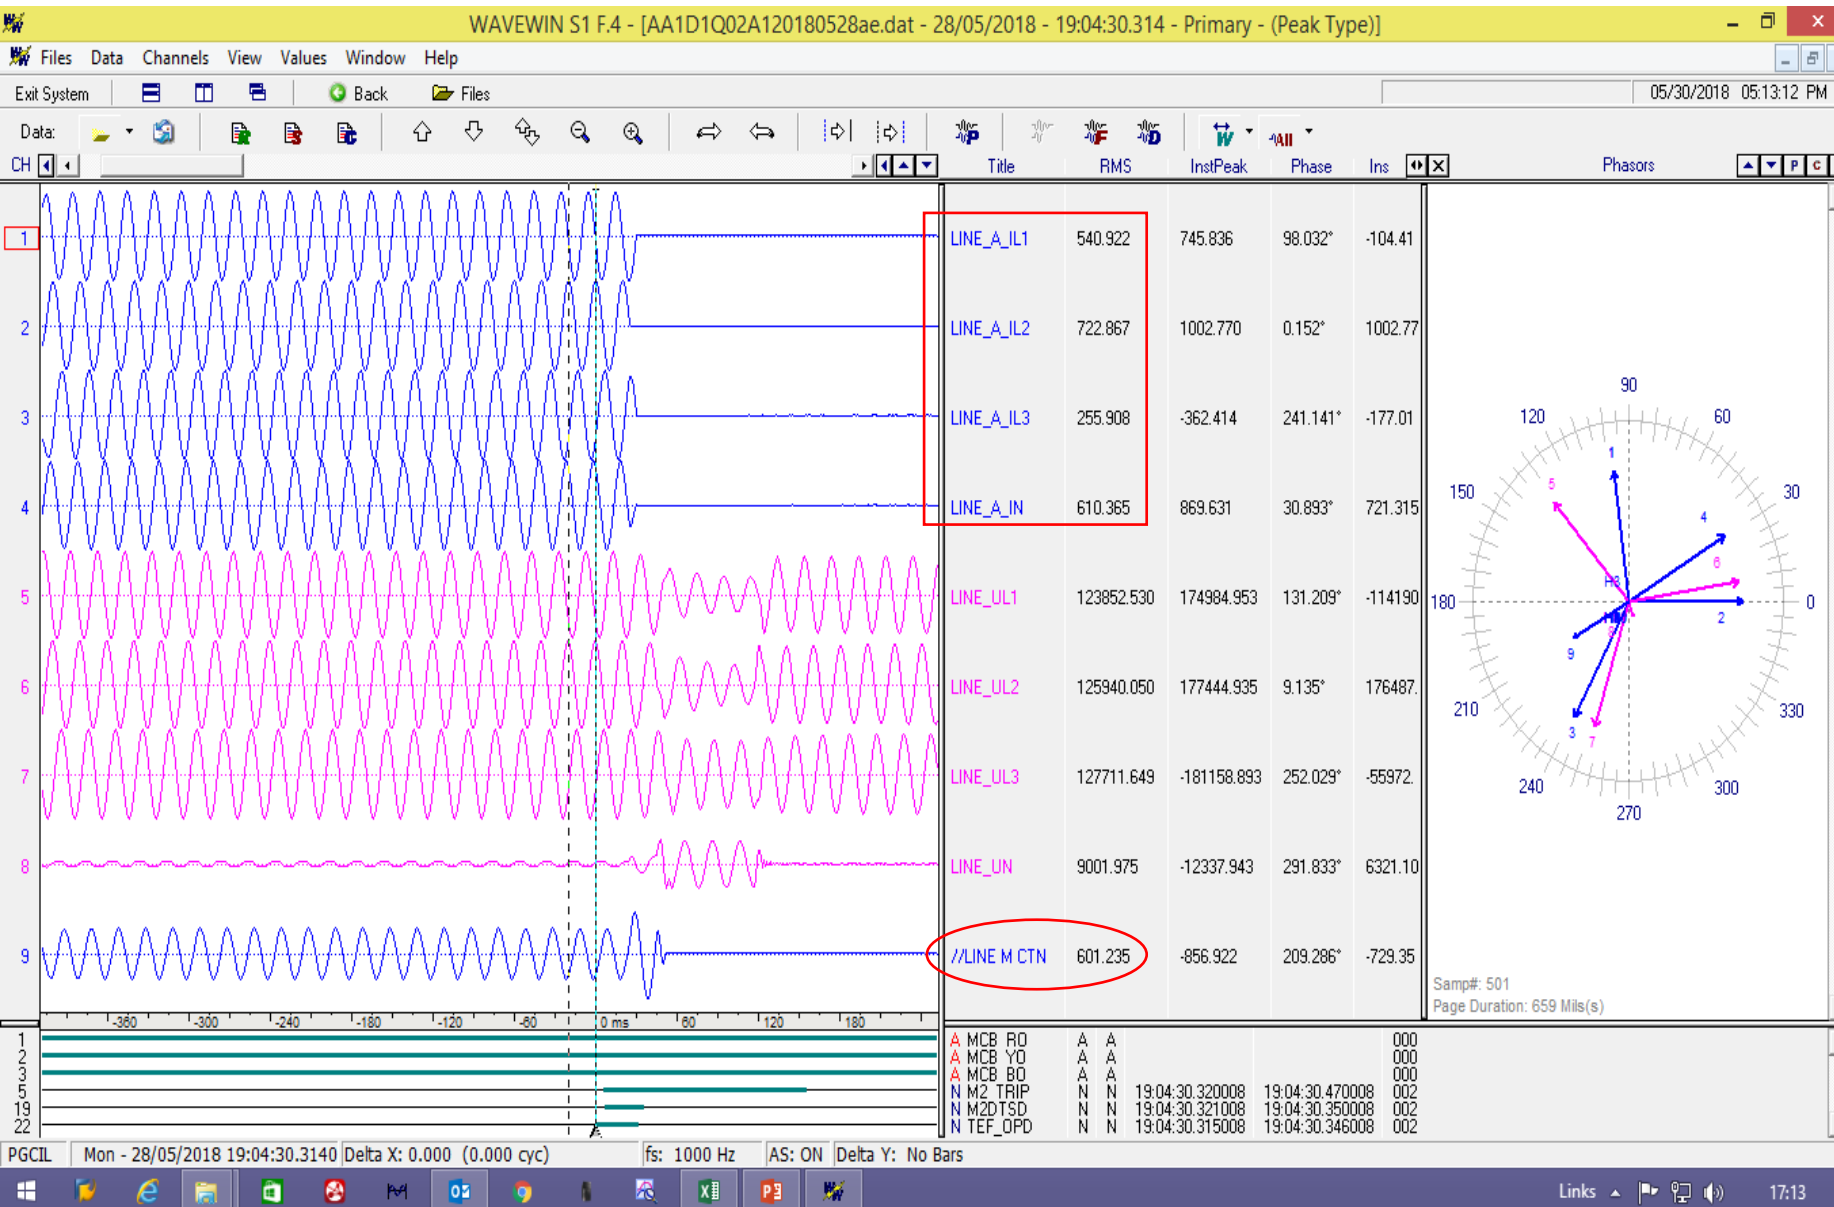
DR of Kishanganj Sub-station for Dalkhola-I Feeder

1. From Kishanganj end DR it is very much clear that no fault in 220 KV system as phase current is almost normal load current.
2. Rise in neutral current is due to unbalance in radial system / Load imbalance for sudden load shifting.

1. Preferably Bus Coupler at Dalkhola end , to be kept in open position, to avoid overloading of all connected links. In this case security will be compromised for 220 KV DLK-DLK-D/C & will be solely dependant upon Malda.
