Minutes of 70th PCC Meeting

Date: 06.09.2018 Eastern Regional Power Committee 14, Golf Club Road, Tollygunge Kolkata: 700 033

MINUTES OF 70TH PROTECTION SUB-COMMITTEE MEETING HELD AT ERPC, KOLKATA ON 21.08.2018 (TUESDAY) AT 10:30 HOURS

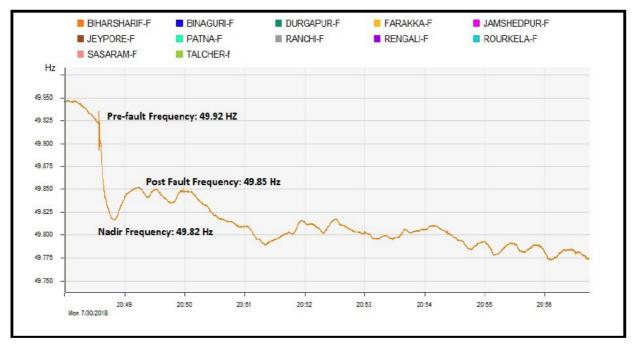
Total Generation Loss: 1057 MW

Due to Generation Loss Frequency dipped from 49.92 Hz to 49.81 Hz (Drop of .11 Hz) and stabilized at 49.85 Hz.

Fig: Frequency dip during the event

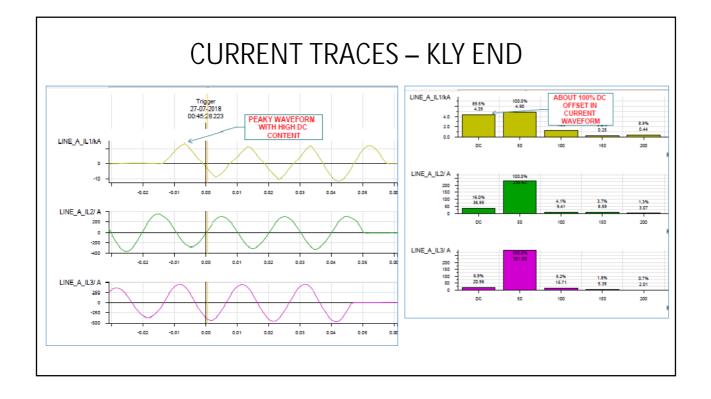
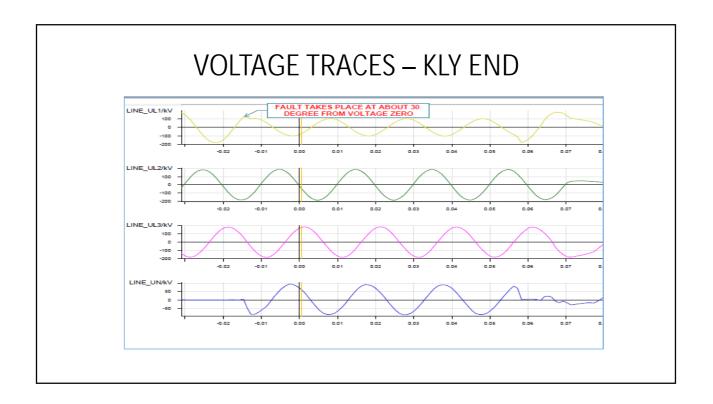
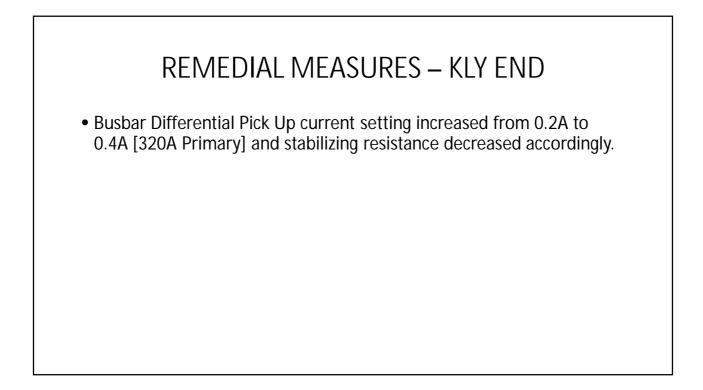
- At about 00:45 hrs of 27.07.18 there was a AN transient fault in L # 228[Kly MTPS]. Fault was cleared at both ends in Distance Zone 1. weather condition during fault was raining and thundering heavily.
- But along with it Kly Bus # 2[Line was in this bus] tripped through Busbar protection – both Main Zone & Check Zone. And at MTPS Bus # 2 [Line was on Bus # 2] tripped through LBB protection of the said line.
- At MTPS end L # 228 LBB timer had become instantaneous and had tripped the entire bus. Timer was replaced with healthy one.
- At Kly end busbar protection relays, CTs of L # 228, Busbar CT circuit IR etc. were done and everything was found O.K.

REASON FOR MALOPERATION OF BOTH MAIN ZONE AND CHECK ZONE

- No clear reason could be furnished.
- Fault was closer to Kly end with RMS current of about 8kA.
- But DR of L # 228 shows fault had occurred nearer to voltage zero and thus DC offset was very high (about 90% of fundamental) in faulted phase current.
- Probably such high DC current was responsible for CT saturation. L # 228 current was seen to be peaky in nature. DR of Kly end indicative of CT saturation.
- Probably lightning fault.

PCC advised DVC to replace the old EM type busbar relay at Kalyaneswari with numerical relay.

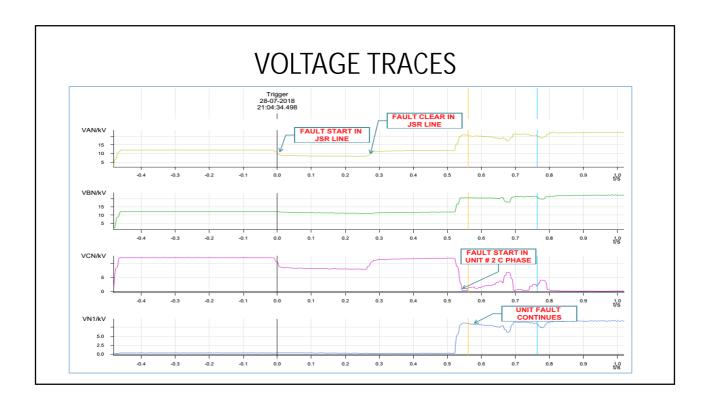
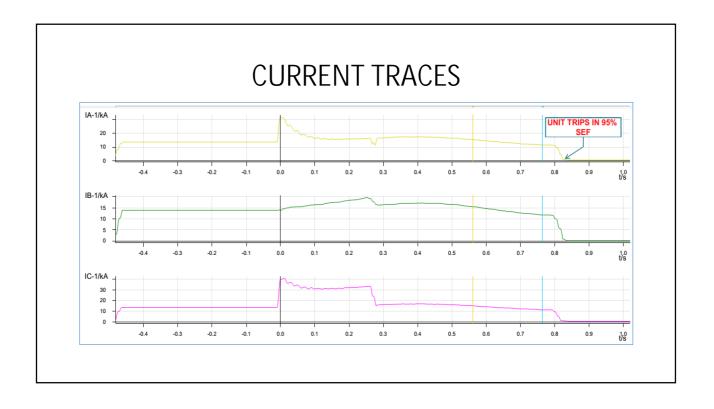
DISTURBANCE IN DSTPS ON 28.07.18 AT ABOUT 21:04HRS

- At about 21:04 hrs of 28.07.18 there was a transient AN fault (IA= 14.5kA) at about 9.8km from DSTPS End on DSTPS JMD Line # 1.
- Fault seen in Zone 1 cleared by Main CB instantaneously but Tie CB(A pole) failed to OPEN Tie LBB operated after 200ms JMD Line # 2 (in other dia) trips 3 pole and Line # 1 also trips 3 pole but A pole of Tie CB remained stuck. Fault cleared by tripping from other end.
- Tie rod of A Pole found damaged. Replacement in progress.
- Unit # 2 tripping was a separate event which took place after the line fault was cleared (about 267ms later). Unit tripped through Neurtal O/V [95% SEF] and 64GIT.
- Some transient fault was present within SEF zone as C Phase voltage had become almost zero while the other phase voltages rise to LL value.

- No fault found in Unit # 2. Unit was synchronised and had run successfully for about 7 days before going for over hauling.
- Stator Resistance normal, PT ratio / Magnetizing current normal, Surge capacitor values normal, LA megger values normal, relay check normal.

DVC informed that tie CB got damaged and the replacement was in process.

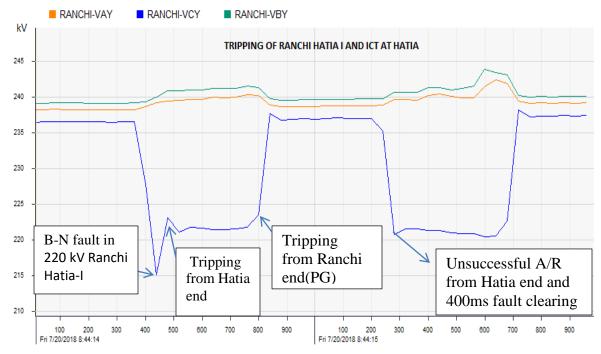
A. At 08:44:14:419 Hrs: Due to clearance issue with some 11 KV feeder (which has an in feed from Hatia old) B-N fault took place in 220 kV Ranchi Hatia-I and at the same time Y phase current also

increases. 220 KV Ranchi-Hatia- tripped from Hatia end(1 phsae) immediately in Z-1 and from Ranchi end(3 phase) after 350 ms in Z-2. Then after 800 ms A/R took place from Hatia end and again B-N fault took place and Z-1 picked up but tripped after 400ms. At the same time all ATR of Hatia and one ATR of Patratu tripped as per verbal information. Also 220 KV Hatia-Patratu-II tripped from Patratu of which no details received.

Figure 2: 400 kV Bus voltage at Ranchi

JUSNL informed that repeated disturbances and total power failure at Hatia substation on 20.07.18 was due to the clearance issue with 11kV feeder under 220kV Ranchi-Hatia D/C line. JUSNL informed that the 11 kV feeders were re-routed after the above incidences to get the sufficient clearance.

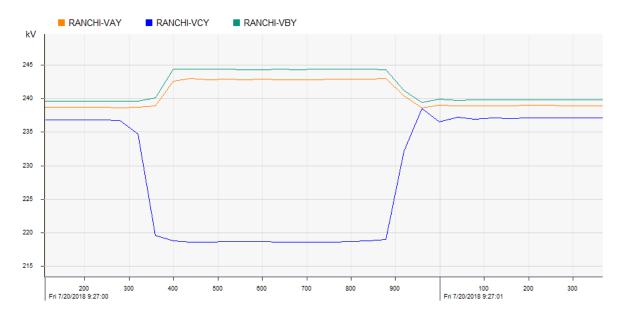
B. At 09:27:00:351 Hrs: Again due to clearance issue with 11 KV feeder Y-B-N fault took place. Though in PMU only B-phase voltage dip observed but from DR it is clear Y phase current also increased. Ranchi end sensed only B-N fault in Z-2 and tripped (3 phase) after 350ms but Hatia end tripped in Z-1, Y-B-N fault immediately (3 Phase).

Figure 3: 400 kV Bus voltage at Ranchi at 09:27:00 hrs

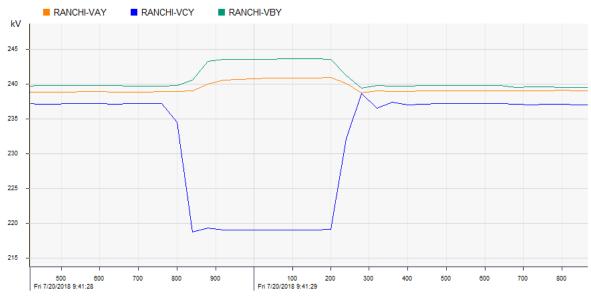
C. At 09:41:28:831 Hrs: Due to clearance issue with some 11 KV feeder (which has an in feed from Hatia old) B-N fault took place in 220 kV Ranchi Hatia-I and at the same time Y phase current also increases. 220 KV Ranchi-Hatia- tripped from Hatia end(1phase) immediately in Z-1 and from Ranchi end (3 phase)after 350 ms in Z-2. At the same time Z-4 picked up for 220KV Hatia-Patratu-2 ,at the same time its R phase current reduced drastically with no change in voltage and again restored to pre fault value after 350 ms(??) Then after 800 ms A/R took place from Hatia end and again B-N fault took place and Z-1 picked up but tripped after 400ms. Again Z-4 of 220KV Hatia-Patratu-2 picked up and line tripped from Hatia end. Also from DR it is seen voltage is also becoming zero implying tripping from Patratu end too. But no details received from Patratu end.

Figure 4: 400 kV Bus voltage at Ranchi at 09:41:28:00 hrs

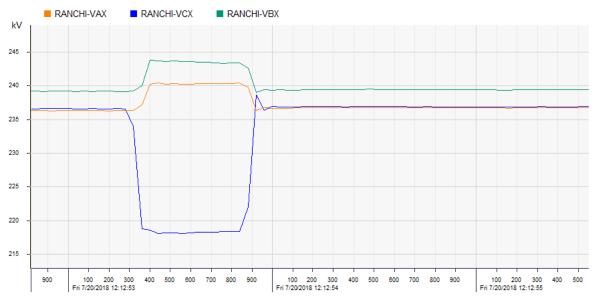
- **D.** At 10:05:13:565 Hrs: 220 KV Hatia-Patratu-1 tripped on over voltage stage-1 and voltage was 254 KV as per DR and there was huge Harmonic content in the line current and Voltage.
- E. At 12:12:53:342 Hrs: Again due to clearance issue with 11 KV feeder Y-B-N fault took place. Though in PMU only B-phase voltage dip observed but from DR it is clear Y phase current also increased. Ranchi end sensed only B-N fault in Z-2 and tripped (3 phase) after 350ms but Hatia end tripped in Z-1, Y-B-N fault immediately (3 phase).

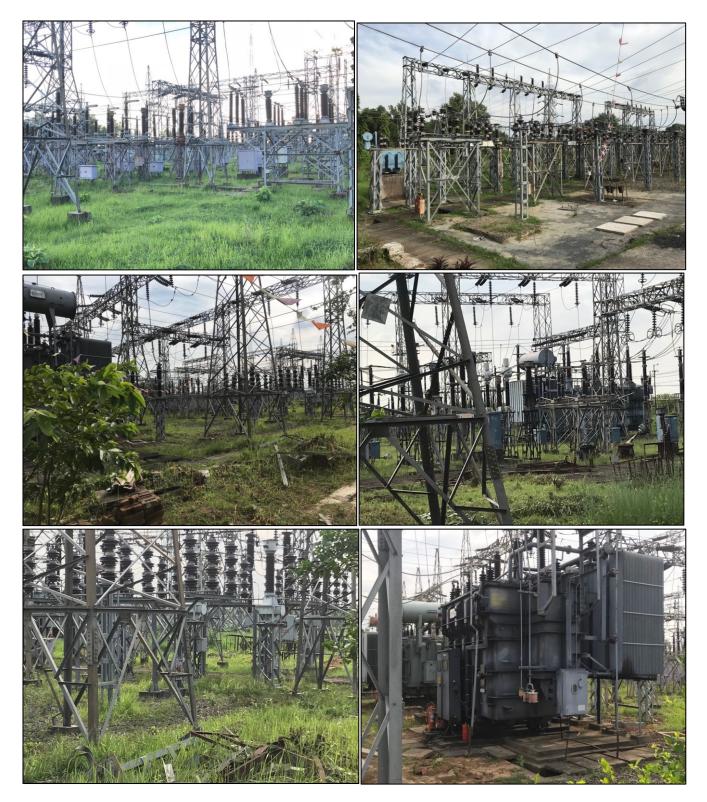
Some Pictures from the substation

- 1. Switchyard and its Maintenance: The whole switchyard was in bad shape. As per the details, the JUSNL part switchyard was commissioned in 1991 (27 years old). Following were observed when switchyard inspection during protection audit was carried out:

- Old Equipment: The switchyard equipment's (Isolator/CT/PT/LA/Breaker) are old and rusty and need immediate attention. Adequate spare management is also required for any emergency. The bays which has been commissioned in 2011 onwards were also found in bad shape due to lack of proper maintenance.

- **PCC and Gravelling:** Long grasses and weeds were observed throughout the switchyard. Proper graveling was not observed in entire switchyard which may be hazardous to human safety, equipment health and can cause unwanted tripping. There is a need for proper PCC and Gravelling in switchyard along.

- 132/33 kV Transformers: Severe oil leakage in one of the 132/33 kV ICT was observed and its oil has also penetrated the panel box of OTI/WTI and can result in unwanted tripping. The ICT panel box also needs proper care as gasket was found to be missing and rainwater can ingress which may also result in unwanted tripping. Silica Gel in 132/33 kV ICTs was found pink and needs to be replaced or recovered by heating. 2 no's of the cooling fan in one of the 50 MVA ICT was not working due to non-replacement of the faulty connector.

- **Bay Equipment Nomenclature:** Proper Bay equipment numbering and phase segregation for identification of equipment have not been done which may result in the wrong operation of equipment and can cause hazard to O & M Personnel.

- Earthing of LA: Proper earthing was not provided to Las in the switchyard.
 - **O&M Activities:** There was no proper O&M for equipment at the substation. This is the major concern that was observed at the substation. No Records were available for the O&M at the substation level. Even the JUSNL Testing team were not able to tell regarding the O&M plan of the substation and its monitoring.

It may kindly be noted that 220/132/33 kV Lalmatia substation is of vital importance for NTPC Farakka, NTPC Kahalgaon and JUSNL. This substation will help in ensuring the proper coal supply as well as act as a path for the black start during emergency between these two large generating stations. So, there is a need for immediate attention in order to improve the condition of this substation at earliest.
