# 71<sup>st</sup> PCC Meeting

### **AGENDA FOR 71<sup>ST</sup> PROTECTION SUB-COMMITTEE MEETING TO BE HELD AT ERPC, KOLKATA ON 19.09.2018 (WEDNESDAY) AT 10:30 HOURS**

# Protection Audit Report of 220/132/33 kV Lalmatia Substation

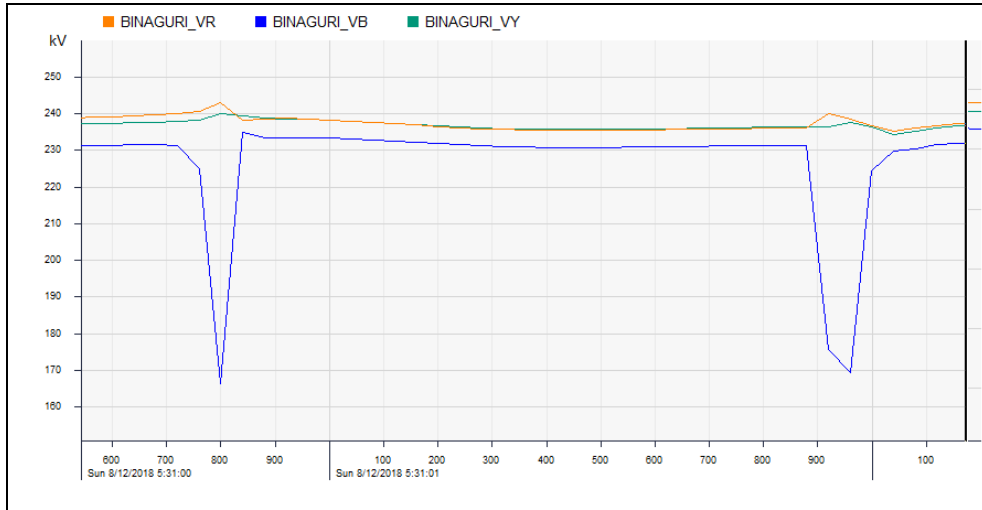
Due to Bad Weather in the Sikkim, 400 kV Binaguri-Rangpo 2 tripped on B phase to earth fault at 05:31 Hrs. Auto-reclosure attempt was taken however line got tripped due to the persisting nature of fault during the event. The PMU plot of the fault is given in figure 1 . Immediately with this SPS-1 operated as line flow was more than 850 MW on other circuit. This in turn has tripped the all-running units of Teesta 3 (Except one Unit) and one unit each of Jorethang, Tashiding, Dikchu and Chujachen. However, it was observed that Dikchu unit 2 also tripped and it was intimated that the differential protection has operated for the unit.

**Fig 1: B phase to Earth fault on 400 kV Rangpo-Binaguri 2 at 05:31 Hrs**

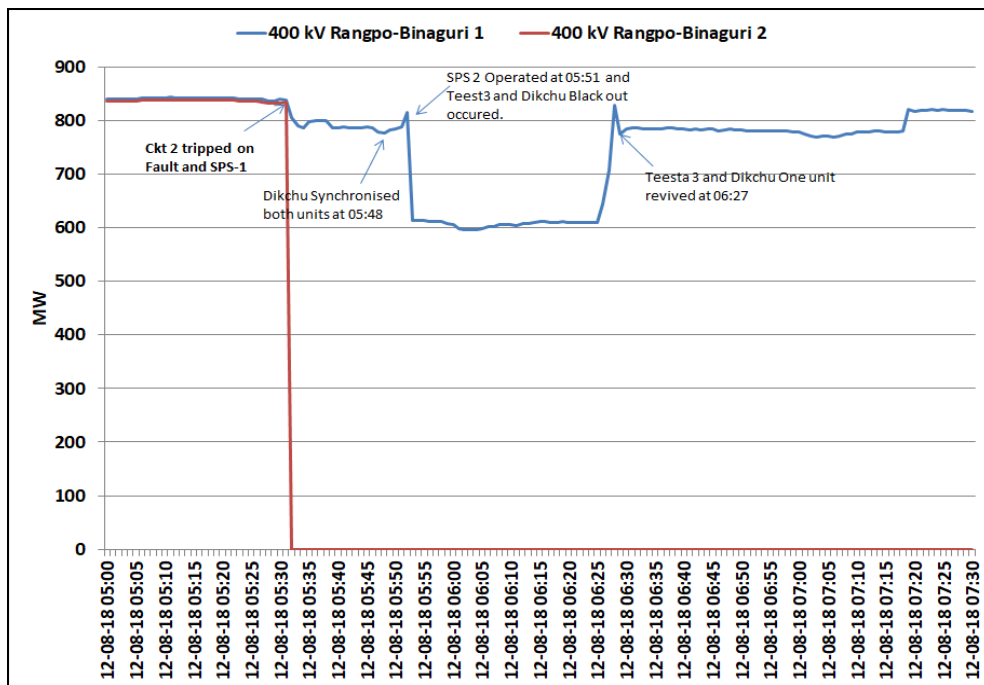
**Fig 2: 400 kV Rangpo-Binaguri D/C during the event.**

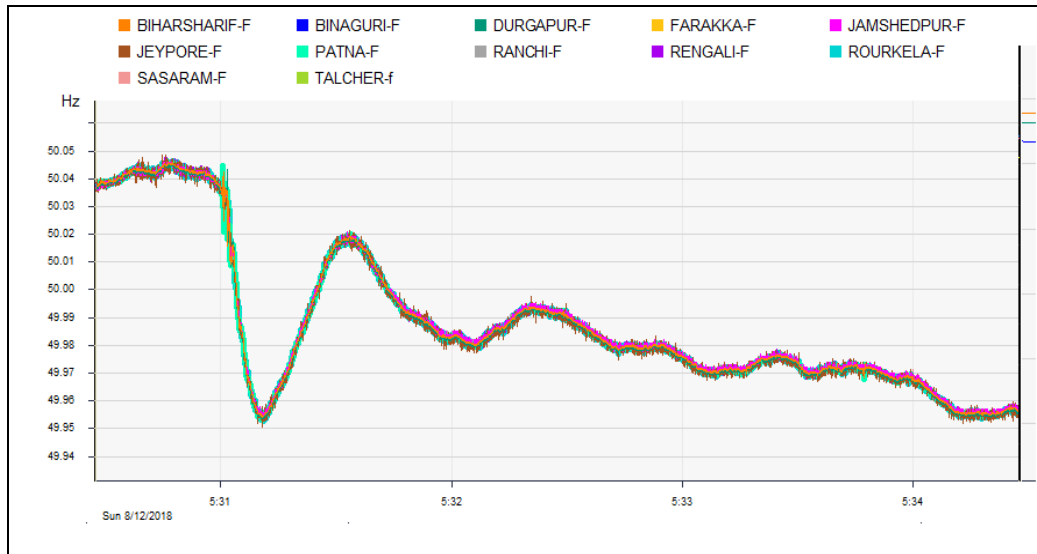
**Frequency Change:** due to Generation Loss of 884 MW at 05:3 Hrs, frequency has dipped by 0.08 Hz (From 50.03 to 49.95 Hz). The frequency drop at SPS-2 operation was not high due to low generation loss.

**Fig: Frequency dip during the SPS 1 operation at 05:31 Hrs**

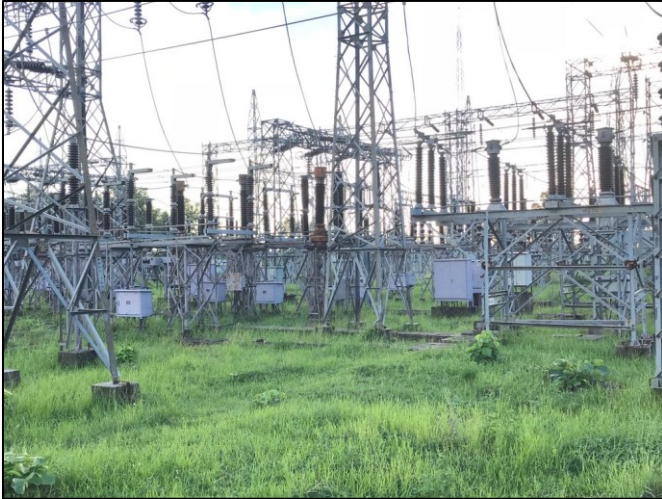
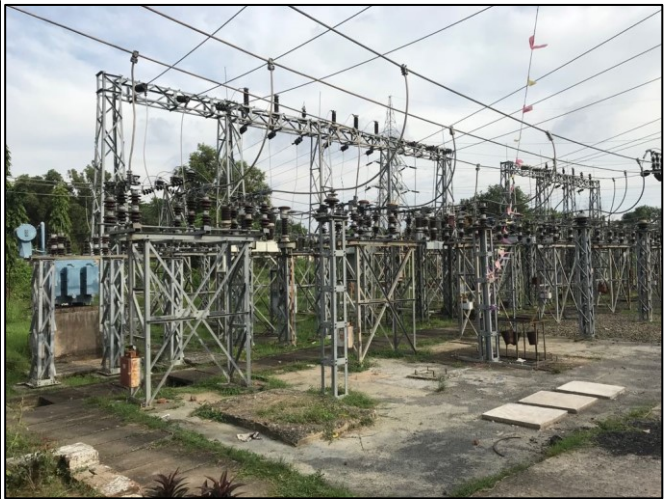
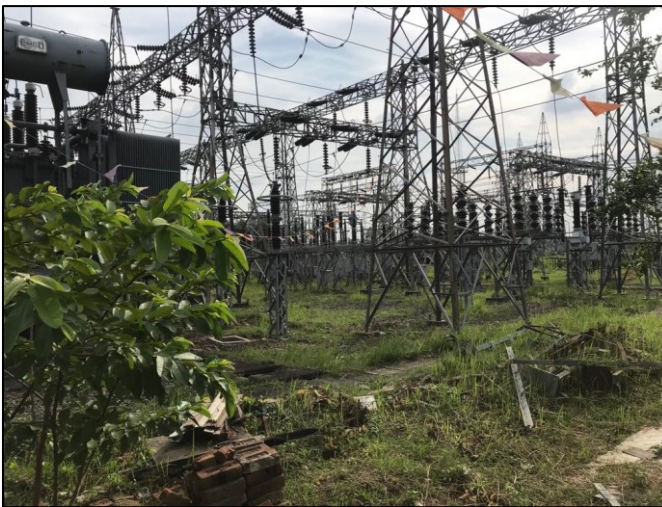
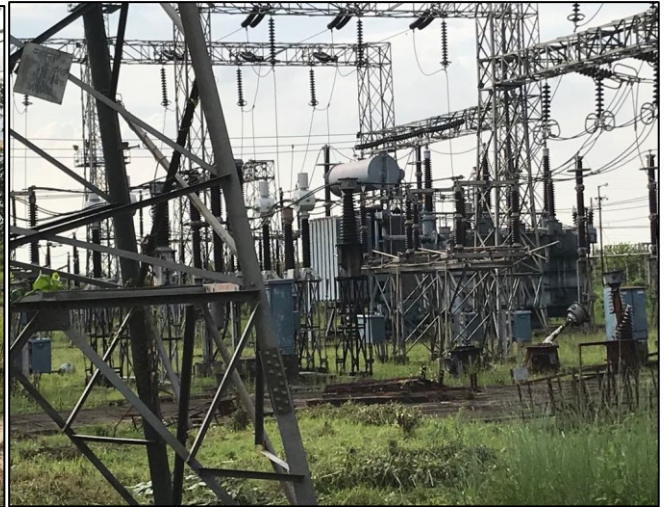
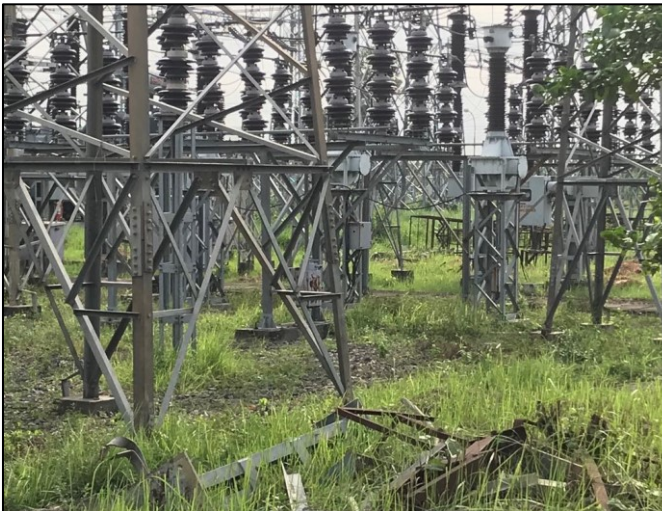
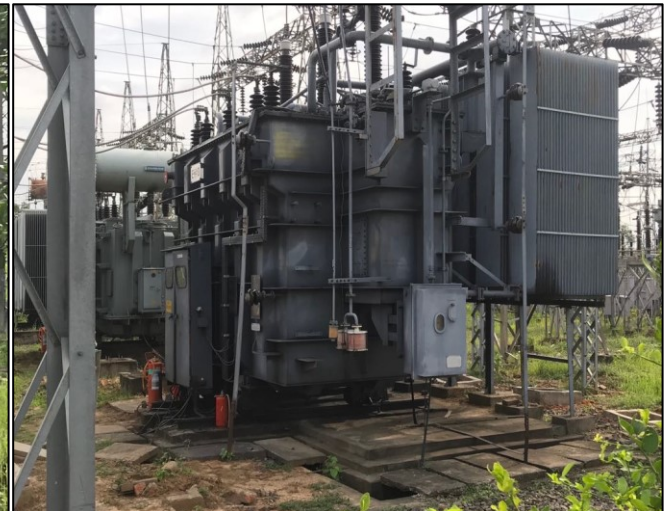
Some Pictures from the substation

**1. Switchyard and its Maintenance:** The whole switchyard was in bad shape. As per the details, the JUSNL part switchyard was commissioned in 1991 (27 years old). Following were observed when switchyard inspection during protection audit was carried out:

- **Old Equipment:** The switchyard equipment's (Isolator/CT/PT/LA/Breaker) are old and rusty and need immediate attention. Adequate spare management is also required for any emergency. The bays which has been commissioned in 2011 onwards were also found in bad shape due to lack of proper maintenance.

- **PCC and Gravelling:** Long grasses and weeds were observed throughout the switchyard. Proper gravelling was not observed in entire switchyard which may be hazardous to human safety, equipment health and can cause unwanted tripping. There is a need for proper PCC and Gravelling in switchyard along.

- **132/33 kV Transformers:** Severe oil leakage in one of the 132/33 kV ICT was observed and its oil has also penetrated the panel box of OTI/WTI and can result in unwanted tripping. The ICT panel box also needs proper care as gasket was found to be missing and rainwater can ingress which may also result in unwanted tripping. Silica Gel in 132/33 kV ICTs was found pink and needs to be replaced or recovered by heating. 2 no's of the cooling fan in one of the 50 MVA ICT was not working due to non-replacement of the faulty connector.
