Minutes of **71st PCC Meeting**

Date: 08.10.2018
Eastern Regional Power Committee
14, Golf Club Road, Tollygunge
Kolkata: 700 033

EASTERN REGIONAL POWER COMMITTEE

MINUTES OF 71ST PROTECTION SUB-COMMITTEE MEETING HELD AT ERPC, KOLKATA ON 19.09.2018 (WEDNESDAY) AT 10:30 HOURS

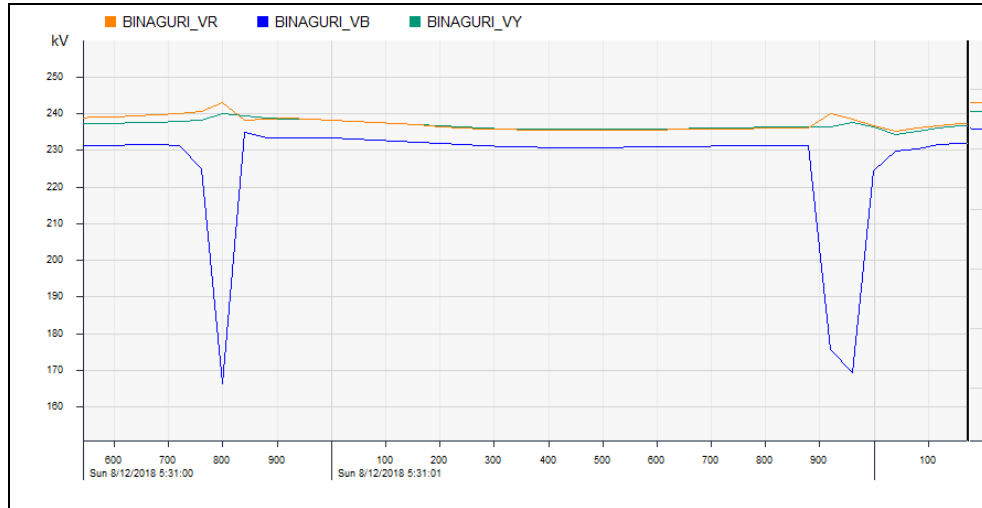
Due to Bad Weather in the Sikkim, 400 kV Binaguri-Rangpo 2 tripped on B phase to earth fault at 05:31 Hrs. Auto-reclosure attempt was taken however line got tripped due to the persisting nature of fault during the event. The PMU plot of the fault is given in figure 1 . Immediately with this SPS-1 operated as line flow was more than 850 MW on other circuit. This in turn has tripped the all-running units of Teesta 3 (Except one Unit) and one unit each of Jorethang, Tashiding, Dikchu and Chujachen. However, it was observed that Dikchu unit 2 also tripped and it was intimated that the differential protection has operated for the unit.

Fig 1: B phase to Earth fault on 400 kV Rangpo-Binaguri 2 at 05:31 Hrs

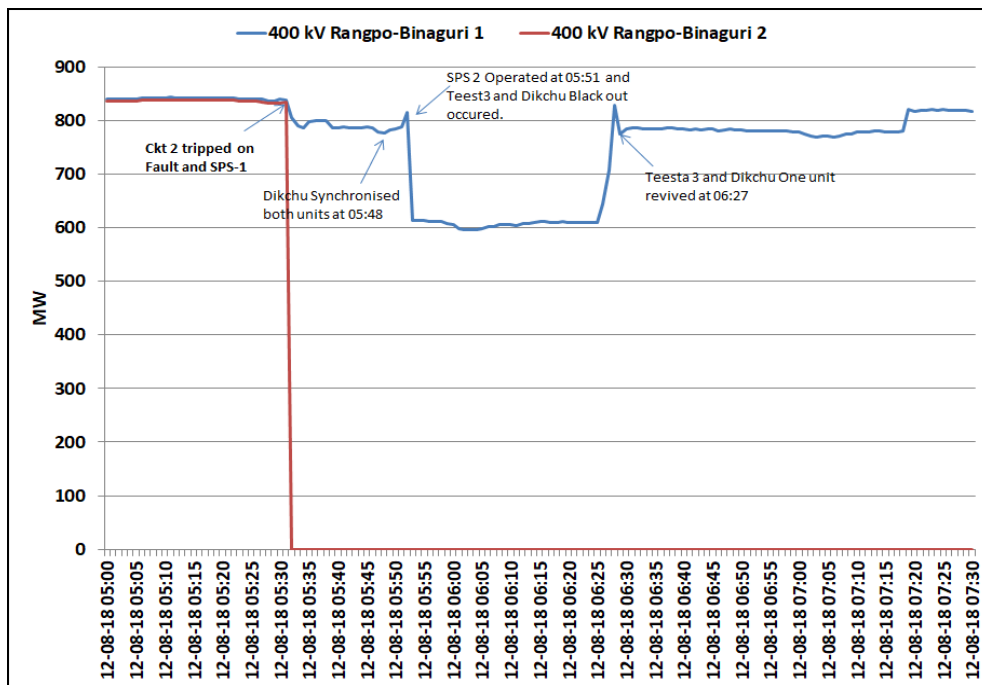
In the meantime, line flow was well below 850 MW on 400 kV Rangpo-Binaguri circuit 1. . At 05:51 Hrs, Dikchu has synchronized both its unit one by one without any information to ERLDC Grid Operator. With this, the power flow on 400 kV Rangpo-Binaguri 1 exceeded 850 MW leading to operation of SPS-2. This led to tripping of 400 kV Teesta3-Ranpo circuit from Teesta end and blackout of Teesta3 and Dikchu generating plant.

Fig 2: 400 kV Rangpo-Binaguri D/C during the event.

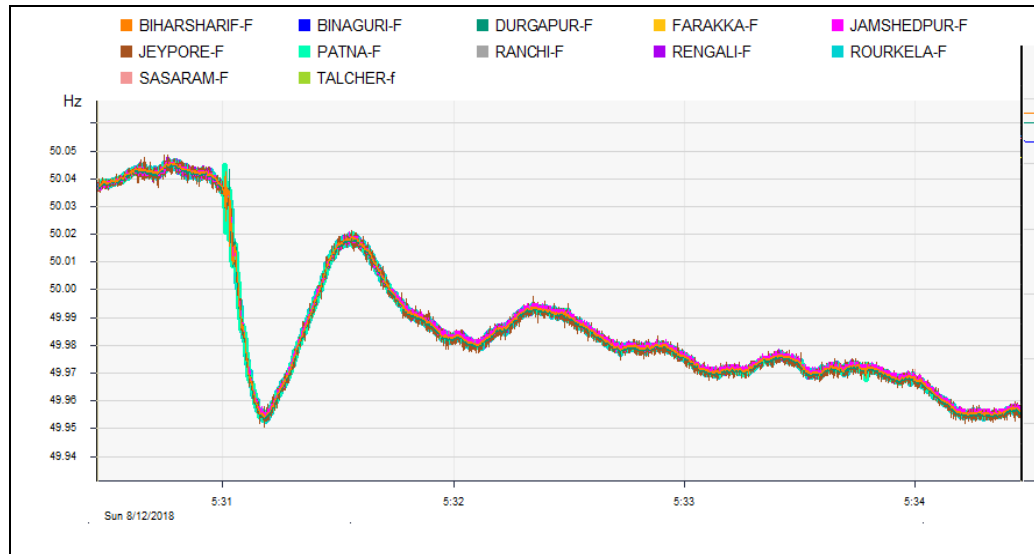
Frequency Change: due to Generation Loss of 884 MW at 05:3 Hrs, frequency has dipped by 0.08 Hz (From 50.03 to 49.95 Hz). The frequency drop at SPS-2 operation was not high due to low generation loss.

Fig: Frequency dip during the SPS 1 operation at 05:31 Hrs

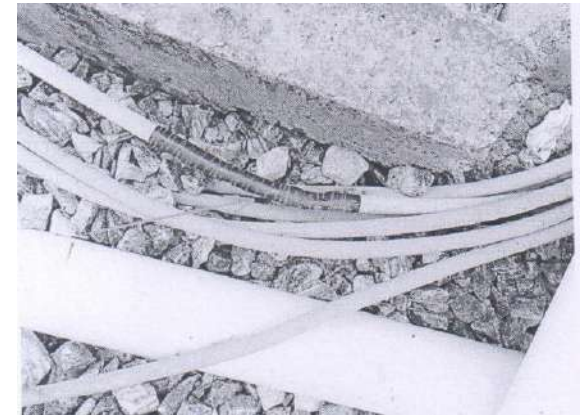
It has been informed that the tripping of both the ICTs was due to damage of control cable, which caused DC earth fault resulting operation of OTI, WTI and buchholz relay of the ICT.

- Buch Trip and OTI Trip are given in 67.1IV- numerical relay SIPROTEC 7SJ804. 67.1IV is powered by DC-1.
- After the study of event log it was observed that the 2 nos. of body trip and 3 nos. of alarm contacts were chattering and simultaneously DC earth fault relay was operated.
- Hence it is confirmed that at the time of tripping a transient DC earth fault has occurred in source-1, due to which contacts for Bucholz and OTI trip started chattering.
- As the threshold voltage of 67.1IV was set to 88V, the contacts operated and hence gave trip command during transient DC earth fault.
- The cable carrying the trip and alarm information is found to be damaged and is covered with insulating tape.

Powergrid added that temporary rectification of cables has been done to avoid DC earth fault however, the control cables would be replaced during next opportunity shutdown.

- The cable insulation damage is suspected for the DC earth fault.
- IR test of the cable to be done or cable replacement to be done in next opportunity shutdown of ICT.
- The Threshold voltage of 67.1IV changed to 176V DC for input binary contacts.

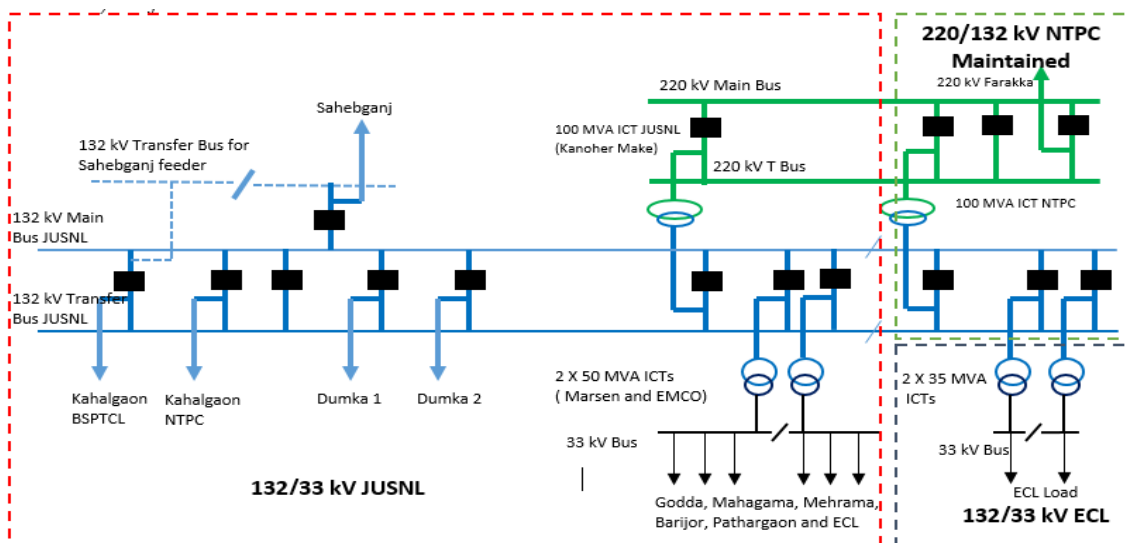
Fig: 220/132/33 kV Lalmatia Substation Single Line Diagram

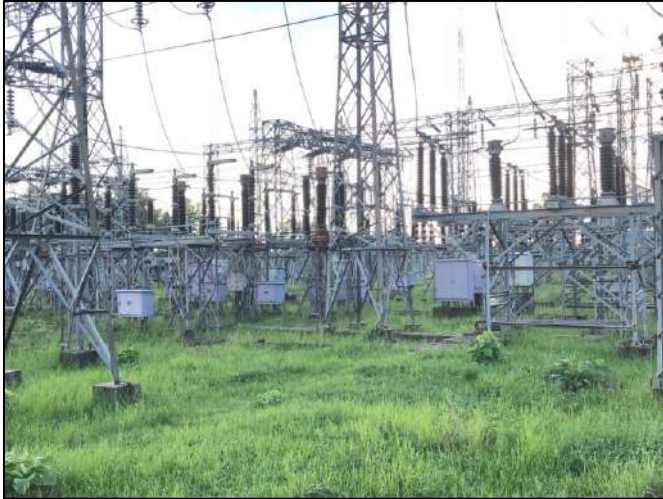
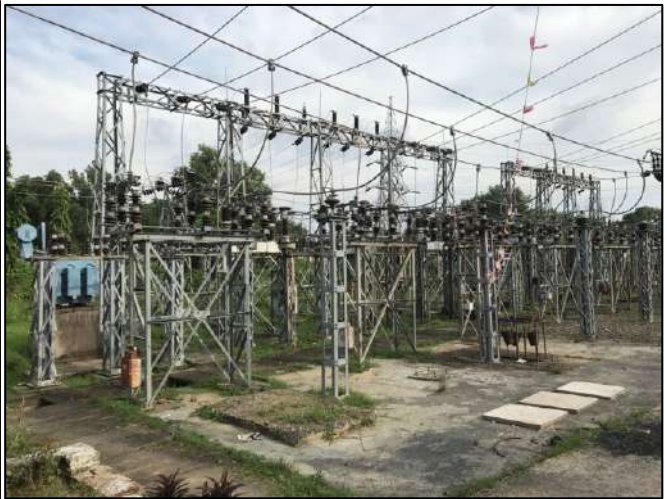
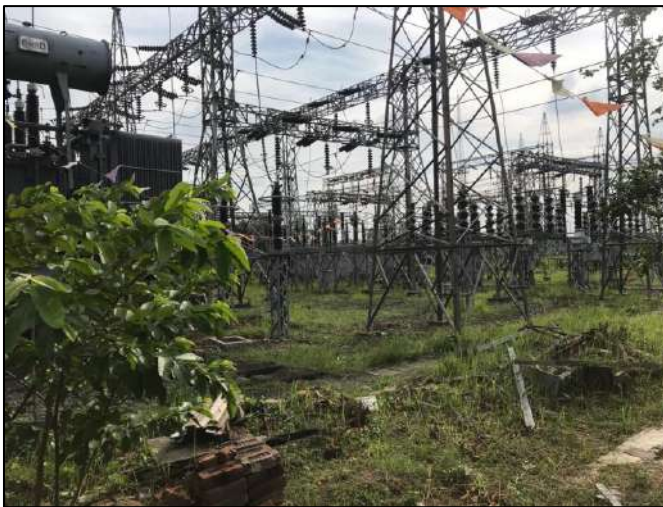
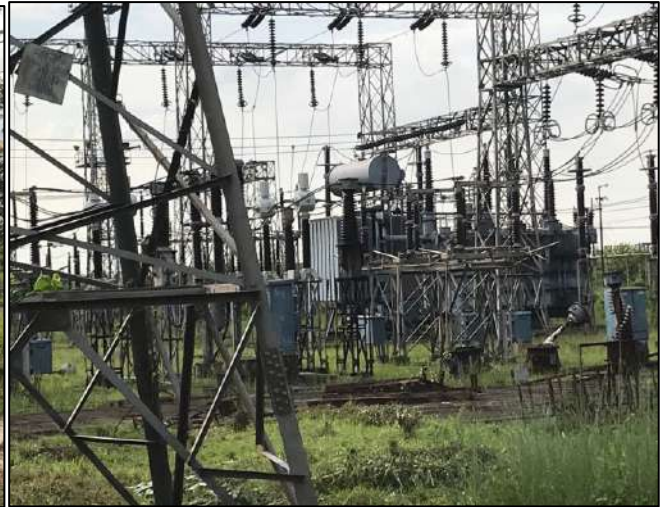
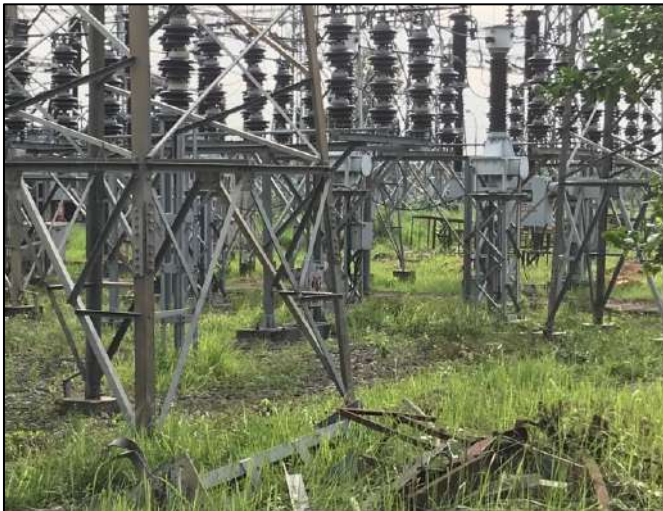
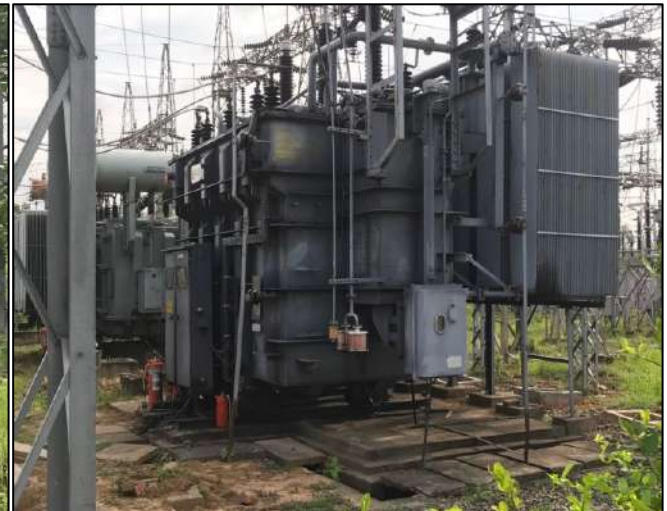
Some Pictures from the substation

1. Switchyard and its Maintenance: The whole switchyard was in bad shape. As per the details, the JUSNL part switchyard was commissioned in 1991 (27 years old). Following were observed when switchyard inspection during protection audit was carried out:

- **Old Equipment:** The switchyard equipment's (Isolator/CT/PT/LA/Breaker) are old and rusty and need immediate attention. Adequate spare management is also required for any emergency. The bays which has been commissioned in 2011 onwards were also found in bad shape due to lack of proper maintenance.

- **PCC and Gravelling:** Long grasses and weeds were observed throughout the switchyard. Proper gravelling was not observed in entire switchyard which may be hazardous to human safety, equipment health and can cause unwanted tripping. There is a need for proper PCC and Gravelling in switchyard along.

- **132/33 kV Transformers:** Severe oil leakage in one of the 132/33 kV ICT was observed and its oil has also penetrated the panel box of OTI/WTI and can result in unwanted tripping. The ICT panel box also needs proper care as gasket was found to be missing and rainwater can ingress which may also result in unwanted tripping. Silica Gel in 132/33 kV ICTs was found pink and needs to be replaced or recovered by heating. 2 no's of the cooling fan in one of the 50 MVA ICT was not working due to non-replacement of the faulty connector.

- **Bay Equipment Nomenclature:** Proper Bay equipment numbering and phase segregation for identification of equipment have not been done which may result in the wrong operation of equipment and can cause hazard to O & M Personnel.

It may kindly be noted that 220/132/33 kV Lalmatia substation is of vital importance for NTPC Farakka, NTPC Kahalgaon and JUSNL. This substation will help in ensuring the proper coal supply as well as act as a path for the black start during emergency between these two large generating stations. So, there is a need for immediate attention in order to improve the condition of this substation at earliest.
