Agenda
for
81st PCC Meeting

EASTERN REGIONAL POWER COMMITTEE

AGENDA FOR 81ST PROTECTION SUB-COMMITTEE MEETING TO BE HELD AT ERPC, KOLKATA ON 18.07.2019 (THURSDAY) AT 11:00 HOURS

ITEM NO. B.1: Disturbance at 400 kV Dikchu S/s on 30.06.2019 at 09:55 Hrs.

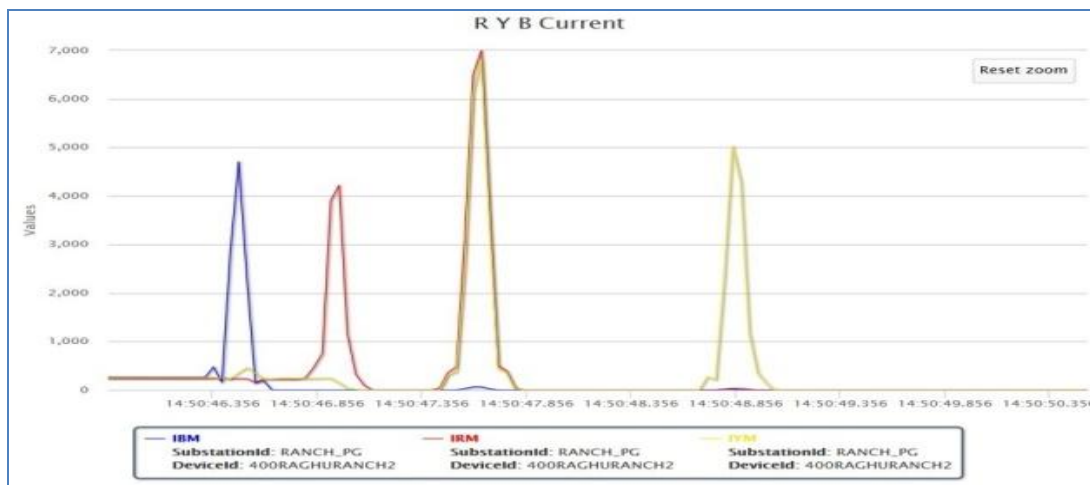
400 kV Ranchi - RTPS - II tripped at 14:50 hrs on 31-05-19 due to fault in the circuit. As per PMU data, A/R of 400 kV Ranchi – RTPS – II started from both ends at 14:50:46.360 hrs (approx) on 31-05-19 on B-N fault. During this, B phase has opened from both ends of the circuit. At 14:50:46.800 hrs (approx), another fault occurred in the R phase and with this the other two poles also opened from both ends thus tripping the circuit. However, it is observed that A/R attempt was again taken at Ranchi end in the faulty R & Y phases at 14:50:47.400 hrs (approx) and Y phase at 14:50:48.800 hrs (approx) even after the three poles opening at 14:50:46.800 hrs (approx). Such repeated auto-reclose operation is not desirable due to vicinity of the generating station for reliability and security.

Fig 1: Line Current measured at Ranchi end for 400 kV Ranchi - RTPS – II from PMU indicating multiple reclosure

In 80th PCC meeting, Powergrid informed that repeated autoreclose operations at Ranchi end was due to some issues in autoreclosure scheme. The scheme was referred to OEM for analysis and recommendations.

PCC advised Powergrid to submit analysis report and decided to discuss the agenda in next PCC meeting.

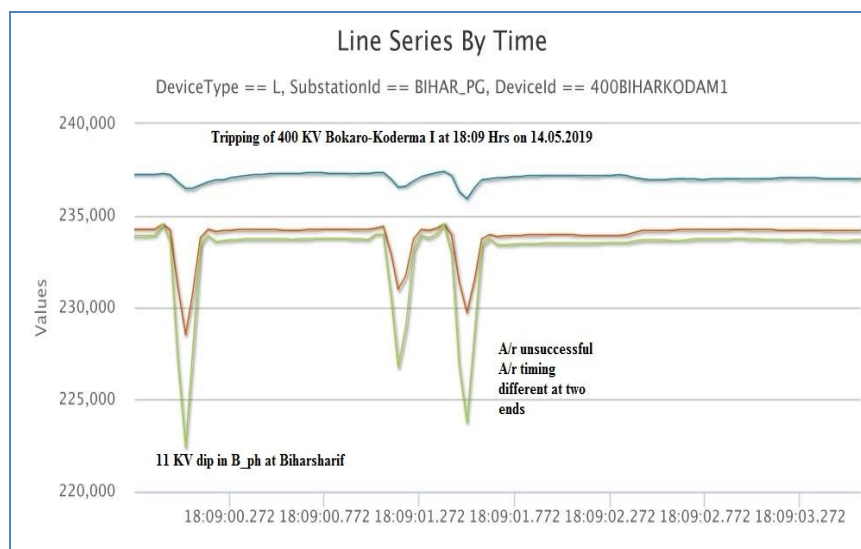
400 kV Koderma-Bokaro-I circuit tripped at 18:09 Hrs due to Y phase to earth fault. In the PMU plot for generator voltage, different dead time has been observed at two ends leading to two faults being fed to the system one by one with A/R operation. It may kindly be noted that, both ends of the line is connected to major generating station of Eastern region and the feeding of fault on two occasions due to different A/R timing is not desirable.

Fig: 400 kV Bihar Sharif Bus Voltage during the event indicating different A/R timing on 400 kV Koderma-Bokaro 1 circuit

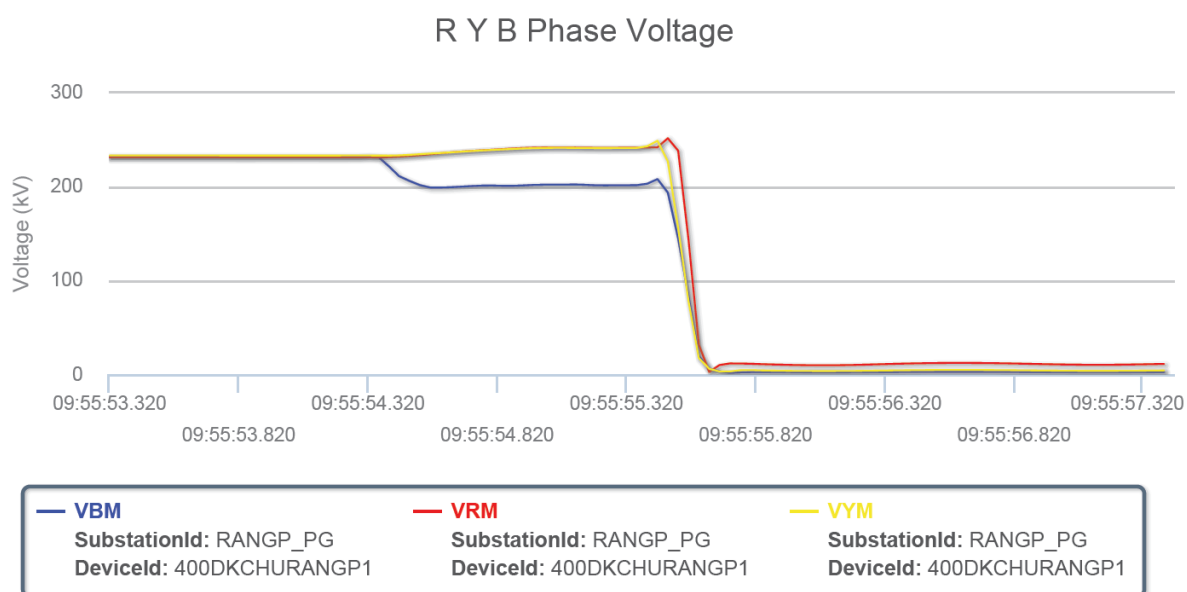
1. **Line Current and Line voltage of 400 kV Dikchu-Rangpo from Rangpo End and 400 kV Teesta III-Kishanganj from Kishanganj end:** Figure 3 shows the line voltage of 400 kV Rangpo-Dikchu line at Rangpo end and Figure 4 show the line current. Figure 5 shows the line Voltage of 400 kV Teesta III-Kishanganj line at Kishanganj end and Figure 6 show line the current. It is seen from the figure that initially very less voltage drop in B phase took place due to high resistance fault and it persisted for 1.1 sec as distance protection could not clear the fault. Then finally fault converted into Y-B fault and distance protection operated and line tipped in zone 1.

Figure 3: Phase voltage of 400 kV Rangpo Dikchu line at Rangpo

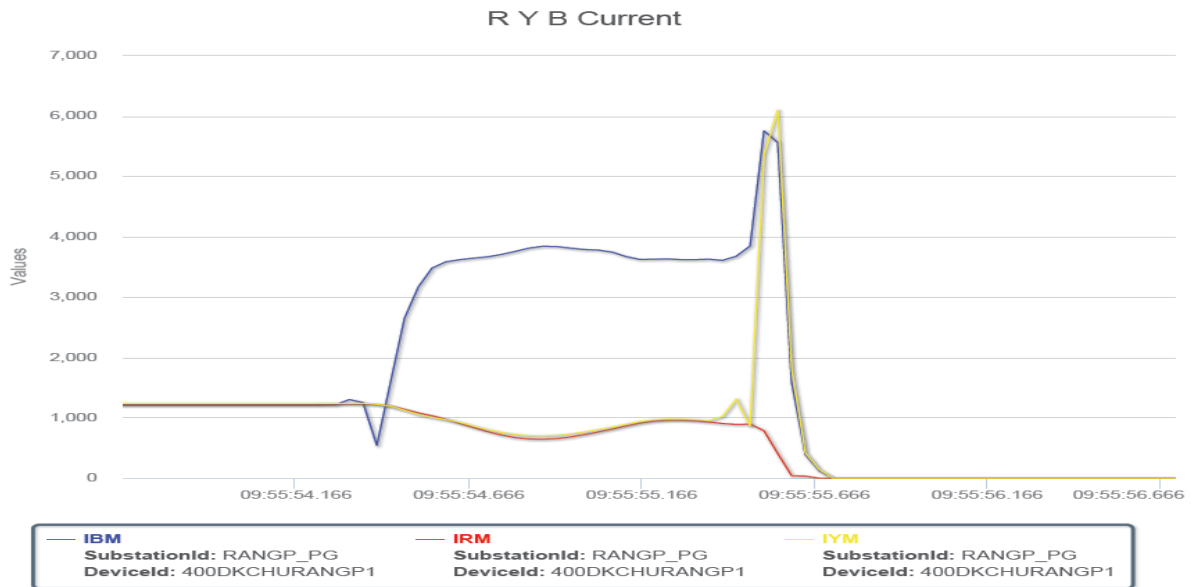
Figure 4: Phase current of 400 kV Rangpo Dikchu line at Rangpo

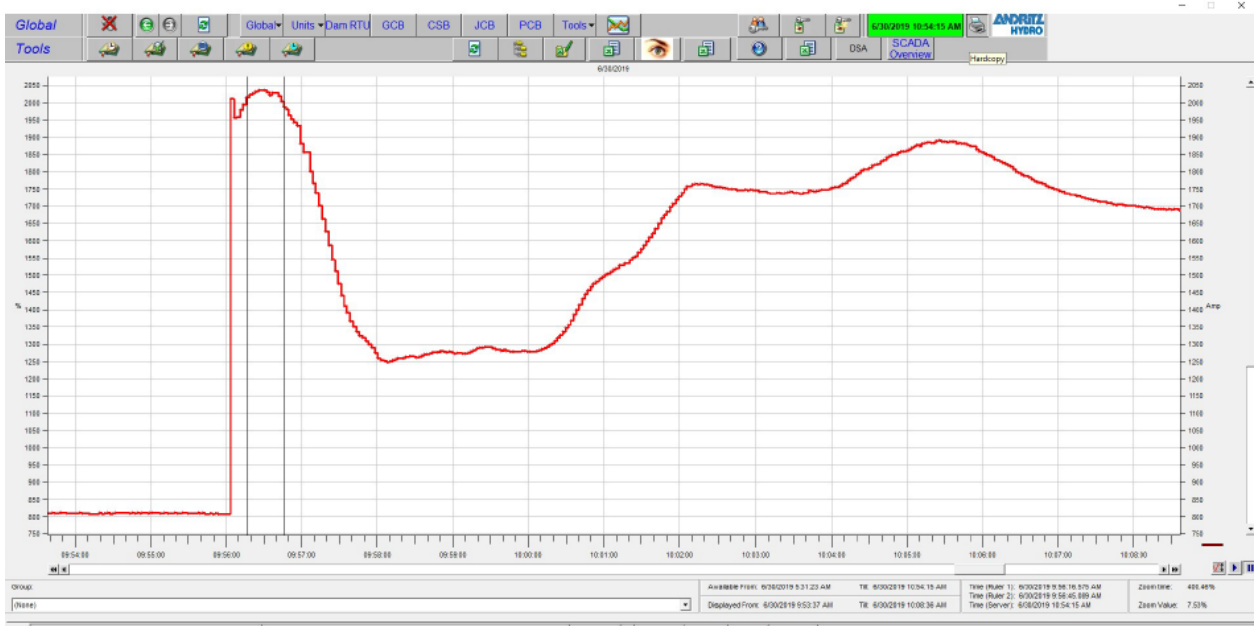
In the 400 kV Teesta III Kishanganj Line after transient current settled just above 2000 Amp and stayed there for 50 sec but no SPS operation at Teesta III reported.

Figure 6: Current of 400 kV Teesta III Kishanganj line at Kishanganj

Flow of Teesta III –Kishanganj Line remain above 2000 AMP for 1 minute but as per SPS action at Teesta III unit 1 not tripped. Teesta III needs to explain the same. As per PMU data value of the current was 2040 Amp so whether SPS fails to detect the condition or not needs to be confirmed by Teesta III.

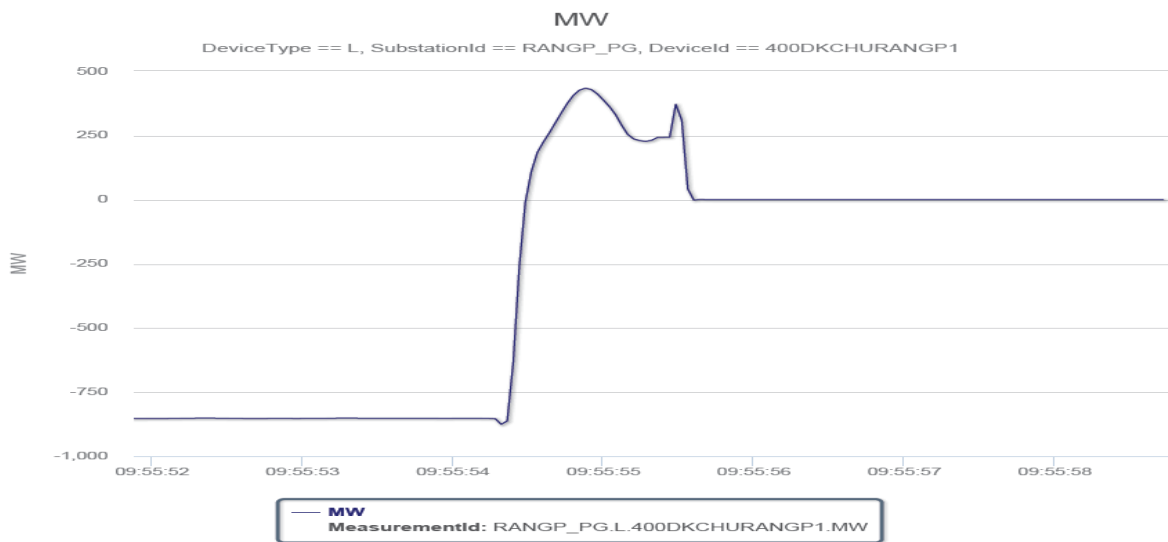
Figure 7 is showing the MW flow of the 400 kV Dikchu-Rangpo line at Rangpo End. Initially power 850 MW was flowing towards Rangpo. Then During the fault around 400 MW was flowing towards the fault. Then finally line tripped.

Figure 7: MW Flow of 400 kV Dikchu Rangpo at Rangpo

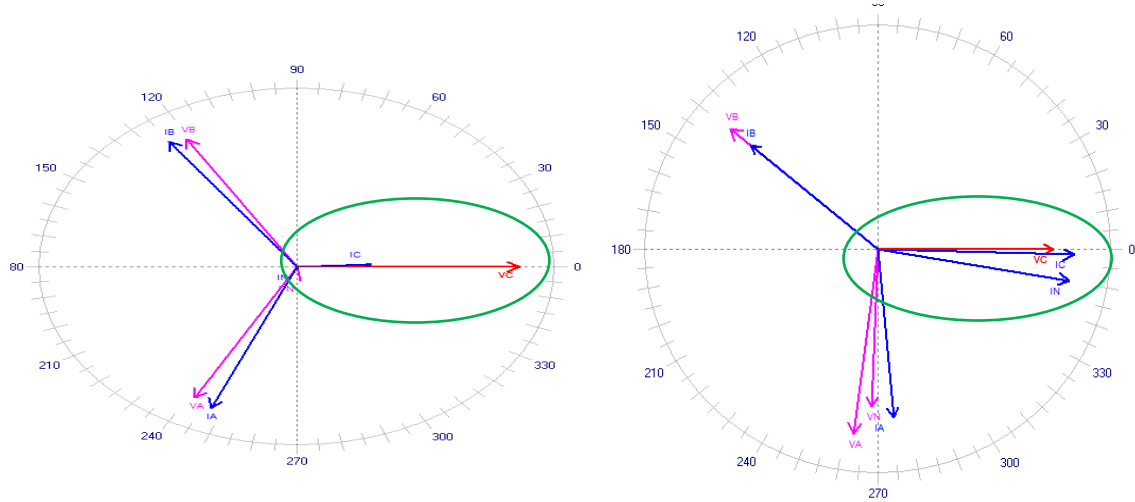
From the DR of Dikchu as well as Rangpo end it is seen that the Phase angle between B phase voltage and current is nearly zero both during pre-fault and fault condition (for the

first 1.1 sec). Only magnitude of the current increases from 1.2 kA during pre-fault condition to 3.5 kA during fault condition. **Also calculating active power supplied to the fault from Both Rangpo and Dikchu end it is seen that almost 1300 MW was consumed by the fault. The same is evident from the PMU measurements also.** Physical nature of such high resistive fault needs to be investigated with due diligence.

Figure 8: Dikchu end Pre and during fault Voltage and Current Phasor

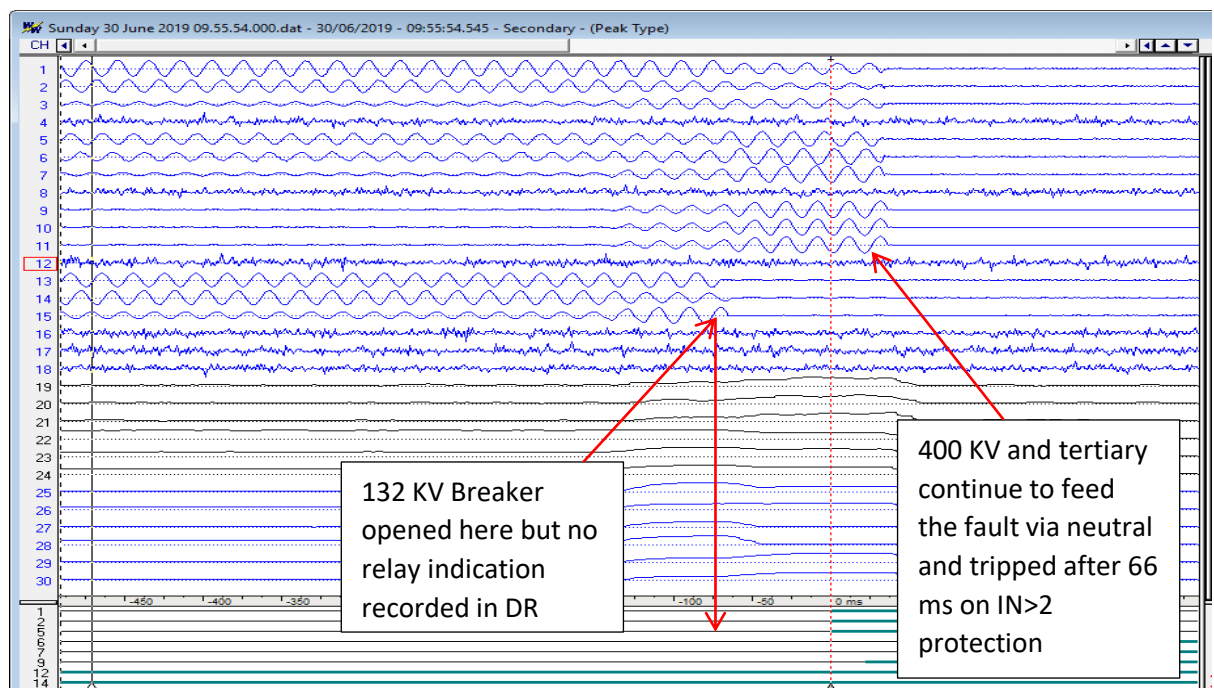
2. Analysis of Dikchu ICT DR:

132 kV current opened 1st but which protection operated is not clear from the DR then after 66 ms 400kV barker tripped on IN>2 protection as fault was continued to fed via neutral.

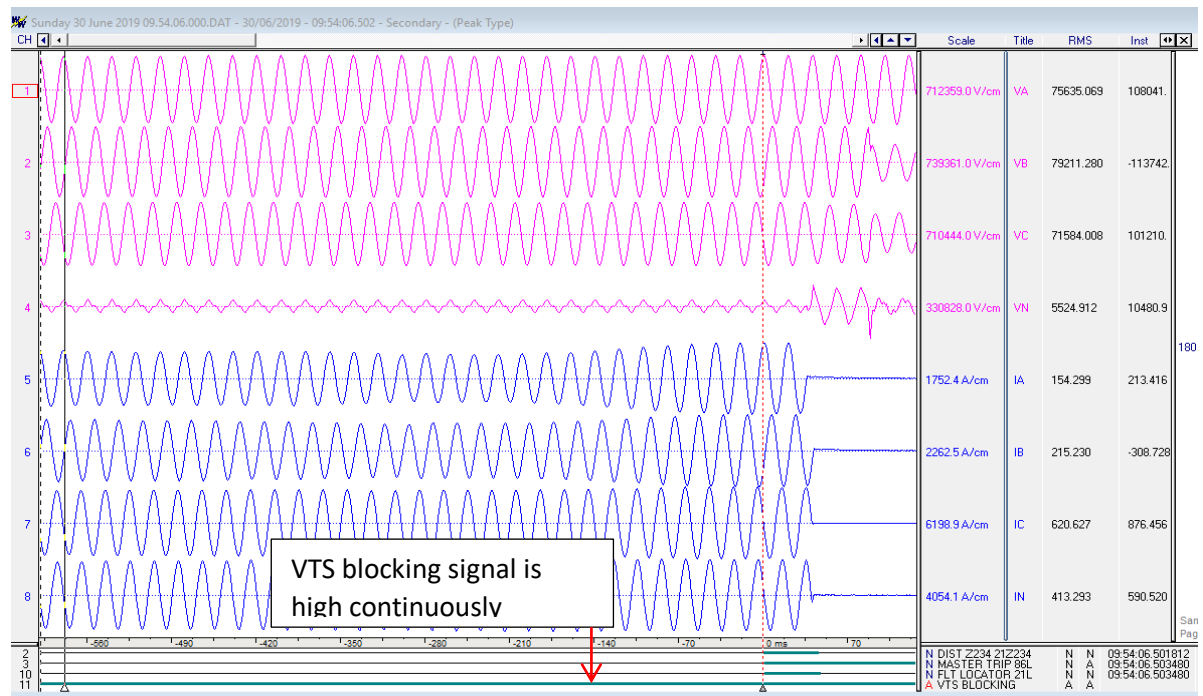
3. DR analysis of 132 kV Rangpo-Chuzachen at Chuzachen:

From Chuzachen end distance protection zone-3 operated as reported by them. But in the DR VTS blocking signal was high, which blocks zone protection. Chuzachen may explain the why VTS blocking was high and then how DP operated. Even if DP operated, then how zone-3 of the line encroached two voltage levels is not clear. Zone-3 setting may be reviewed.

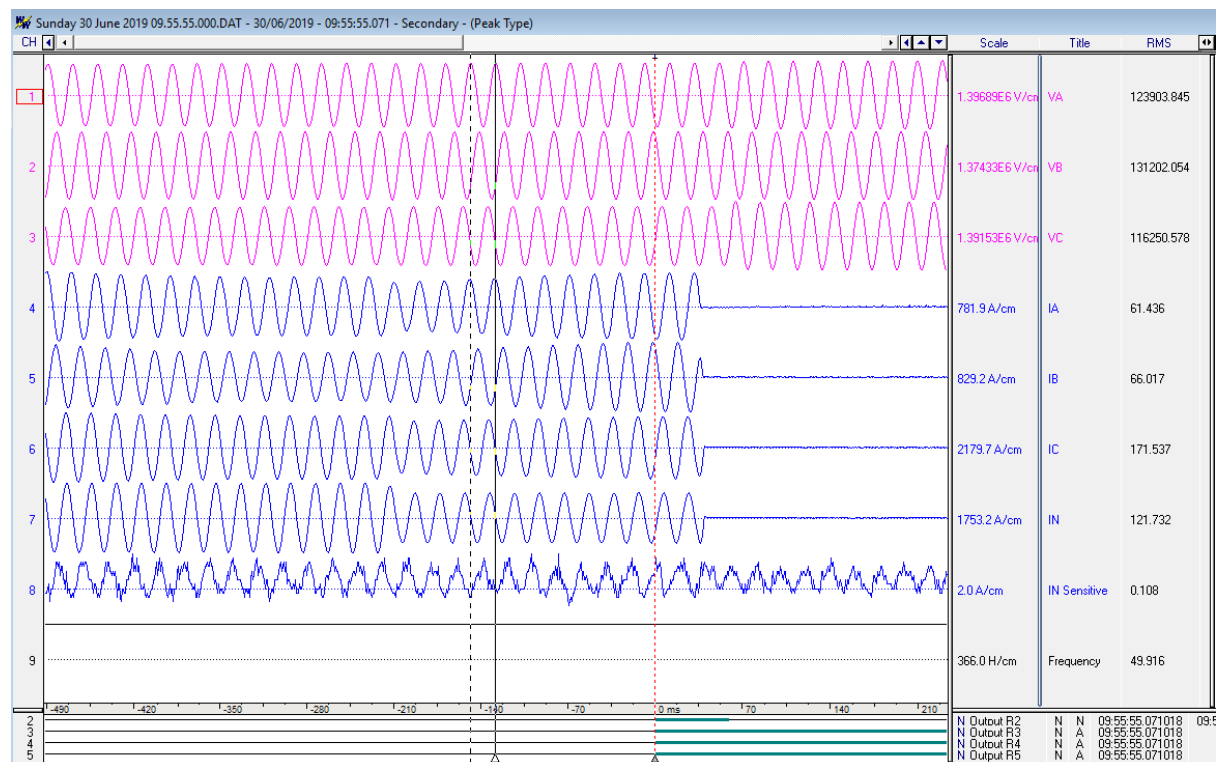
4. DR analysis of Jorethang-New Melli at Jorethang:

DR Digital channels are not properly configured. So it is not clear which protection operated. Operation of DEF within 650 ms suggests that DEF setting need to be reviewed.

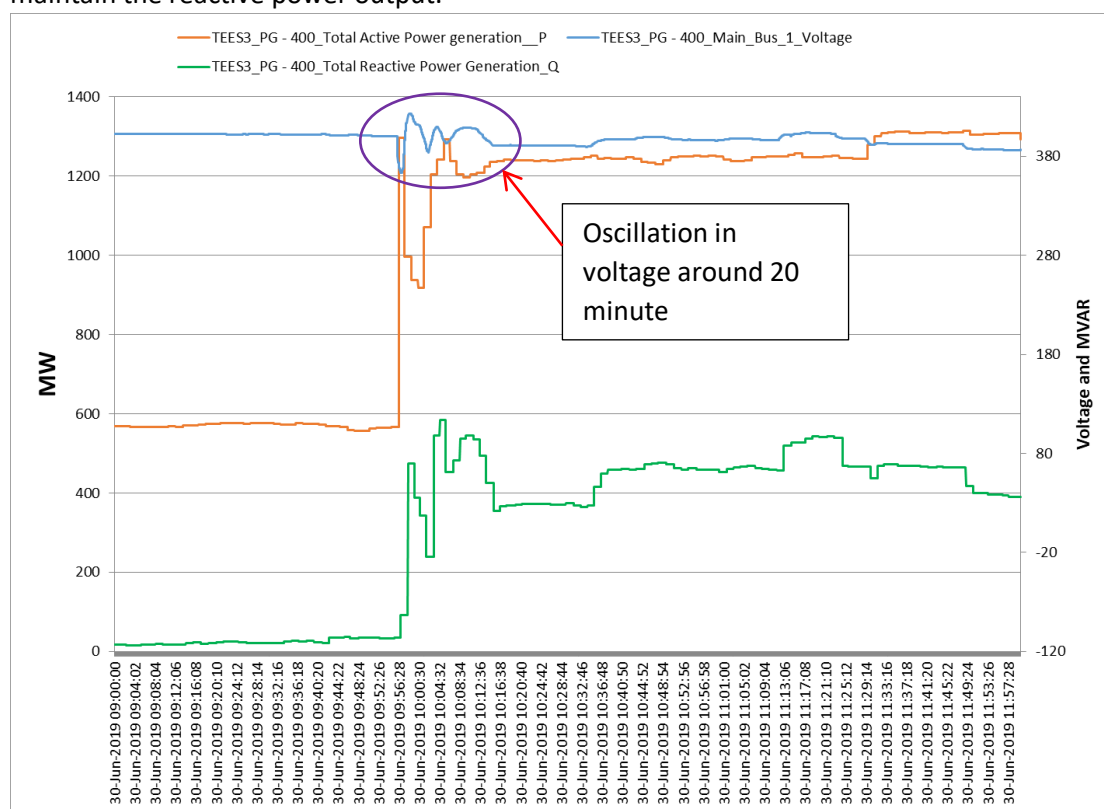
This mode of operation can cause voltage stability issue for Grid connected generators as it has a slower outer control loops which vary the voltage set point of the generators to maintain the reactive power output.

Figure 9: Active Reactive generation of Teesta III and Teesta III Bus voltage

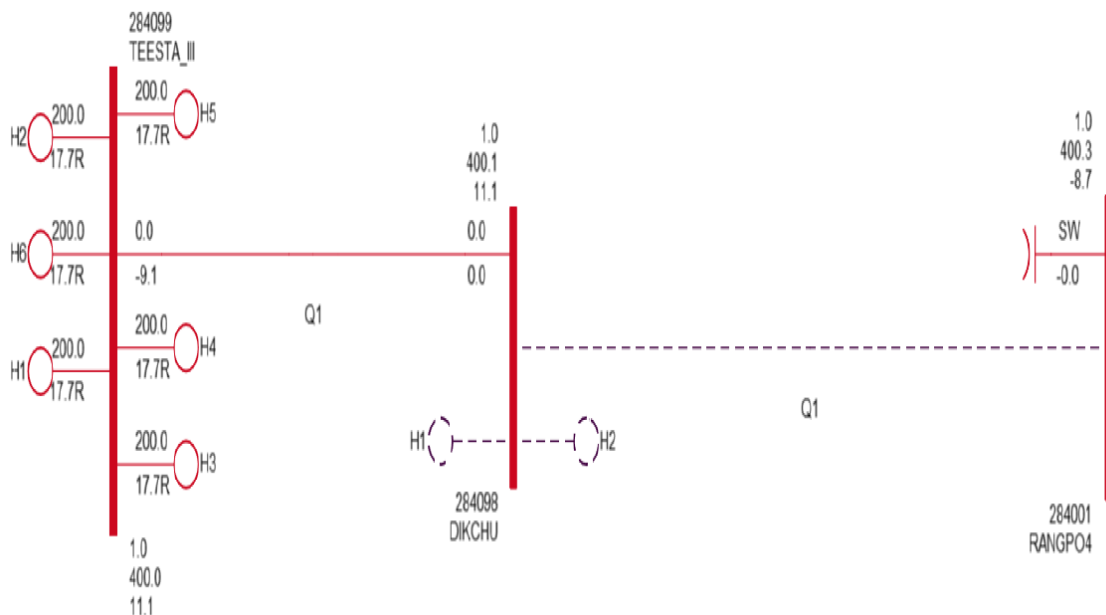
During restoration the phase angle difference between 400 kV Rangpo and Dikchu (or Teesta III) was more than 20 degree. Also in the study done by ERLDC and NLDC in PSSE similar angle difference is observed.

Figure 11: PSSE study for calculating Phase angle difference between Rangpo and Teesta III
