Minutes of 81st PCC Meeting

EASTERN REGIONAL POWER COMMITTEE

MINUTES OF 81ST PROTECTION SUB-COMMITTEE MEETING HELD AT ERPC, KOLKATA ON 18.07.2019 (THURSDAY) AT 11:00 HOURS

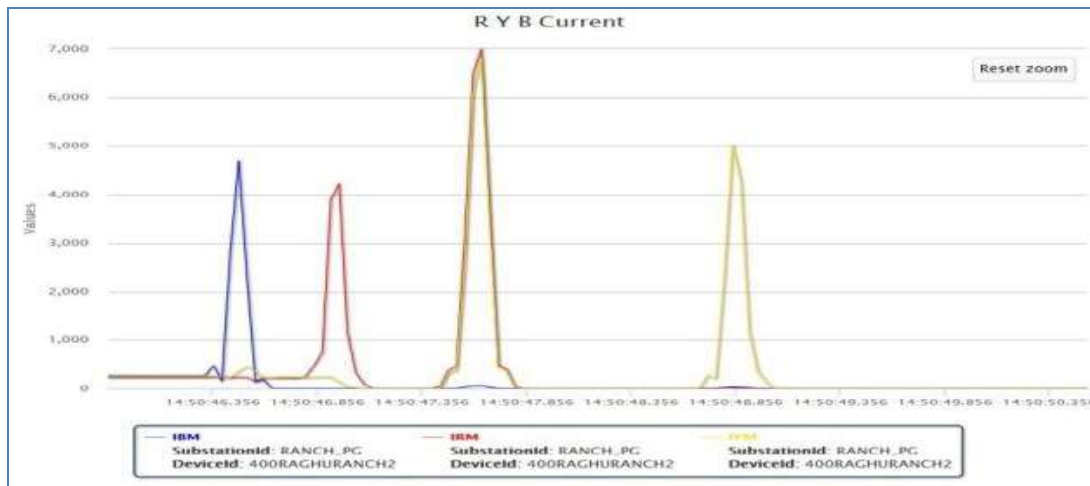
Fig 1: Line Current measured at Ranchi end for 400 kV Ranchi - RTPS – II from PMU indicating multiple reclosure

In 80th PCC meeting, Powergrid informed that repeated autoreclose operations at Ranchi end was due to some issues in autoreclosure scheme. The scheme was referred to OEM for analysis and recommendations.

Powergrid vide mail intimated that the analysis report from OEM has not been received. However while checking the scheme, they found that three phase initiation for A/R was enabled in Main-I distance relay which they have rectified.

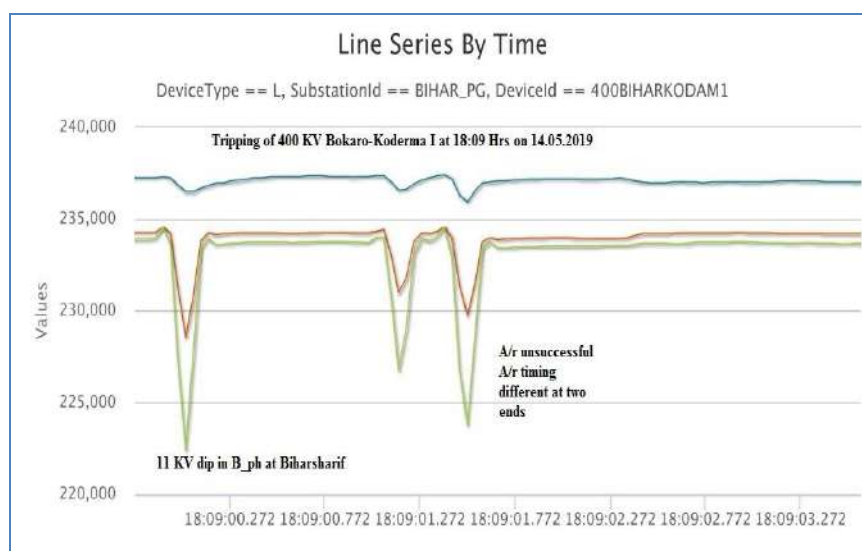
400 kV Koderma-Bokaro-I circuit tripped at 18:09 Hrs due to Y phase to earth fault. In the PMU plot for generator voltage, different dead time has been observed at two ends leading to two faults being fed to the system one by one with A/R operation. It may kindly be noted that, both ends of the line is connected to major generating station of Eastern region and the feeding of fault on two occasions due to different A/R timing is not desirable.

Fig: 400 kV Bihar Sharif Bus Voltage during the event indicating different A/R timing on 400 kV Koderma-Bokaro 1 circuit

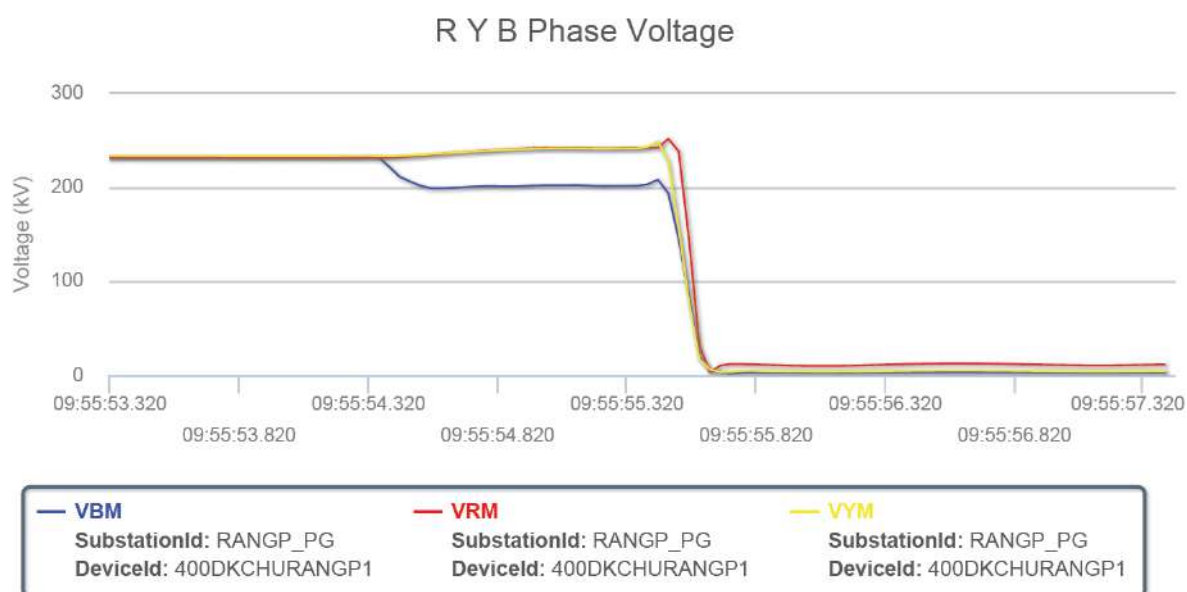
1. **Line Current and Line voltage of 400 kV Dikchu-Rangpo from Rangpo End and 400 kV Teesta III-Kishanganj from Kishanganj end:** Figure 3 shows the line voltage of 400 kV Rangpo-Dikchu line at Rangpo end and Figure 4 show the line current. Figure 5 shows the line Voltage of 400 kV Teesta III-Kishanganj line at Kishanganj end and Figure 6 show line the current. It is seen from the figure that initially very less voltage drop in B phase took place due to high resistance fault and it persisted for 1.1 sec as distance protection could not clear the fault. Then finally fault converted into Y-B fault and distance protection operated and line tipped in zone 1.

Figure 3: Phase voltage of 400 kV Rangpo Dikchu line at Rangpo

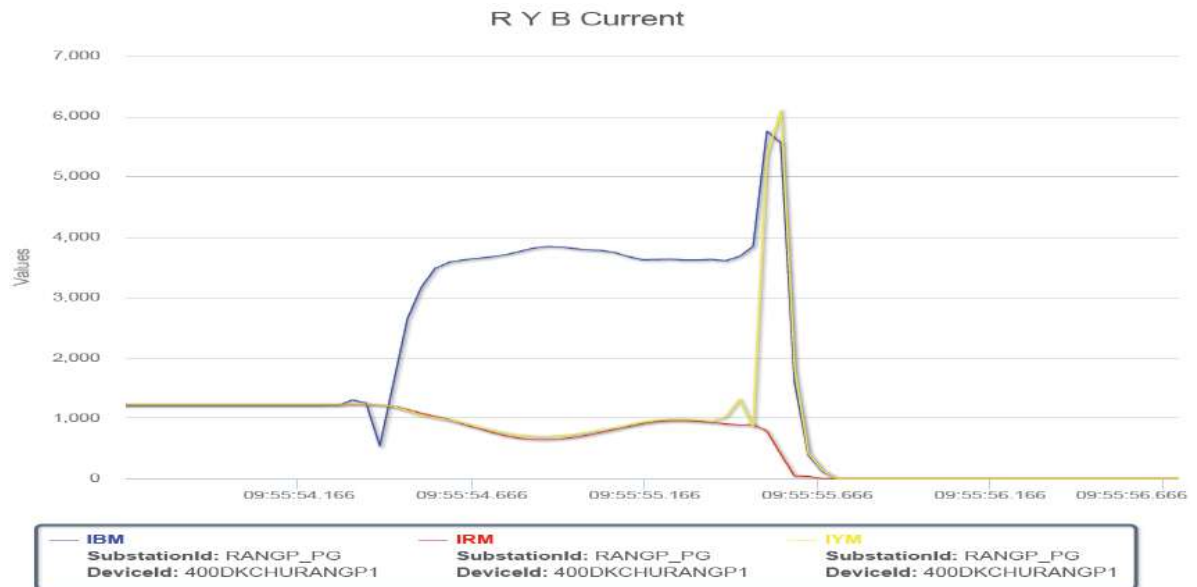
Figure 4: Phase current of 400 kV Rangpo Dikchu line at Rangpo

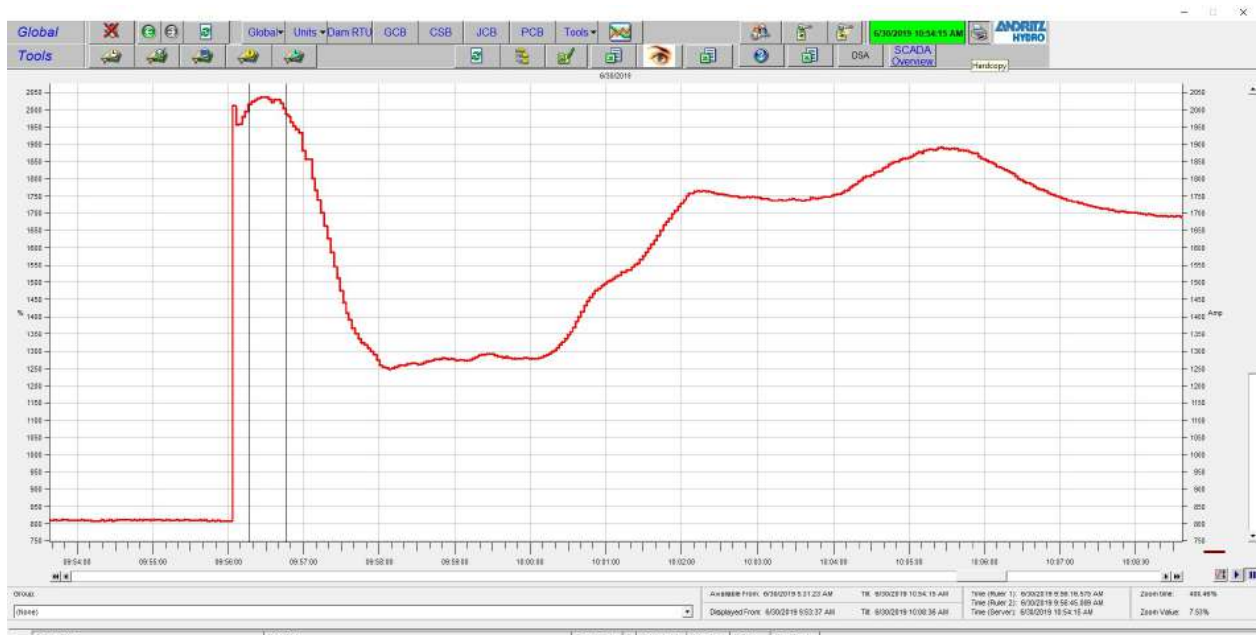
In the 400 kV Teesta III Kishanganj Line after transient current settled just above 2000 Amp and stayed there for 50 sec but no SPS operation at Teesta III reported.

Figure 6: Current of 400 kV Teesta III Kishanganj line at Kishanganj

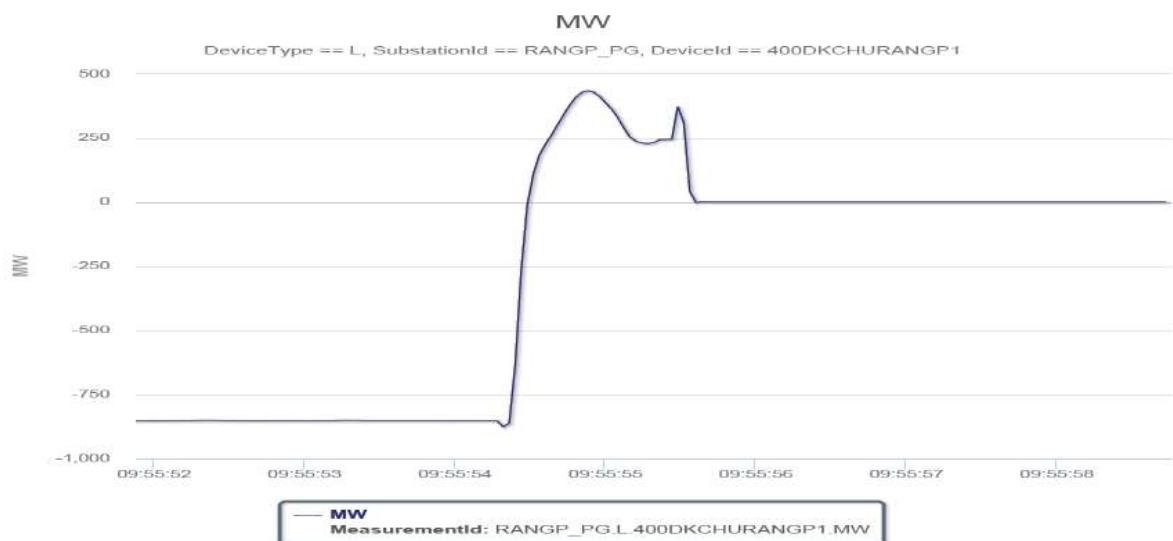
Figure 7 is showing the MW flow of the 400 kV Dikchu-Rangpo line at Rangpo End. Initially power 850 MW was flowing towards Rangpo. Then During the fault around 400 MW was flowing towards the fault. Then finally line tripped.

Figure 7: MW Flow of 400 kV Dikchu Rangpo at Rangpo

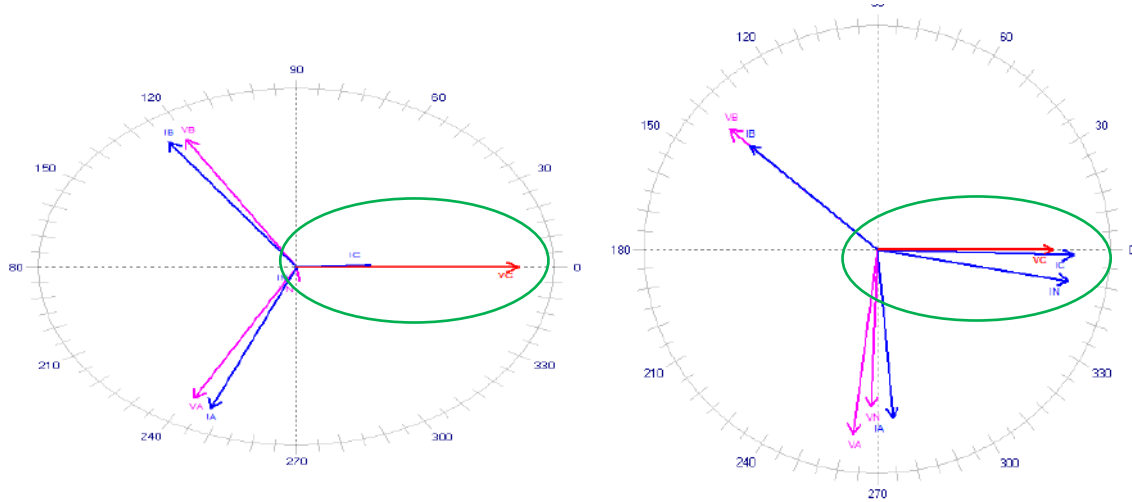
From the DR of Dikchu as well as Rangpo end it is seen that the Phase angle between B phase voltage and current is nearly zero both during pre-fault and fault condition (for the

first 1.1 sec). Only magnitude of the current increases from 1.2 kA during pre-fault condition to 3.5 kA during fault condition. **Also calculating active power supplied to the fault from Both Rangpo and Dikchu end it is seen that almost 1300 MW was consumed by the fault. The same is evident from the PMU measurements also.** Physical nature of such high resistive fault needs to be investigated with due diligence.

Figure 8: Dikchu end Pre and during fault Voltage and Current Phasor

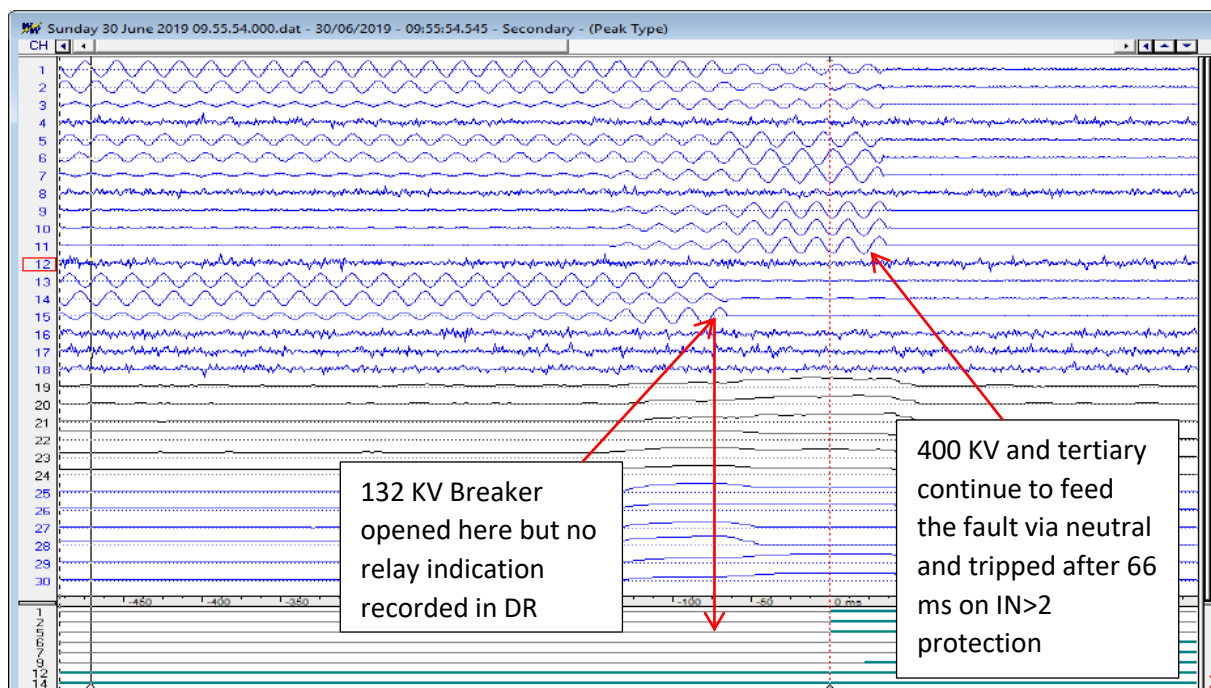
2. Analysis of Dikchu ICT DR:

132 kV current opened 1st but which protection operated is not clear from the DR then after 66 ms 400kV barker tripped on IN>2 protection as fault was continued to fed via neutral.

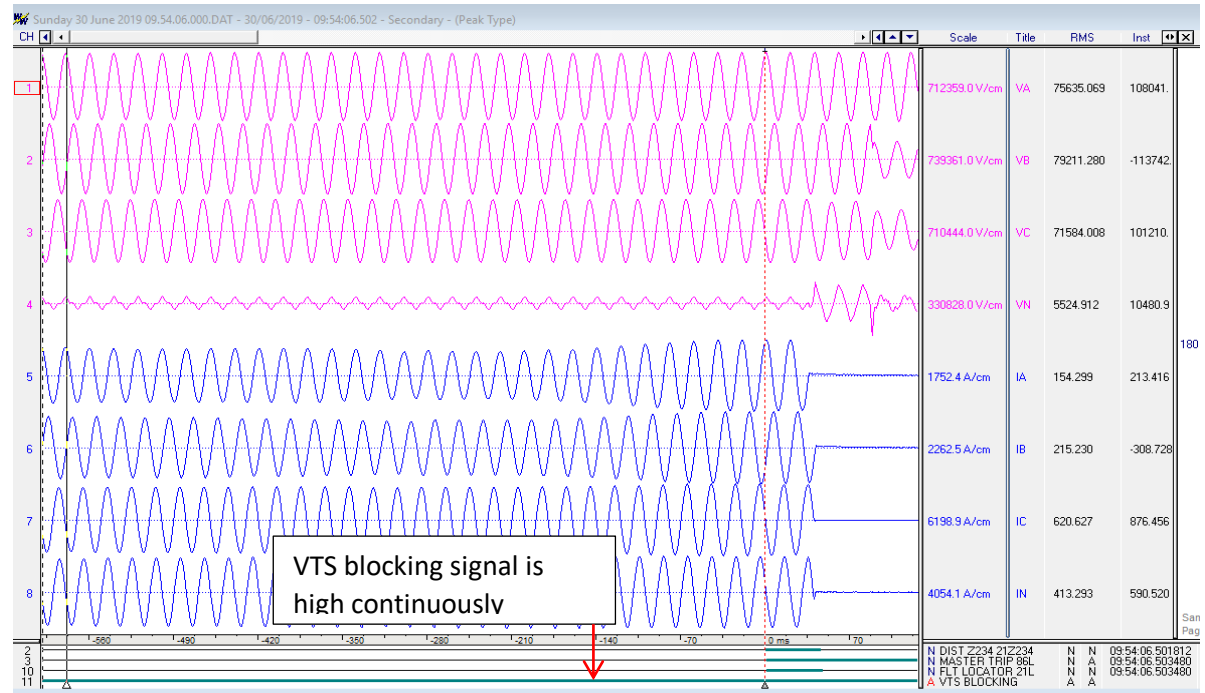
3. DR analysis of 132 kV Rangpo-Chuzachen at Chuzachen:

From Chuzachen end distance protection zone-3 operated as reported by them. But in the DR VTS blocking signal was high, which blocks zone protection. Chuzachen may explain the why VTS blocking was high and then how DP operated. Even if DP operated, then how zone-3 of the line encroached two voltage levels is not clear. Zone-3 setting may be reviewed.

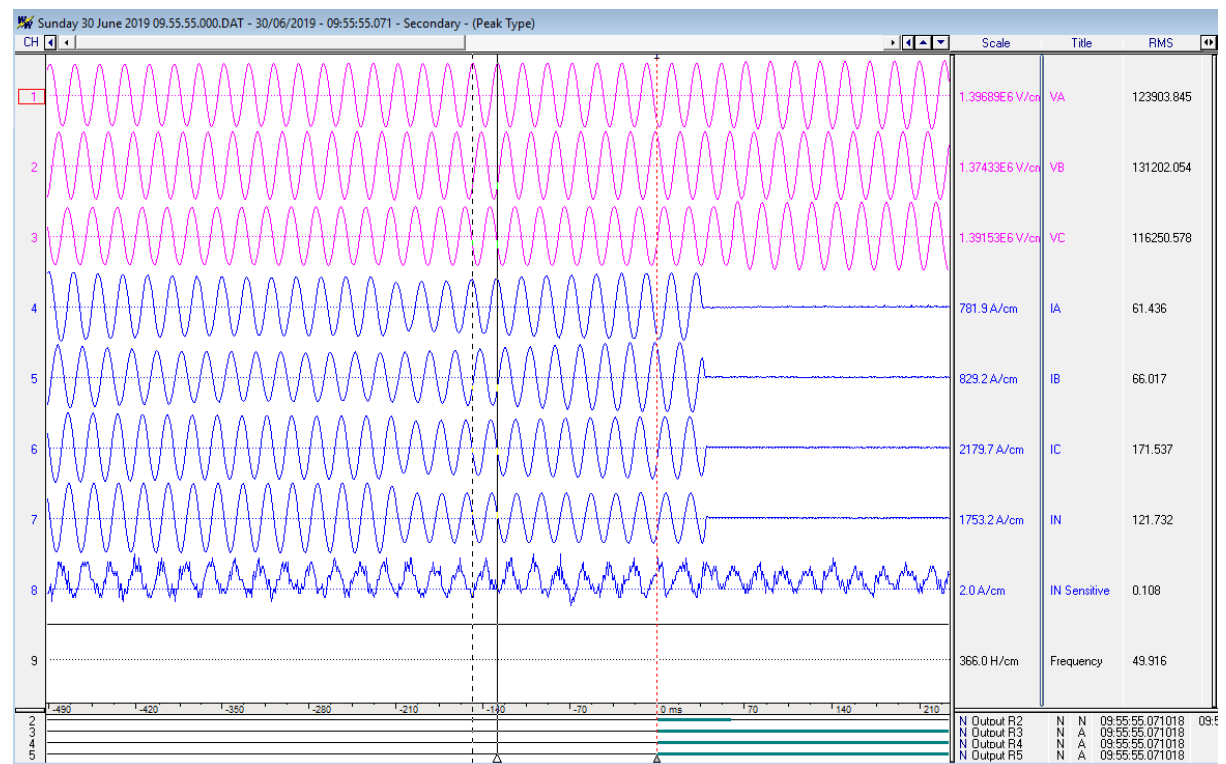
4. DR analysis of Jorethang-New Melli at Jorethang:

DR Digital channels are not properly configured. So it is not clear which protection operated. Operation of DEF within 650 ms suggests that DEF setting need to be reviewed.

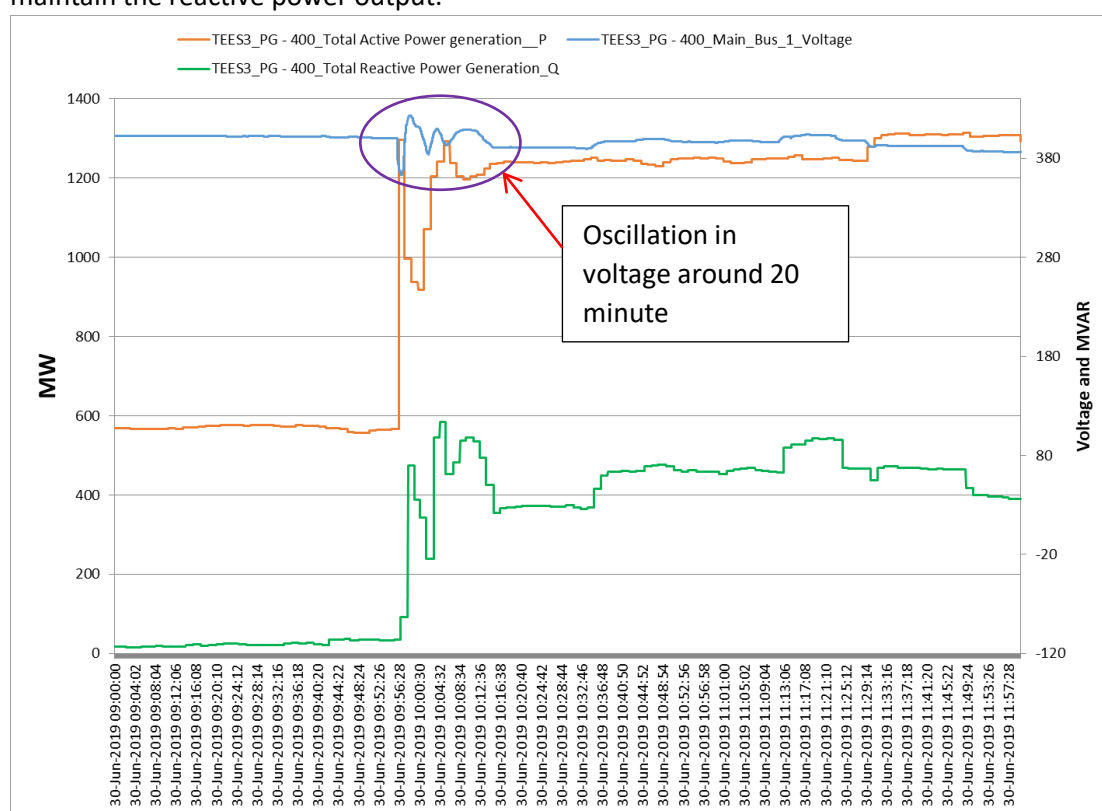
This mode of operation can cause voltage stability issue for Grid connected generators as it has a slower outer control loops which vary the voltage set point of the generators to maintain the reactive power output.

Figure 9: Active Reactive generation of Teesta III and Teesta III Bus voltage

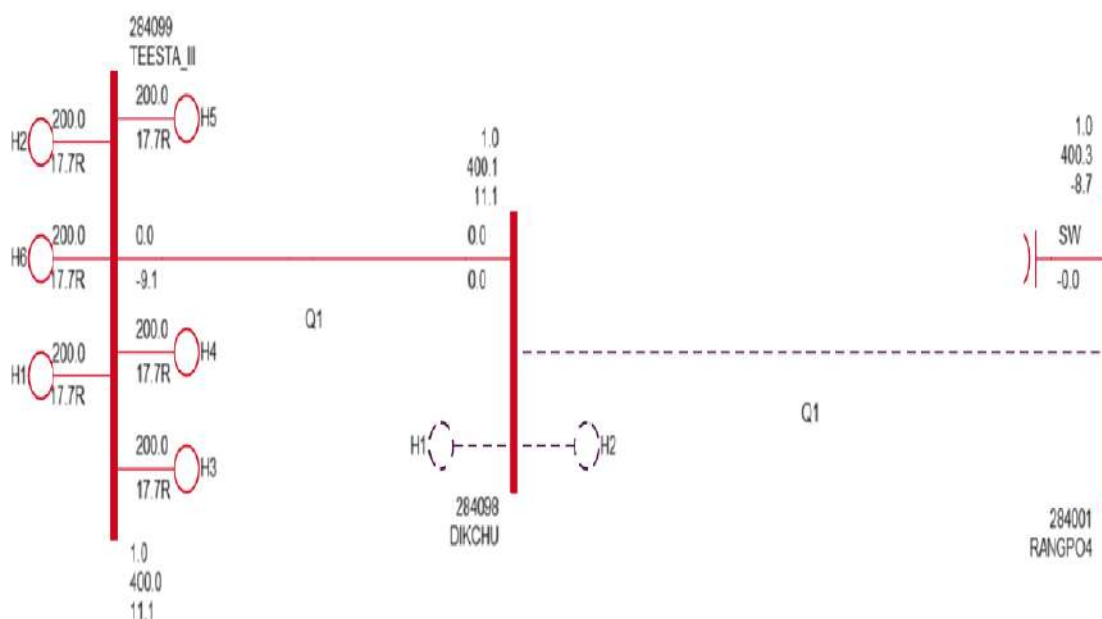
During restoration the phase angle difference between 400 kV Rangpo and Dikchu (or Teesta III) was more than 20 degree. Also in the study done by ERLDC and NLDC in PSSE similar angle difference is observed.

Figure 11: PSSE study for calculating Phase angle difference between Rangpo and Teesta III
