Agenda for 89th PCC Meeting

EASTERN REGIONAL POWER COMMITTEE

AGENDA FOR 89TH PROTECTION SUB-COMMITTEE MEETING TO BE HELD AT ERPC, KOLKATA ON 13.03.2020 (FRIDAY) AT 11:00 HOURS

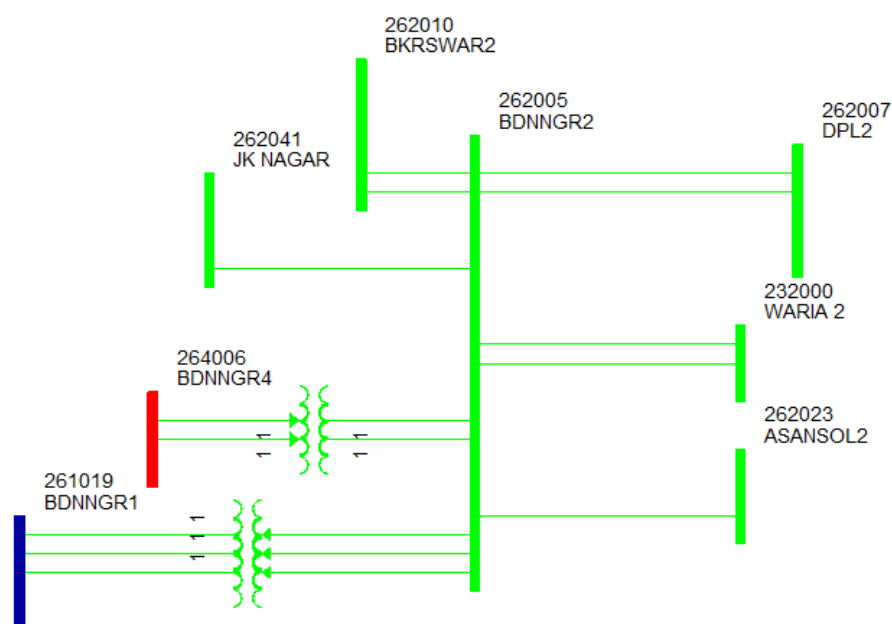
ITEM NO. B.1: Disturbance at 220 kV Bidhannagar Substation on 01.02.2020 at 21:05 Hrs.

At 21:05 Hrs, R phase CT of 220 kV Bus coupler at 400/220/132 kV Bidhan Nagar (WBSETCL) substation failed which led to Bus fault on both 220 kV Buses. With this, 220 kV both buses and all connected elements tripped on Bus bar protection operation.

Both 220 kV buses at Bidhannagar S/S tripped on Bus differential protection resulting into tripping of all 220kV outgoing feeders connected at Bidhannagar, 2 x 315MVA 400/220kV ICTs at Bidhannagar, 3 x 160MVA 220/132kV ICTs at Bidhannagar and two running units (unit #7 & #8) of DPL due to loss of evacuation path. There is a load loss of approx. 300 MW around Bidhannagar, DPL embedded area and Ukhra.

Generation Loss: 350 MW and Load Loss: 350 MW

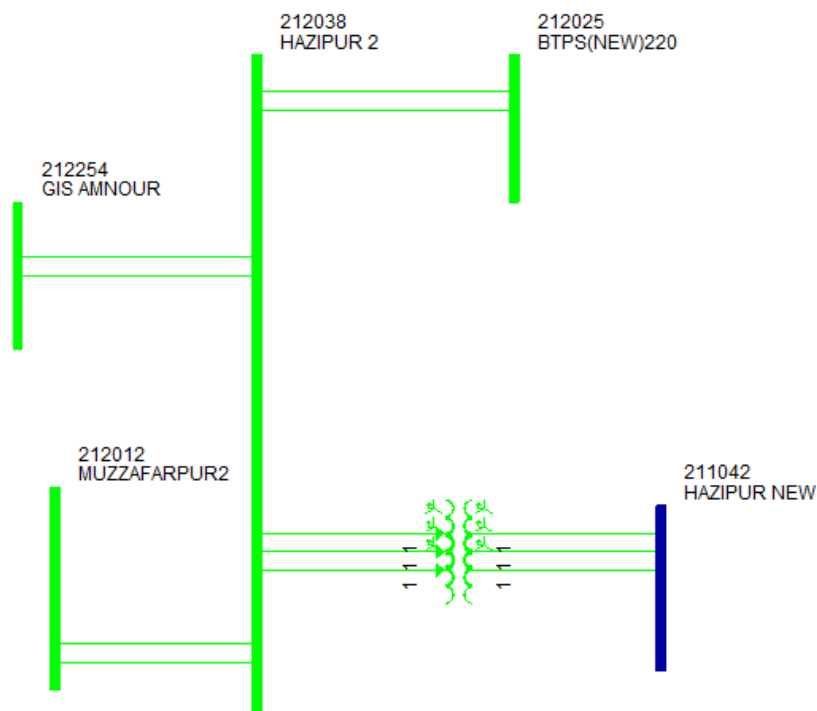
ITEM NO. B.2: Tripping of 220 kV Muzaffarpur-Hajipur D/C on 09.02.2020 at 12:53 Hrs.

At 12:53 hrs, 220 kV Muzaffarpur-Hajipur D/C tripped due to bus bar protection operation at Hajipur leading to tripping of all feeders connected to 220 KV Hajipur S/S, causing load loss at Hajipur, Amnour, Siwan, Chhapra, Hathua, New Siwean(Raghunathpur) & Gopalganj (traction load loss of approx. 25MW at Hajipur, Siwan, Chhapra)

As per PMU data at Muzaffarpur, no fault has been observed.

Load Loss: 183 MW

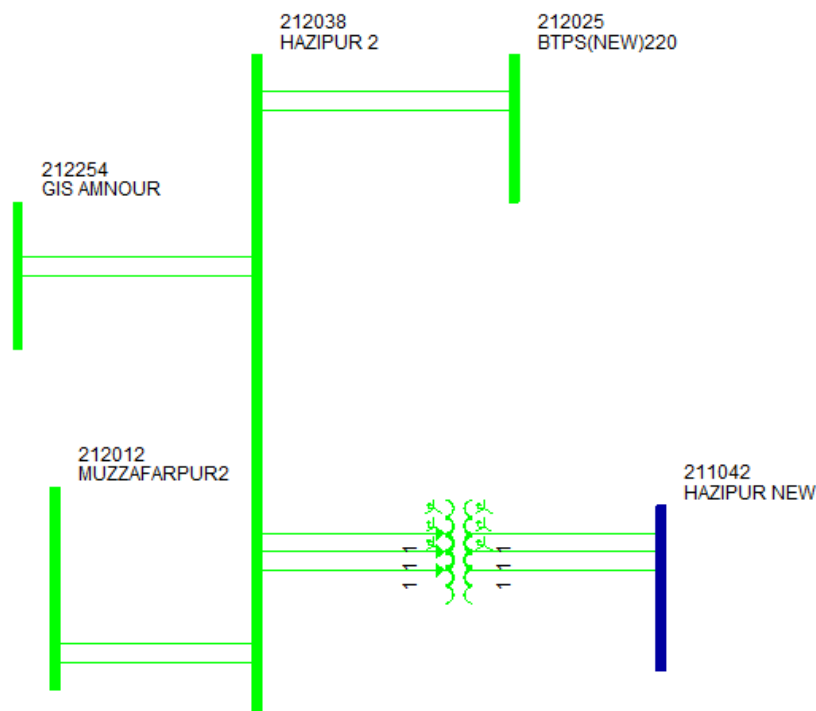
ITEM NO. B.3: Tripping of 220 kV Hajipur-Amnour D/C on 10.02.2020 at 17:32 Hrs.

At 17:32 hrs, 220 KV Hajipur-Amnour D/c tripped leading to load loss of 142 MW at Amnour, Siwan, Chhapra, Hathua, New Siwan(Raghunathpur) & Gopalganj (traction load loss of approx. 15MW at Siwan, Chhapra).

As per PMU data at Muzaffarpur, no fault has been observed.

Load Loss: 142 MW

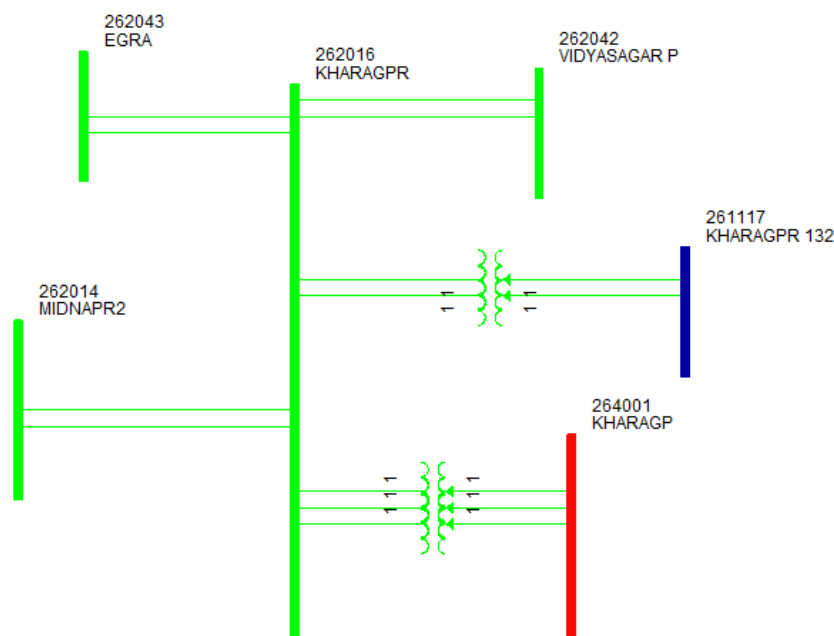
ITEM NO. B.5: Total Power Failure at Egra and Vidyasagar S/s on 11.02.2020 at 08:33 Hrs

220 KV Kharagpur-Midnapore D/c under planned shutdown. At 08:33 Hrs, LBB of 220 KV Kharagpur-Vidyasagar Park I operated due to closing of earth switch at Kharagpur end resulting into tripping of both 220 KV buses at Kharagpur and total power failure at Vidyasagar Park and Egra.

It was reported by WBSETCL that Both Zone 1 and 2 along with check zone of Bus bar protection has operated causing tripping of both 220 kV buses at Kharagpur. This has led to all 220 kV Connected elements tripping from 220 kV buses of Kharagpur along with 400/220 kV and 220/132 kV ICTs.

With this 220 kV and 132 kV buses were having no supply at Kharagpur. This has led to total power failure at radially fed 220/132 kV Vidyasagar Park and Egra substation and 132 kV Keshiary causing load loss of 262 MW.

As per PMU data, fault has been cleared within 100 ms.

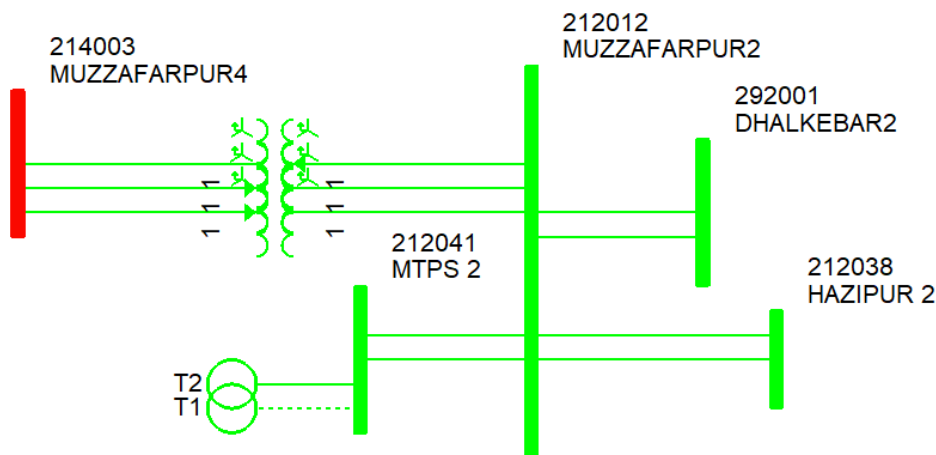
ITEM NO. B.6: Disturbance at Muzaffarpur Substation on 20.02.2020 at 12:29 Hrs.

At 12:29 Hrs, 220 KV Bus 2 at Muzaffarpur (PG) tripped leading to tripping of 220 KV Muzaffarpur-Dhalkebar 2, 220 KV Muzaffarpur-Hajipur 2, 220 KV Muzaffarpur-MTPS (KBUNL) 2, 500 MVA 400/220 KV ICT III. Subsequently 220 KV Muzaffarpur-Dhalkebar I also tripped on O/c and supply to Nepal interrupted.

As per PMU data at Muzaffarpur, 0.5 kV voltage dip observed in all three phases for more than 6 seconds. All three-phase voltage raised by 1 kV after that.

Load Loss: 260 MW

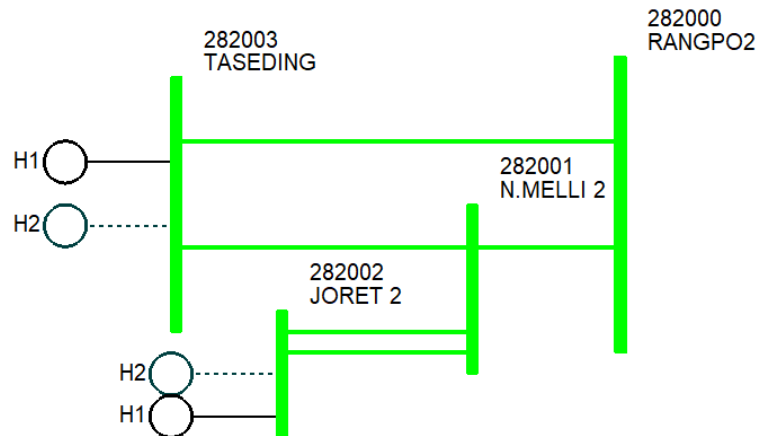
ITEM NO. B.10: Total power failure at Tashiding Substation on 16.01.2020 at 15:48 Hrs.

At 15:48 hrs, 220 kV New Melli-Tashiding S/C, 220 kV-Tashiding-Rangpo S/C, 220 kV New Melli-Jorethang-I tripped on Y-N fault resulting total power failure at Tashiding S/S. There was no generation at Tashiding

In 88th PCC meeting ERLDC informed that there was a B-N fault in 220kV New Melli-Jorethang line -I and Jorethang end tripped on zone 1. The fault got cleared within 100 ms. Reason for tripping of 220 kV New Melli-Tashiding S/C, 220 kV-Tashiding-Rangpo S/C lines needed explanation.

PCC observed that there was uncoordinated tripping at Jorethang & Tashiding due to improper protection relay settings. In earlier PCC Meetings, DANS Energy was advised to review the relay settings. The compliance report is yet to be received from DANS Energy.

PCC decided to conduct protection audit at Jorethang, Tashiding and New Melli S/s in the month of March, 2020.

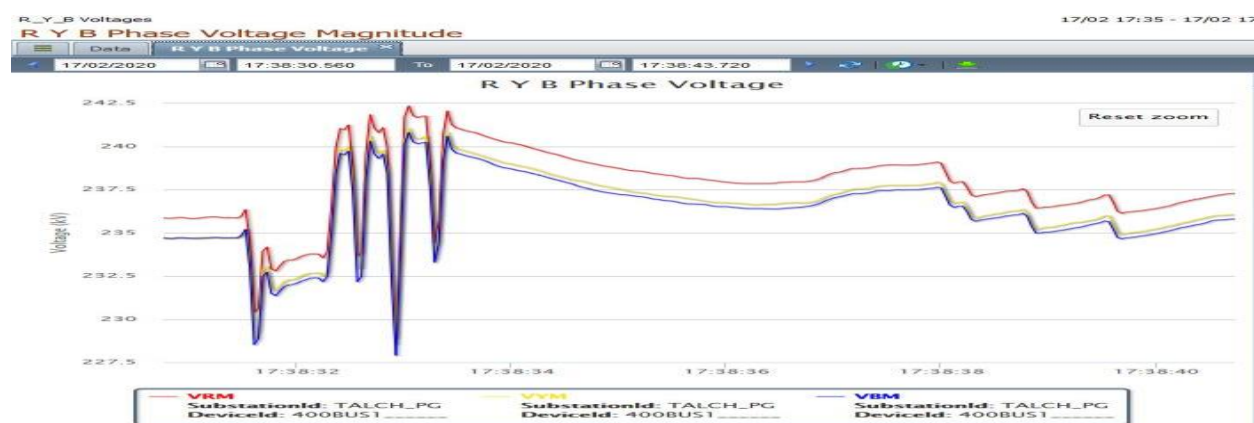
Figure-1

At 17:38:31.600 hrs, severe transients observed in AC side voltage of Talcher end due to persistent DC line fault in HVDC Talcher-Kolar Bipole. After 17:39 hrs, there was continuously dip in voltages due to switching off of filters due to ramping down of Pole-I from 1000 MW to 150 MW. The bus voltage of Talcher station is given below in Figure-1:

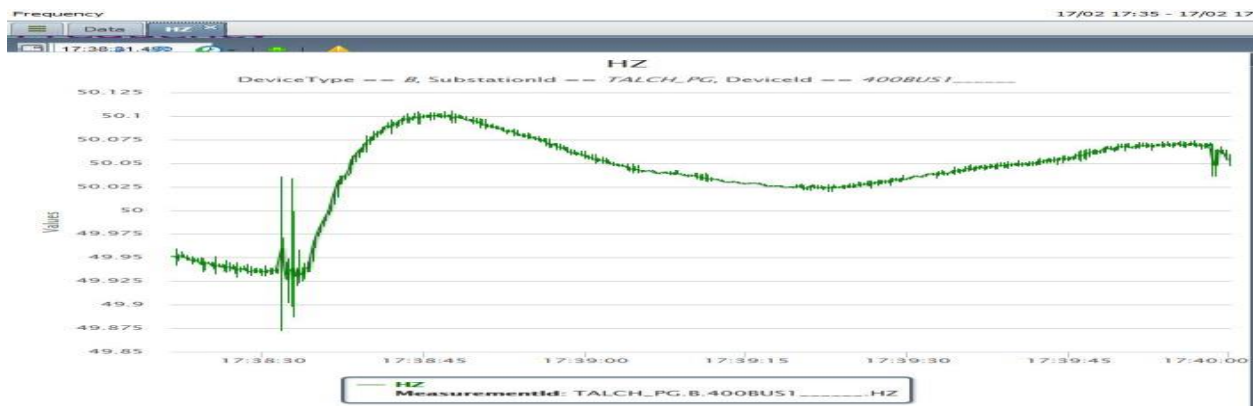
Figure-2

At 17:38:31.600 hrs, pole-II got tripped. At this time TS1 and TS2 signal generated at Kolar end and load relief of 1415 MW obtained in southern region. It led to the frequency rise to 50.10 Hz from 49.935 Hz. Due to primary response, the frequency gone down to 50.025 Hz. Then at 17:39:58.400 hrs, Pole-I went into ground return mode and at Talcher end, signal 3 was generated. Due to instantaneous backdown of 666 MW from Talcher stg II, the frequency dipped to 49.96 Hz from 50.07 Hz and finally settled to a higher value of 50.04 Hz. The frequency during the incident is given below in Figure-2:

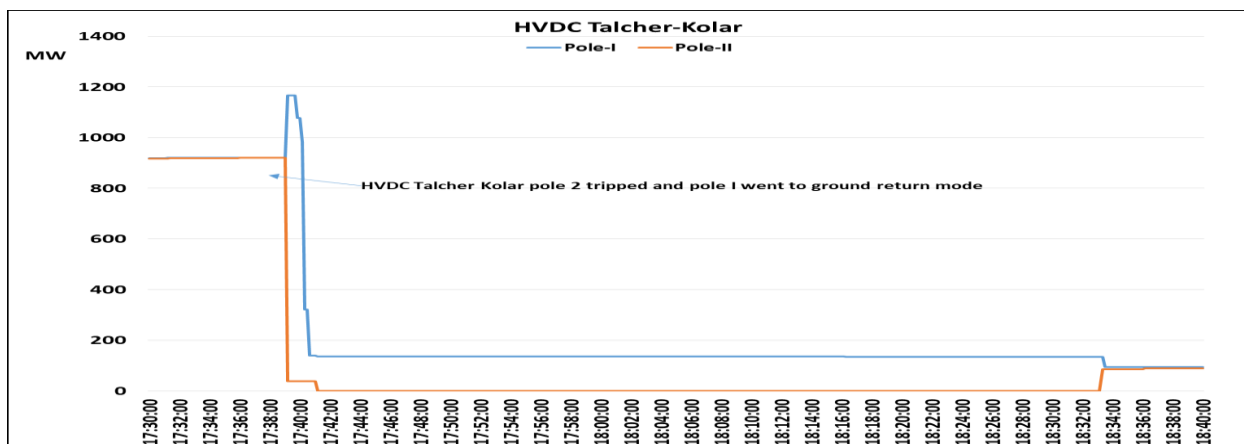
The rise of pole –I power flow above 1000 MW after outage of pole-II can also be observed in SCADA plots. The flow of HVDC Talcher-Kolar Bipole is given below. Prior to incident flow is less than 1000 MW as shown in Figure-3

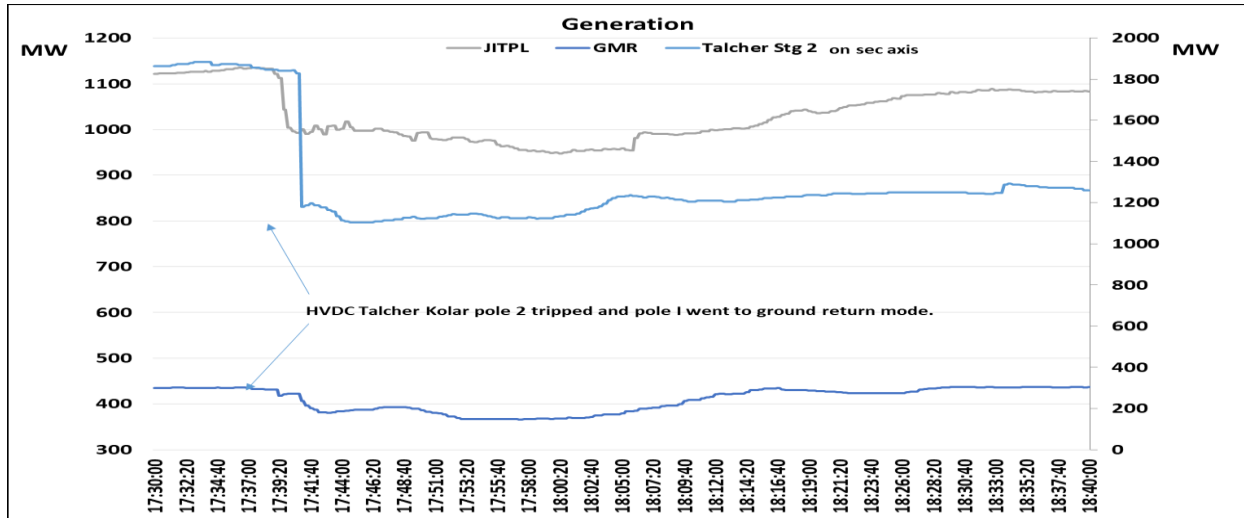
Figure-4

After Pole tripping SPS Signal-3 was generated at Talcher end. Due to this there was instantaneous back down of 666 MW in Talcher stg-2. There was gradual decrease in generation backdown of 50 MW and 130 MW in JITPL and GMR respectively. The generation is given below in Figure-4:

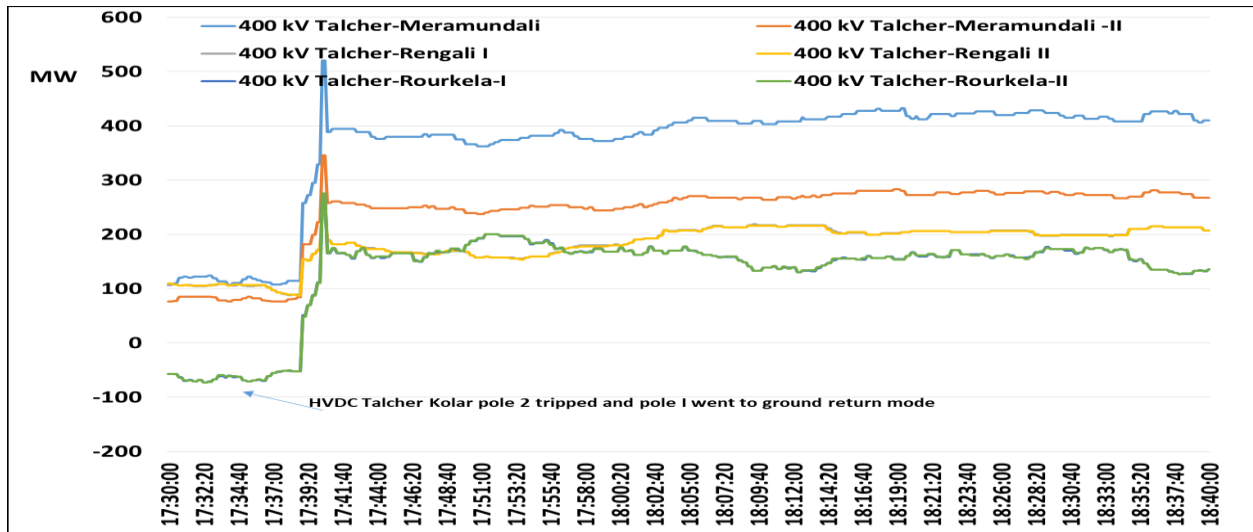
With the loss of 750 MW power flow on Bipole, the flow on 400 kV Talcher-Rengali D/C and 400 kV Talcher- Meramundali D/C is increased with sensitivity of 15.8 % and 35.16 % respectively and flow on 400 kV Rourkela-Talcher decreased with sensitivity of 40 %. The flow on all the 400 kV lines from Talcher end is given below in Figure-5

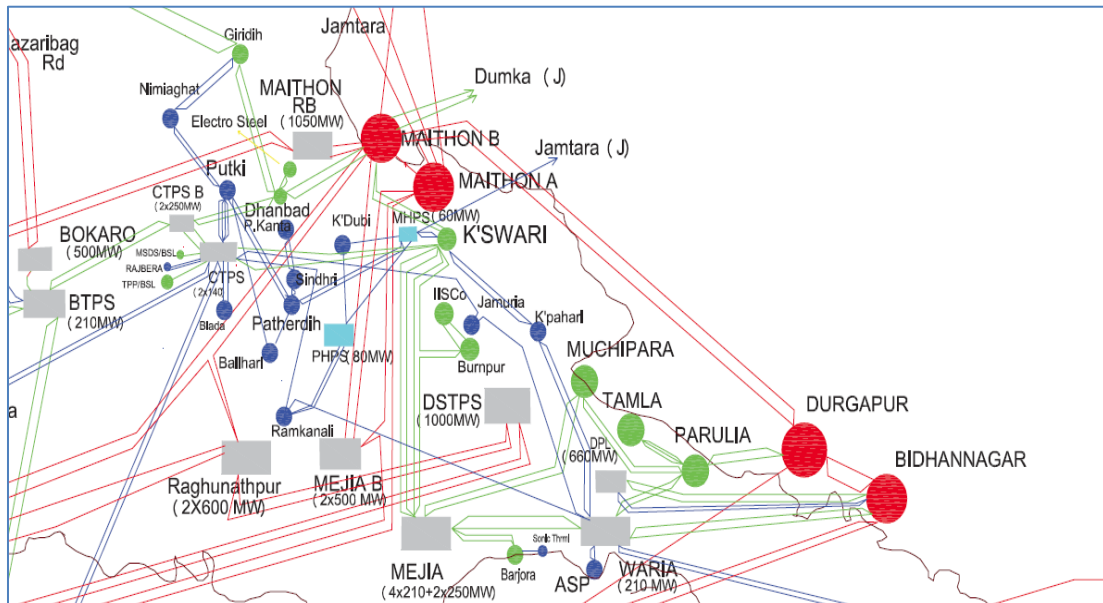
Figure 1: Network across affected area

- 1) **Date / Time of disturbance:** 08-02-2020, 01:55 hrs.
- 2) **Systems/ Subsystems affected:** RTPS and Andal (DSTPS)
- 3) **Antecedent condition:** 400 kV Andal – Jamshedpur 1 I is under planned outage since 03-02-2020. 400 kV Maithon – RTPS S/C tripped at 01:53 hrs prior to the incident due to DT received from Maithon.
