Minutes of 94th PCC Meeting

EASTERN REGIONAL POWER COMMITTEE

MINUTES OF 94TH PROTECTION SUB-COMMITTEE MEETING HELD ON 28.09.2020 AT 10:30 HOURS

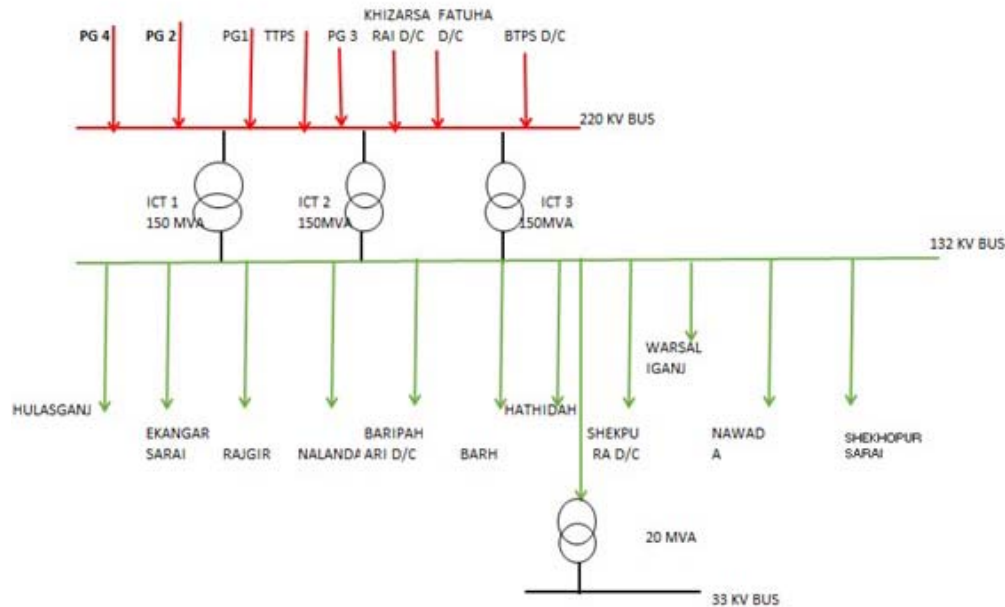
SLD OF BIHARSHARIF GSS

BSPTCL may share the reason for the tripping of 400/220 and 220/132 kV ICTs at Bihar Sharif. Lack of protection coordination has been observed during the event at 400/220 kV Bihar Sharif (PGCII) and 220/132 kV Bihar Sharif (BSPTCL) during this event. The status of the entire protection system at 220/132 kV Bihar Sharif substation may kindly be shared by BSPTCL as non-operation of 132 kv line protection is of serious concern.

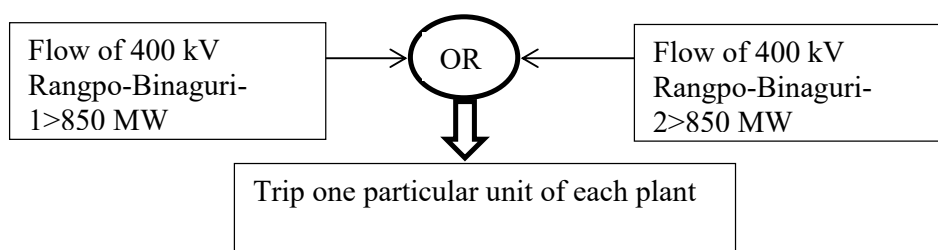
SPS:

Following SPS logic may be implemented for ensuring reliability during the above mentioned three critical N-2 contingency:

In 94th PCC, ERLDC explained that flow of 400 kV Rangpo-Binaguri-1 and II is to be measured and if the power flow greater than 850 MW in any one line then SPS signal would be generated and issue trip command to one unit of each plant i.e. Teesta III, Dikchu, Jorethang and Tashiding HEP.

ERLDC informed that trip logic to be connected to the unit which is running at low load. If one unit is already out then tripping of other unit at the particular station is not required.

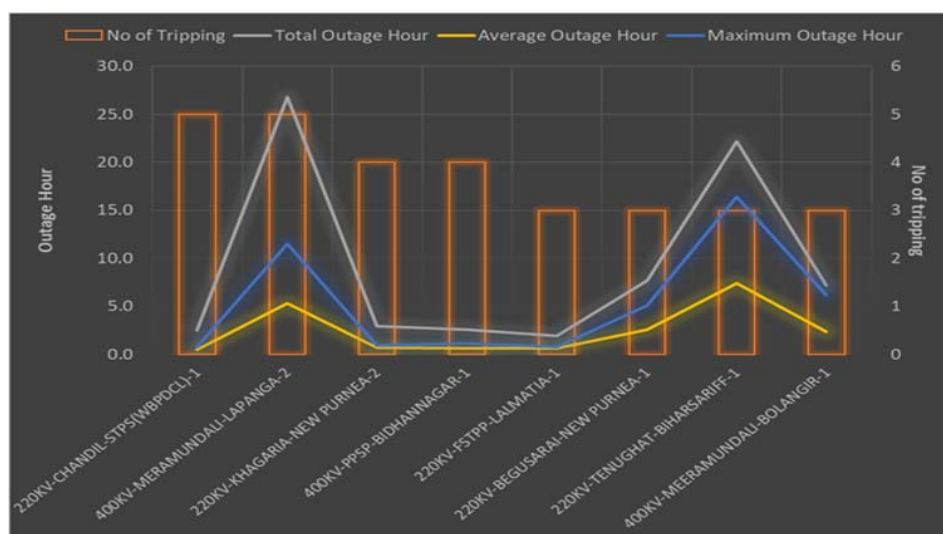
During August 2020, repeated tripping has been observed in few of the transmission lines. List of these transmission lines along with number of tripping and outage duration are shown below:

It has been observed that few transmission lines have tripped repeatedly on the same reason. Transmission utilities are advised to share the remedial action taken to reduce the number of such tripping of these transmission lines (list given below).

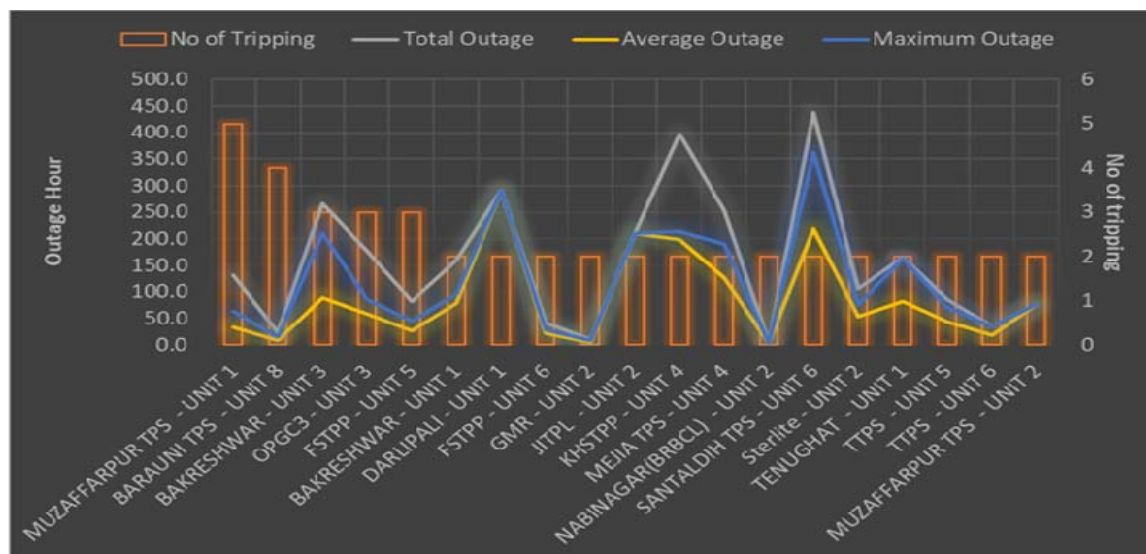
During August 2020, repeated tripping has been observed for few generating units. List of such generating units along with number of tripping and outage duration is shown in below plot.

It has been observed that few generating units tripped repeatedly due to same reason. Generating stations may be asked to share the remedial action taken to reduce the no of tripping of these units (list given below).

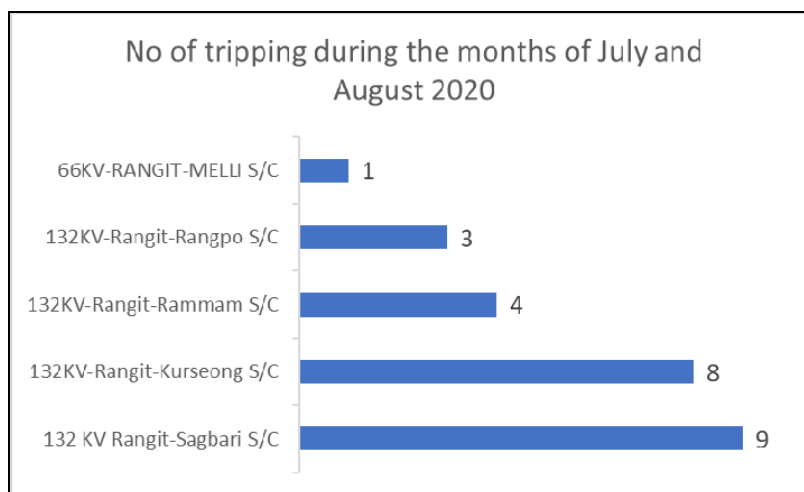
During the months of July and August 2020, occurrence of repeated tripping has been taken place for the transmission lines connected to Rangit Hydro Electric Plant due to short circuit faults at various locations. No of tripping incidents for each line is shown below:

During fault, all the running units contribute fault currents. Repeated occurrence of faults may result in damage of the generating units.

Utilities are requested to maintain healthiness of these transmission lines.

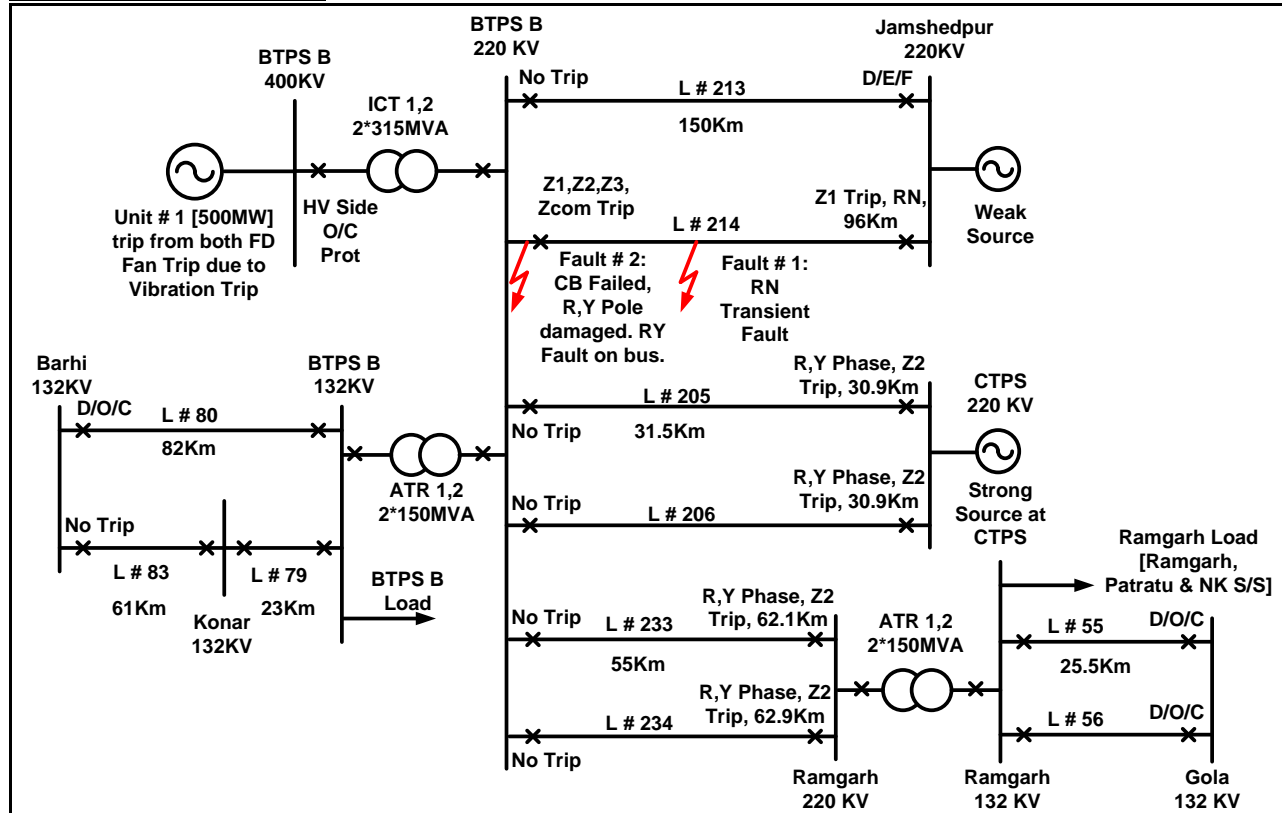
RELEVANT SYSTEM SLD:

BRIEF HISTORY: At around 01:52 Hrs on 16-08-2020, a system disturbance occurred at 220KV BTPS-B S/Y, DVC. As reported, the Y-Pole CB of 220kV Bokaro-Jamshedpur Ckt-II (L#214) burst out at BTPS-B end also causing damage to the R-Ph CB pole leading to TPF at BTPS-B (220& 132kV both), Ramgarh (220& 132kV both), Patratu & NKP S/S. There was also oil splashing of 220KV Y Phase CT of L # 214 at Jamshedpur End. Both the 315MVA ICTs of BTPS-A tripped at BTPS-A end along with the tripping of BTPS-A U#1(500MW Capacity).

1. The R & Y CB pole of L # 214 at BTPS B End was replaced and the CB was put into service.
2. R Phase CT at Jamshedpur End of L # 214 was replaced by a healthy one.
3. LBB Protection function in L # 214 was switched ON in the REL 670 distance relay.
4. Vibration Protection in FD Fan motors of BTPS A Unit was switched OFF.
