# Minutes of 95<sup>th</sup> PCC Meeting

## **EASTERN REGIONAL POWER COMMITTEE**

### **MINUTES OF 95<sup>TH</sup> PROTECTION SUB-COMMITTEE MEETING HELD ON 15.10.2020 AT 10:30 HOURS**

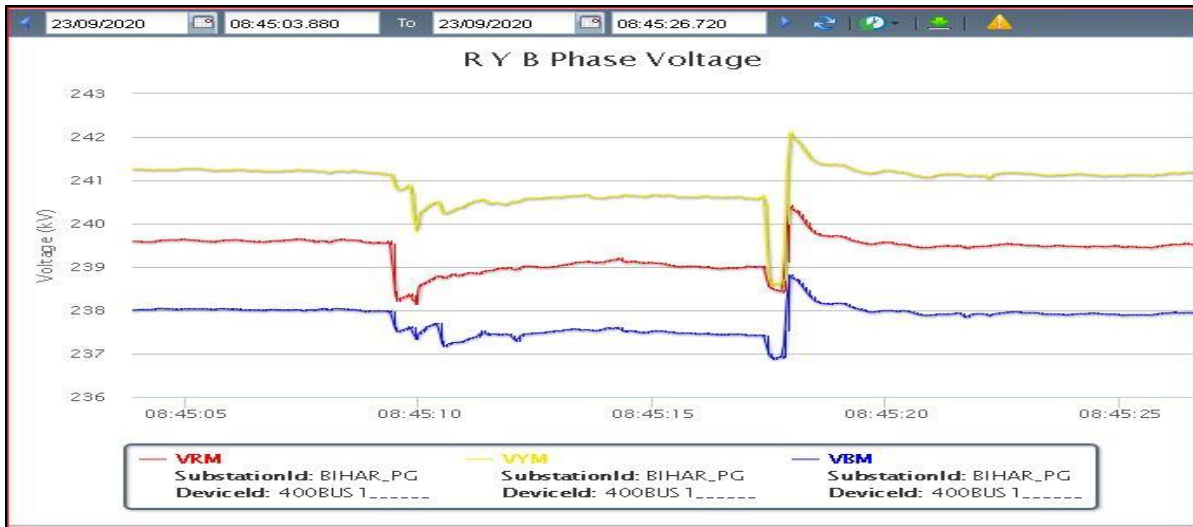
Figure 2: Initially around 1 kV dip has been observed in all three phases at Biharshariff PMU. Dip in R phase voltage was more than other phases. Around 8 seconds after the start of the fault, the dip in the Y phase increased to 2.5 kV. After 500 ms, fault in all three phases got cleared.

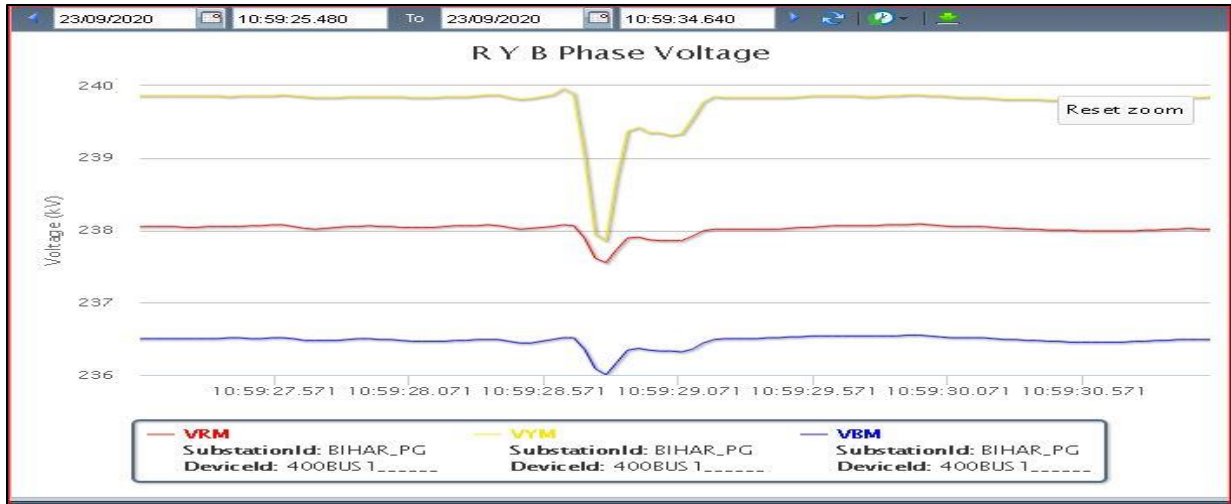
Figure 3: Three phase PMU recorded at 10:59 hrs at Biharshariff shows the existence of Y phase to earth fault at the time of the event. The fault clearing time was around 350 ms.

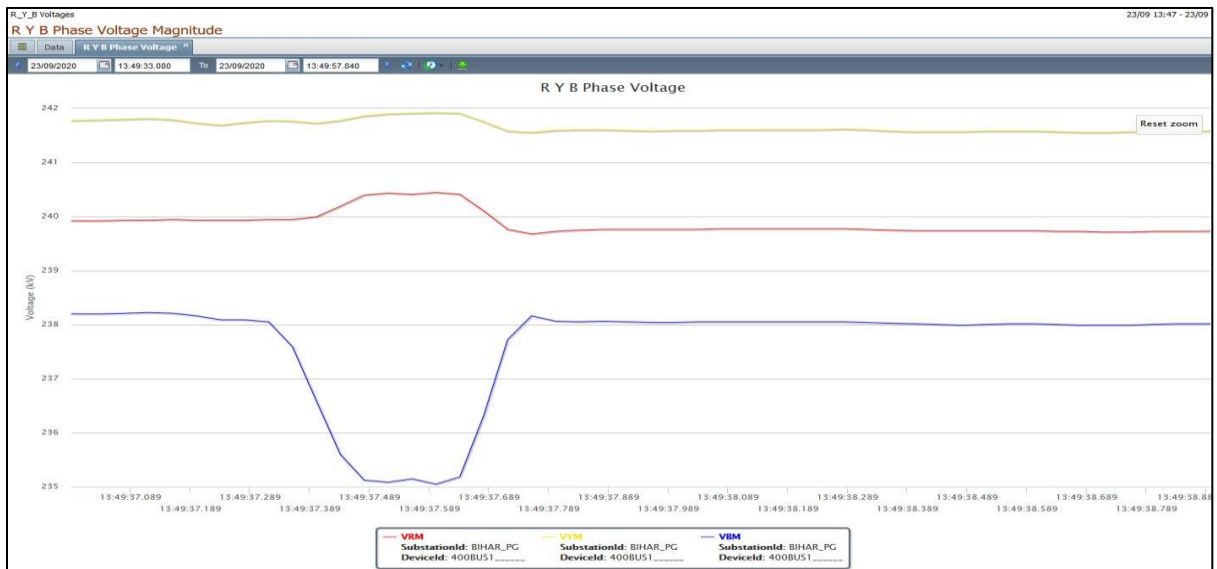
Figure 4: Three phase PMU recorded at 13:49 hrs at Biharshariff shows the existence of B phase to earth fault. The fault clearing time was less than 160 ms.

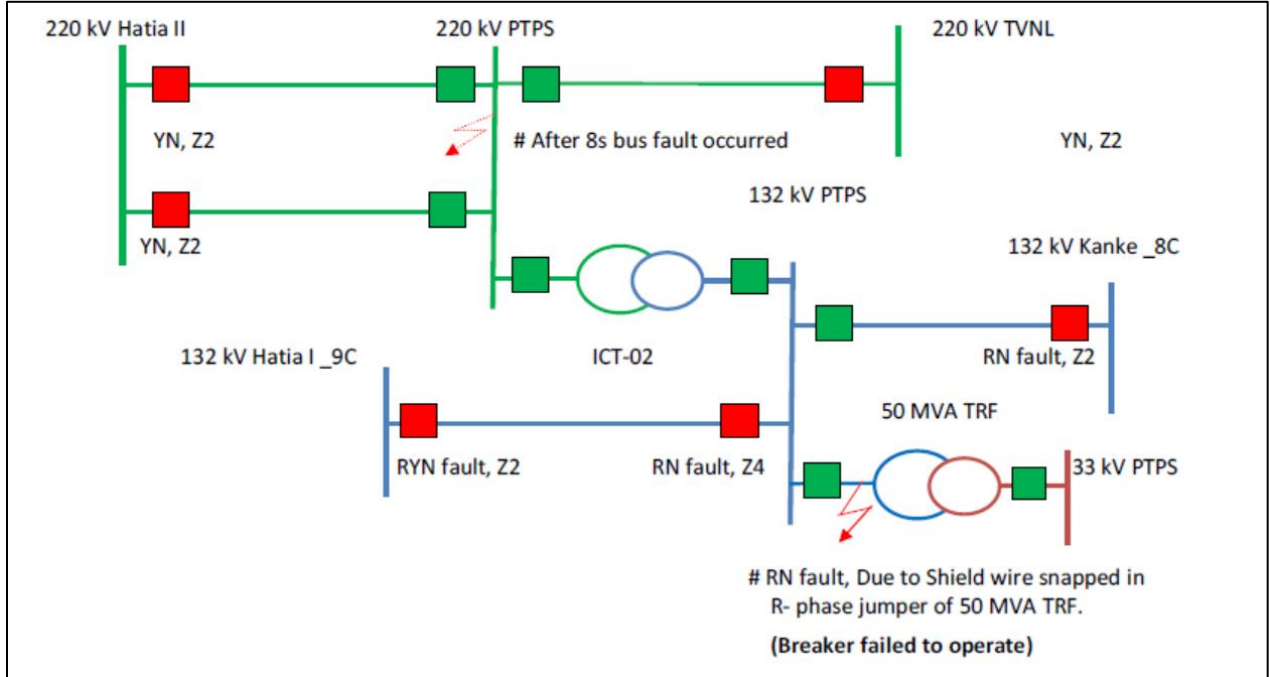
Figure 5: Status of the network of affected area after event 1

- At 08:45 hrs R phase to earth fault occurred at Patratu S/S due to snapping of the shield wire on 132 kV side R – Phase jumper of 50 MVA, 132/33 kV ICT. Differential & REF (field CT is used for Diff & REF) protection of affected ICT sensed the fault and issued trip command instantly to the breaker. But the breaker failed to operate due to the problem in its mechanism. The air pressure lock mechanism was found in the open condition during the investigation.

- 220/132 kV ICTs at Patratu S/s did not trip. So, the fault was being fed from 220 kV side via 220 kV Hatia Patratu D/C and 220 kV Tenughat Patratu S/C. Directional earth fault protection at Hatia end of 220 kV Hatia Patratu D/C sensed the fault. But the breaker did not trip as the fault current was below the pick-up setting (15% of 800/1). O/C and E/F protection of 220/132 kV ICT - 2 at Patratu failed to sense the fault. **JUSNL may share O/C and E/F protection setting of 220/132 kV ICT - 2 at Patratu.**

kV Hatia Patratu D/C and 220 kV Tenughat Patratu S/C tripped in Zone - 2 protection from Hatia and Tenughat end respectively. As a result, a total power failure occurred at Patratu S/S.

- Breaker of 50 MVA 132/33 kV ICT at Patratu failed to trip due to problem in the air pressure lock mechanism. JUSNL may share the remedial action taken after this event. The healthiness of the breaker at Patratu may be checked by JUSNL. **(JUSNL to update)**

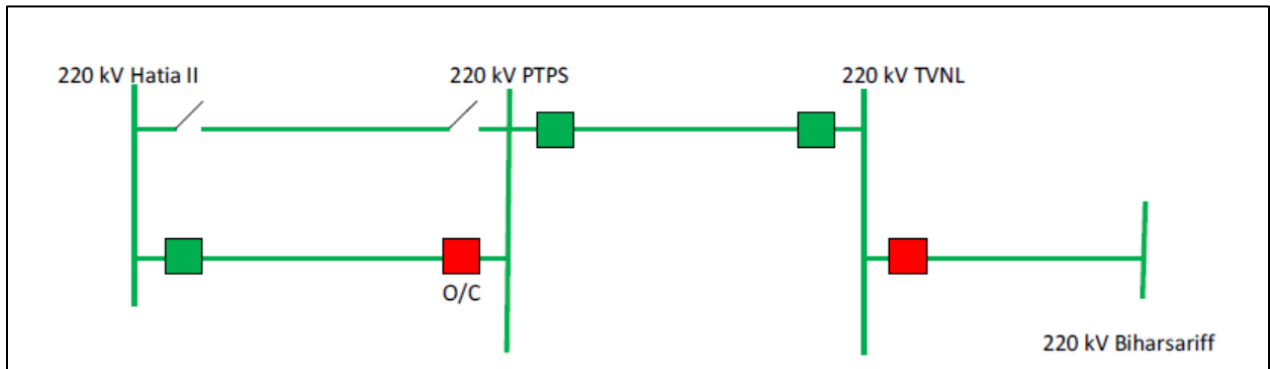
Figure 6: Status of the network of affected area after event 2

- During event 2, 220 kV Patratu – Hatia – 1 was not in service. At 13:49 hrs 220 KV Tenughat-Biharshariff S/C tripped due to B phase to earth fault at 106 km from Tenughat.
