# Agenda for 96<sup>th</sup> PCC Meeting

## **EASTERN REGIONAL POWER COMMITTEE**

### **AGENDA FOR 96<sup>TH</sup> PROTECTION SUB-COMMITTEE MEETING TO BE HELD ON 12.11.2020 AT 10:30 HOURS**

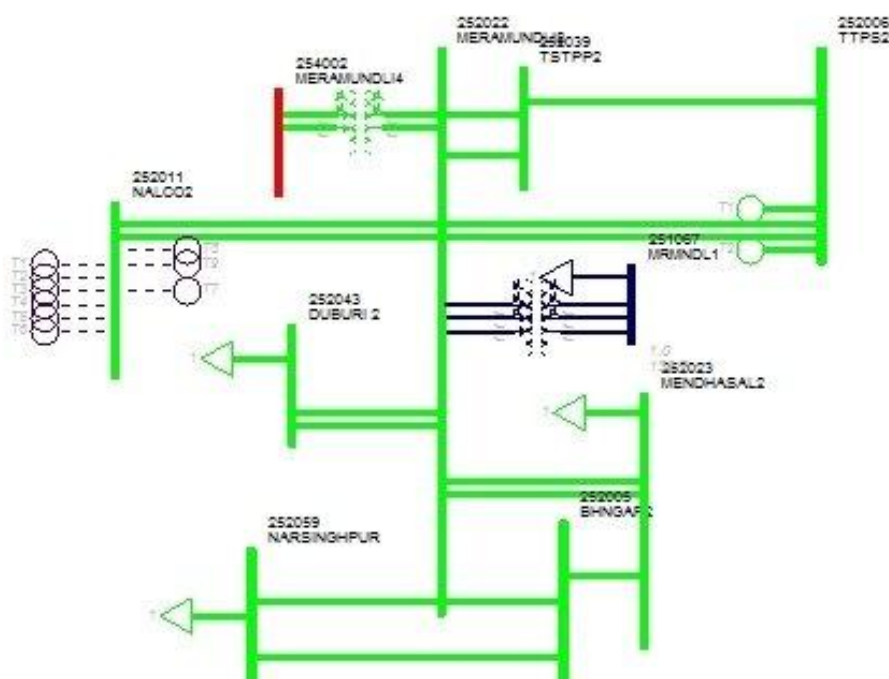
At 04:07 hrs, line side pipe at Meramundali end of the above-mentioned circuit got broken and fell on the ground along with the breaker jumper causing line fault at Meramundali S/s. Bus jumper of 220 kV bus 1 at Meramundali also got damaged at several places which led to bus fault at 220 kV bus 1 at Meramundali. All the elements connected with 220 kV bus 1 along with the bus coupler tripped at Meramundali.

Time	Name	End 1	End 2	PMU Observation
04:07 hrs	220 kV Meramundali NALCO - 1	B-N, Zone-4, F/C =2.3 kA, 511ms	Yet to be received	Around 20 kV dip has been observed in all three phase voltages at Meramundali PMU data during the fault at 22:36 hrs on previous day. The fault clearing time was around 900 ms. During this event, around 200 kV dip has been observed in Y phase voltage at Meramundali PMU data. But as per Talcher PMU, fault was in B phase. Same has been observed in DR output recorded at Meramundali. The fault clearing time was around 500 ms. Around 70 – 200 kV rise has been captured in healthy phases of Meramundali PMU data during the fault.
	220 kV Meramundali NALCO - 2	B-N, Zone-4, F/C =2.4 kA, 516ms	Yet to be received	
	220 kV Meramundali TTPS - 1	B-N, F/C =5.3 kA, Distance: 1km, 526 ms	Did not trip	
	220 kV Meramundali TTPS - 2	B-N, F/C =5.1 kA, Distance: 1km, 522 ms	Did not trip	
	220 kV Meramundali Narsinghapur S/C	Did not trip, only zone – 4 picked up	B-N, Zone-2, F/C =0.9 kA, 357 ms, Dist. 75 km

220 kV Meramundali Duburi S/C	Did not trip, only zone – 4 picked up	B-N, Zone-2, F/C =3.1 kA, 397 ms, Dist. 83 km	
	220 kV Meramundali Bhanjanger S/C	Did not trip, only zone – 4 picked up	B-N, Zone-2, F/C =1.2 kA, 350 ms, Dist. 166.7 km	
	220 kV Meramundali Tata Steel - 1	Did not trip	B/U relay operated, IR=1.1 kA, IY=1.8kA, IB=5.17 kA	
	220 kV Meramundali Tata Steel - 2	Tripped on E/F protection	B/U relay operated, IR=2.3kA, IY=2.7kA, IB=7.8kA	
	220/132 kV ICT – 1 at Meramundali	67N, IB=6.4KA, 494ms	NA	
	220 kV Bus coupler at Meramundali	E/F tripped	NA

1. OPTCL may explain the tripping of 220 kV Meramundali – NALCO – 1 on 30<sup>th</sup> September 2020 at 22:36 hrs,
2. Status of Bus bar protection of 220kV level at Meramundali S/S.

3. The reason for non-operation of 220 kV Meramundali NALCO D/C and 220 kV Meramundali TTPS D/C in the zone – 2 protection from NALCO and TTPS ends respectively may be clarified.
4. 220 kV Meramundali-Tata Steel D/C tripped from Tata Steel end in back up protection. Details of back up protection operation may be shared by OPTCL and Odisha SLDC.
5. Plan for the installation of carrier protection at 220 kV Meramundali Narsinghapur S/C, 220 kV Meramundali Duburi S/C and 220 kV Meramundali Bhanjangan S/C may be shared.
6. As per PMU data, around 70 – 200 kV rise has been observed in healthy phases during the fault at 04:07 hrs. OPTCL may share the reason for so high voltage in healthy phases during single line to ground fault.

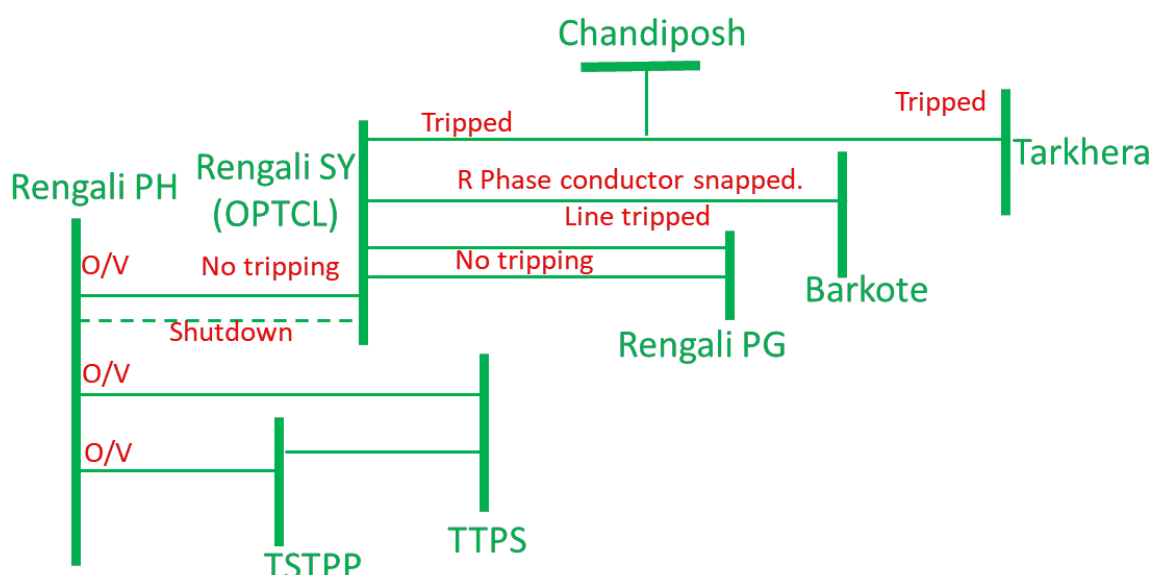
On 10<sup>th</sup> October 2020 at 16:08 hrs, 220 kV Rengali Switchyard (OPTCL) - Barkote S/C and 220 kV Rengali Switchyard (OPTCL)-Tarkera S/C tripped due to R phase to earth fault and B phase to earth fault respectively. It was reported that top conductor (R phase) of 220 kV Rengali Switchyard (OPTCL) - Barkote S/C snapped at location no 336.

Thereafter, 220 kV Rengali PH – TSTPP S/C and 220 kV Rengali PH – TTPS S/C and 220 kV Rengali PH – Rengali Switchyard (OPTCL) – 1 tripped on overvoltage from Rengali PH end. Subsequently all the running units at Rengali PH tripped. 220 kV Rengali Switchyard remained connected to rest of grid through 220 kV Rengali PG – Rengali SY D/C.

Time	Name	End 1	End 2	PMU Observation
16:10 Hrs	220 kV Rengali SY – Tarkera S/C	B-N, Zone 2, 75 km from Rengali, F/C 5.2 kA	B-N, Zone 1, 65 km from Tarkera, F/C 2.3 kA	Around 10 kV dip has been observed in B phase voltage and around 9 kV dip has been observed in R
	220 kV Rengali S/Y - Barkote S/C	D/P, Zone 1, 34 km from Rengali, F/C 8 kA	R-N, Zone 1, 13 km from Barkote, F/C 2.3 kA	
	220 kV Rengali (PH) –	Tripped on	Did not trip

Rengali SY - 1	overvoltage		phase simultaneously in 400 kV bus voltage of Talcher. The fault clearing time was around 350 ms.
220 kV Rengali PH – TSTPP S/C	Tripped on overvoltage	Yet to be received	
220 kV Rengali PH – TTPP S/C	Tripped on overvoltage	Yet to be received	
Unit # 1, 2, & 3 at Rengali PH	instantaneous O/V. 115% over speed trip. 86 KLM operated.		
Unit # 5 at Rengali PH	Tripped on solenoid trip circuit faulty. 86 LM operated.

1. 220 kV Rengali Switchyard (OPTCL)-Tarkera S/C has been tripped within zone 2 time (350 ms). The status of carrier-based protection scheme may be placed.
2. 220 kV Rengali PH – TSTPP S/C and 220 kV Rengali PH – TTPS S/C and 220 kV Rengali PH – Rengali Switchyard (OPTCL) – 1 tripped on overvoltage from Rengali PH end. GRIDCO SLDC/OHPC may share voltage at Rengali PH at this time along with DR recorded at Rengali PH.

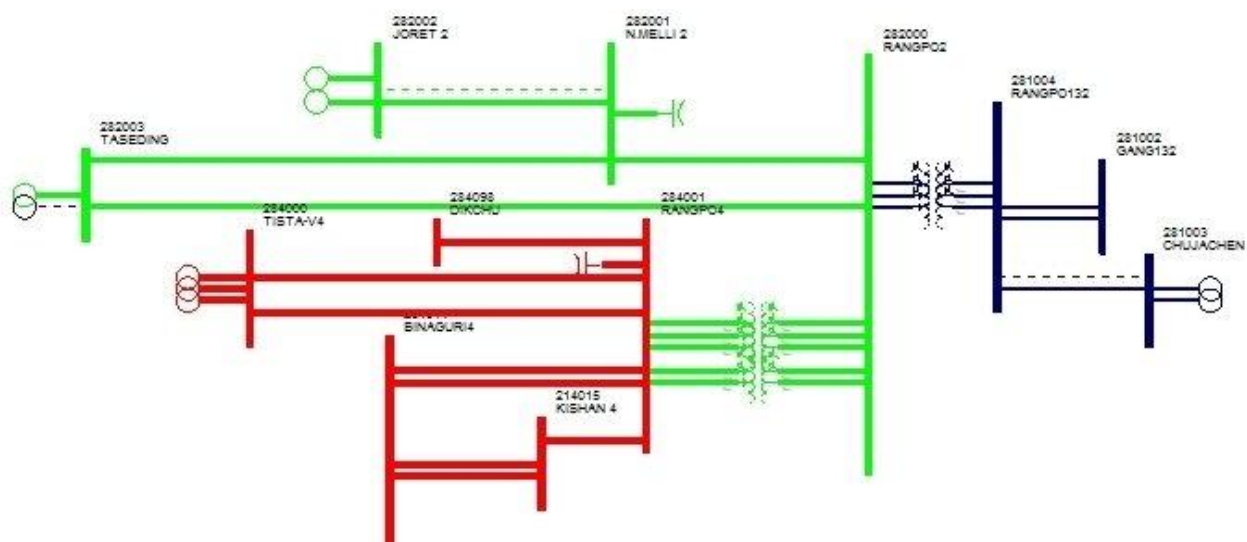
On 1<sup>st</sup> Oct 2020 at 14:03 hrs, 132 kV Rangpo-Chuzachen - 1 tripped due to B phase to earth fault. Charging was attempted at 14:32 hrs but the line could not be charged. Chuzachen HEP was connected to the rest of the grid via 132 kV Rangpo-Chuzachen – 2. 220 kV Jorethang – New Melli – 1 was under emergency shutdown. Hence, Jorethang HEP was connected to the rest of grid via 220 kV Jorethang – New Melli – 2.

At 14:47 Hrs, 400 kV Rangpo-Dikchu S/C tripped due to B phase to earth fault. Tripping of 400 kV Rangpo – Dikchu S/C (only outgoing feeder connected to 400 kV bus 1 at Dikchu), resulted in the isolation of both units from the grid leading to tripping of both running units at Dikchu HEP. At the same time, 220 kV Jorethang – New Melli – 2 and 132 kV Rangpo-Chuzachen – 2 also got tripped resulting in total power failure at Jorethang and Chuzachen HEP also.

**Dikchu, Jorethang Chuzachen and Powergrid may explain.**

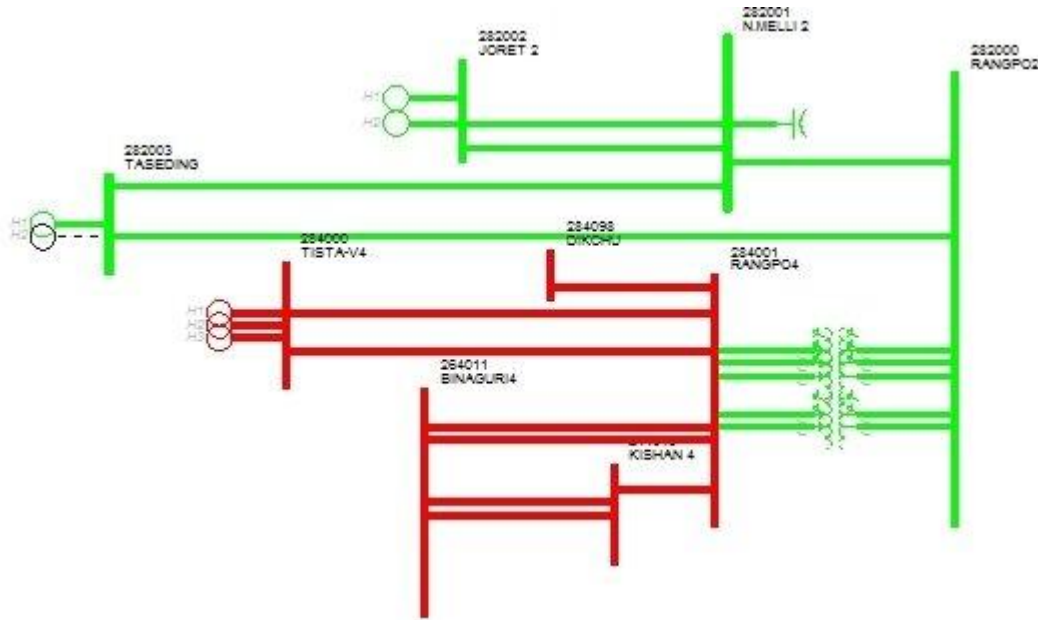
At 13:15 hrs on 30-10-2020, 400 kV TEESTA V - Rangpo line- 1 tripped. At the same time, 220 KV Jorethang- New Melli D/C tripped at Jorethang end only resulting in total power failure at Jorethang HEP.

As per PMU data, initially there was a high resistance fault in R phase. After around 800 ms, this fault got converted to R and B phase fault.

Time	Name	End 1	End 2	PMU Observation
13:15 hrs	400 kV Teesta V – Rangpo – 1	R-B, Zone 1, 1.9 Km from Teesta V	R-B, IR = 5.9 kA, IY = 6.5 kA, 10 km from Rangpo	As per voltage measurement by Rangpo PMU data, initially the fault was evolving nature in R phase. After around 700 ms, it converted to R and B phase to earth fault. Around 120 kV dip in R and B phase voltage has been observed at Rangpo PMU data. The fault clearing time was around 800 ms
	220 kV Jorethang New Melli – 1	R phase O/C and E/F. 110 km from Jorethang end	Did not trip	
	220 kV Jorethang New Melli – 2	R phase O/C and E/F. 110 km from Jorethang end.	Did not trip	
	Unit 1 at Jorethang HEP	Loss of evacuation path

1. Delayed clearance of fault has been observed in PMU data for 400 kV Rangpo-Teesta V circuit 1. The same may explained.
2. Uncoordinated tripping of 220kV Jorethang- New Melli – D/C lines to be explained.
3. DR recorded for MICOM P141 relay at Jorethang end has not been configured as per ERPC's guideline.
4. DR output at Teesta V has not been configured as per ERPC's guideline. It has been observed turn ratio has not been properly incorporated in DR. Same may be checked by Teesta V HEP.

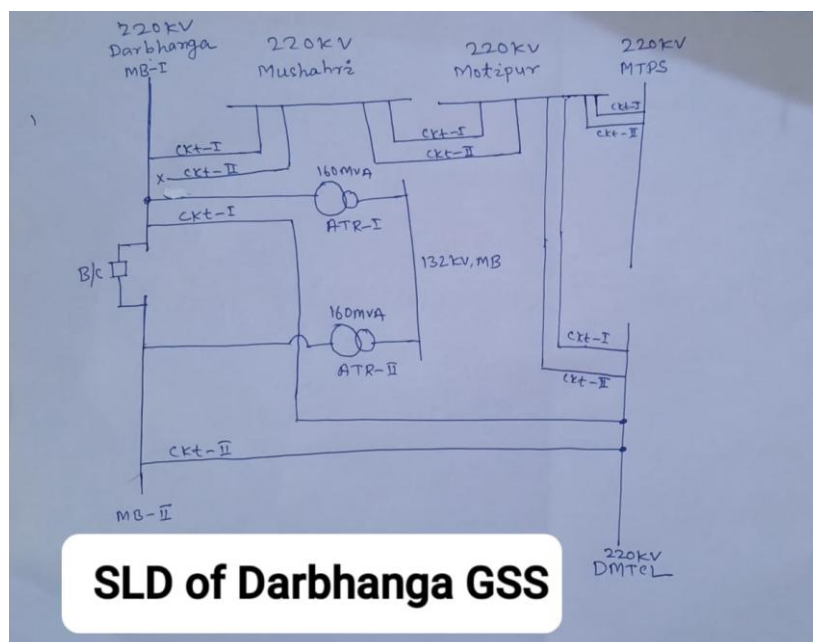
*In 95<sup>th</sup> PCC, BSPTCL submitted that, 220 kV Darbhanga(DMTCL)– Darbhanga (BSPTCL) Ckt-II was connected via the transfer bus coupler (TBC) bay at Darbhanga (BSPTCL) S/s which was connected to Main Bus-I, in order to perform breaker timing test the said line got tripped on backup protection within 100 ms.*

*220 kV Darbhanga(DMTCL)– Darbhanga (BSPTCL) Ckt-II tripped from Darbhanga (DMTCL) end and Ckt-I was manually tripped by BSPTCL from their end. Darbhanga (BSPTCL)-Musahari Ckt- I & II tripped on Z2 tripping time of 350msec, for this DR has been submitted to ERLDC by BSPTCL. 220kV Darbhanga (DMTCL) – Motipur Ckt I tripped on Z2 from BSPTCL end*

*DMTCL submitted that the ICT I&II tripped on backup overcurrent E/F protection within 100msec.*

- For ICT I & II at Darbhanga S/S, DMTCL has to review backup overcurrent E/F protection*
- For 220 kV Darbhanga(DMTCL)– Darbhanga (BSPTCL) Ckt, back up protection to be coordinated properly (as it is tripped on 100msec).*
- BSPTCL to collect all the relay indications from MTPS and other sub-stations and send the same to ERPC & ERLDC along with a brief report on how the fault got cleared.*

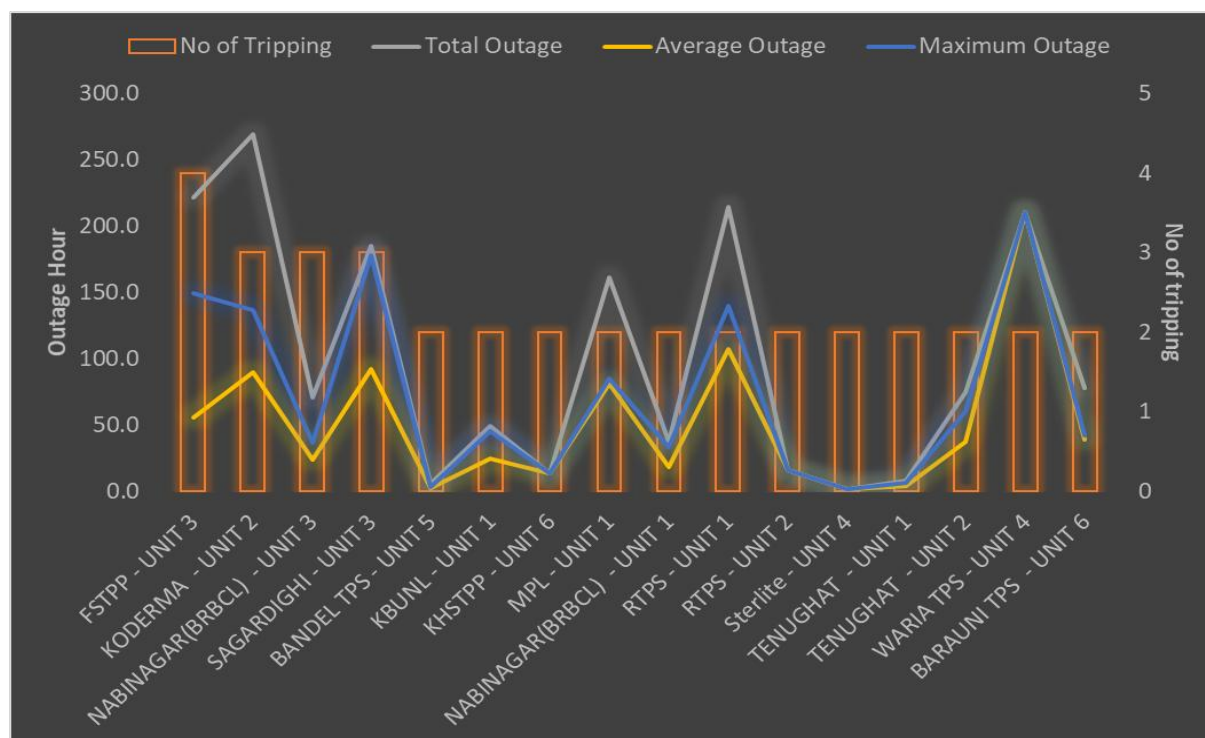
During October 2020, repeated tripping of following generators has been observed:

Name of generating units	Reason for tripping	No of tripping	Utility to respond
Farakka Unit 3	Boiler Tube leakage, High Furnace Pressure, Cooling water system problem	3	NTPC
Koderma Unit 2	Boiler Tube Leakage	3	DVC
BRBCL Unit 3	Boiler Tube leakage, High Furnace Pressure, High Primary Air	3	BRBCL

Pressure		
<b>Sagardighi Unit 3</b>	High Turbine vibration, Rotor Earth fault System checking	2	WBPDC
