Minutes
of
96th PCC Meeting

EASTERN REGIONAL POWER COMMITTEE

MINUTES OF 96TH PROTECTION SUB-COMMITTEE MEETING HELD ON 12.11.2020 AT 10:30 HOURS

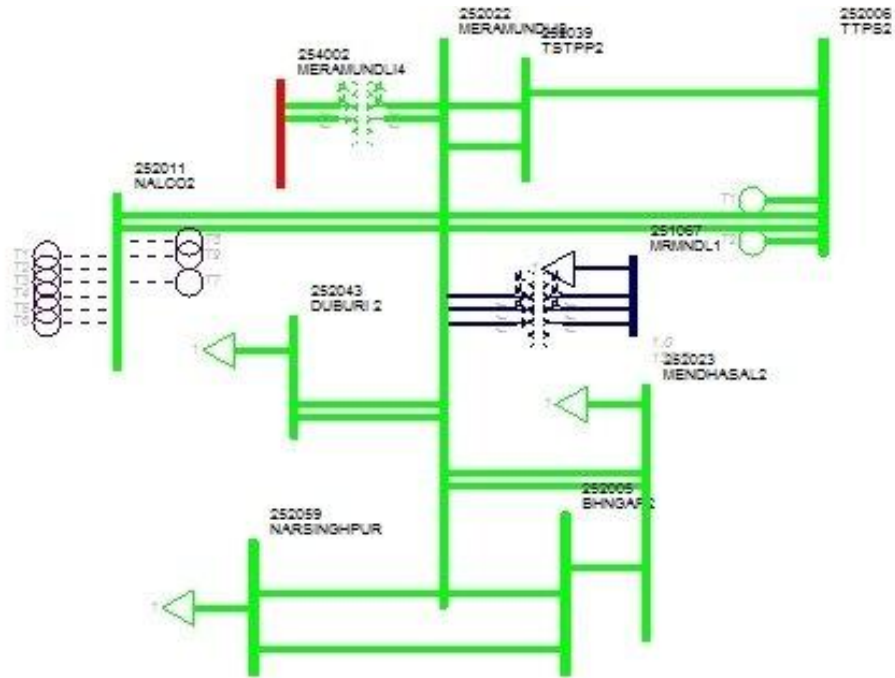
On 30th September 2020 at 22:36 hrs, 220 kV Meramundali – NALCO - 1 was tripped on overcurrent protection. The line was charged at 00:05 hrs on 01st October 2020. At 01:35 hrs, sparking was noticed on this circuit at Meramundali end switchyard due to which GRIDCO SLDC advised NALCO to reduce the loading of the circuit.

At 04:07 hrs, line side pipe at Meramundali end of the above-mentioned circuit got broken and fell on the ground along with the breaker jumper causing line fault at Meramundali S/s. Bus jumper of 220 kV bus 1 at Meramundali also got damaged at several places which led to bus fault at 220 kV bus 1 at Meramundali. All the elements connected with 220 kV bus 1 along with the bus coupler tripped at Meramundali.

OPTCL informed that on 30th Sep 2020, at 22:36 hrs, 220 kV Meramundali – NALCO - 1 was tripped from Meramundali end on overcurrent protection within 900 ms as the voltage dip was very less to pickup by the distance protection. OPTCL explained that as per the information received from NALCO, Bucholz relay was operated at NALCO end and NALCO is yet to share the details of the tripping.

OPTCL explained that at 01:35 hrs on 1st Oct 2020, 160 MW power was flowing in both circuit 1 and circuit 2 of 220 kV Meramundali – NALCO D/C line which resulted in sparking at Meramundali end switchyard. SLDC, Odisha advised NALCO to reduce the loading of the circuit. At 04:07 hrs, due to heavy load, the line side pipe at Meramundali end of the above-mentioned circuit got broken as the pipes were 20-21 years old, and fell on the ground along with the breaker jumper causing Bus fault at 220kV Bus-1 of Meramundali S/s. All the elements connected with 220 kV bus-1 along with the bus coupler tripped from either remote end or Meramundali end as per the relay indications given in the agenda.

PCC advised OPTCL to reduce the zone-4 time settings till restoration of the Busbar protection at 220 kV Meramundali and analyze the reason for rise in healthy phase voltage at Meramundali S/s during single phase to ground fault. PCC advised OPTCL and SLDC, Odisha to collect the tripping details from NALCO & TTPS, NTPC and submit a report to ERLDC and ERPC.

PCC also advised OPTCL to carry out proper maintenance of transmission line and substation equipment to avoid failure of any component and prepare a plan for replacement of old equipment to avoid major disturbances.

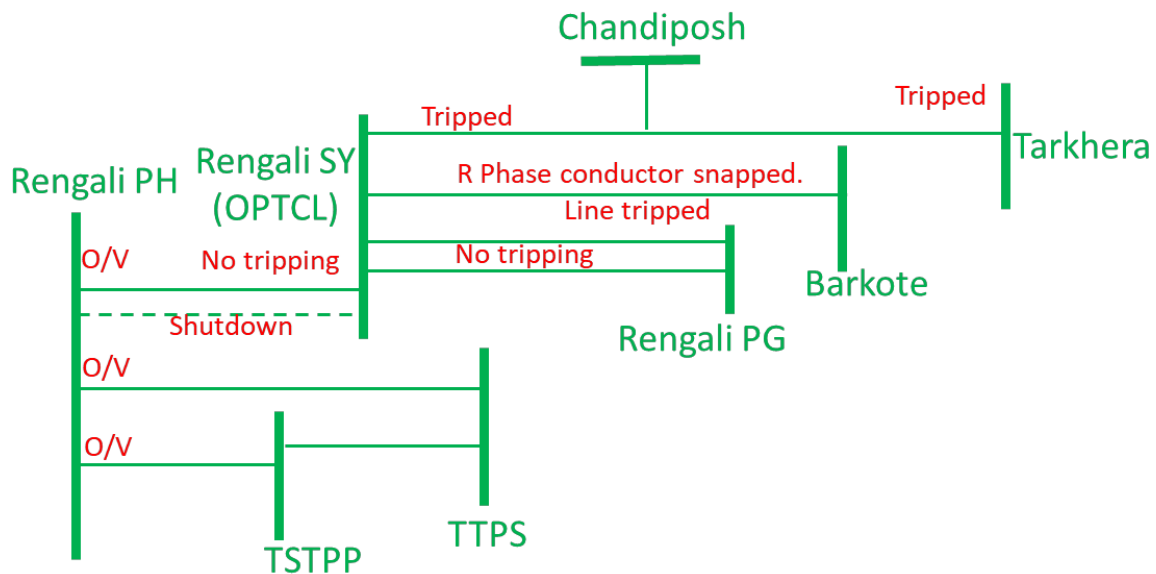
On 10th October 2020 at 16:08 hrs, 220 kV Rengali Switchyard (OPTCL) - Barkote S/C and 220 kV Rengali Switchyard (OPTCL)-Tarkera S/C tripped due to R phase to earth fault and B phase to earth fault respectively. It was reported that top conductor (R phase) of 220 kV Rengali Switchyard (OPTCL) - Barkote S/C snapped at location no 336.

Thereafter, 220 kV Rengali PH – TSTPP S/C and 220 kV Rengali PH – TTPS S/C and 220 kV Rengali PH – Rengali Switchyard (OPTCL) – 1 tripped on overvoltage from Rengali PH end. Subsequently all the running units at Rengali PH tripped. 220 kV Rengali Switchyard remained connected to rest of grid through 220 kV Rengali PG – Rengali SY D/C.

OPTCL informed that there were multiple faults in Rengali due to heavy rain and wind. First R-N fault was occurred in 220 kV Rengali Switchyard (OPTCL) - Barkote S/C line due to snapping of R-ph conductor (top conductor) at location no 336. The line was tripped from both the ends in zone 1. Thereafter, B-N fault was initiated in 220 kV Rengali Switchyard (OPTCL)-Tarkera S/C due to lightening. The line was tripped in zone 2 from Rengali SY end and zone 1 from Tarkera end.

OPTCL further explained that 220 kV Rengali PH – TSTPP S/C, 220 kV Rengali PH – TTPS S/C and 220 kV Rengali PH – Rengali Switchyard (OPTCL) – 1 tripped on overvoltage from Rengali PH end. Subsequently all the running units at Rengali PH tripped on overvoltage and overspeed. 220 kV Rengali Switchyard was remained connected to rest of grid through 220 kV Rengali PG – Rengali SY D/C.

PCC advised SLDC, Odisha to coordinate with OHPC and provide a detailed report on overvoltage tripping at Rengali PH.

PCC opined that overvoltage protection may not be required at 220kV level. If the overvoltage protection is being used at 220kV level, the settings may be kept higher than the 400kV level settings to avoid unwanted tripping of transmission lines.

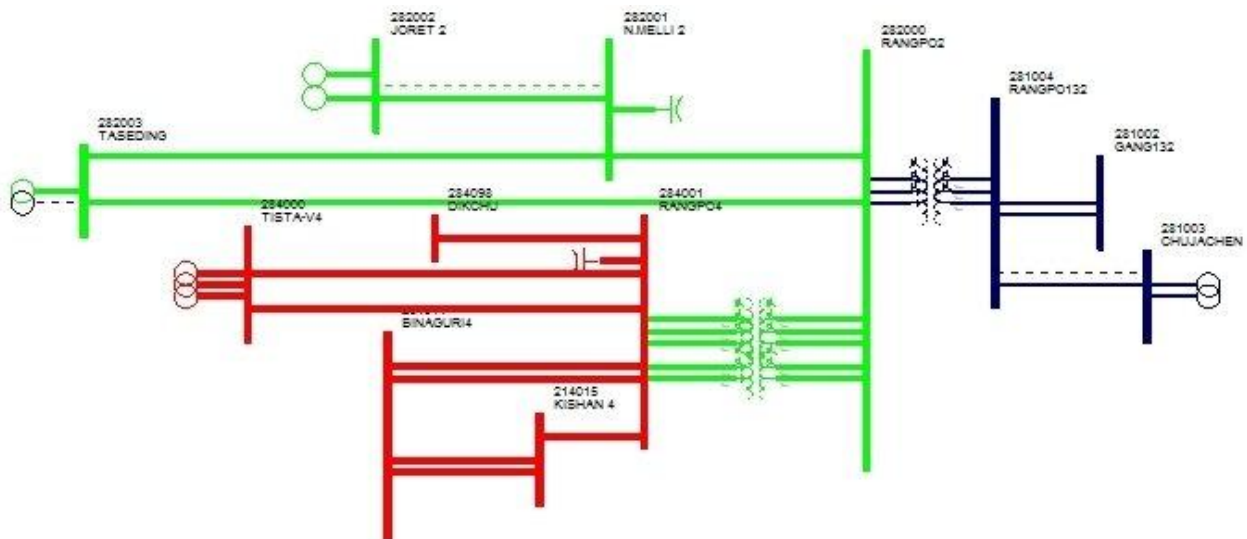
On 1st Oct 2020 at 14:03 hrs, 132 kV Rangpo-Chuzachen - 1 tripped due to B phase to earth fault. Charging was attempted at 14:32 hrs but the line could not be charged. Chuzachen HEP was connected to the rest of the grid via 132 kV Rangpo-Chuzachen – 2. 220 kV Jorethang – New Melli – 1 was under emergency shutdown. Hence, Jorethang HEP was connected to the rest of grid via 220 kV Jorethang – New Melli – 2.

At 14:47 Hrs, 400 kV Rangpo-Dikchu S/C tripped due to B phase to earth fault. Tripping of 400 kV Rangpo – Dikchu S/C (only outgoing feeder connected to 400 kV bus 1 at Dikchu), resulted in the isolation of both units from the grid leading to tripping of both running units at Dikchu HEP. At the same time, 220 kV Jorethang – New Melli – 2 and 132 kV Rangpo-Chuzachen – 2 also got tripped resulting in total power failure at Jorethang and Chuzachen HEP also.

Dikchu informed that on 1st Oct 2020 at 14:47 Hrs, 400 kV Rangpo-Dikchu S/C tripped due to B phase to earth fault. Dikchu added that fault was high resistive in nature so the line tripped from both ends in directional overcurrent earth fault protection and fault clearing time was 1.5 second. Tripping of 400 kV Rangpo – Dikchu S/C (only outgoing feeder connected to 400 kV bus 1 at Dikchu), resulted in the isolation of both units from the grid leading to tripping of both running units at Dikchu HEP. 400 kV Dikchu – Teesta III was in service via Bus 2 however due to problem in GIS, units were only connected to Bus 1.

PCC observed that 132 k V Rangpo-Chuzachen – 2 and 220 kV Jorethang – New Melli – 2 should not trip in this case. PCC advised Chuzachen to send the relay settings of distance protection to ERPC and ERLDC for review. It was informed that backup overcurrent earth fault protection relay settings of Jorethang are being reviewed.

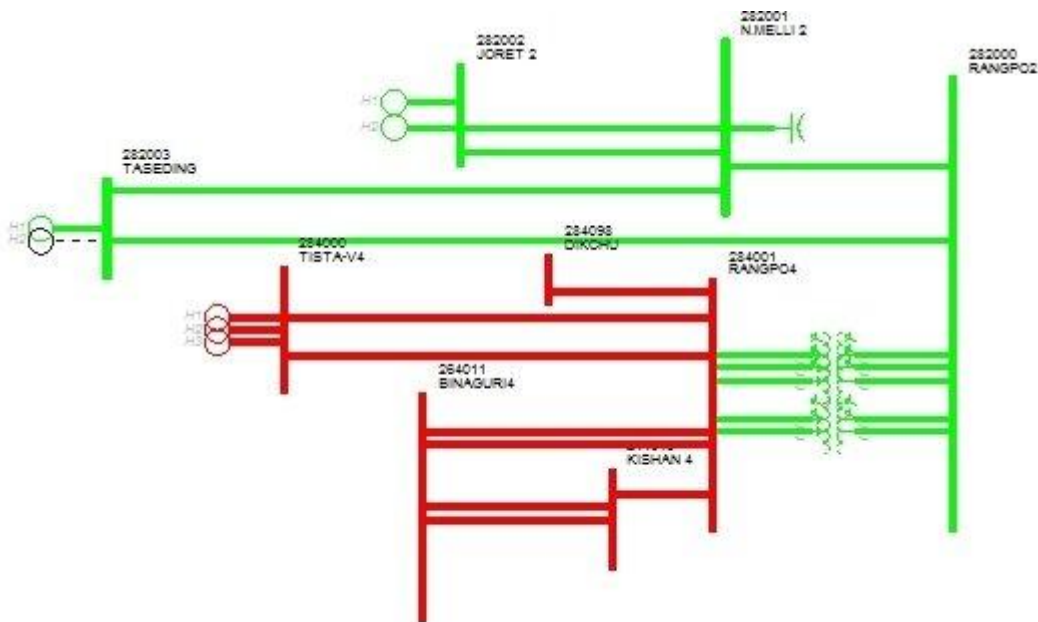
At 13:15 hrs on 30-10-2020, 400 kV TEESTA V - Rangpo line- 1 tripped. At the same time, 220 KV Jorethang- New Melli D/C tripped at Jorethang end only resulting in total power failure at Jorethang HEP.

As per PMU data, initially there was a high resistance fault in R phase. After around 800 ms, this fault got converted to R and B phase fault.

Powergrid explained that initially the fault in 400 kV Teesta V – Rangpo – 1 was high resistive R-N fault which converted to R and B phase to earth fault after around 700 ms. Rangpo observed RB-N fault in zone 1 and the line was tripped from both the ends on zone 1.

PCC observed that 220 kV Jorethang- New Melli D/C line got tripped on backup O/C, E/F protection due to DT settings. The same is in process of review with IDMT characteristics.

PCC advised NHPC and Jorethang to review the DR configuration as per ERPC guidelines.

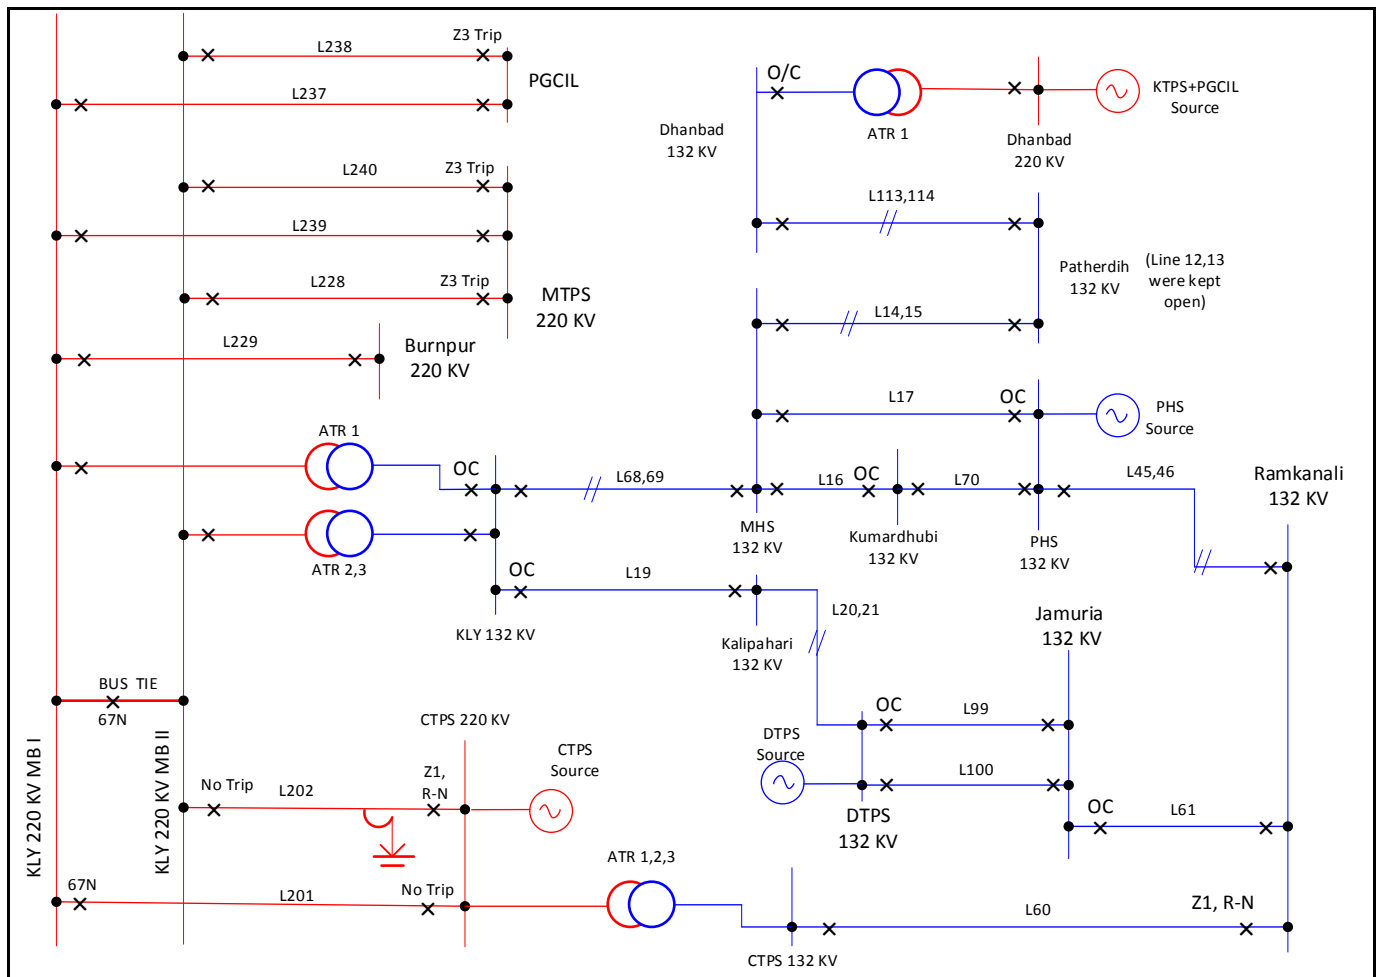
As the line fault was not cleared from 220 kV Kalyaneshwari, all the Lines connected to Main Bus2 tripped from remote end on Zone-3 protection. 220kV Bus Tie also tripped through Directional earth fault Protection and thereby separated Bus1 from the faulty section. Further, 220/132kV ATR 2 & 3 which were in the Bus 2 were tripped as a result all the corresponding Load was transferred to 220/132kV ATR 1 and the transformer got tripped on LV side O/C protection. Total load of three ATRs was around 360-390 MVA prior to the disturbance. Thereafter, loading of single 220/132kV ATR of Dhanbad increased due to sharing of the additional load of Kalyaneshwari Sub-station and the ATR tripped through over current protection as the load current exceeded 800 A (pick-up value).

DVC added that PHS Unit#2 running with 31 MW load, tripped in under frequency and Unit #1 and Unit # 2 of MHS collectively generating around 32 MW also tripped with auxiliary power failure/under voltage.

DVC informed that healthiness of Distance Protection SHPM101 and back-up protection CDD relay of 220 kV Kalyaneshwari – Chandrapura line 2 at Kalyaneshwari has been checked by panel injection method and found okay.

PCC observed that protection system at 220/132kV Kalyaneshwari S/s is very old and it needed to be upgraded immediately to avoid wrong operation of the protection system.

DVC informed that upgradation of protection system at 220 kV Kalyaneshwari S/S is in process. CT and PT were already changed and old relays would be replaced by new numerical relays within 3-4 months.

PCC also observed that one more 220/132kV ATR at 220kV Dhanbad S/S would improve the reliability of DVC system. PCC advised DVC to explore for installation of one more 220/132kV ATR at 220kV Dhanbad S/S.

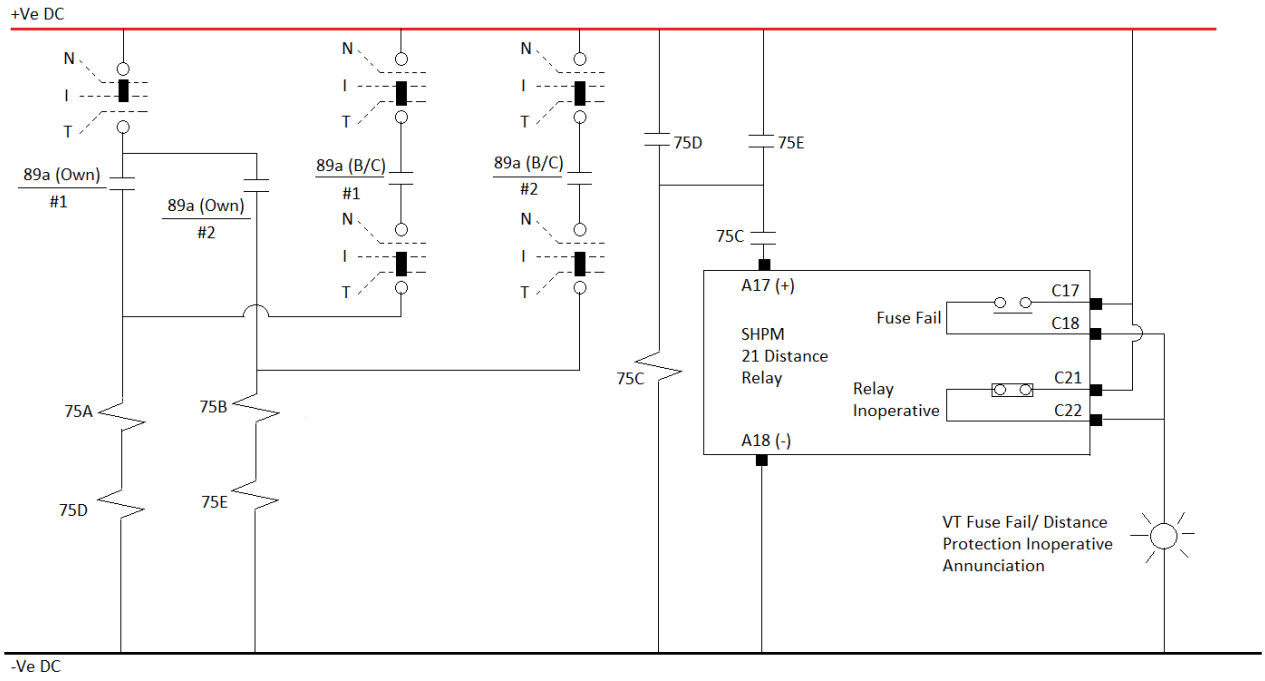
DC CIRCUIT INVOLVED

3. As SHPM Relay (old static Relay) does not have the provision of DR/event record facility it is not possible to pin point the exact reason for such non operation of Protection Relay. However malfunctioning of Isolator contact is a very probable cause of such non operation in SHPM relays well as directional back up O/C & E/F (CDD Relay) relay protection scheme. As the Relay auxiliary DC and the PT potential gets through the operation of 75A/B voltage selection Relay which in turn operates with the 89a contact of Isolator. During any B/C diversion, due to any mal operation of Isolator contact (any bus side isolator of bus coupler bay), 75A/B relay would get de-energized and the SHPM relay would become non functional due to DC outage. **(Refer Annexure-2)**

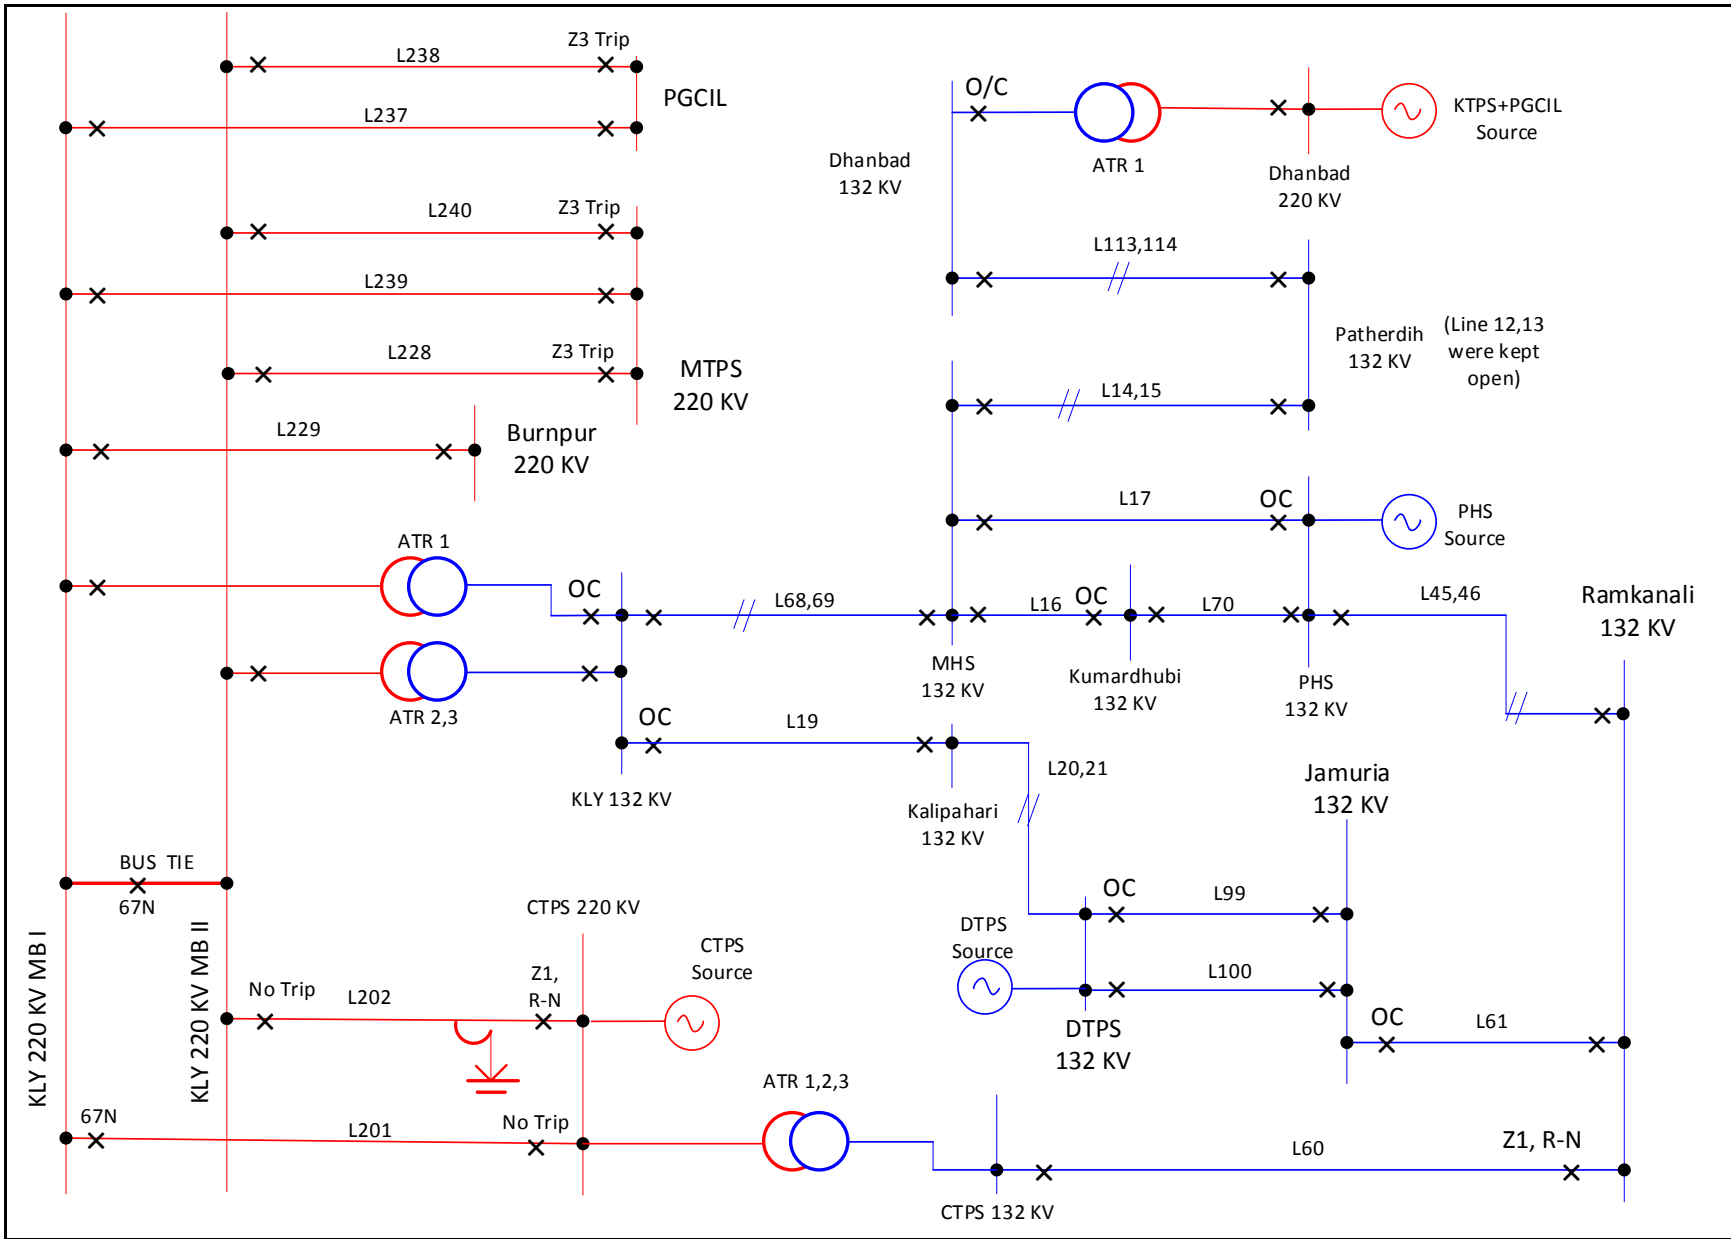
SLD OF AFFECTED SYSTEM

1. Outage of Main Bus #2 lead to outage of ATR #2 & 3. As soon as all the Load was transferred to ATR#1, it tripped with LV O/C protection. Total load of three ATRs was around 360-390 MVA prior to the Bus failure.

The single ATR of Dhanbad (having a load around 60 MVA) started to share the additional load of Kalyaneshwari Sub-station through Line #14,15 and Line #68,69 via Patherdih S/S (L#113 & 114). It tripped through over current as load current exceed 800 A. As these load divided through Line #113 & 114 (O/C setting 600A), the Dhanbad ATR tripped before the tripping of the Lines #113,114. Putki - Patherdih (L#12 & 13) loop was kept in open condition as per CLD.

3. With the outage of Dhanbad source, DTPS and CTPS started to share more the load of the Kalyaneshwari. Overloading of Line# 60 lead to jumper failure and the Line tripped through Distance protection and thereby separating CTPS source.

4. Timely Replacement of Static /electro-mechanical relays with numerical relays under PSDF.

5. All electromechanical / static relays of DVC System (up to 33 kV) required to be replaced by numerical relay with time synchronization through GPS. It will be helpful for root cause analysis of any tripping / disturbance.
