## Eastern Regional Power Committee

### **Minutes of the Meeting on “Total Power Failure in NALCO from 30.09.2021 to 02.10.2021” held on 15<sup>th</sup> February 2021 (Monday) through online MS Teams platform**

**Presentation**  
**on**  
**TOTAL POWER FAILURE**  
**at**  
**NALCO, ANGUL**  
**(30.09.2020-02.10.2020)**

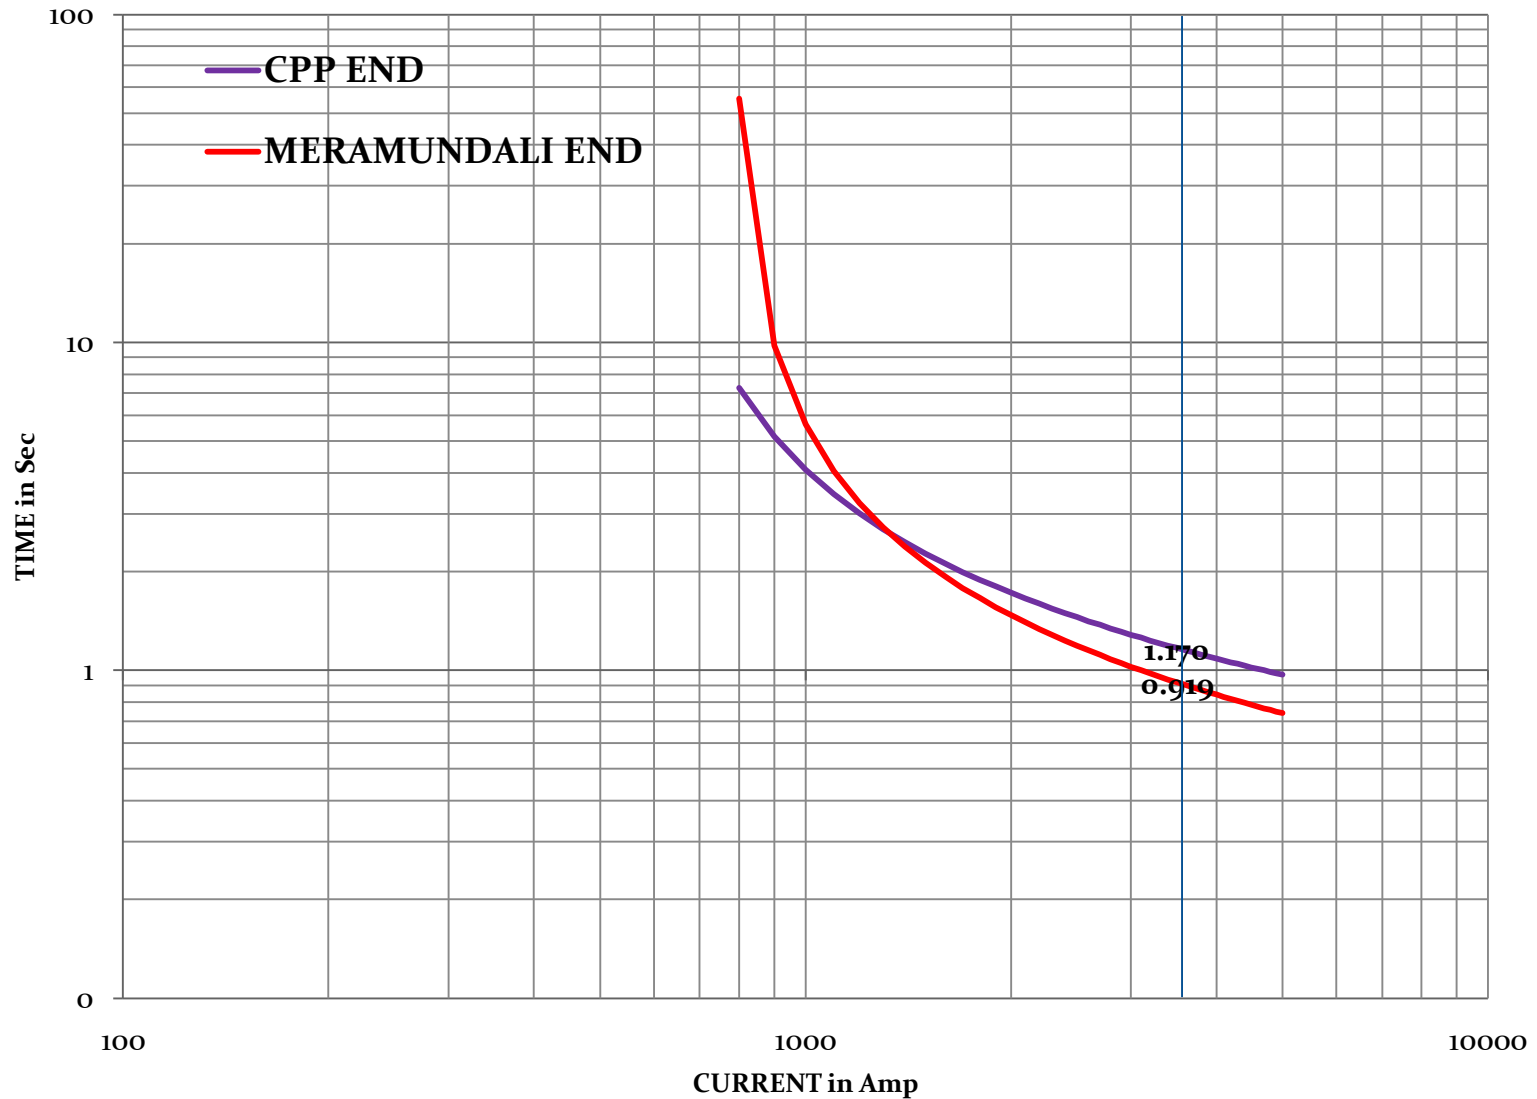
## IDMT CURVE\_GRIDCO-3 & 4

- The feeder tripped at 300 mSec on 'Transformer Buchholz'. This tripping is not very clear. It may be due to malfunctioning of Buchholz relay following high current disturbance in transformer.
- However, the feeder would otherwise have tripped on 'over-current' and this did not create any additional problem.
- After this, current in Bus Coupler fell to almost half as desired.

- Proper relay coordination is to be ensured with the GRIDCO feeders to avoid the cascading effect of the fault into the grid system and proper islanding of the system.
