Tripping of 400 kV Meramundali - JSPL Ckt 1& 2

Report on the grid event in Eastern Region (पूर्वी क्षेत्र में ग्रिड घटना पर रिपोर्ट)

Multiple tripping of STPS-CHANDIL

**Outage of 220KV Bus-1 along with system disturbance occurred at
Budhipadar Grid S/s on dt. 08.04.2021.**

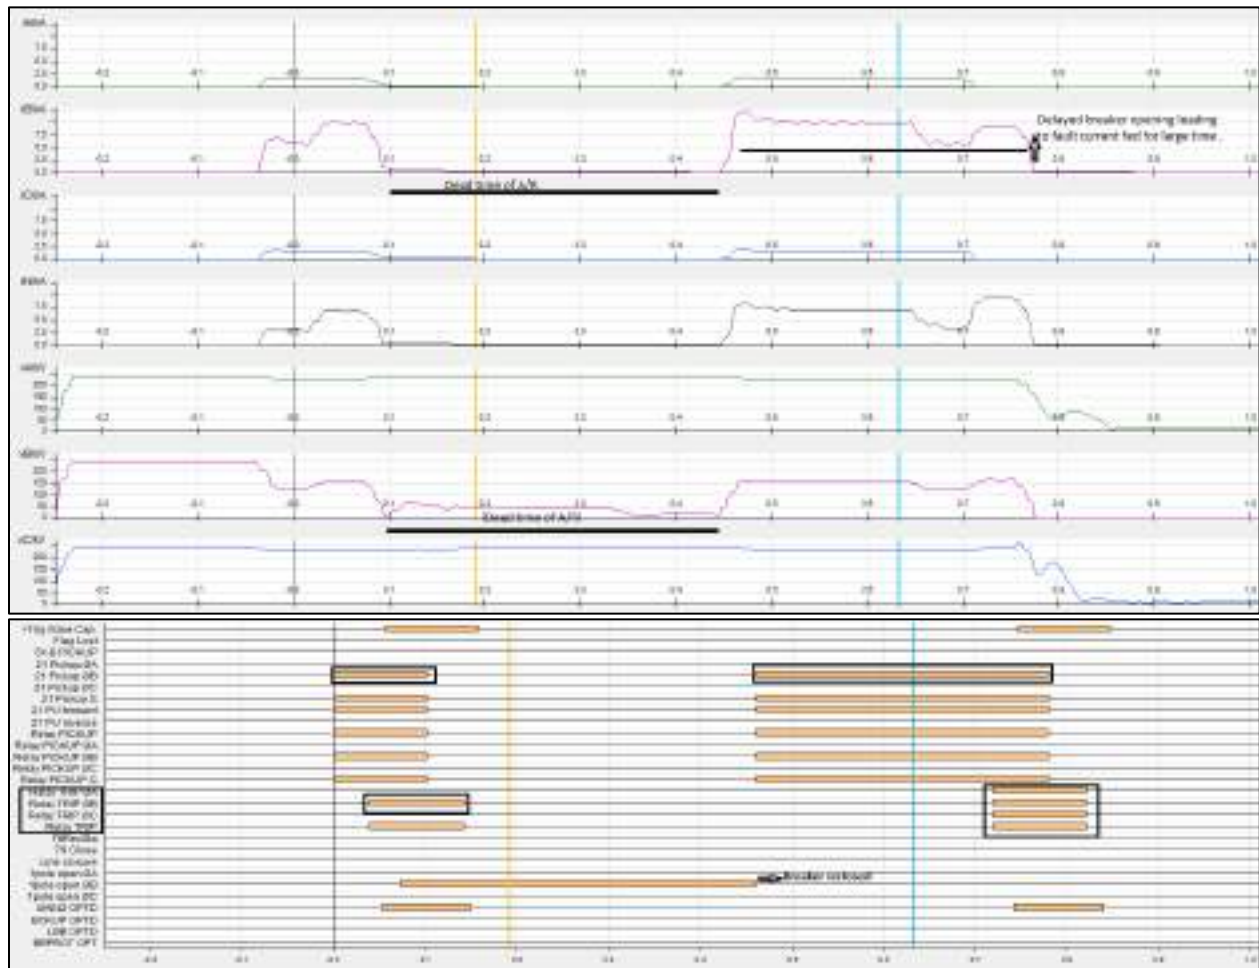
On 09/03/2021 at 07:50 Hrs 400 Kv Meramundali –JSPL -2 tripped and at 08:02 Hrs Line -1 tripped due to Y –Earth fault ,some protection discrepancy are found as mentioned below ,

Low Dead time of Auto Reclose: There was Y-earth fault in the line at 35Km from meramundali , Y phase breaker got opened within 100 Ms but again after 350 ms Y phase breaker got closed and again it fed the fault for next 300 ms and then all 3 poles got opened.

From DR as well as PMU it appears that A/R dead time is kept only 350 ms as after 350 ms ,Y pole breaker got closed in both the cases of line tripping.

Reason may please be explained and **such low dead time is not recommended as it will cause secondary arcing** and in case of transient faults also ,chances of successful auto reclose is very low and also will cause unnecessary stress on breaker.

Delayed breaker opening at the instance of reclose:

At the instance of reclose Y pole opened after 400 ms which should not occur and should trip instantaneously, reason for this may be looked. **Proper carrier communication may be ensured** to avoid delayed tripping from any end .**SOTF feature may be used to avoid** this delayed opening of breaker at the A/R instance.

Above issues may be checked and rectified .Kindly update regarding above issues .

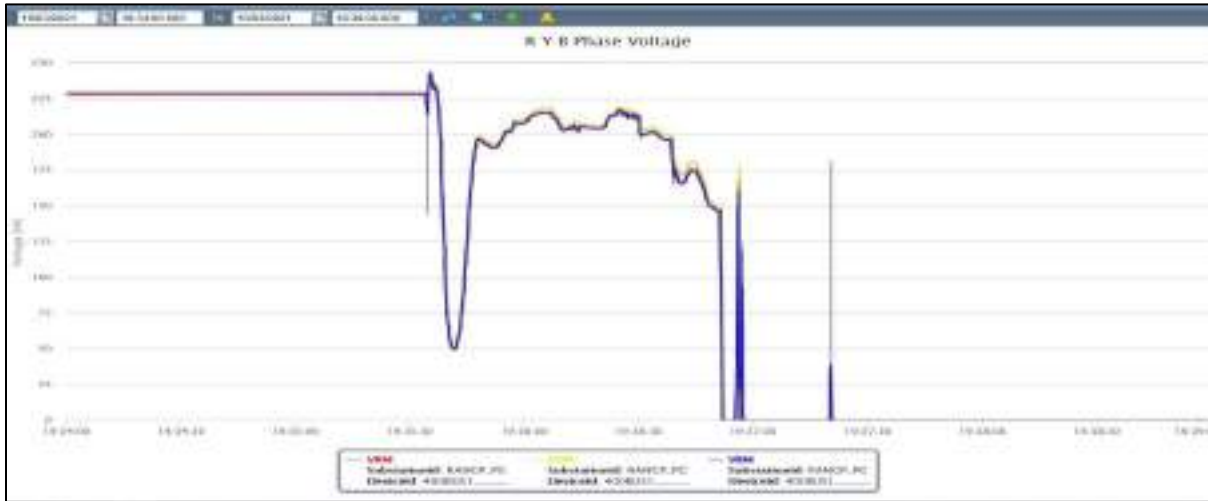
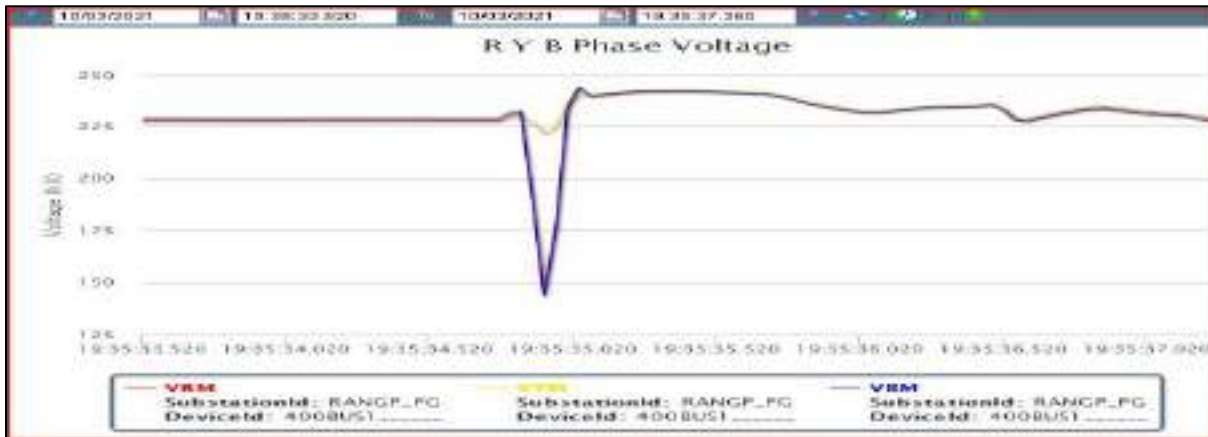
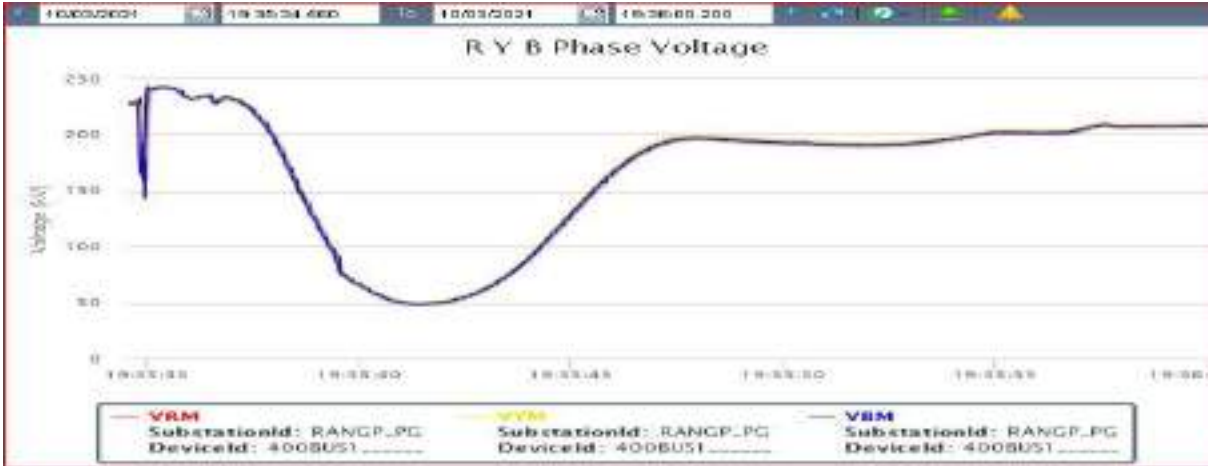
Figure 3: Three phase voltage captured at Rangpo S/S shows the existence of R and B phase fault at 19:35:34 hrs. Around 75 kV dip has been observed in R and B phase voltage at Rangpo PMU data. The fault clearing time was less than 100 ms. After the fault, power swing has been captured at three phase voltage at Rangpo S/S followed by voltage collapse within 90 seconds.

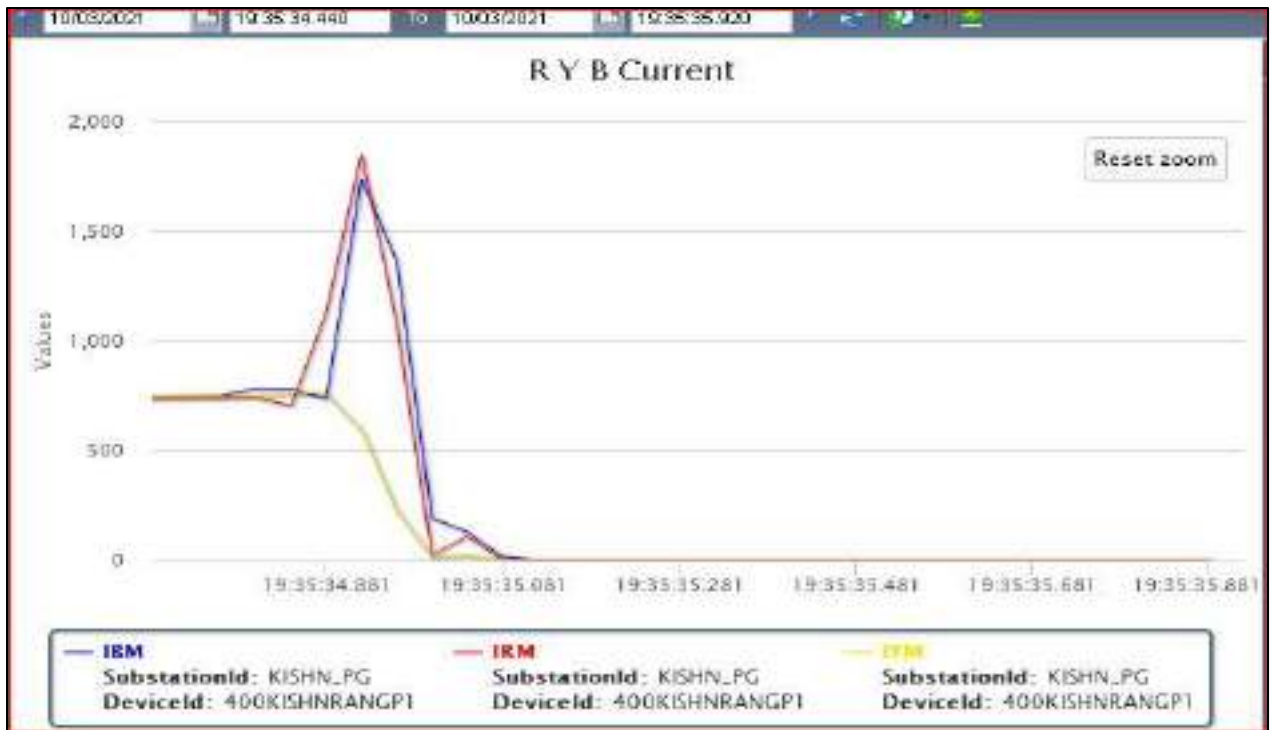
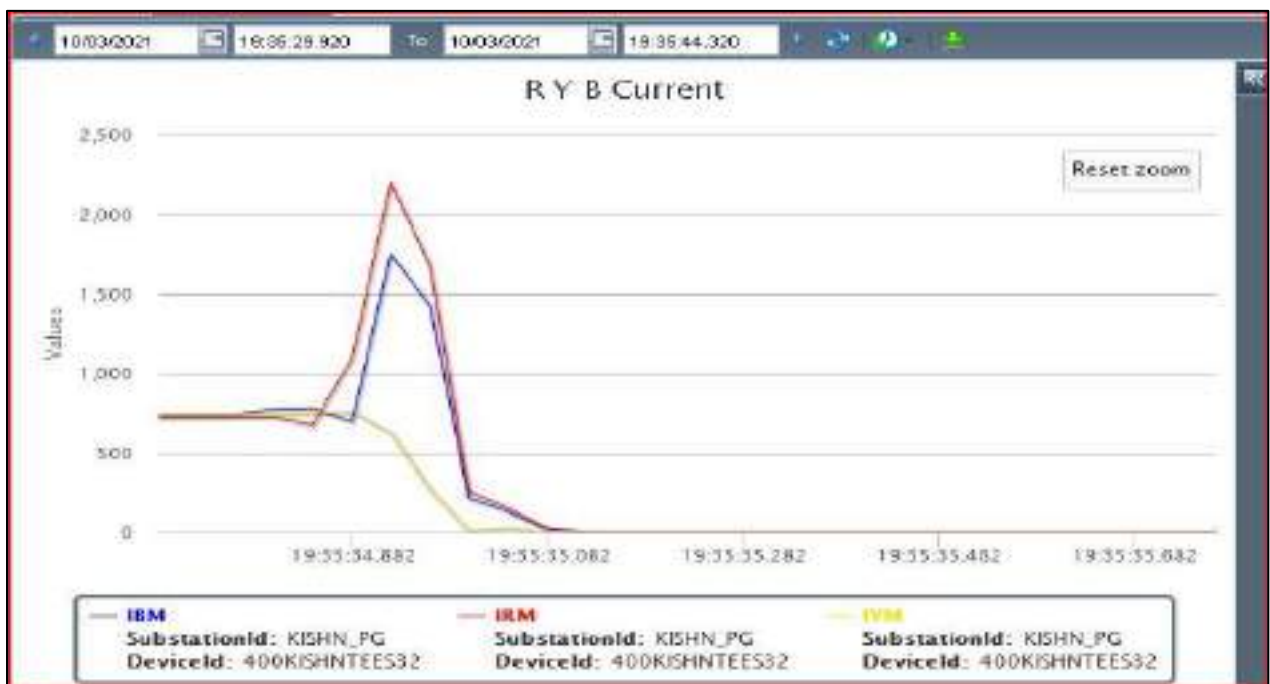
Figure 4: Three phase current captured at Kishangunj S/S of 400 kV Kishangunj Rangpo S/C and 400 kV Kishangunj Teesta III shows the existence of short circuit fault in R and B phase to earth fault at 19:35 hrs. The fault clearing time was less than 100 ms.

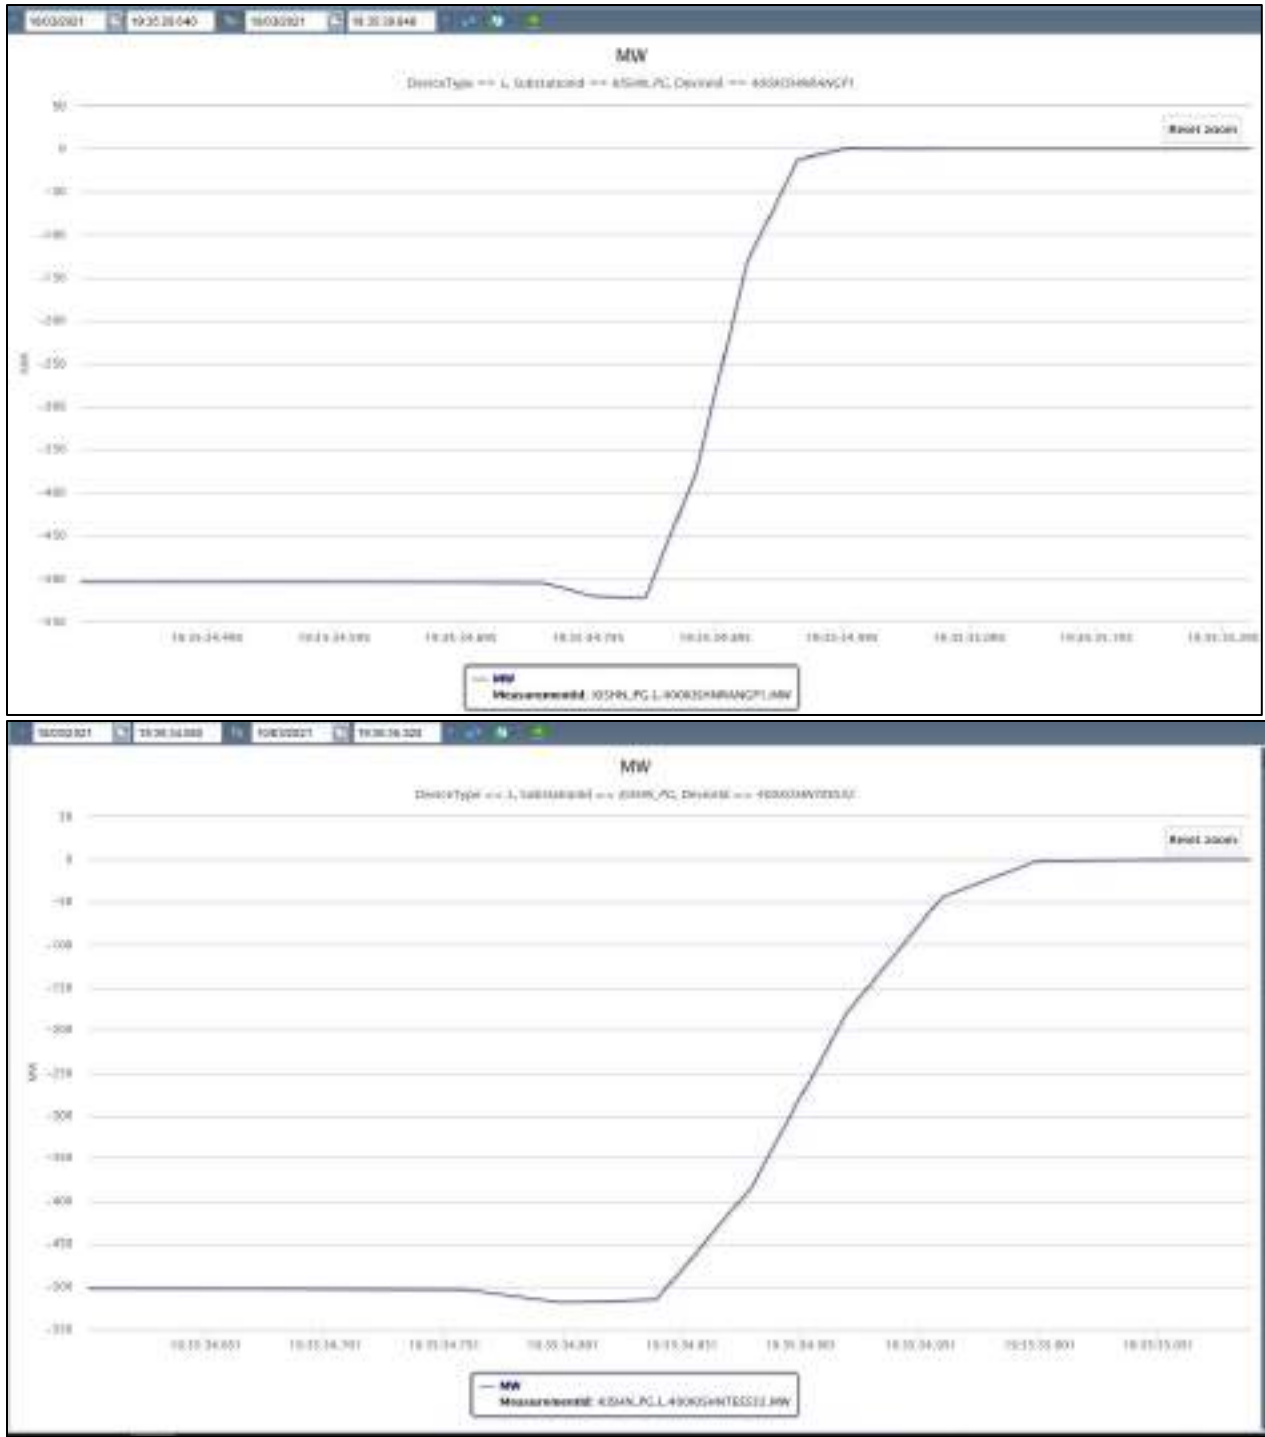
Figure 5: Three phase power flow captured at Kishangunj for 400 kV Teesta III and Rangpo feeders. Power flow through both the circuits was around 500 MW before the incident.

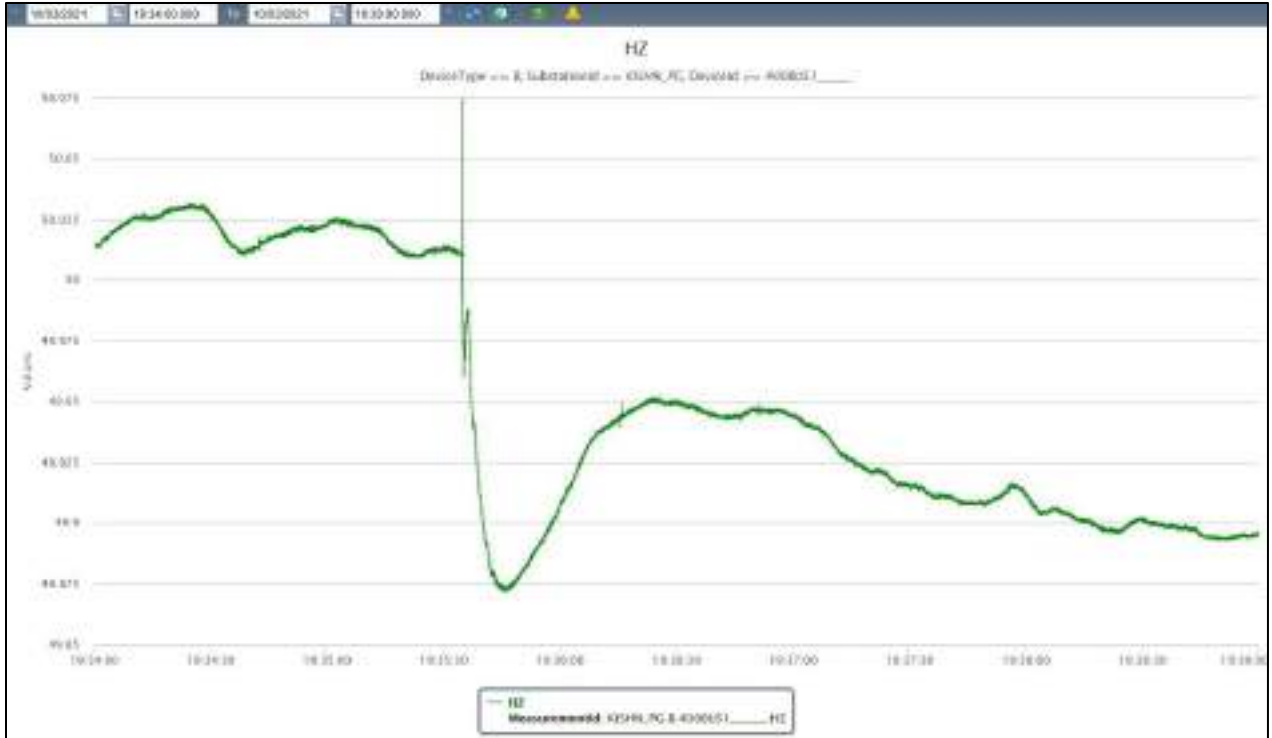
Figure 6: Frequency variation captured at Kishangunj PMU during the event. Rest of the grid frequency dropped from 50.01 Hz to 49.87 Hz. Later it stabilized to 49.95 Hz.

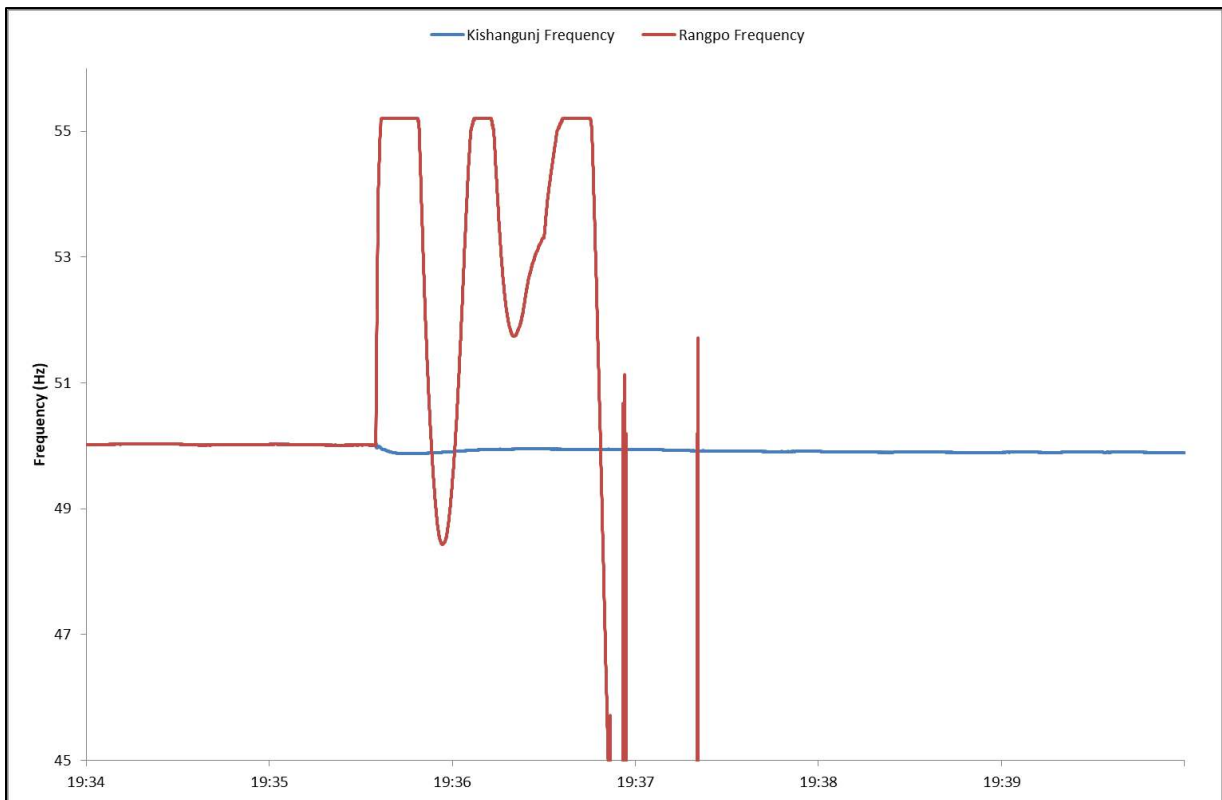
Figure 7: Frequency variation captured at Kishangunj and Rangpo PMU during the event shows frequency variation after forming islanding with Sikkim complex generation and Sikkim load. PMU frequency data gets capped between 55 and 45 Hz. Hence frequency value more than 55 Hz gets capped at 55 Hz. Island survived around 90 seconds.

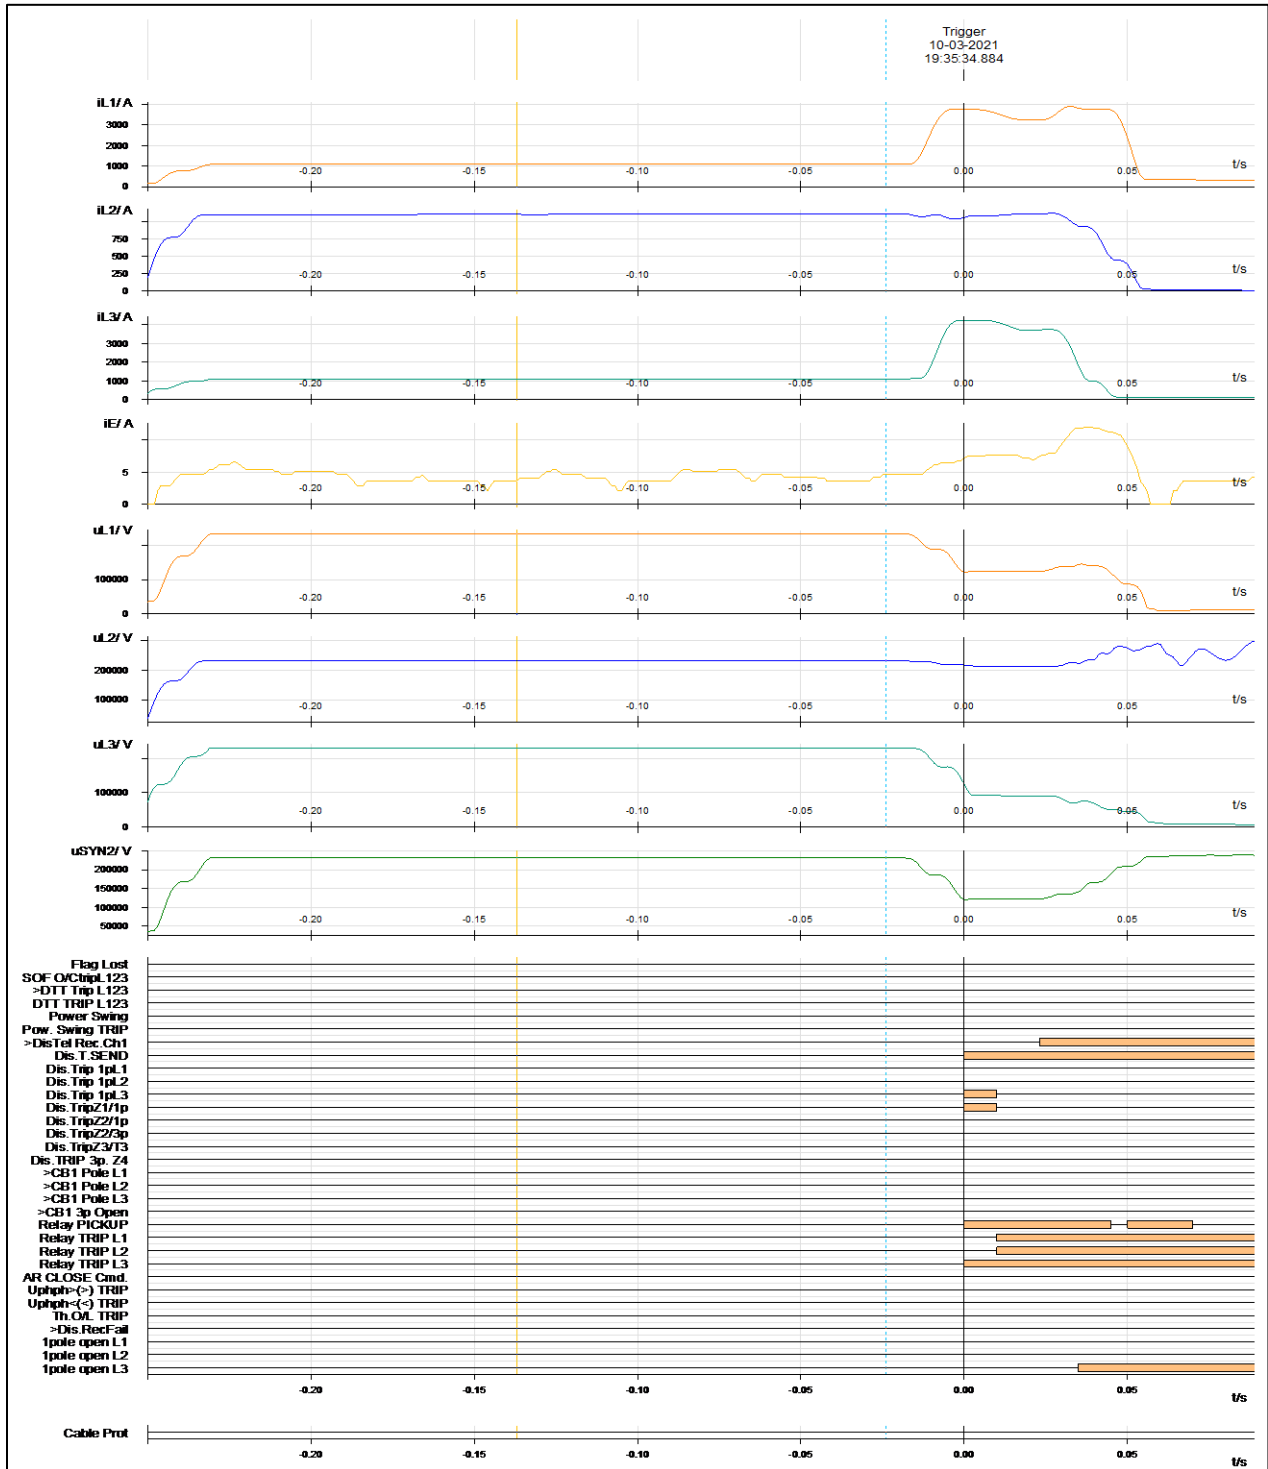
Annexure 5: DR output at Teesta III end for tripping of 400 kV Teesta III – Kishangunj S/C

Time window is not properly configured.

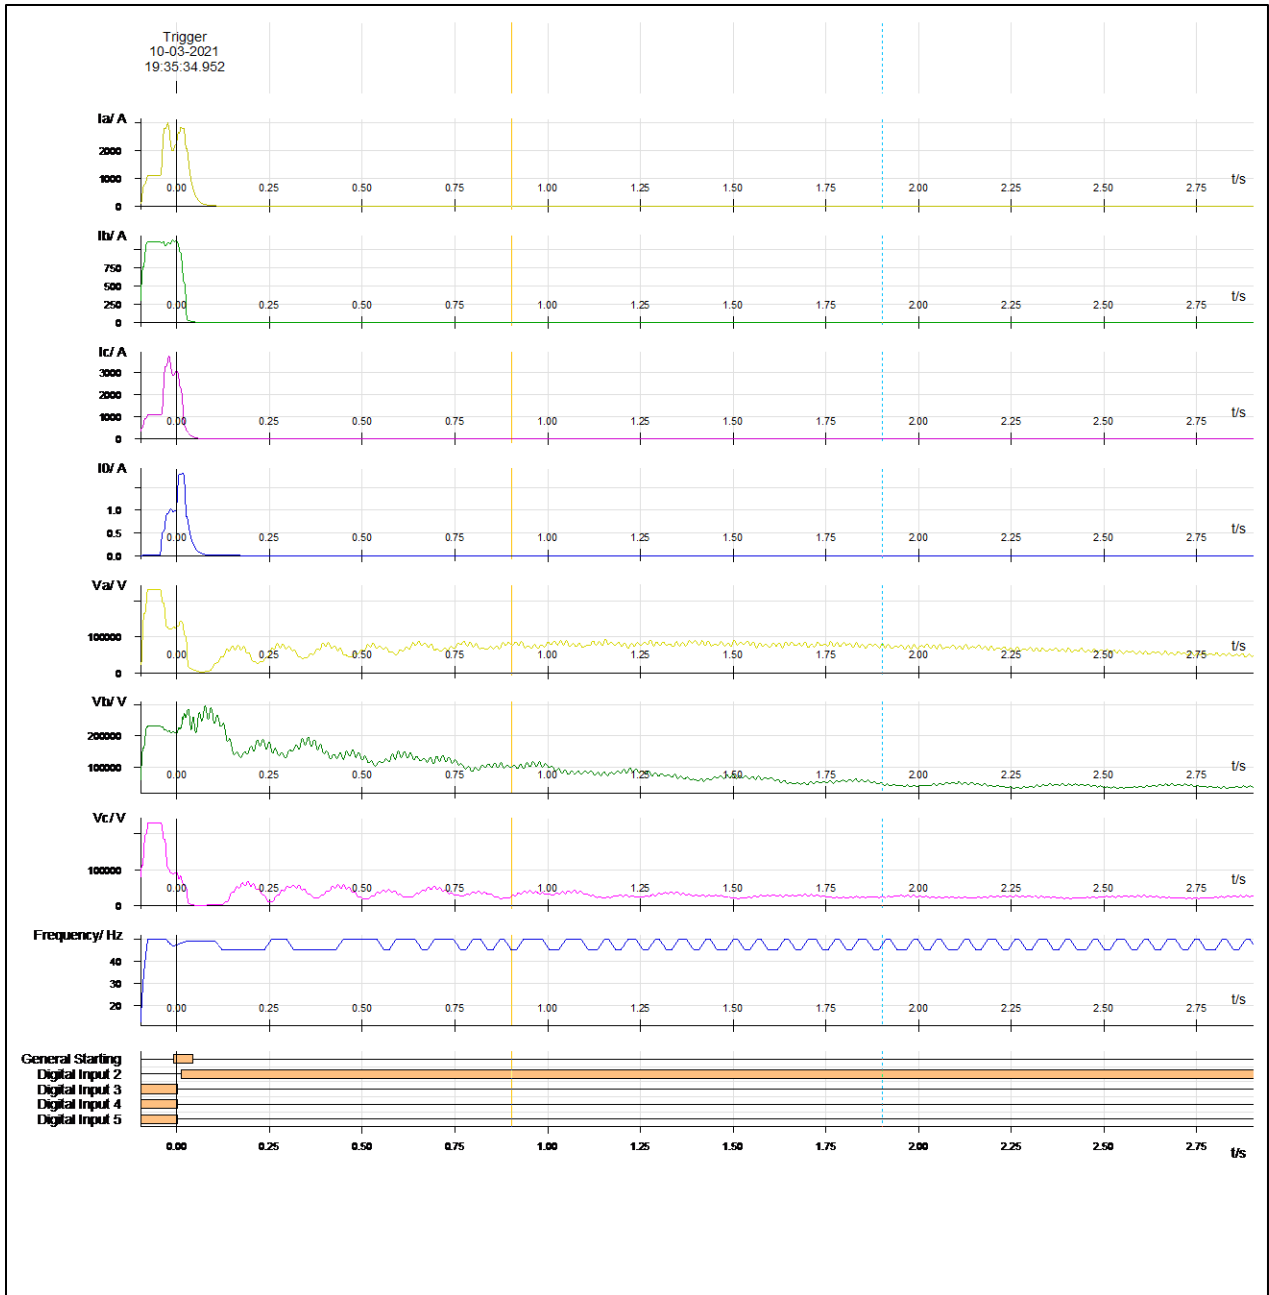
Digital channel is not configured as per ERPC's guidelines

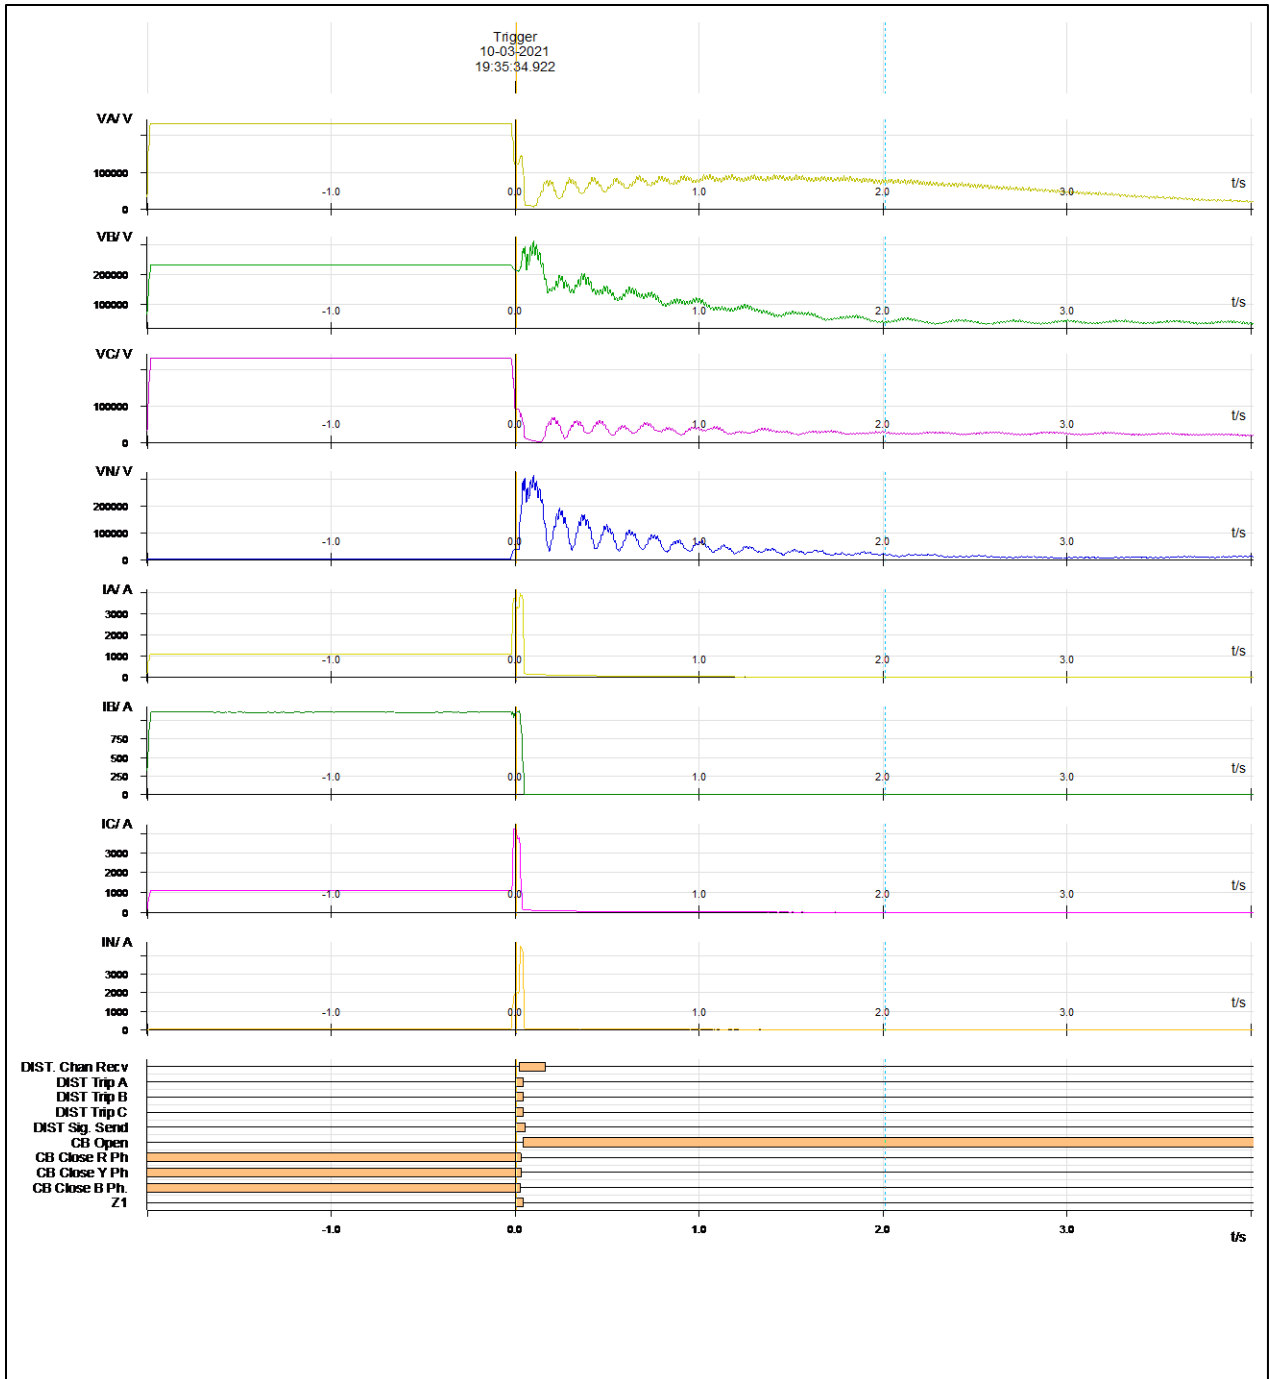
Digital channel is not configured as per ERPC's guidelines

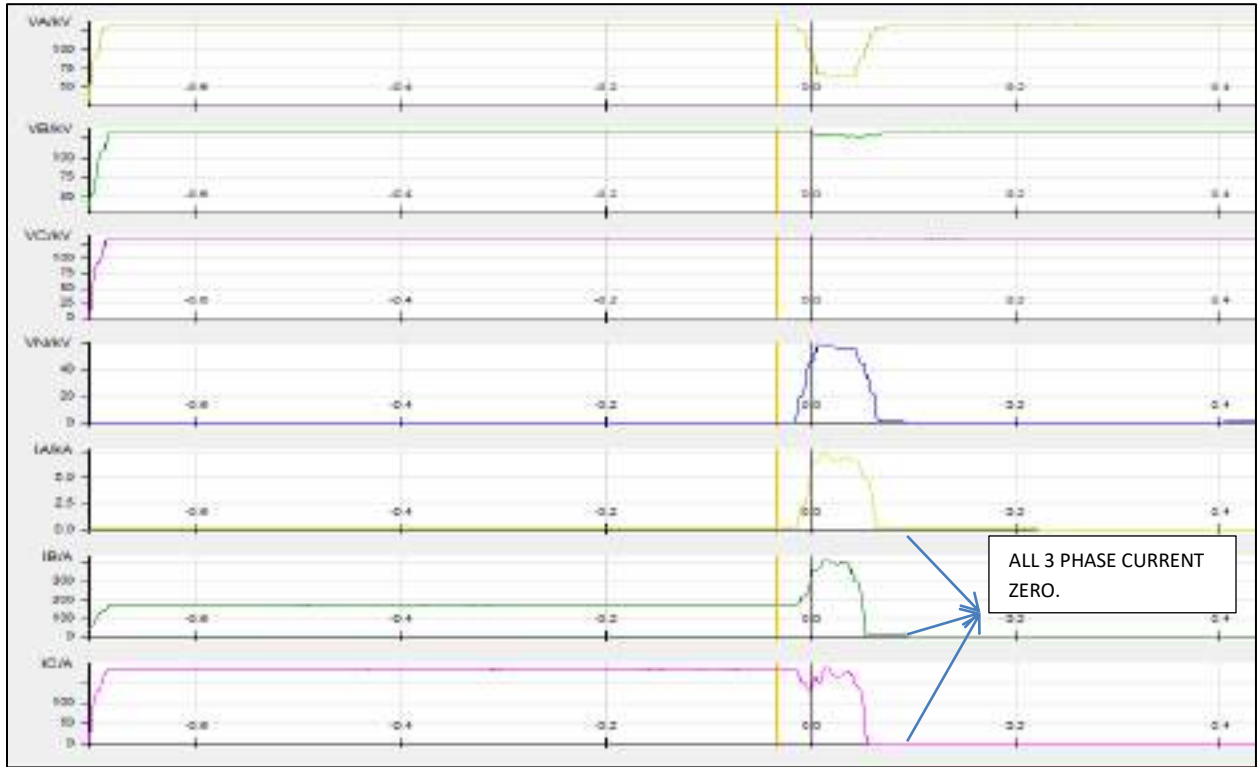
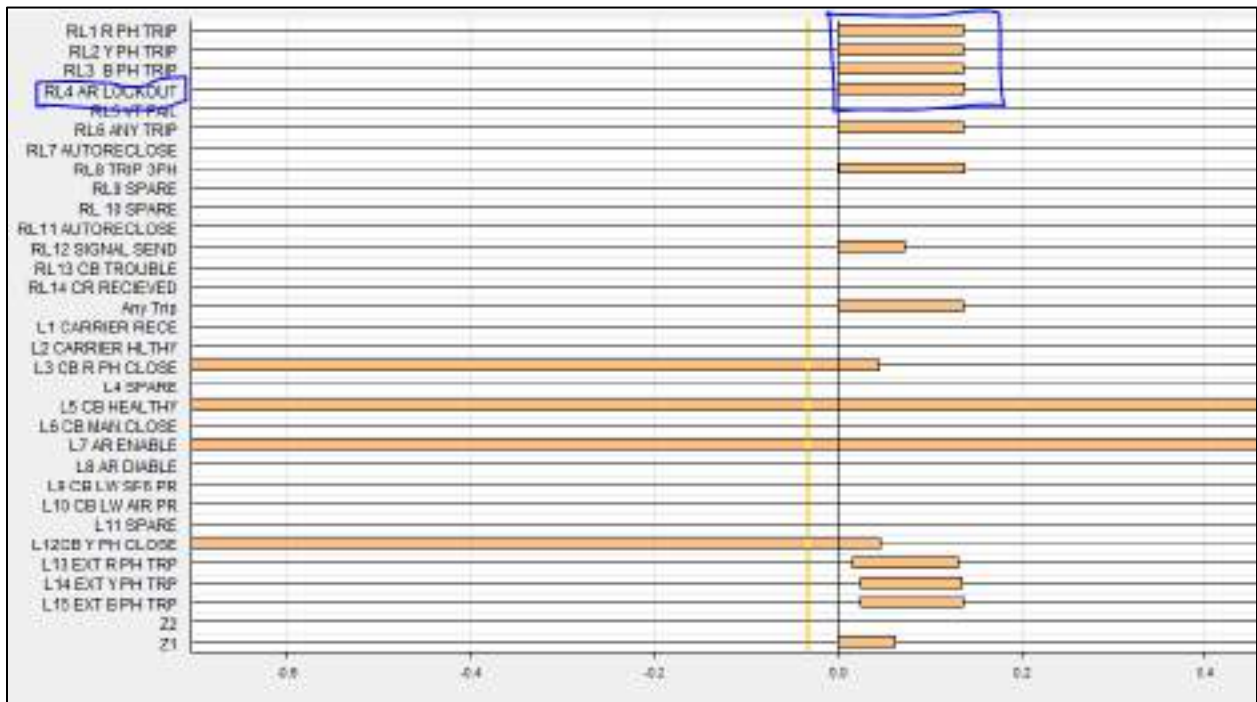
DR at STSPS END FOR 23/03/2021

In all cases of tripping it is observed that from Santaldih end, fault is in zone-1 and 3 phase tripping is occurring at the instant of single phase fault. So no auto reclose is observed in any event from Santaldih end ,if Auto reclose would have operated some tripping's of transient fault could have been avoided. Whether Auto reclose scheme is implemented and functional may please be communicated.

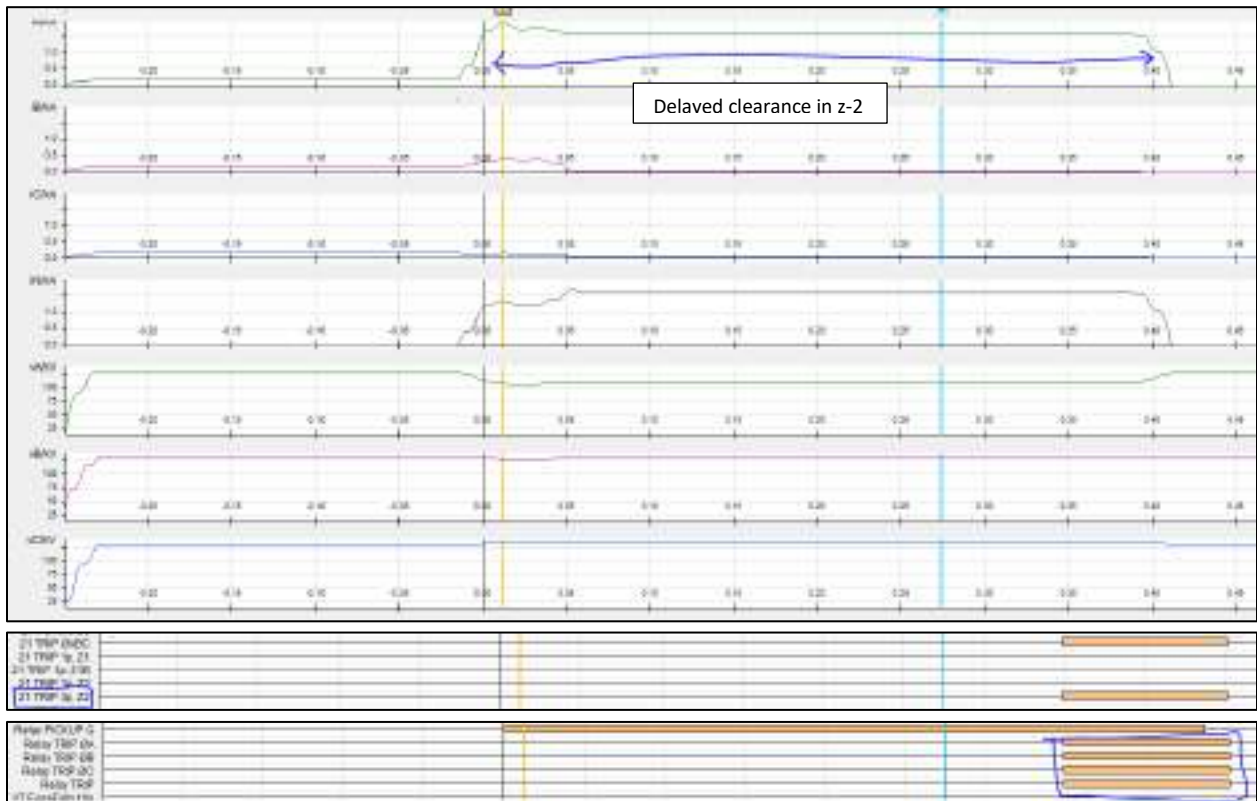
DR at CHANDIL END FOR 23/03/2021:

Carrier communication scheme failure : All faults were in zone-2 from Chandil end and delayed tripping observed after zone-2 time in each case, and all 3 phases from Chandil end tripped after z- 2time . Seems also carrier communication scheme not working as STPS end is sensing z-1 so it should send carrier signal to remote end to trip instantaneously faulty phase in case of zone-2 start at remote end and will further proceed for auto reclose after dead time .Delayed clearance also could have been avoided along with line tripping.

Healthiness of carrier communication scheme may also be checked and communicated.

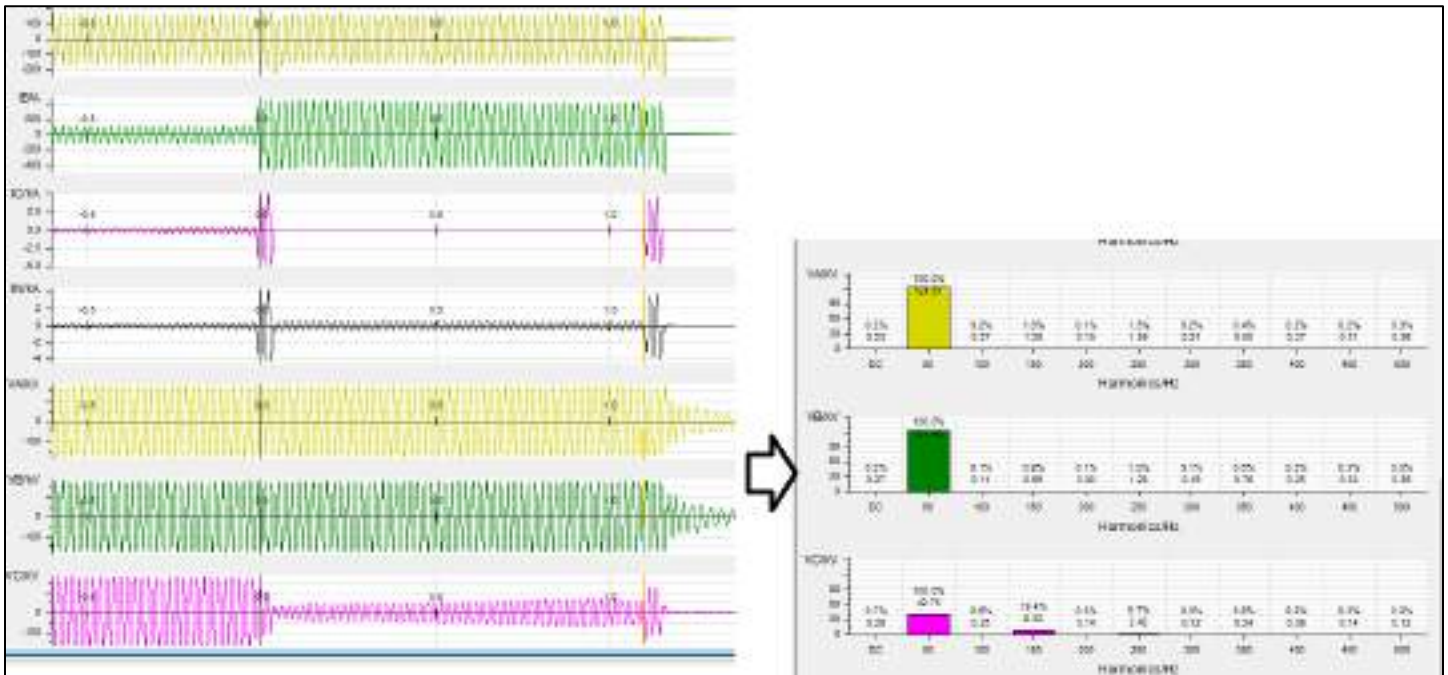
220 kv Daltonganj –Garwa –II tripped on 30 March with B phase to ground fault and during dead time of Auto reclose B, Phase voltage was existing with approx. 90Kv showing persistent arcing kind of phenomenon. Then at the charging instance after few milli-seconds line tripped due to Y-B fault and it appears from DR that prior to tripping B phase fault converted to Y-B fault which was pre-existing in the line with small magnitude which after charging increased in few ms and got detected by Distance protection and tripping issued .

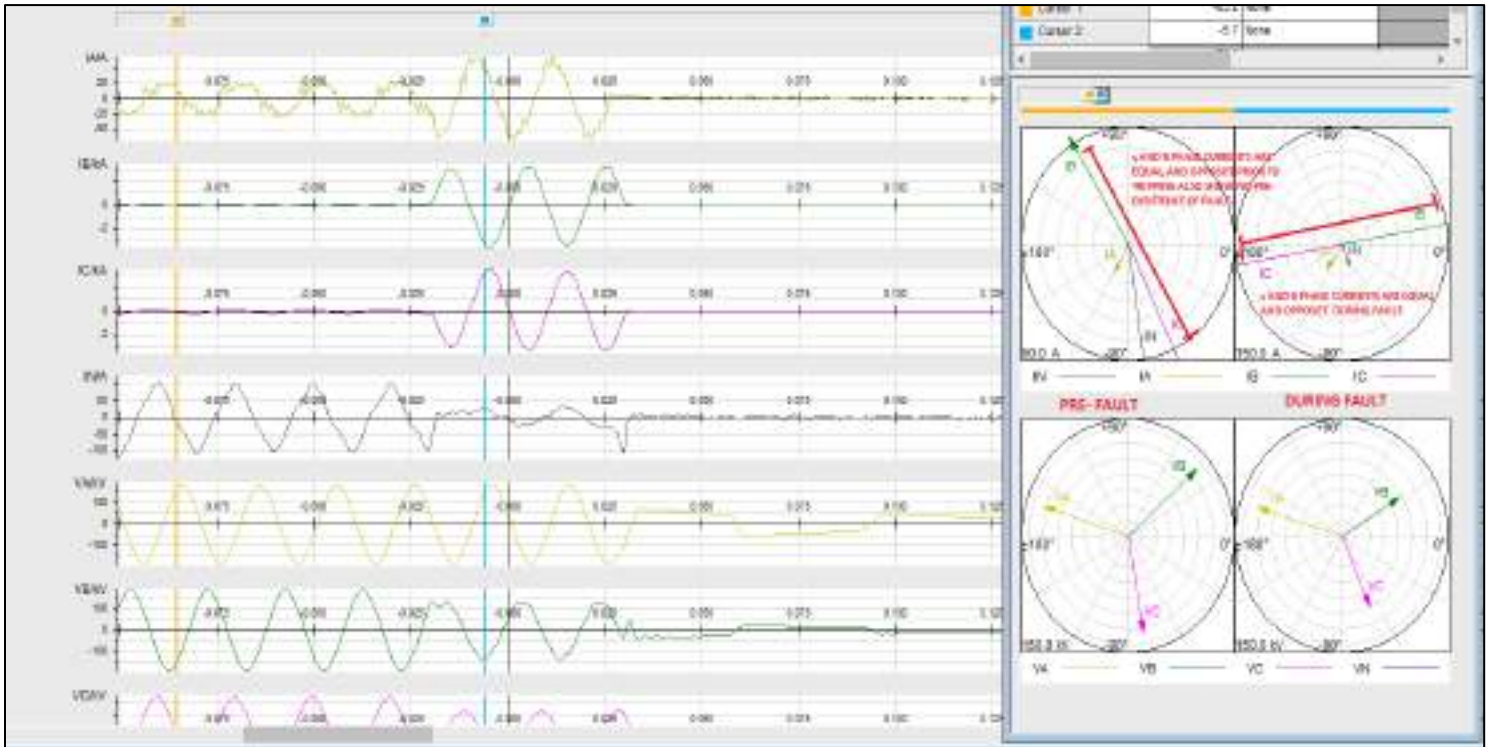
AT CHARGING INSTANCE: Then at the charging instance after few milli line tripped due to Y-B fault and it appears from DR that prior to tripping B phase fault converted to Y-B fault and was existing in the line with small magnitude which increased in few milli seconds and got detected and tripping issued .

Similar phenomenon is also observed in the past this may be checked that what nature of fault is occurring where first B phase fault is being converted to Y-B phase fault with some small arcing kind of phenomenon leading to Phase to phase conversion. Whether any Row or clearance issue is there?

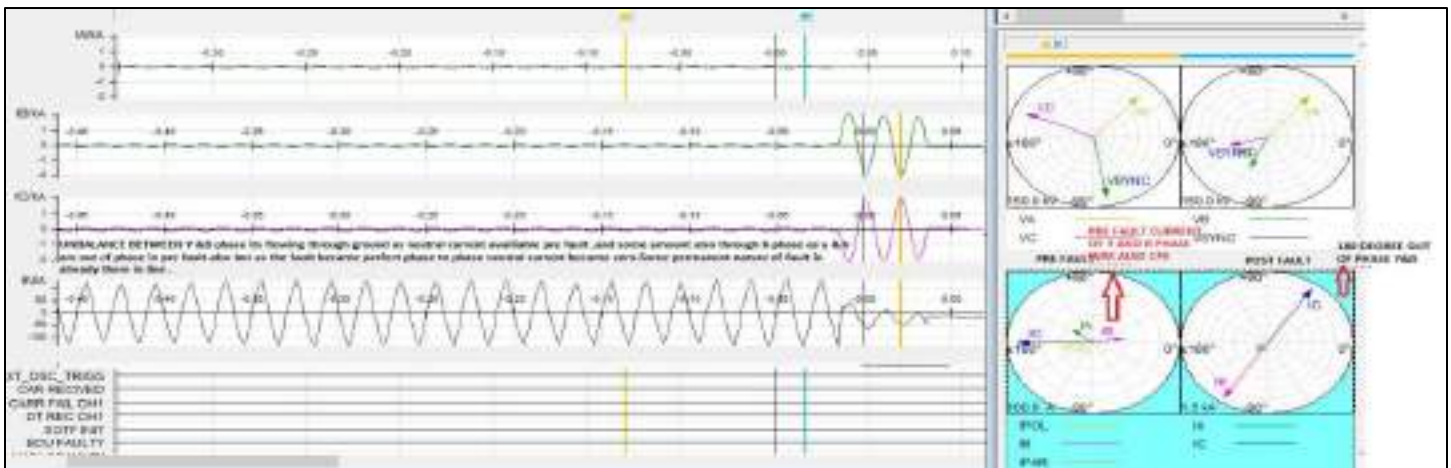
.Please refer DR as shown below for 19th august tripping at the time of charging.

Similar incident was also observed in one past case also where line tripped on B phase fault and while charging Y-B phase fault observed .At the charging instance similar phenomenon observed where Y-B fault was pre-existing it was already having some permanent nature of fault shorting both phases but after few milliseconds it got converted to perfect phase to phase Y-B fault with Y & B currents 180 degree out of phase and current also increased up to 1.5 ka and line tripped.

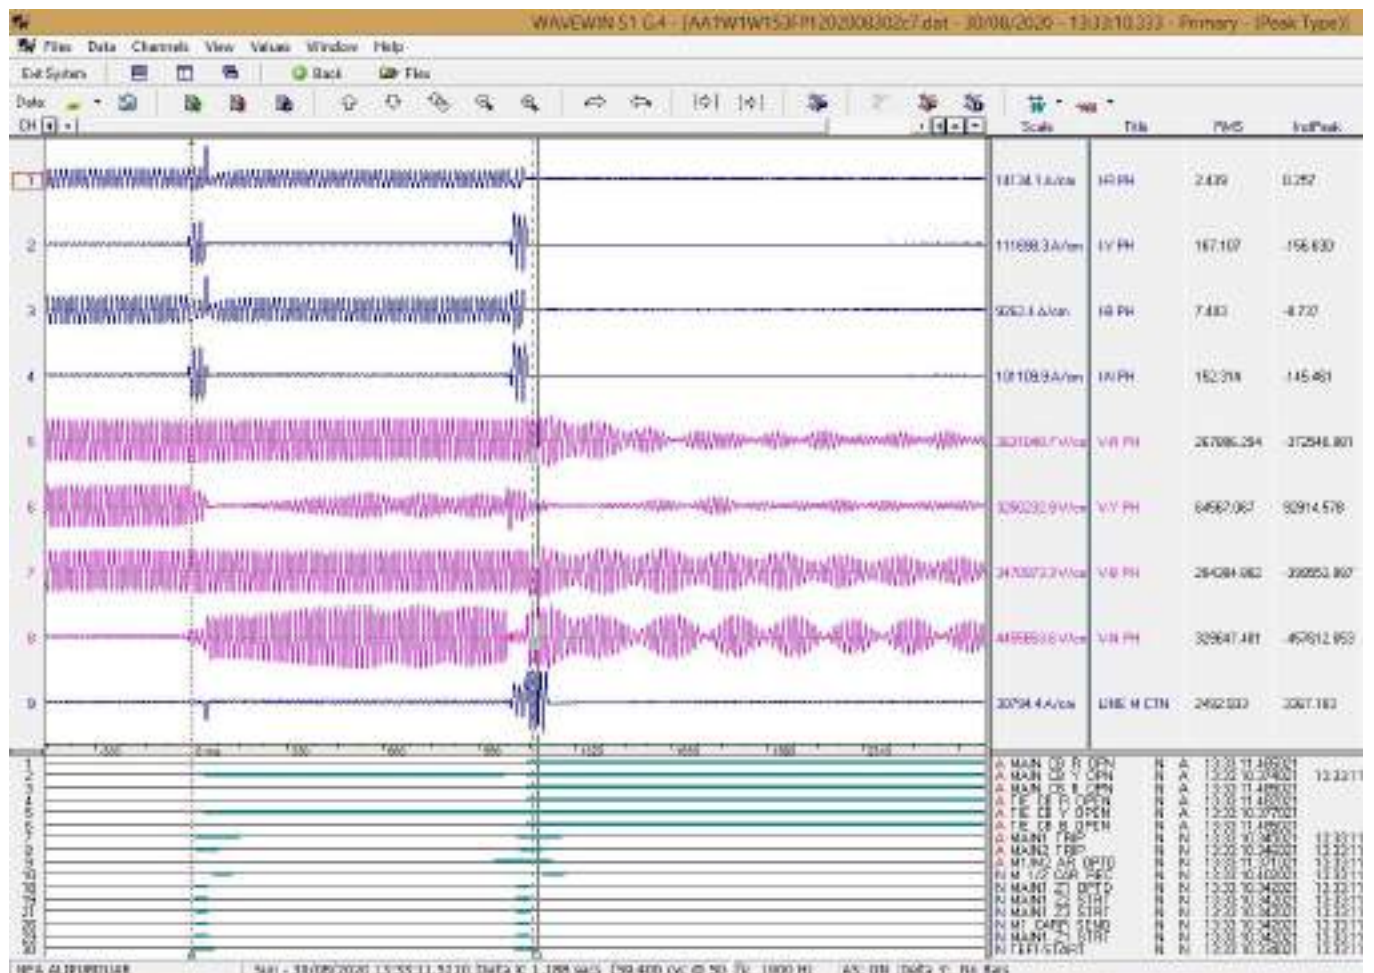
Disturbance Recorder:

Due to ferro-resonance problem, the voltage in healthy phases shoot up to 291 KV (Ph-N) i.e. approx. 1.26 times of normal voltage and the neutral voltage up to 366KV. This will create stress in healthy equipment like- CT, CVT, WT, LA etc and may deteriorate the life of costly equipment.

Both the 50MVAR Line Reactors are switchable in nature and hence Reactor CB to be given 3-ph trip command in case any single phase operation of Line Protection, so that Line Reactor will be out of service to avoid resonance problem.
