Minutes of 102nd PCC Meeting

Date: 28.05.2021
Eastern Regional Power Committee
14, Golf Club Road, Tollygunge
Kolkata: 700 033

MINUTES OF 102ND PROTECTION SUB-COMMITTEE MEETING HELD ON 13.05.2021 AT 10:30 HOURS

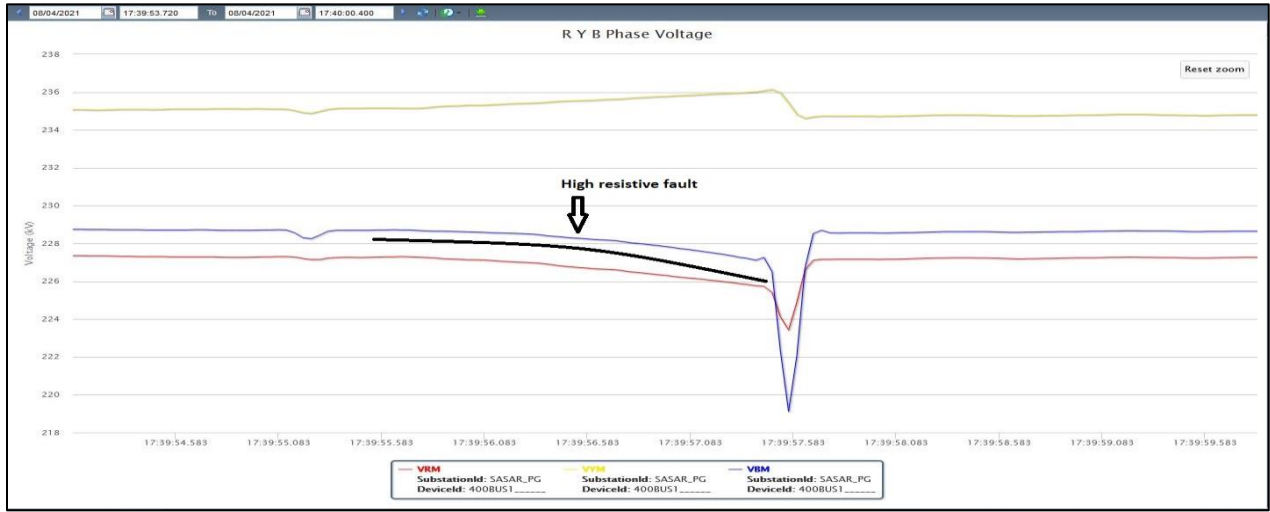
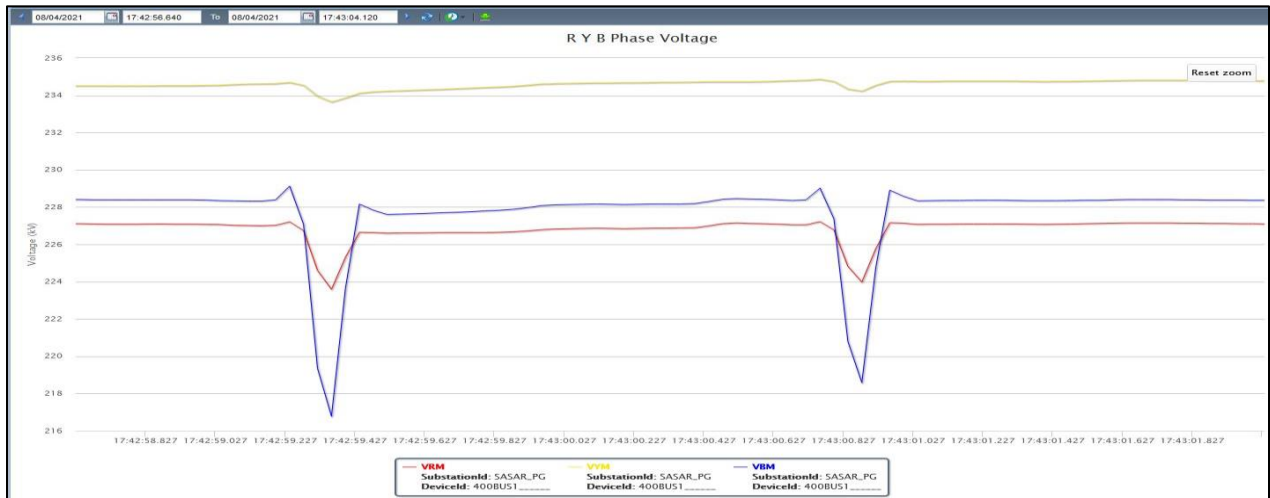
Figure 2: Three phase 400 kV bus voltage captured at 765/400 kV Sasaram S/S for both events.

समय	नाम	उप केंद्र 1 रिले संकेत	उप केंद्र 2 रिले संकेत	पीएमयू पर्यवेक्षण
17:39 Hrs	220 kV Daltongunj – Garwah - 2	B-N , FD: 12.7 Km, FC: 3.8KA. Zone 1, Fault clearance 800 ms, DEF trip, DT sent	Yet to be received	B phase high resistive earth fault with delayed clearance of more than 1 second.
17:43 Hrs	220 kV Daltongunj – Garwah - 1	DALTONGUNJ END: B-N FAULT, FD: 13.2KM, FC: 2.26 KA	GARWAH END: Z-1, B-N FAULT, FC:- 1.4kA, FD:- 83.710km	A/R successful after 1 second again fault appeared in reclaim time and line got tripped.

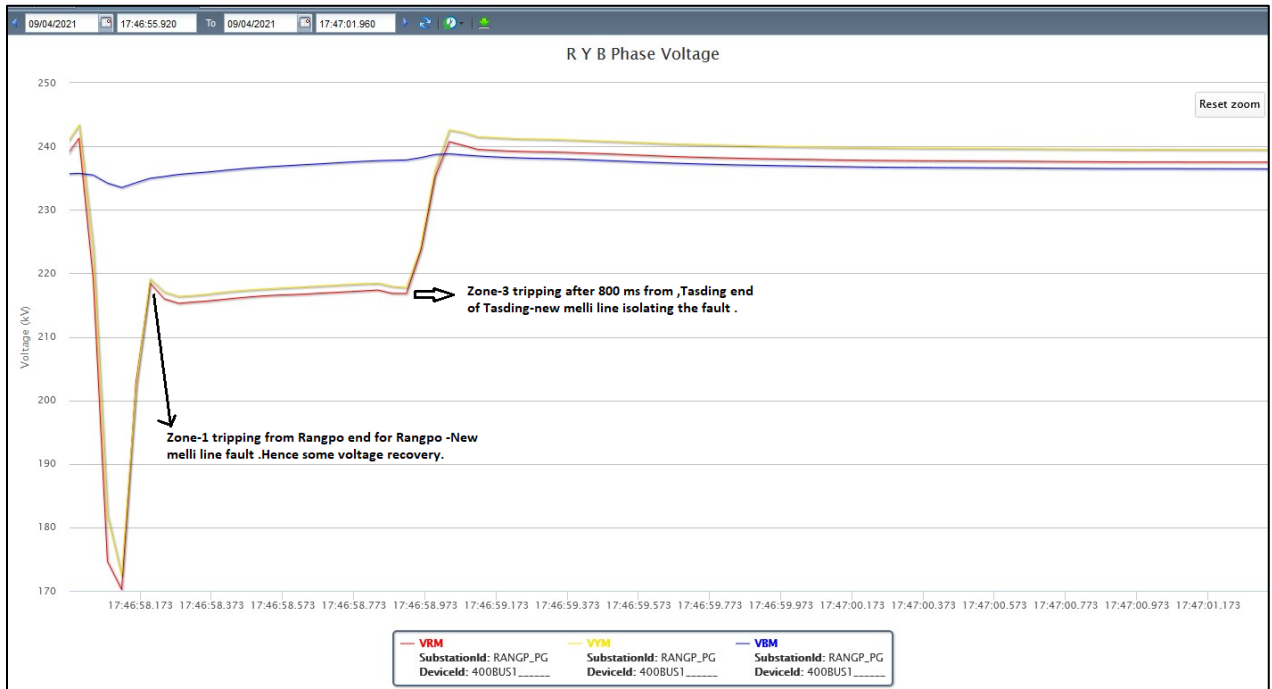
Figure 2: Three phase bus voltage captured at 400 kV Rangpo S/S indicating the fault and its delayed clearance.

समय	नाम	उप केंद्र 1 रिले संकेत	उप केंद्र 2 रिले संकेत	पीएमयू पर्यवेक्षण
17:47	220KV-TASHIDING-RANGPO-1	Did not trip	R_Y, Z-3, FD- 85.04 FC= Iy= 422.7A Iy= 407A	Delayed clearance of fault (around 800 ms) has been observed in PMU data
17:47	220KV-New Melli-RANGPO-1	Did not trip	Z1, R-Y,59Mtr, Ir-0.73kA, Iy-10.67kA	Delayed clearance of fault (around 800 ms) has been observed in PMU data
17:47	220KV-New Melli- TASHIDING	Did not trip	Z-3 ,f/c-R&Y2.5Ka as per DR,f/d-160%	Delayed clearance of fault (around 800 ms) has been observed in PMU data

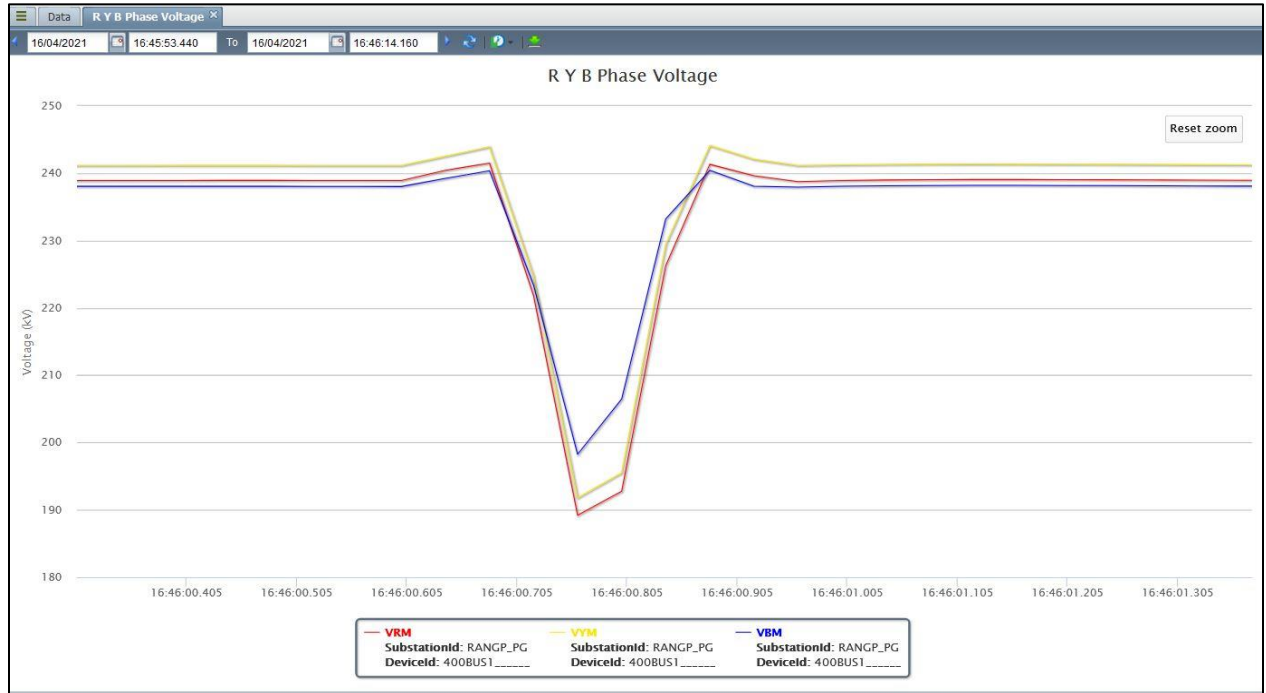
Figure 2: Three phase fault captured through 400 kV Rangpo bus voltage through PMU.

समय	नाम	उप केंद्र 1 रिले संकेत	उप केंद्र 2 रिले संकेत	पीएमयू पर्यवेक्षण
16:46 Hrs.	220 kV-TASHIDING-RANGPO	RYB IR 4.8 KA IB 3.9 KA IY =4.1 KA F.D 36 KM Z1 AT RANGPO	NO TRIP AT TASHIDING	Fault clearance in less than 160 ms.
16:46 Hrs	220 kV-NEW MELLI-TASHIDING	RYB 13.5 KM Z1 IR=3.75 Ka IY =3.65 kA IB =3.92 AT NEW MELLI (19.8 KM LINE LENGTH)	Z1 B-N 5.603 KM 2.371 KA Z1 AT TASHIDING	Fault clearance in less than 160 ms.

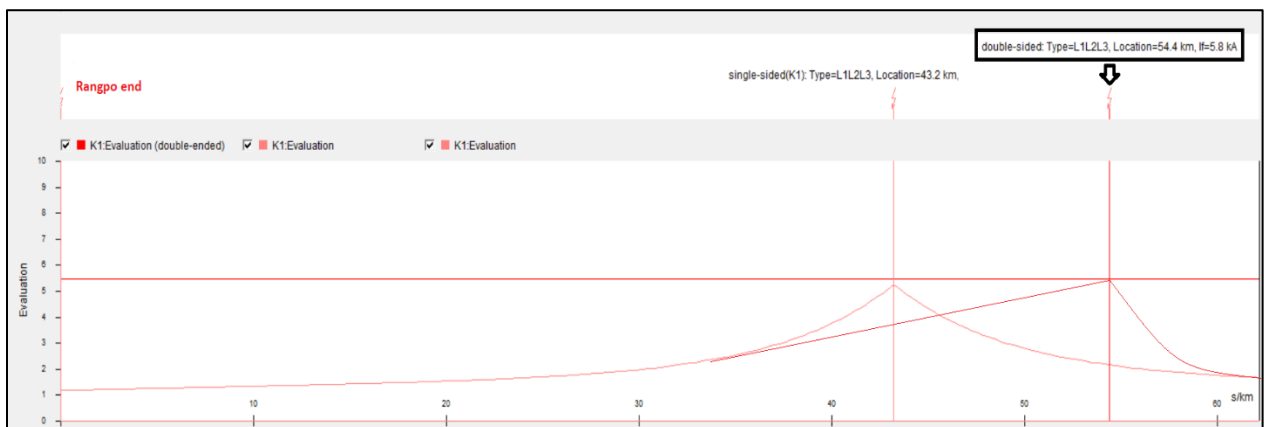
Figure 5: Double ended fault location.

Results obtained from the calculation also shows that the fault location at a distance of 54 Km from Rangpo end which lies in Tashiding-New Melli section line, and also matched with relay details of Tashiding -new Melli line, at a distance of 6 km from Tashiding ($46+6=52$ km). Result is shown in below figure (5).

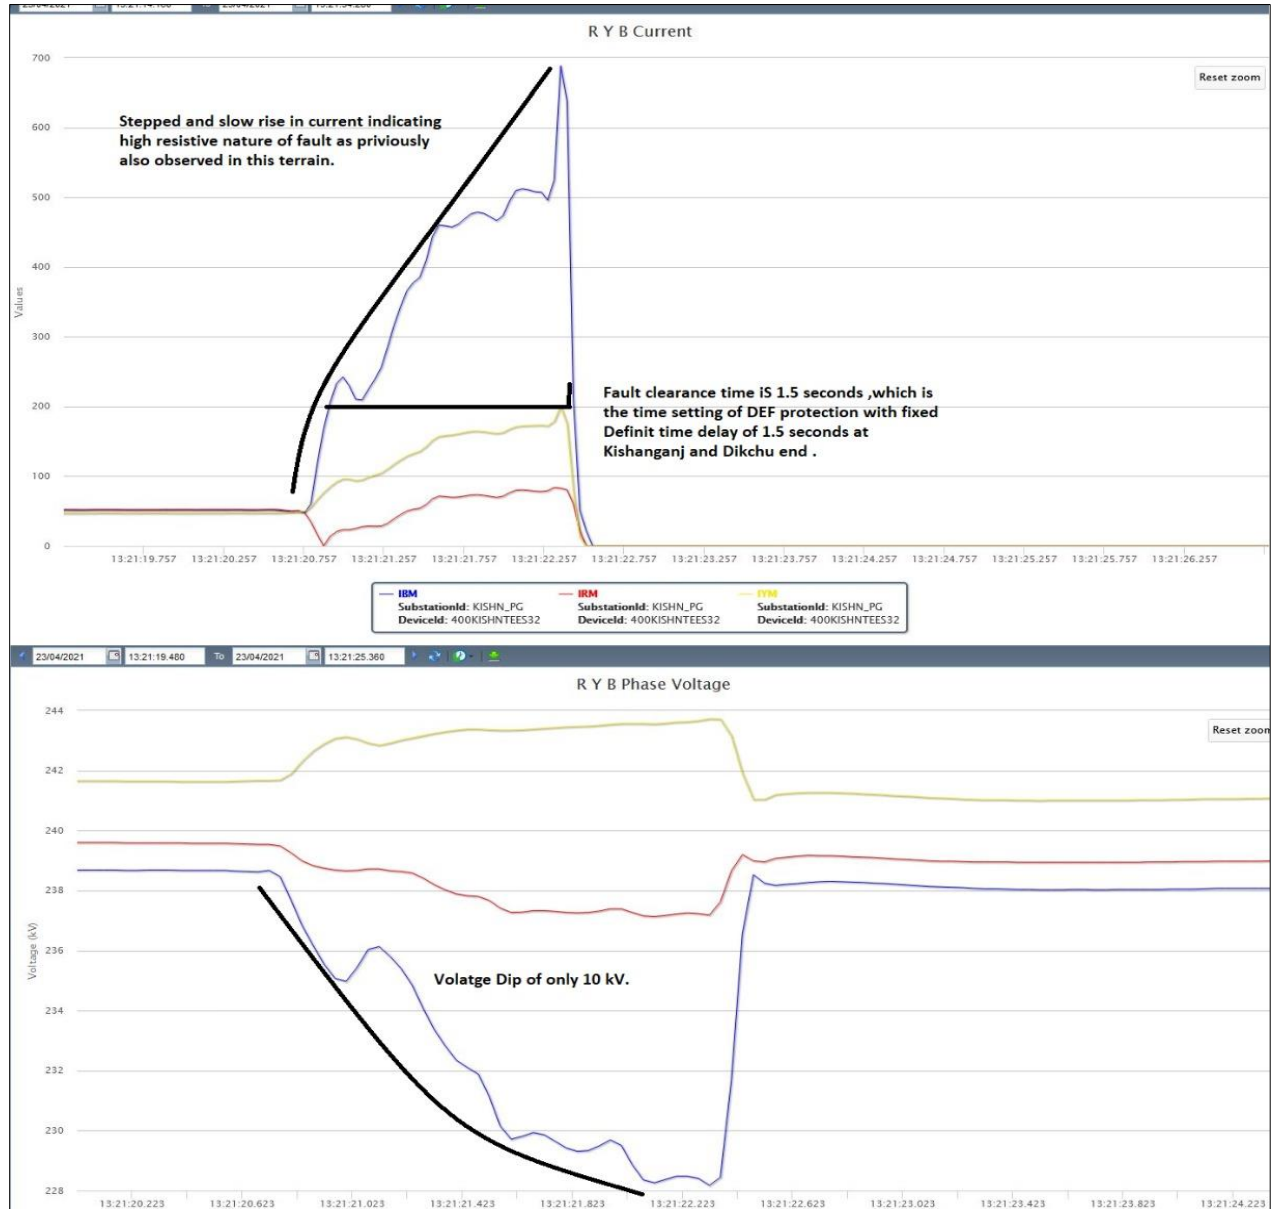
Figure 2: Three phase current of 400 kV Kishangunj-Teesta 3 and 400 kV Kishangunj bus voltage captured at Kishangunj S/S indicating the event.

Based on DR/EL and PMU data analysis, It is observed that DEF tripping command at 400 kV Kishangunj- Teesta 3 circuit at Kishangunj end for the fault on 400 kV Teesta 3-Dikchu circuit is not coordinated properly. The tripping time of 400 kV Teesta 3-Dikchu at Teesta 3 should be earlier compared to the 400 kV Kishangunj -Teesta 3 circuit at Kishangunj

PCC observed that the fault should be cleared from Teesta III end for Teesta III-Dikchu circuit before tripping of the line at Kishanganj end and opined that DEF relays at Teesta III, Dikchu and Kishanganj end need to be coordinated properly.

समय	नाम	उप केंद्र 1 रिले संकेत	उप केंद्र 2 रिले संकेत	पीएमयू पर्यवेक्षण
13:21	400 kV Teesta-III- Kishangunj S/C	Teesta 3: DT Received	Kishangunj: B phase to earth fault, 208.4 km, 1.6 kA, Directional E/F trip, IN>1, DT sent	High resistance fault and Fault clearance time 1.5 sec
13:21	400 kV Teesta-III - Dikchu S/C.	Teesta 3-Directional E/F trip, B phase to earth fault, IN> 1, DT sent	Dikchu: B phase to earth fault, IN>1 trip, DT received.

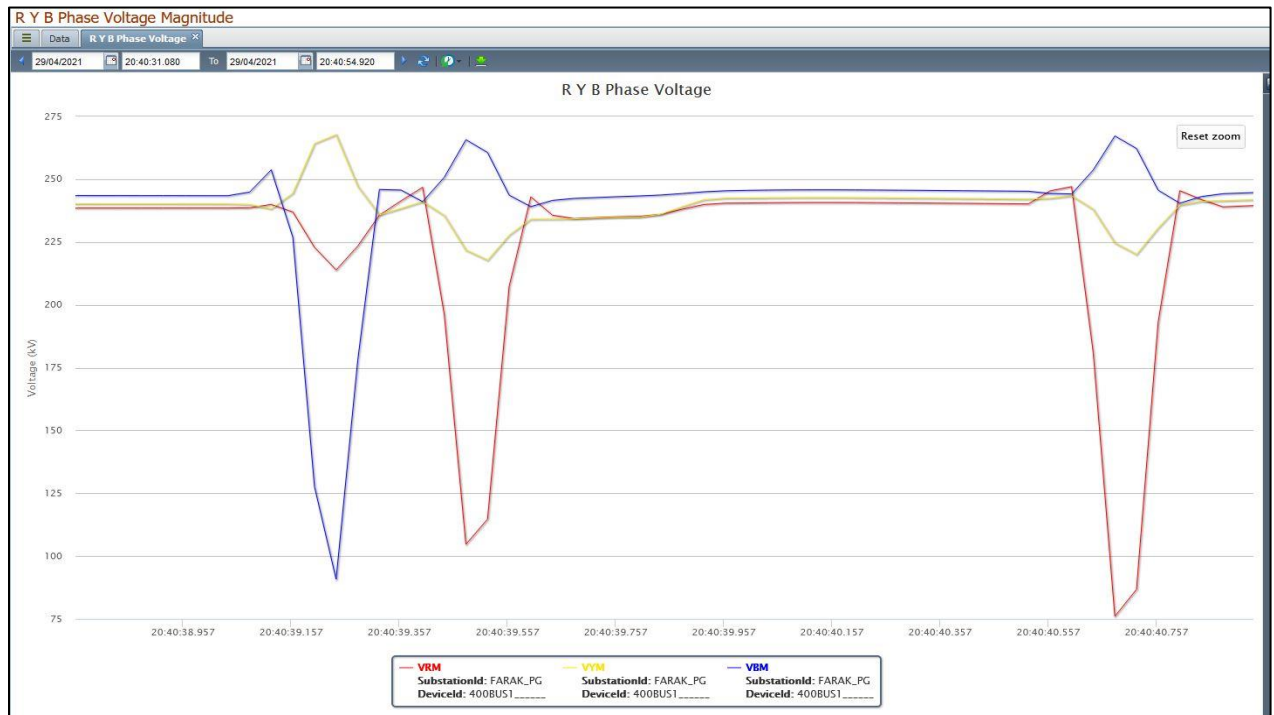
Figure 2: Three phase voltage measured by Farakka PMU shows the existence of one B phase to earth fault and one persistent R phase to earth fault at the time of the event.

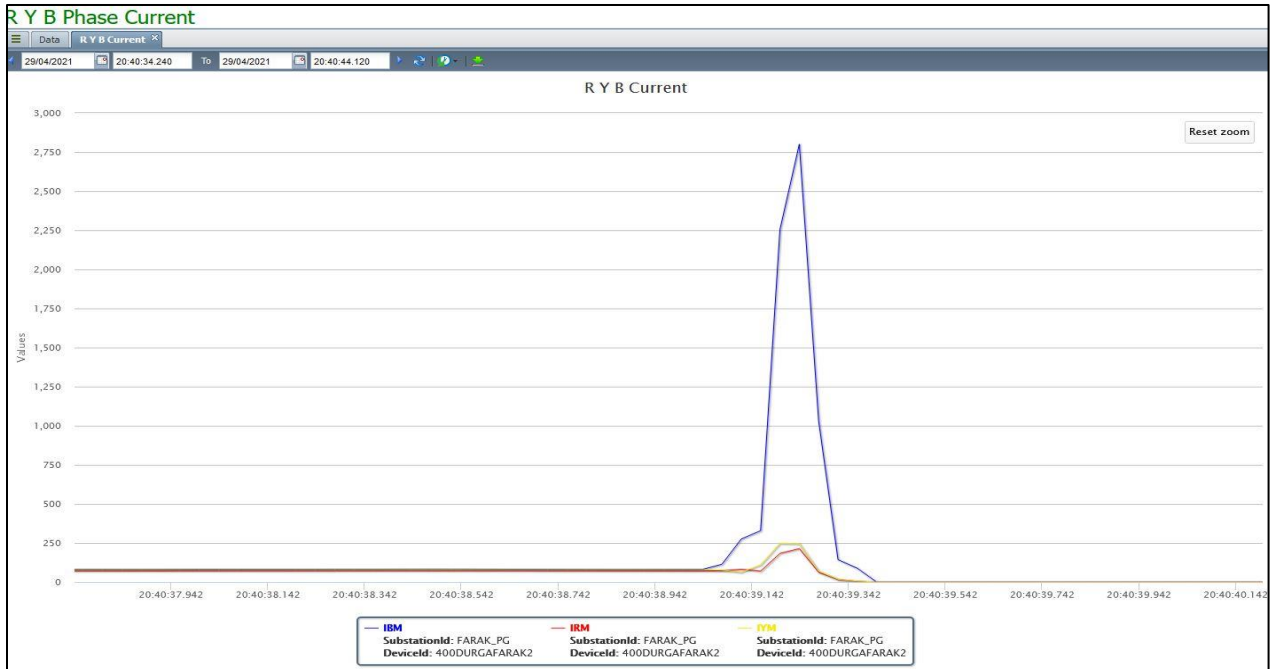
Figure 3: Three phase current measured at Farakka for 400 kV Durgapur 2 feeder shows the existence of B phase to earth fault current at the time of the fault. No auto-reclose attempt was taken place as it was in block condition. Fault clearing time was less than 100 ms.

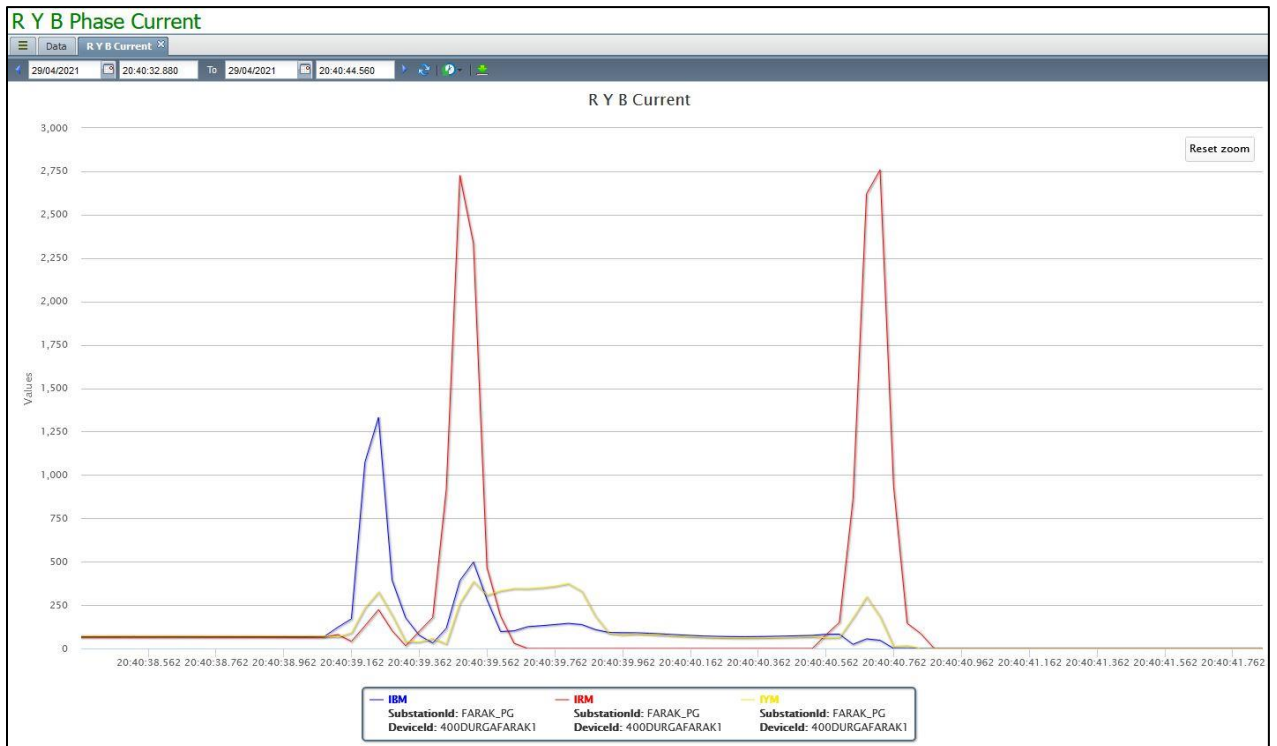
Figure 4: Three phase current measured at Farakka for 400 kV Durgapur 1 feeder shows the existence of R phase to earth fault current at the time of the fault. As fault was persistent in nature auto-reclose was unsuccessful. Fault clearing time was less than 100 ms.

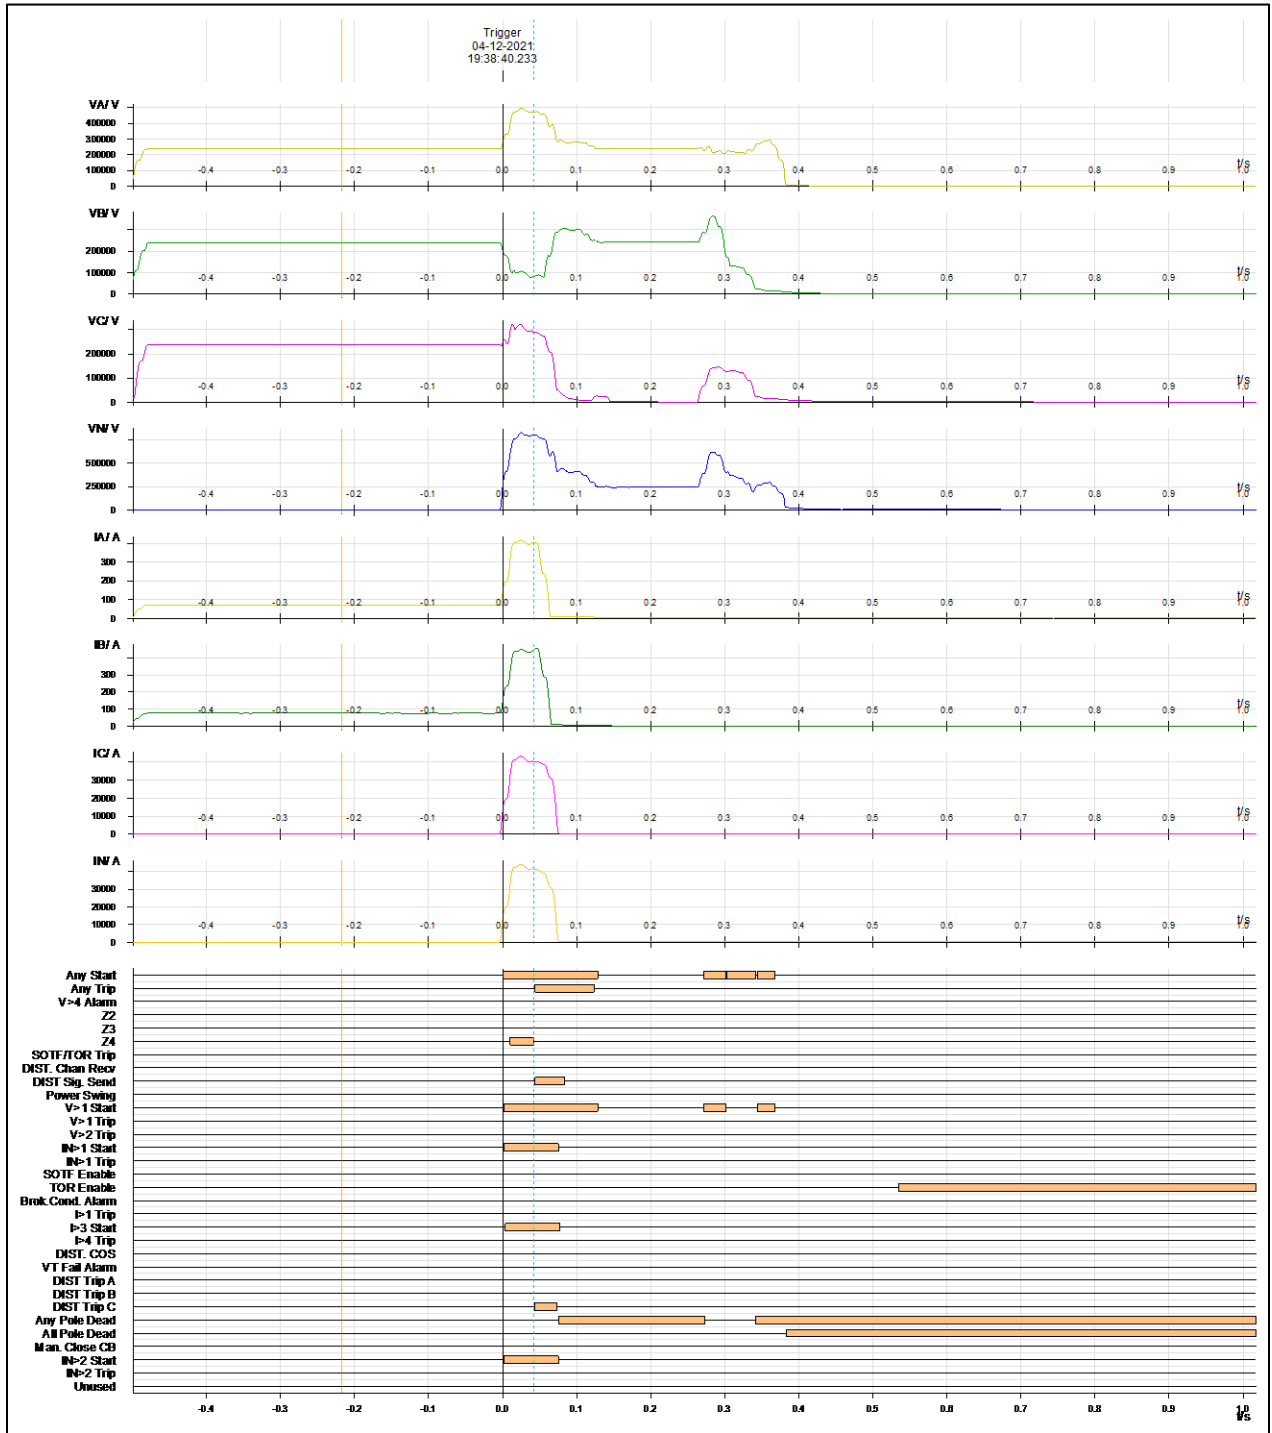
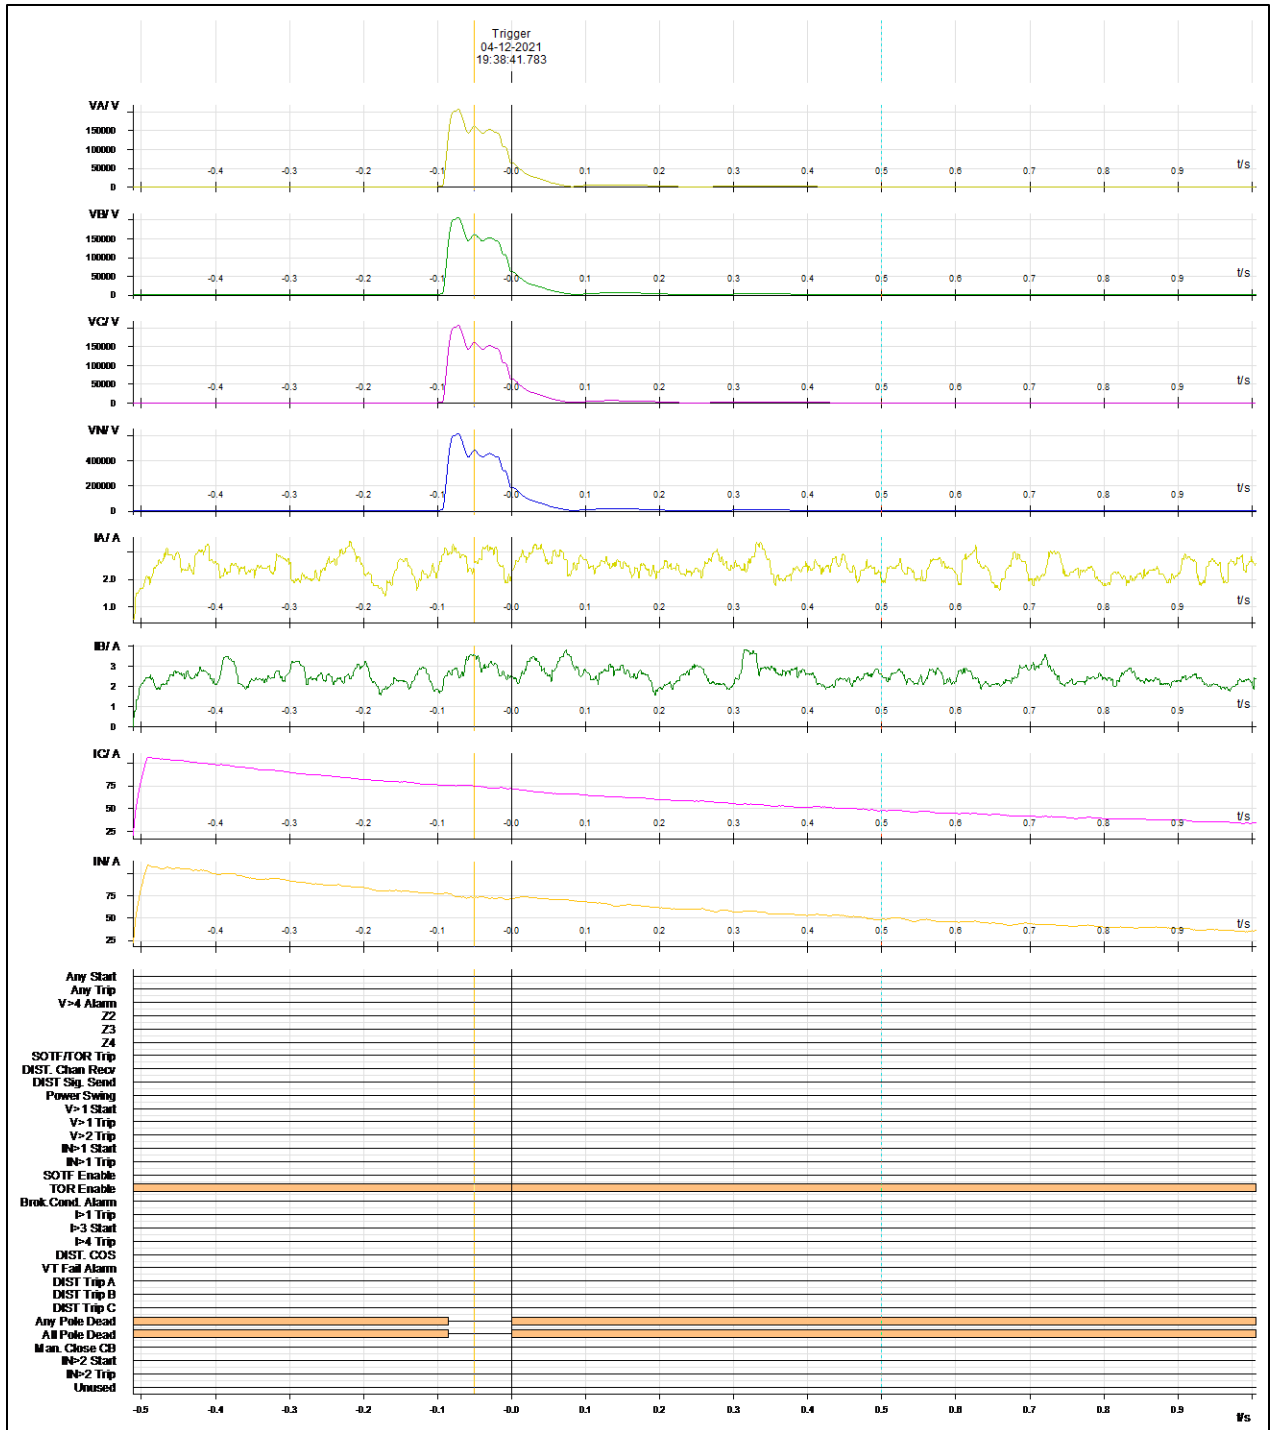
Annexure 3: DR recorded at Farakka for 400 kV Farakka Durgapur – 2

Line voltage in all three phases reappears for around 100 ms around 1.5 seconds after the three poles tripping at Farakka on zone - 4. Current was zero at that time at Farakka end. DR is not time synchronized.

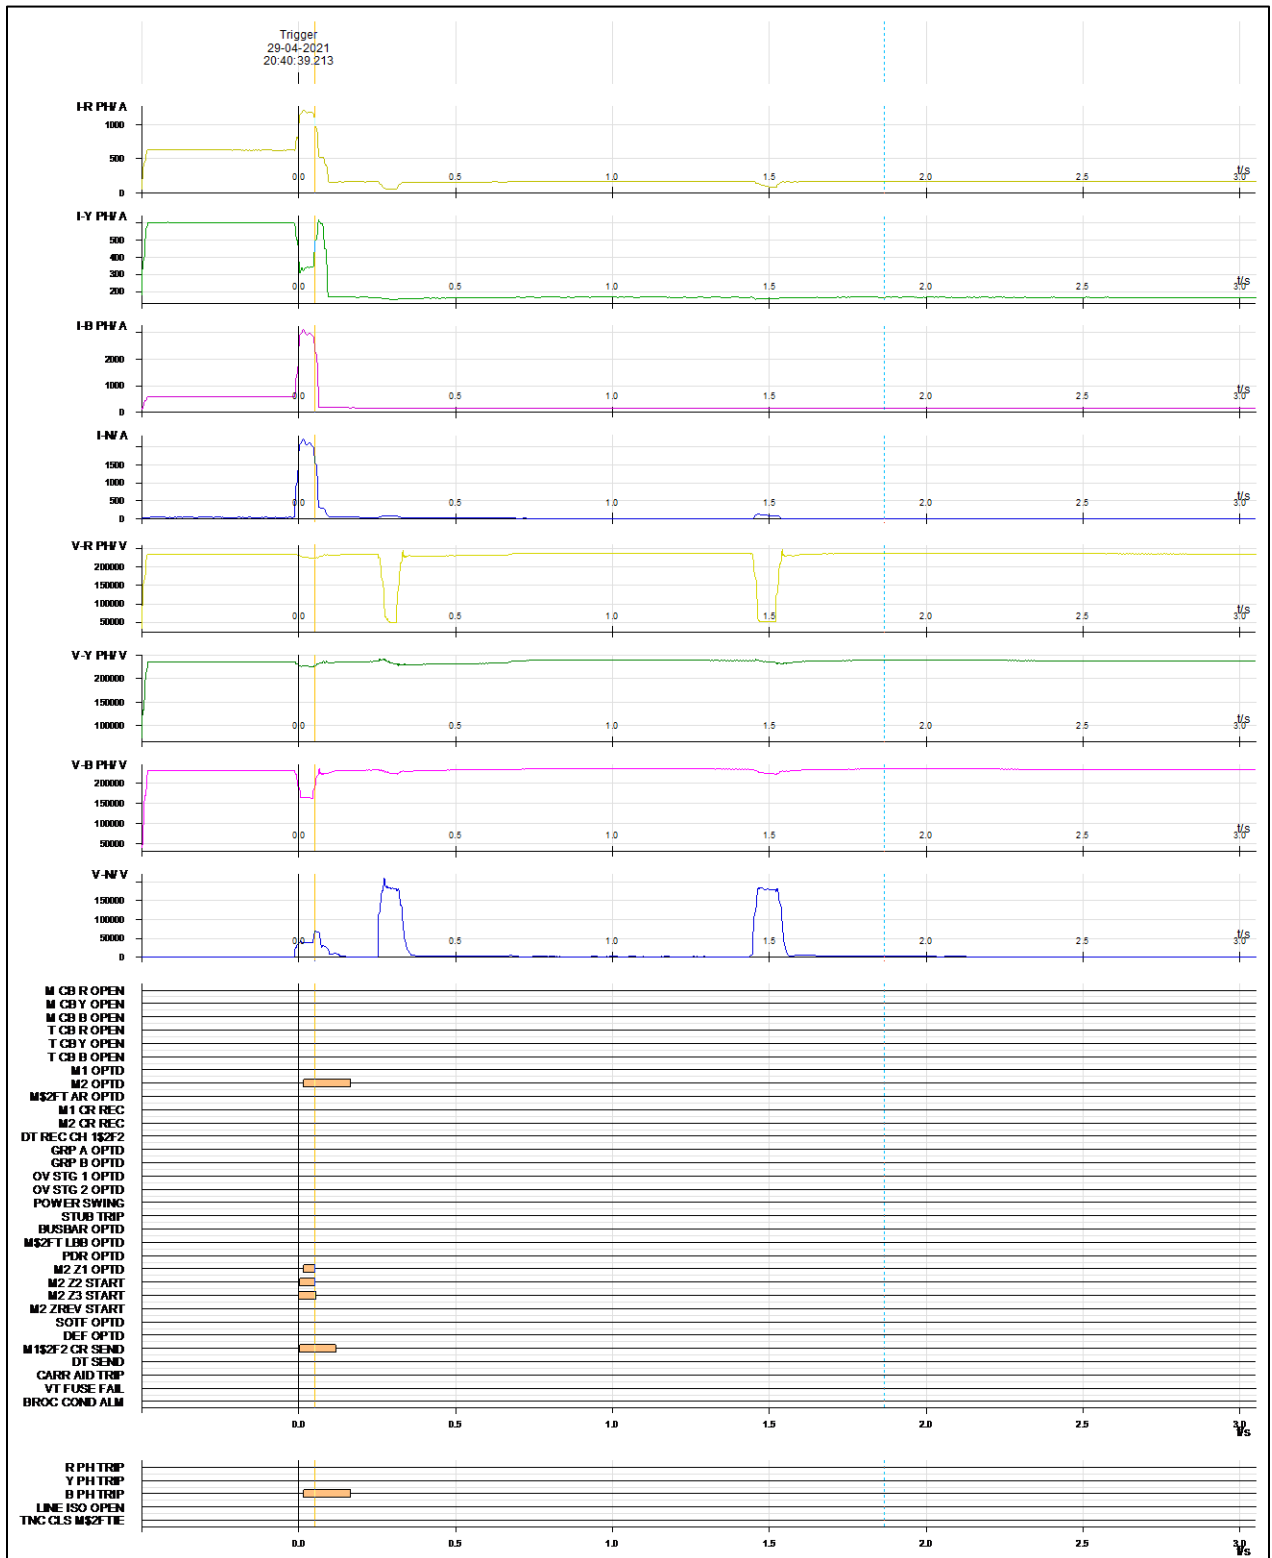
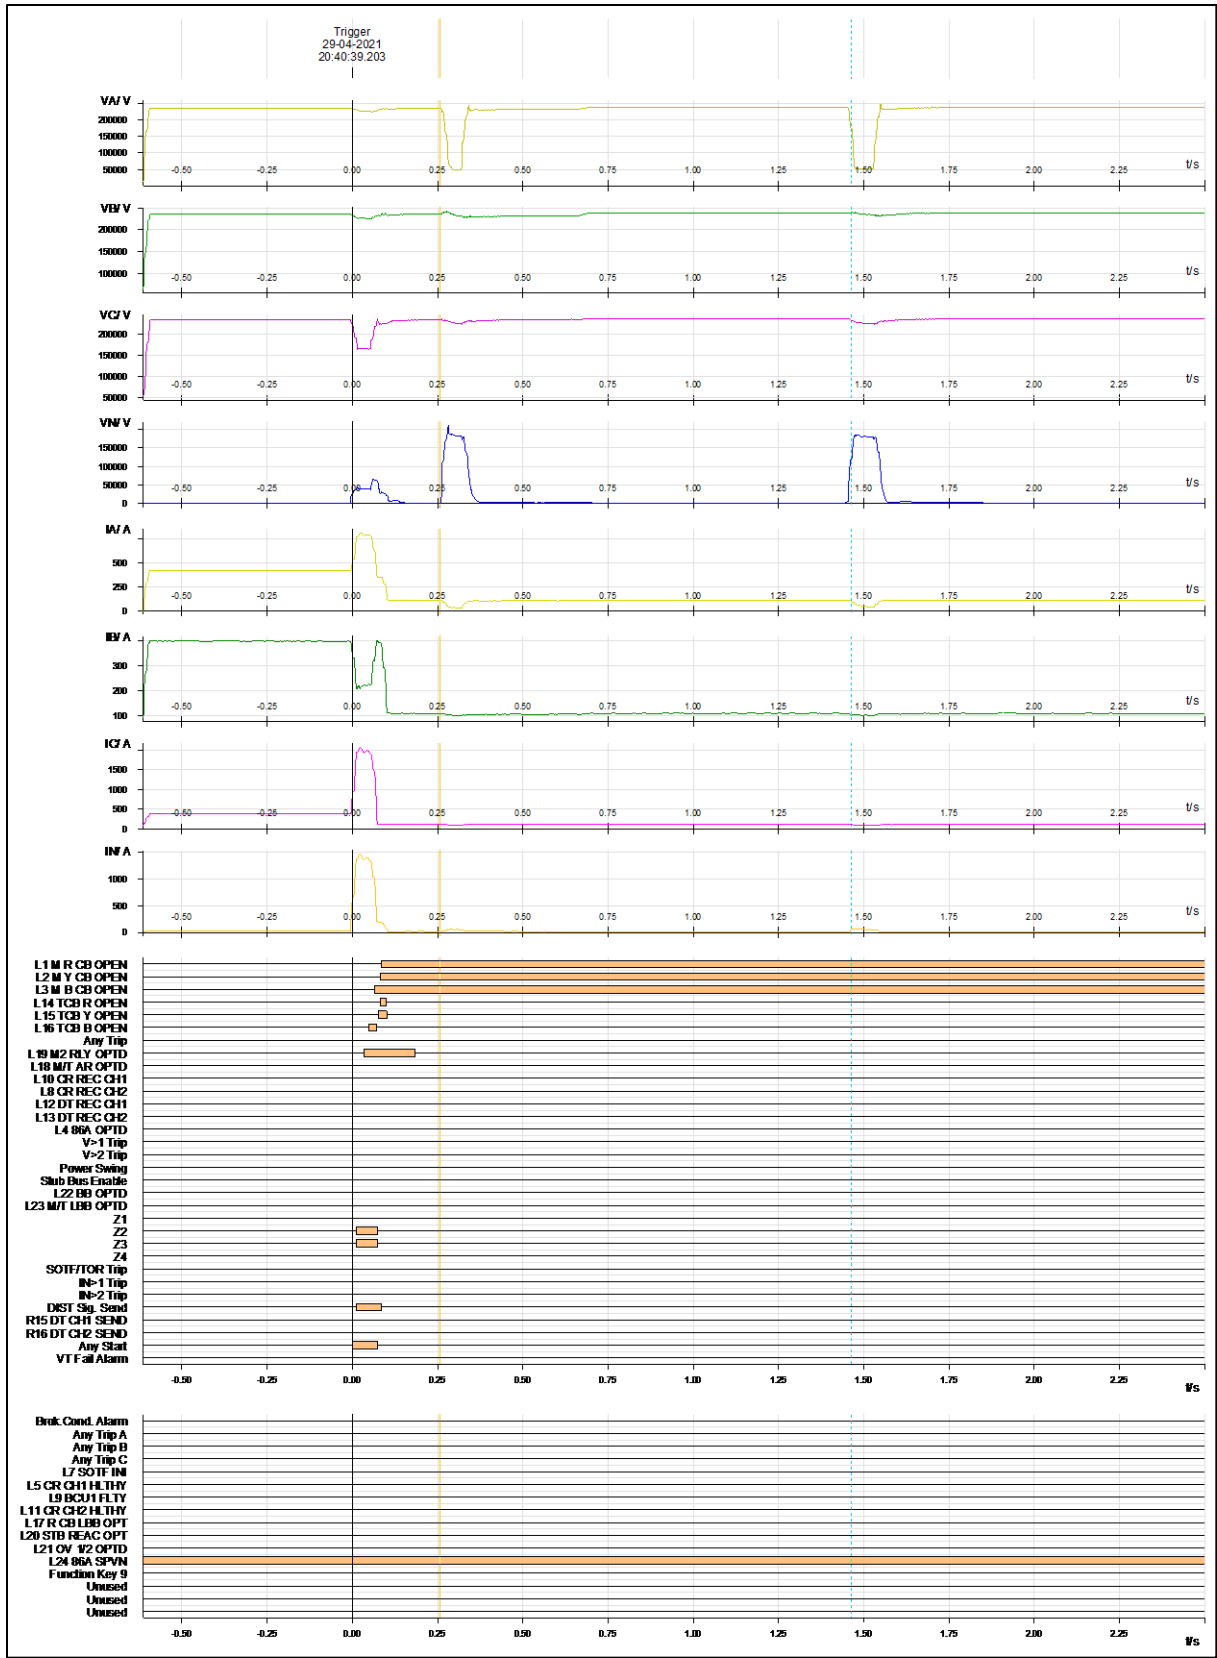
Annexure 4: DR recorded at Purnea end for 400 kV Farakka New Purnea – 1

Fault was sensed in zone – 1; Unsuccessful auto-reclose operation.

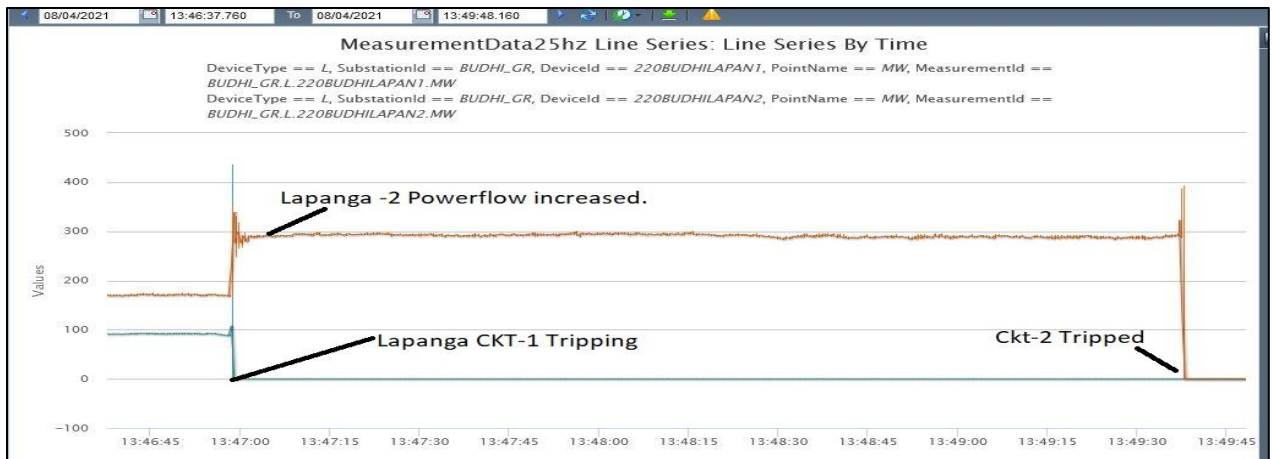
Figure 4: 220 kV Budhipadar-Lapanga D/C active power plot by PMU. (Magnitude of MW in PMU for circuit 1 is not accurate due to CT ratio or other problem while circuit 2 is correct. However, the dynamic behaviour is showing correctly. In addition, circuit loading should be almost equal)

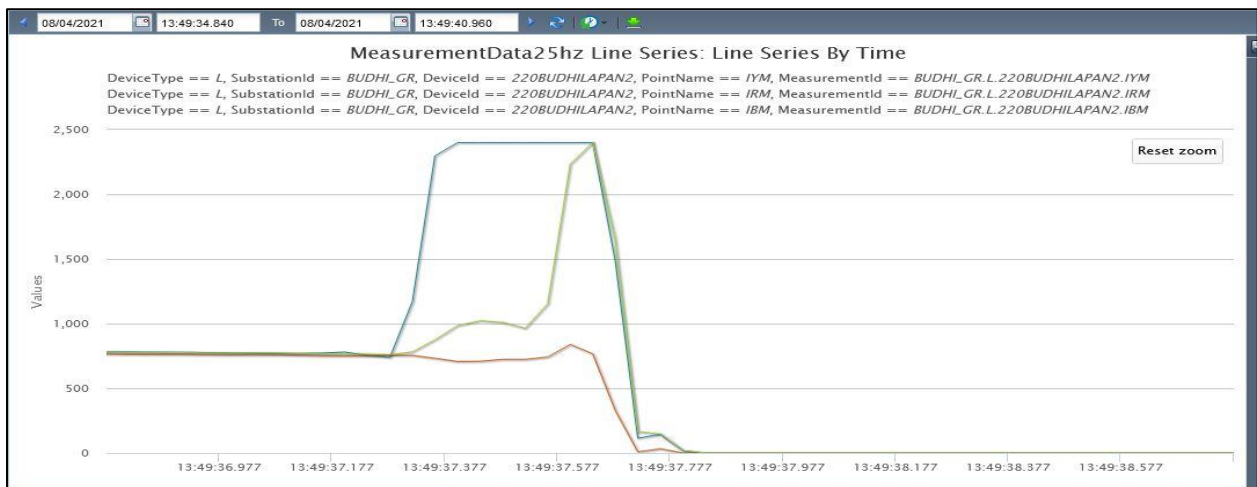
Figure 6: 220 kV Budhipadar-Lapanga-2 current indicating Ckt-2 Y-B Phase to phase fault with delayed clearance

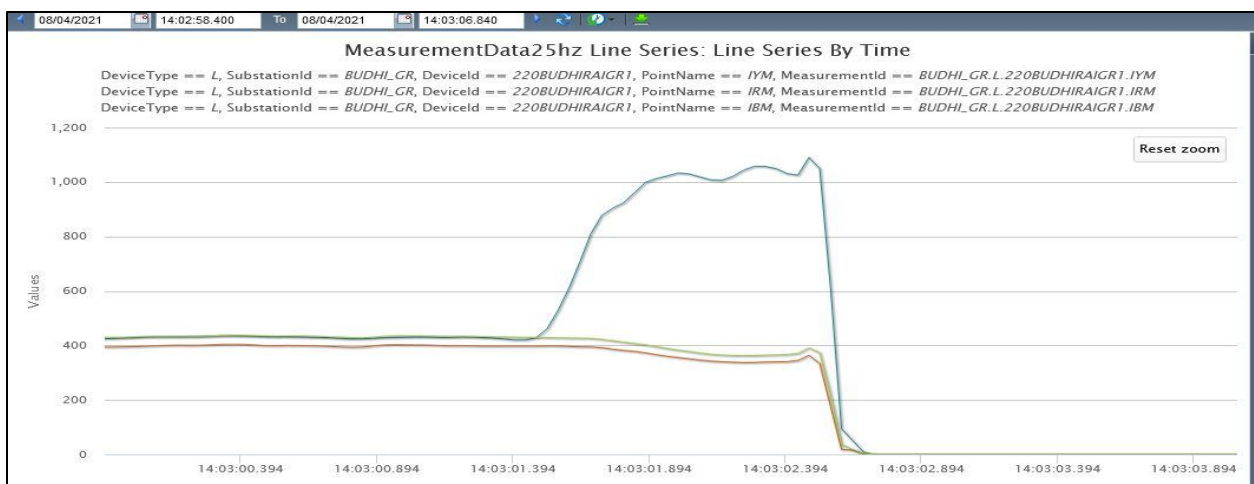
Figure 8: 220 kV Budhipadar-Raigarh Current indicating slowly developing B phase to earth fault.

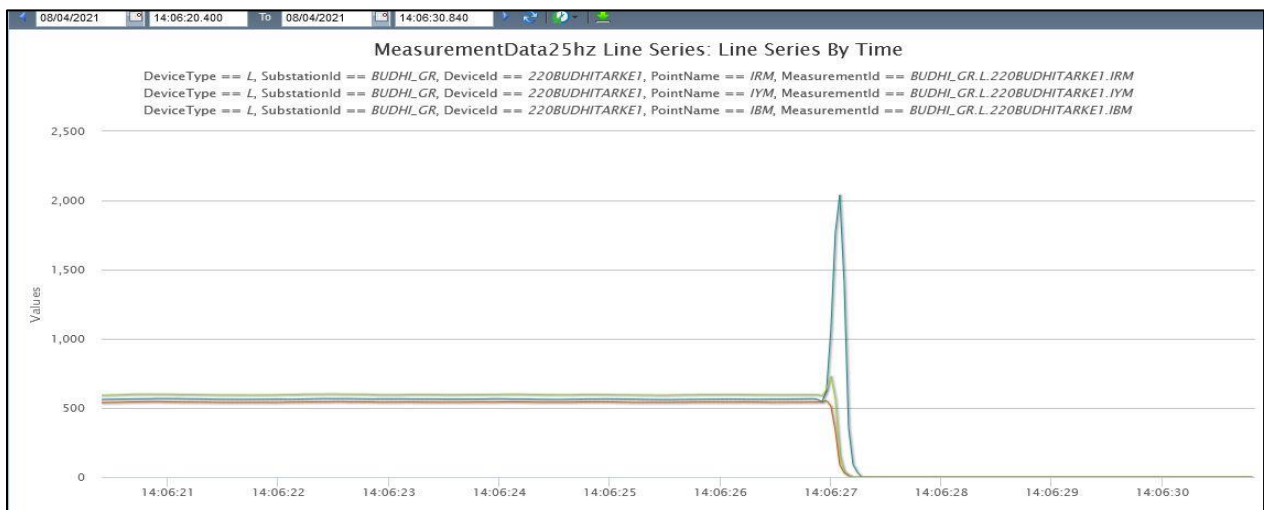
Figure 10: 220 kV Budhipadar-Tarkera-1 current indicating R phase to E/F.

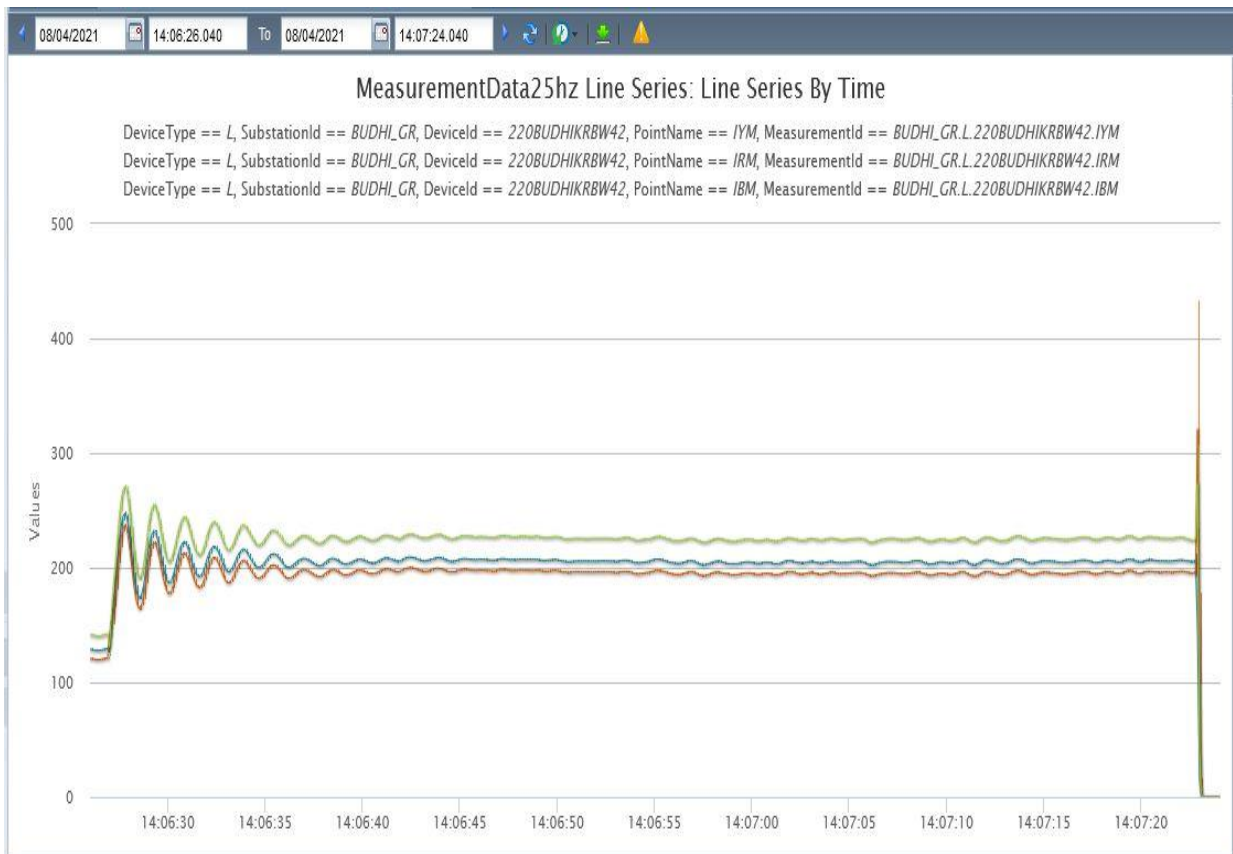
Figure 13: 220 kV Budhipadar-Korba East 2 Line current indicating R phase fault and its tripping on bus bar protection for 220 kV Bus 1 on which it was connected.
