Minutes
of
104th PCC Meeting

EASTERN REGIONAL POWER COMMITTEE

MINUTES OF 104TH PROTECTION COORDINATION SUB-COMMITTEE MEETING HELD ON 13.07.2021 AT 10:30 HOURS

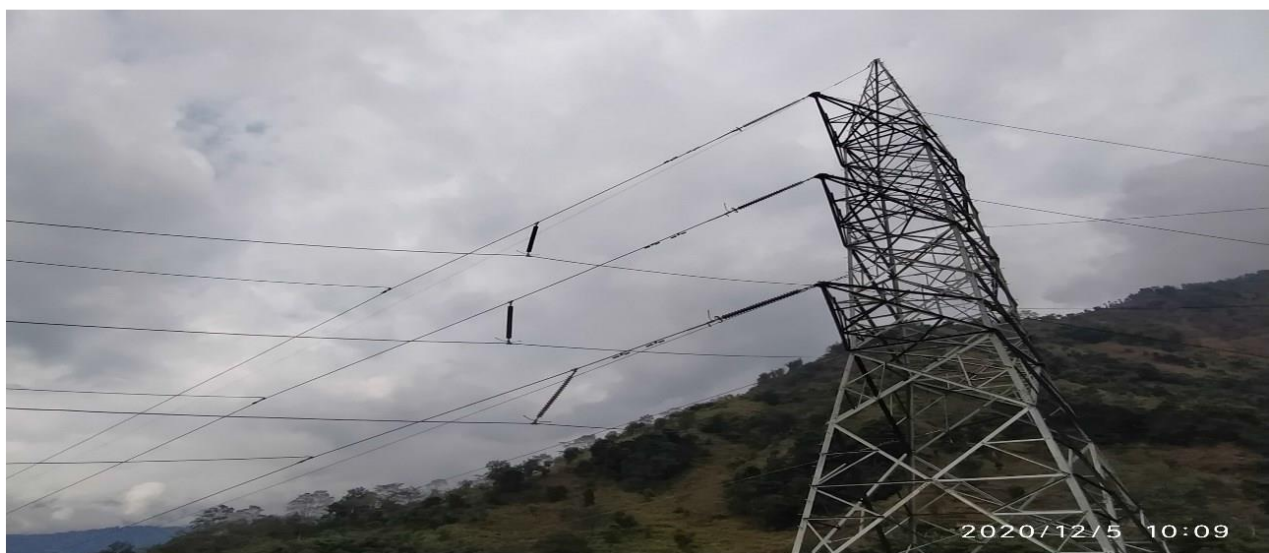
- *The fault occurred near LILO arrangement where Y-Phase conductor of both 220 kV Tashiding – Rangpo and 220 kV Tashiding-New Melli were detached from the tower and fell on the B phase of 220 kV Tashiding - Rangpo line creating Y-B phase to phase fault .*
- *As both the lines turned almost 90 degree at LiLO location, 220 kV Tashiding - Rangpo line crosses the 220 kV Tashiding-New Melli line. The same may be seen in the picture given below:*

- Moreover ,220 kV Tashiding - Rangpo line phases were supported with the help of composite insulators from the respective phases of 220 kV Tashiding - New Melli line to maintain the safe clearances.
- The Y-Ph composite insulator string of Tashiding-New Melli line was broken into two parts from near to lower end of the string.
- While detaching of the Y-Ph of Tashiding - New Melli line from the tower arm, it also pulled the Y-Ph of Tashiding -Rangpo line and consequent to this Y-Ph conductors of both lines detached from the Tashiding tower arm and fell over the B-Ph of Tashiding -Rangpo line resulting into Y-B phase fault.

Regarding restoration of the lines, they informed that at present lines were restored with temporary arrangement. The permanent restoration of the lines would be done within a week.

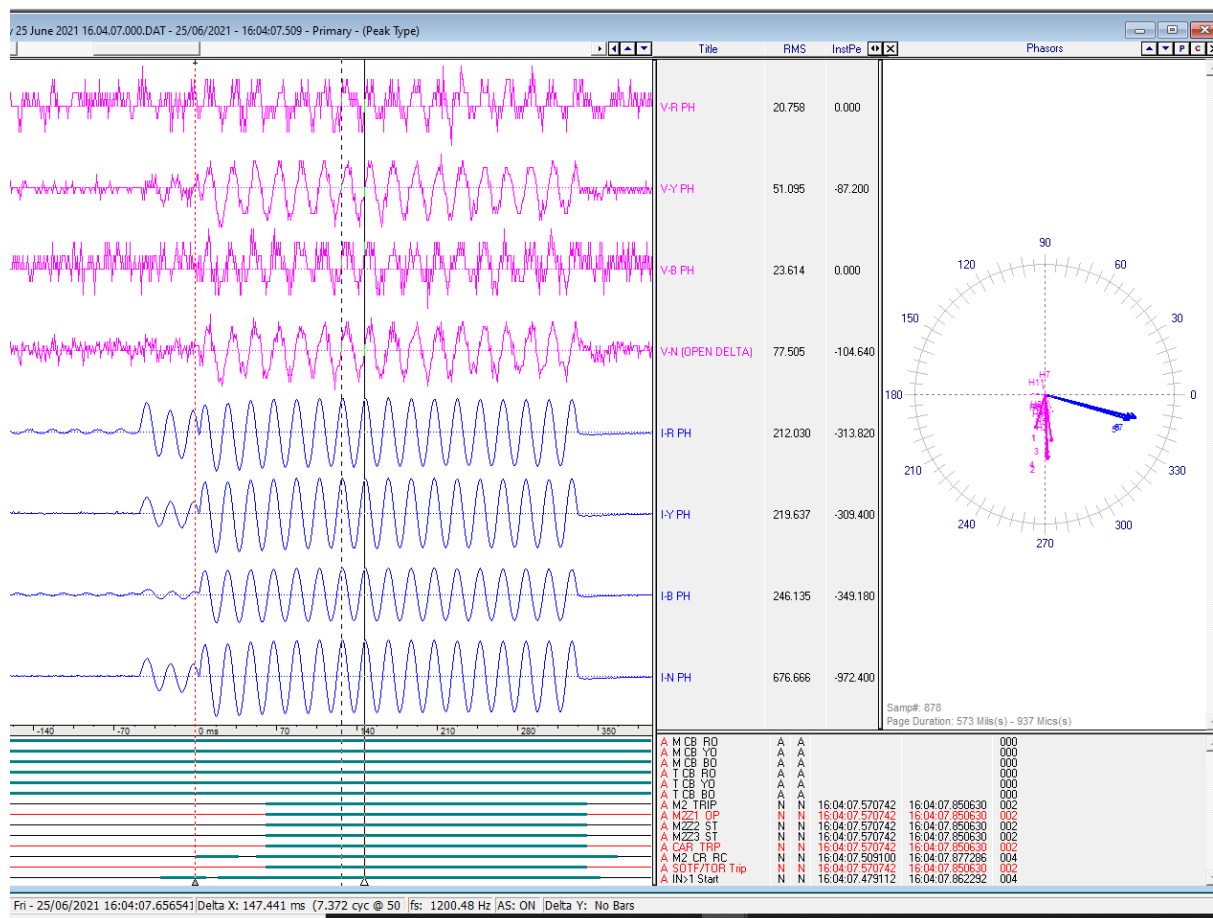
DR record of Sonenagar Ckt-1 at the time of event

As observed from the DR, there was a R-N fault in Sonenagar Ckt-2 at 16:04:07 hrs in Z-1 with fault current as 1.9 KA. R-pole of this line opened and this was ready for A/R operation.

Before this fault in Ckt-2, in Sonenagar Ckt-1 there was almost zero current in each R,Y & B phase and neutral of CT (primary values) during S/D condition. During this fault, the circulating current values in Ckt-1 increased up to 200-245A in each phase and 670 A in neutral. At this time the SOTF protection of Main-2 Relay operated. This in turn initiated the LBB protection and as the current was already more than the LBB pick up value the LBB operated after 200 msec. The DR records are as follows:

Corrective Action: While going through the tripping analysis, it seems that the protection including LBB has operated as per the scheme. If Busbar had not tripped then A/R of Sonenagar Ckt-2 would have also been successful and there might have not been any tripping.

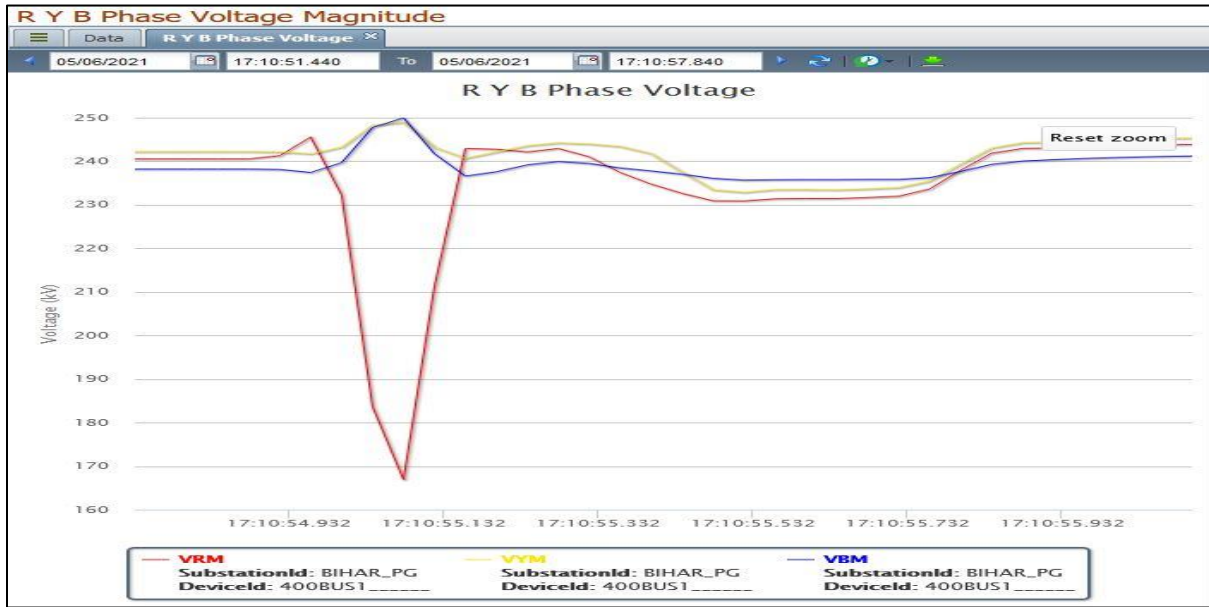
Figure 3: Three phase Bus voltage captured by Biharshariff PG PMU shows existence of R phase to earth fault then a R-Y phase.

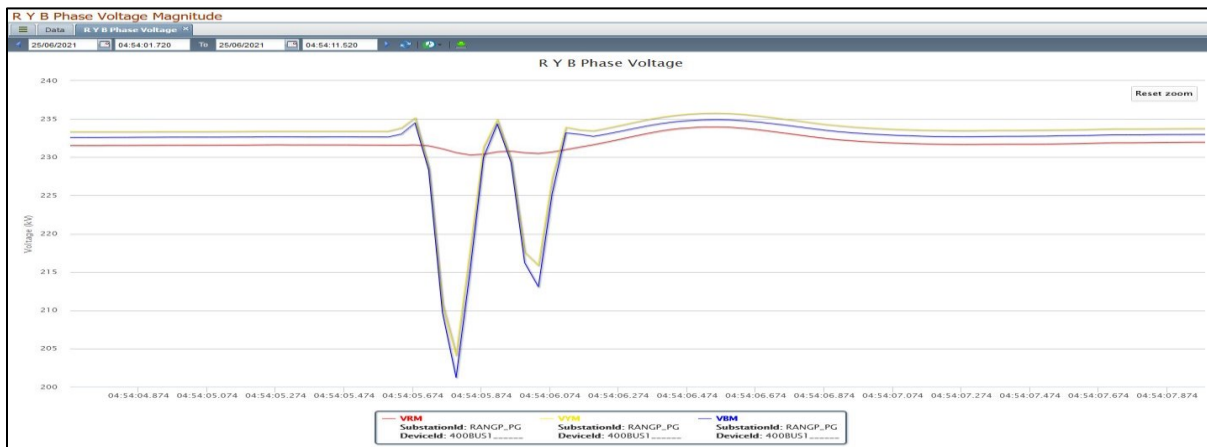
Figure 3: Three phase voltage captured by Rangpo PMU shows existence of Y-B fault at 04:54 hrs. Around 30 kV dip has been observed in Y phase and 35 kV dip is observed in B phase voltage at Rangpo PMU. Two consecutive dips in Y-B phase are captured. Fault clearing time was around 240 ms.

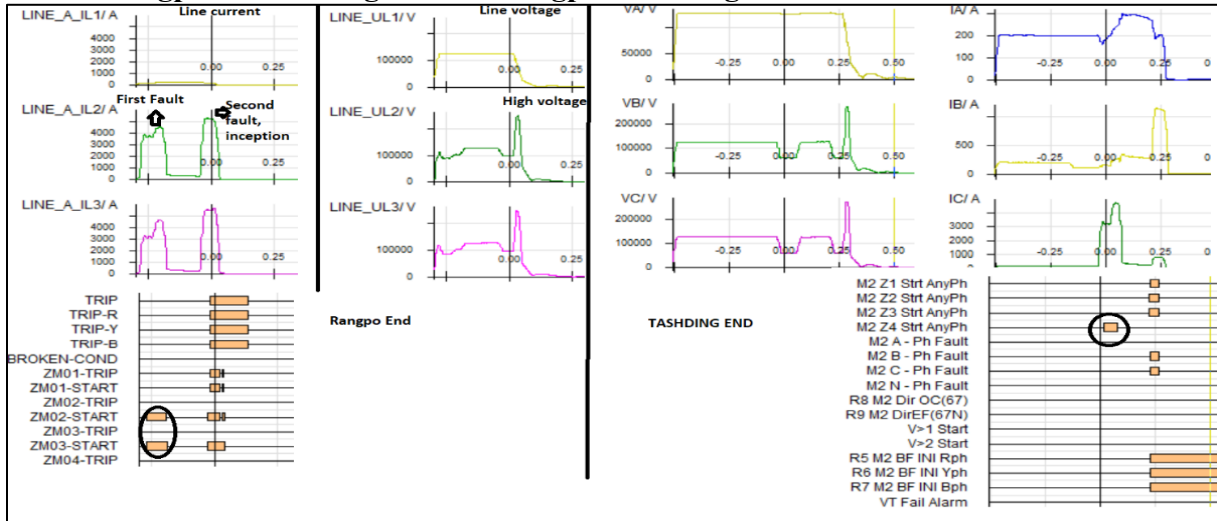
DR of Rangpo & Tashiding end for Rangpo-Tashiding Line:

- Fault was of evolving nature B phase converting to Y-B phase and at the second instance of fault when Rangpo Tashding tripped ,very high voltage in Y&B phase was observed indicating fault due to suspected insulator back-flashover.

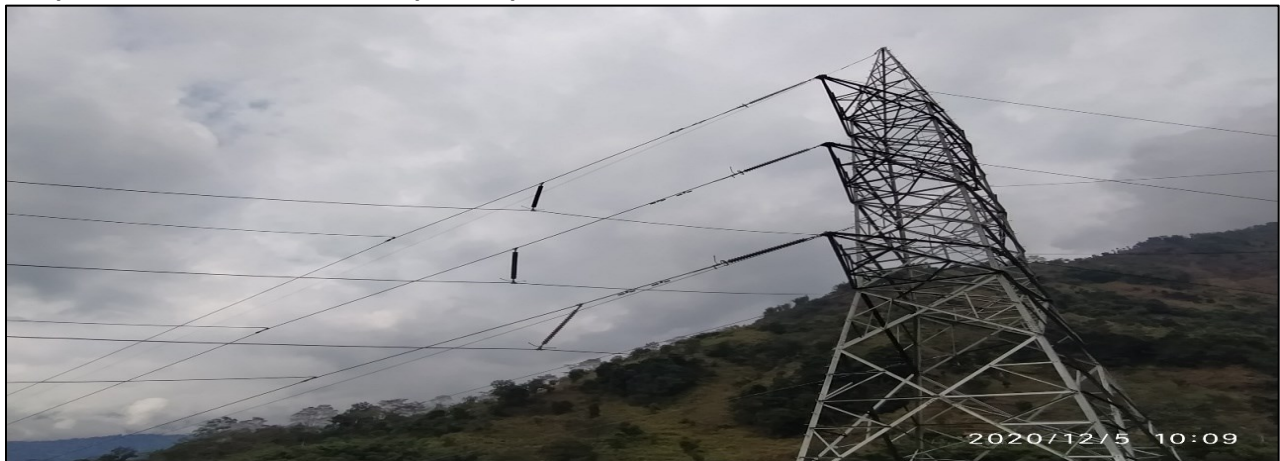
Interim arrangement through which THEP-Rangpo line phases were supported with the help of composite insulators from the respective phases of THEP-New Melli line

At location 22 the 220 kV Tashiding-Rangpo line crossed the 220 kV Tashiding-Melli as show above in Figure. However, as the conductor configuration is Vertical and Rangpo line and Melli line are crossing at an angle. Following factors may be critical therefore:

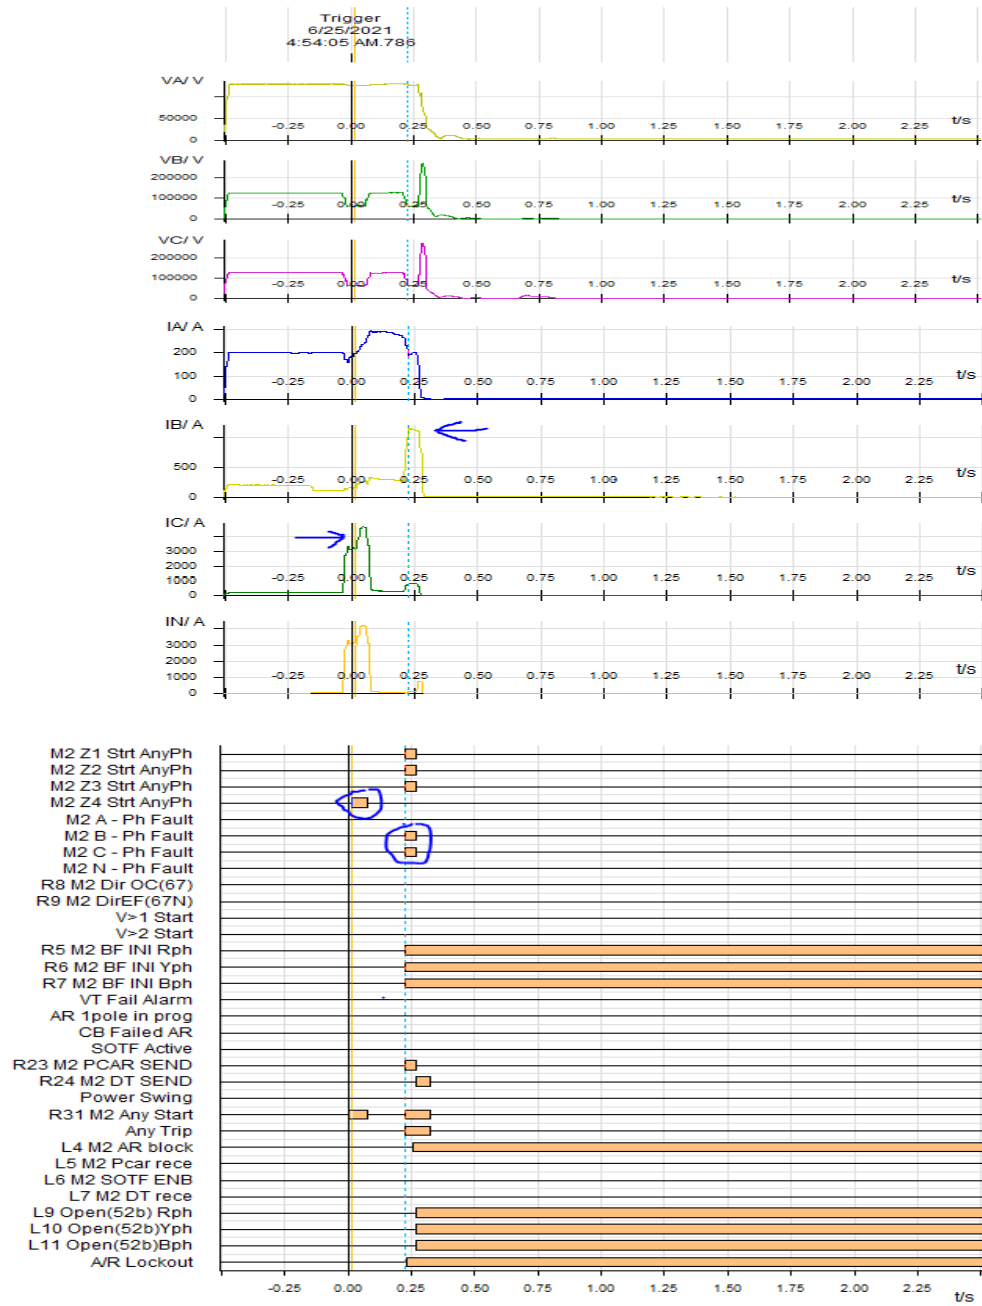
Annexure 2: DR recorded at Tashiding end for 220 kV Tashiding Rangpo S/C.

- Initially Fault sensed in Z-4 and after 250 ms. fault appeared in Y phase.

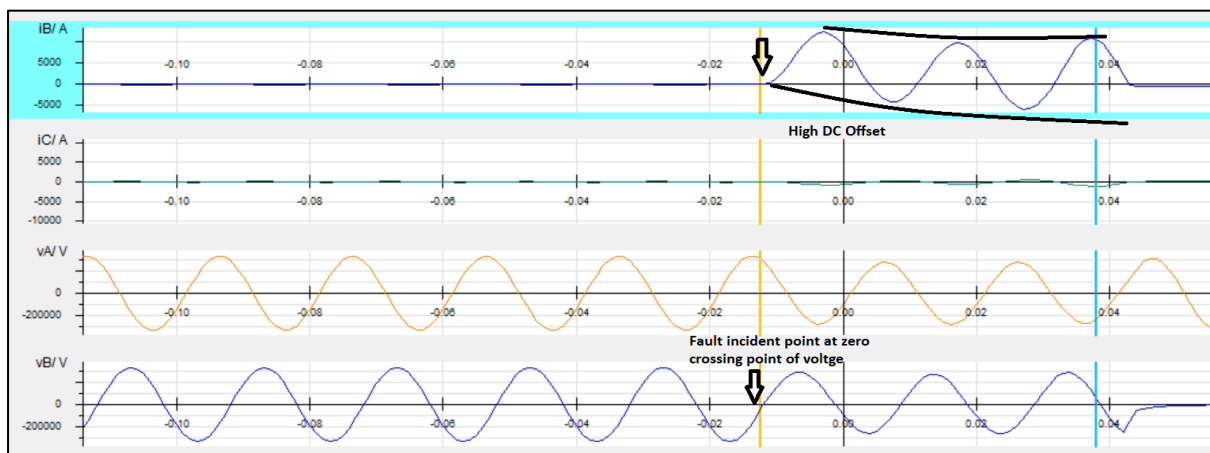
DR of Bokaro End for 04/06/2021:As can be seen lightning event can hit at any moment of voltage point and here it is observed that at zero crossing it hit the Y phase and due to which high DC offset in current observed also.

Hence Tower footing resistance, Sheilding/ground wire near the location may be checked to ensure.

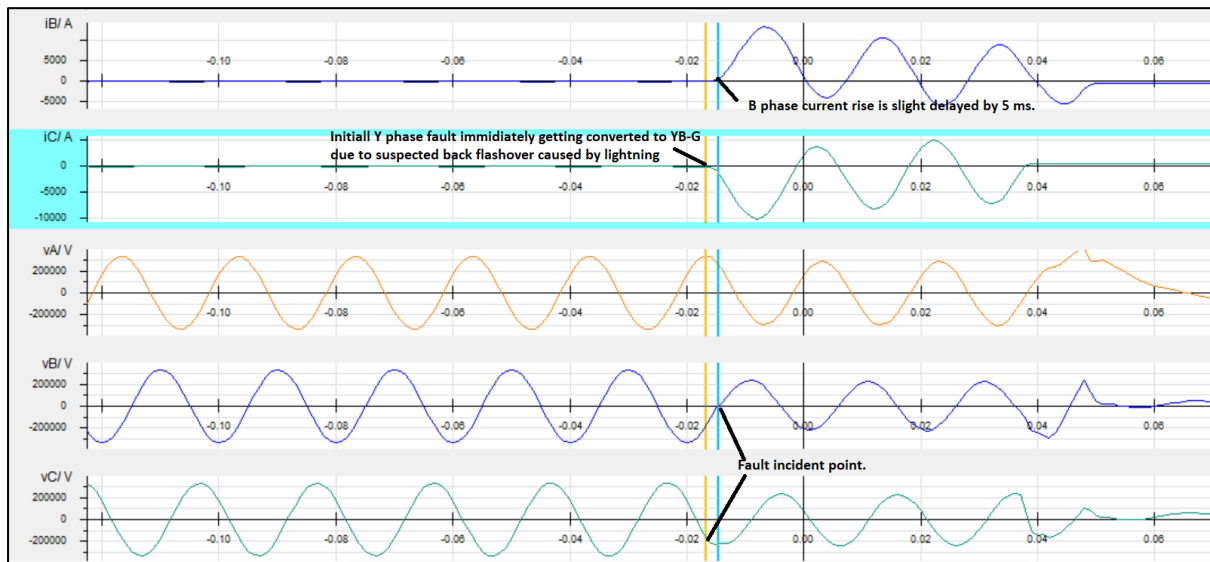
DR of Koderma End for 13/06/2021 For Ckt-2:

- In this case also Y-B phase fault observed, fault incident point was as shown in figure which is random point each time due to lightning hit.
- Also initially B phase fault observed then within 10 ms got converted to Y-B-G fault due to suspected Back flashover induced by lightning hit on B phase .

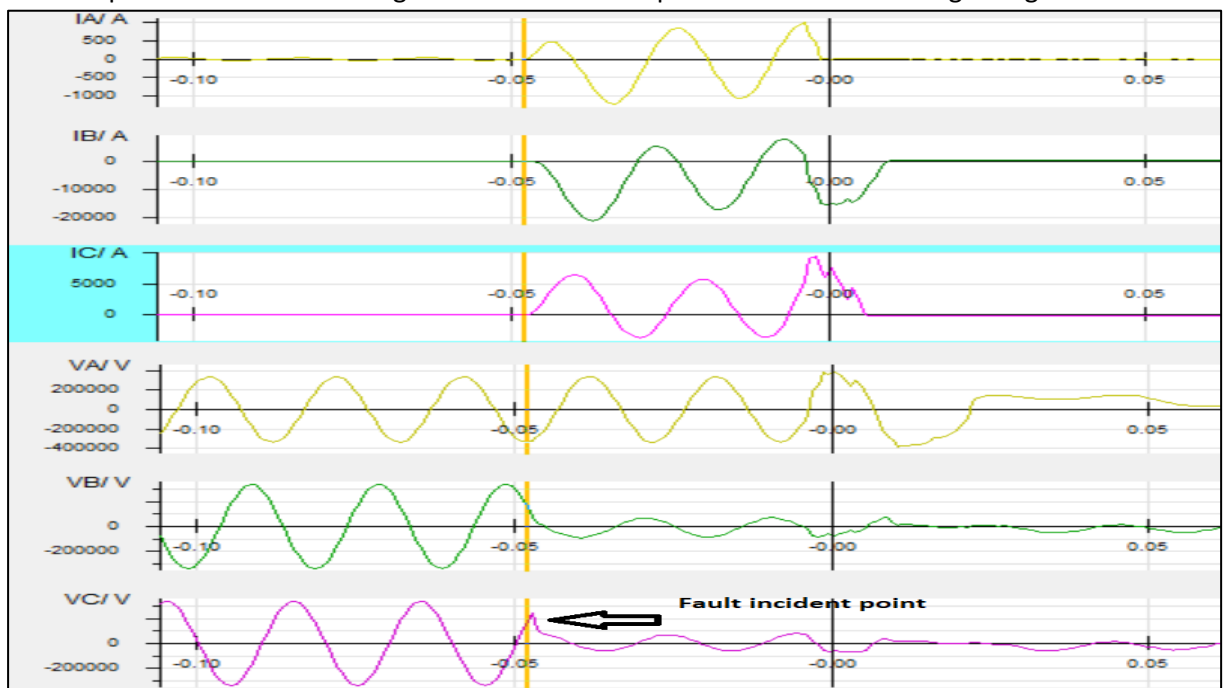
DR of Bokaro End for 13/06/2021 For Ckt-1: In this case also Y-B phase fault observed, fault incident point was as shown in figure which is random point each time due to lightning hit.

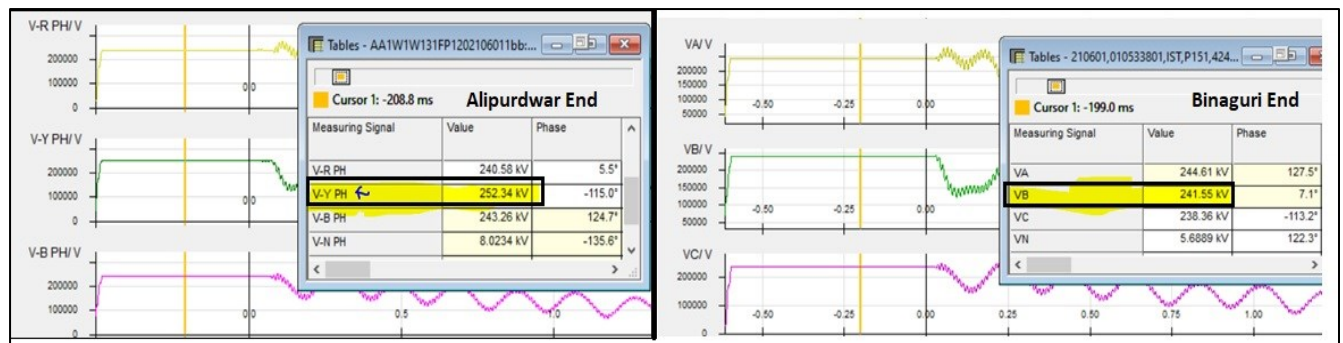
For each tripping It is observed that Alipurdwar end Y phase voltage is 17 Kv higher than rest two phases ,while at Binaguri end no such thing observed .Which indicates that there is no such actual voltage rise existing in line due to mutual induction or transposition .DR Comparison shown below.

Hence there may be some issue with CVT and earthing at Alipurdwar end which needs to be checked and rectified.

Powergrid informed that the overvoltage issue was due to damage in the CRP cable in switchyard. The cable has been changed and presently there is no overvoltage issue at Alipurduar end.
