# Agenda for 105<sup>th</sup> PCC Meeting

**Date:23.08.2021**  
**Eastern Regional Power Committee**  
**14, Golf Club Road, Tollygunge**  
**Kolkata: 700 033**

### AGENDA FOR 105<sup>TH</sup> PROTECTION COORDINATION SUB-COMMITTEE MEETING TO BE HELD ON 23.08.2021 AT 10:30 HOURS

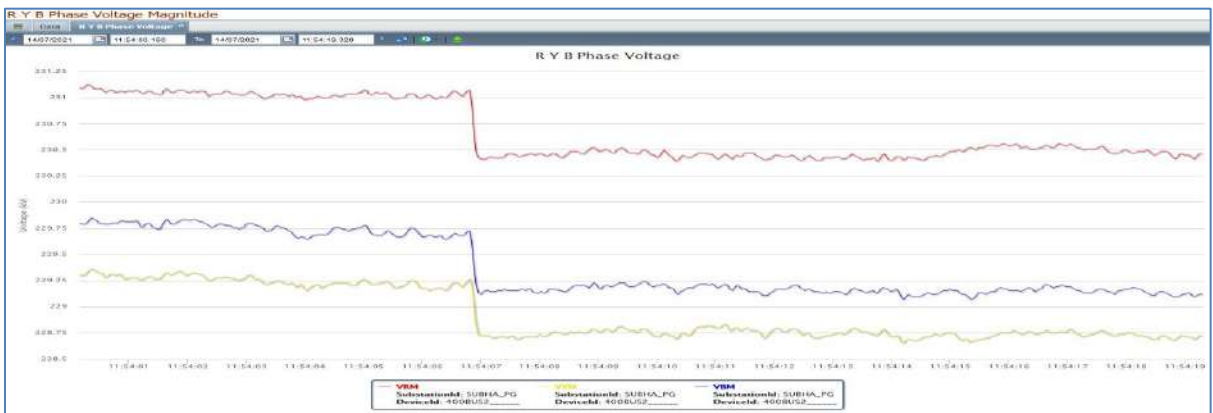
Figure 3: PMU captured at Subhashgram shows no fault and 1kv dip in voltage is observed.

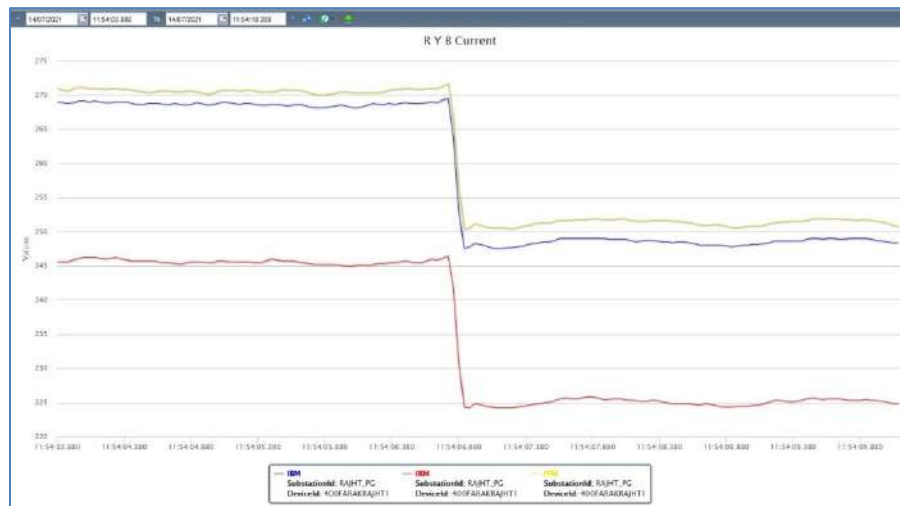
Figure 4: PMU captured at Rajarhat shows no fault and 20 kV dip in voltage is observed in all phases.

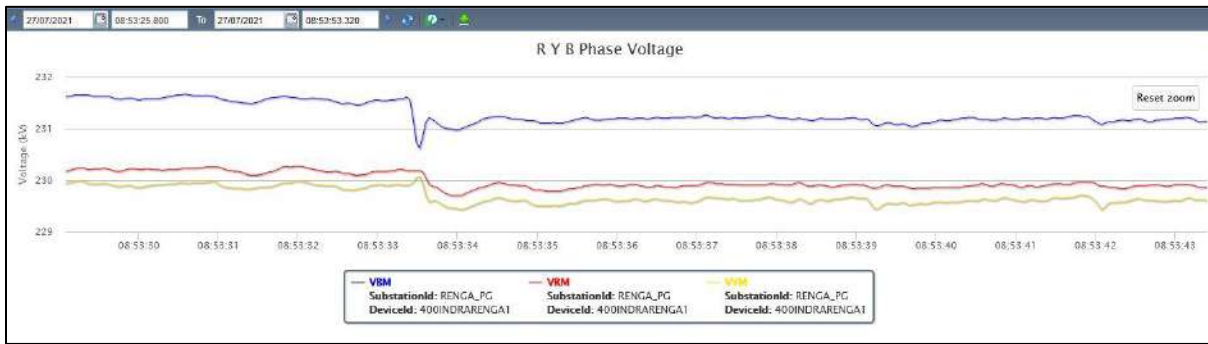
Figure 3: PMU captured at Rengali shows B-Earth fault and slight dip in voltage

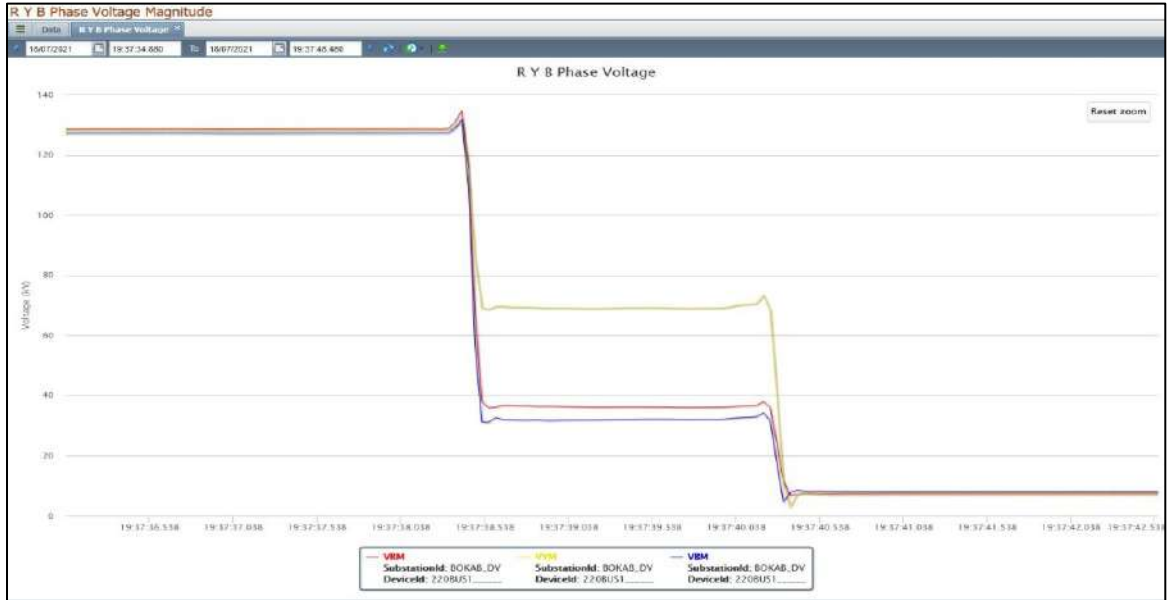
Figure 3: PMU captured at Bokaro shows fault was cleared in around 1.5 seconds after first dip

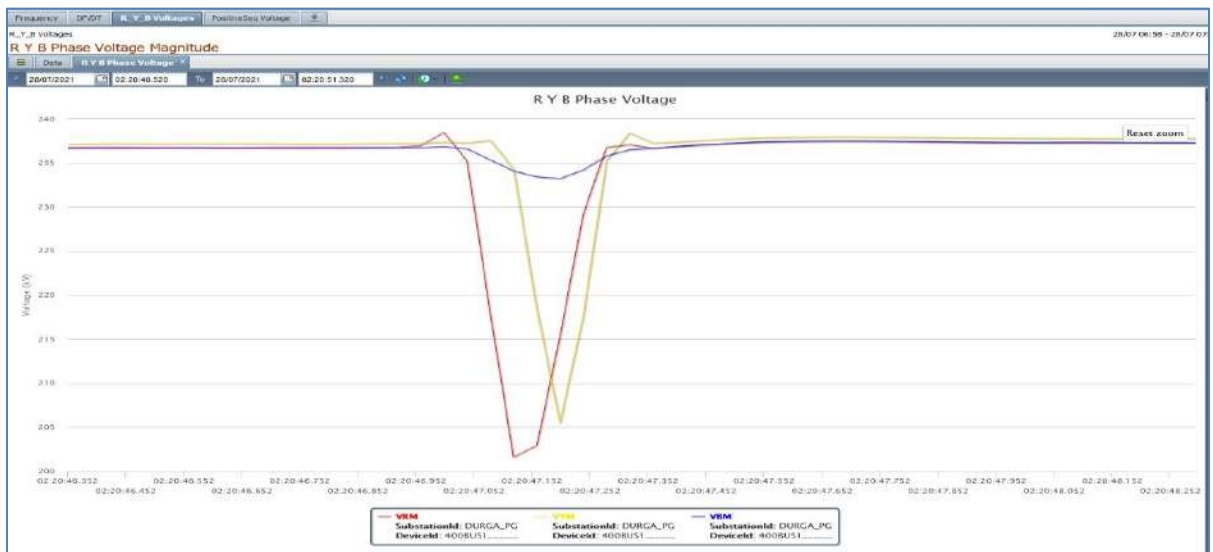
Figure 3: PMU captured at Durgapur shows R-Y-Earth fault cleared in 100ms seconds and dip of around 35 kV.

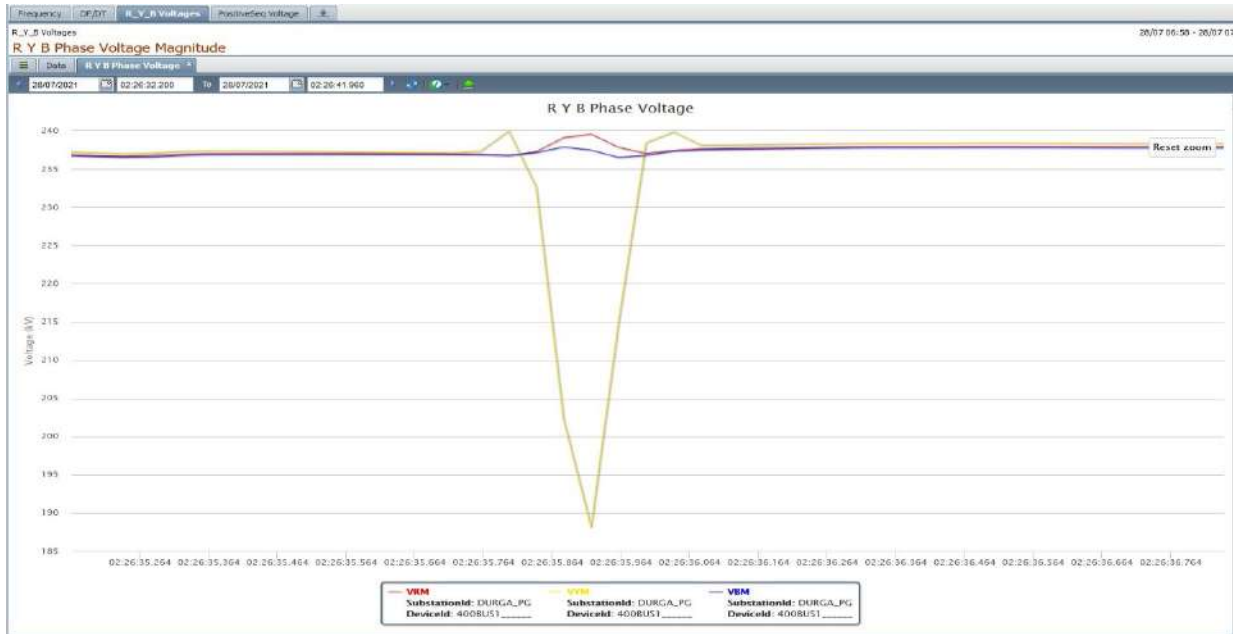
**Figure 4: PMU captured at Durgapur shows Y-Earth fault cleared in 100ms seconds and dip of around 48 kV.**

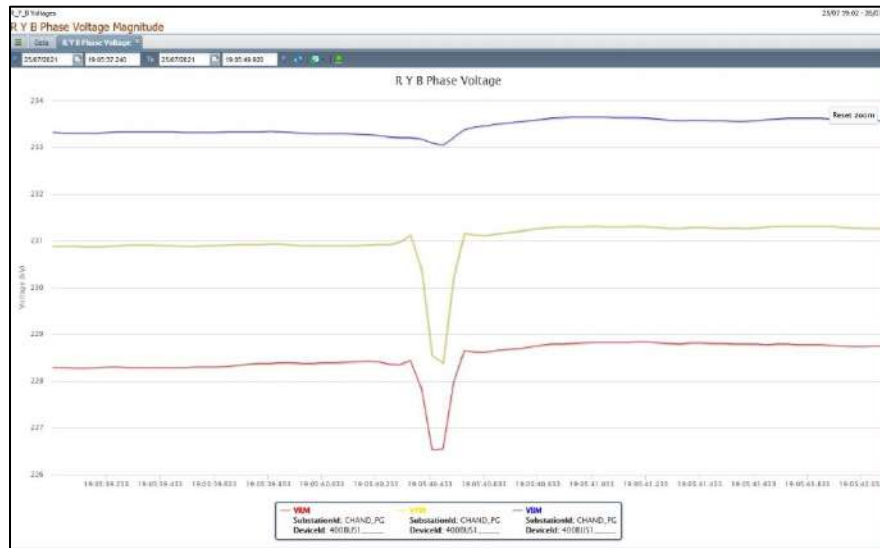
Figure 3: PMU captured at Chandauti shows 3kV dip in R and Y phases indicating fault in R-Y phases.

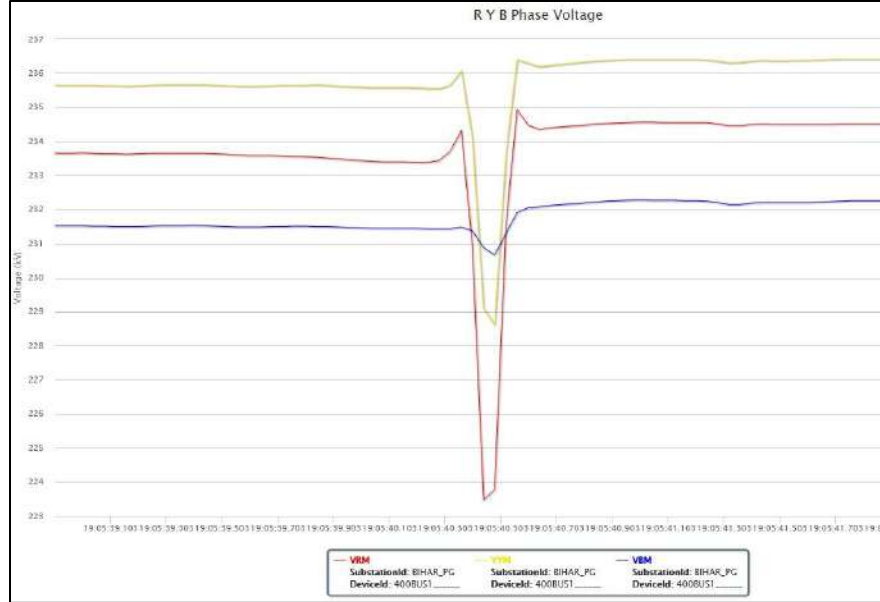
Figure 4: PMU captured at BiharShariff shows 20 kV dip in R and Y phases indicating fault in R-Y phases

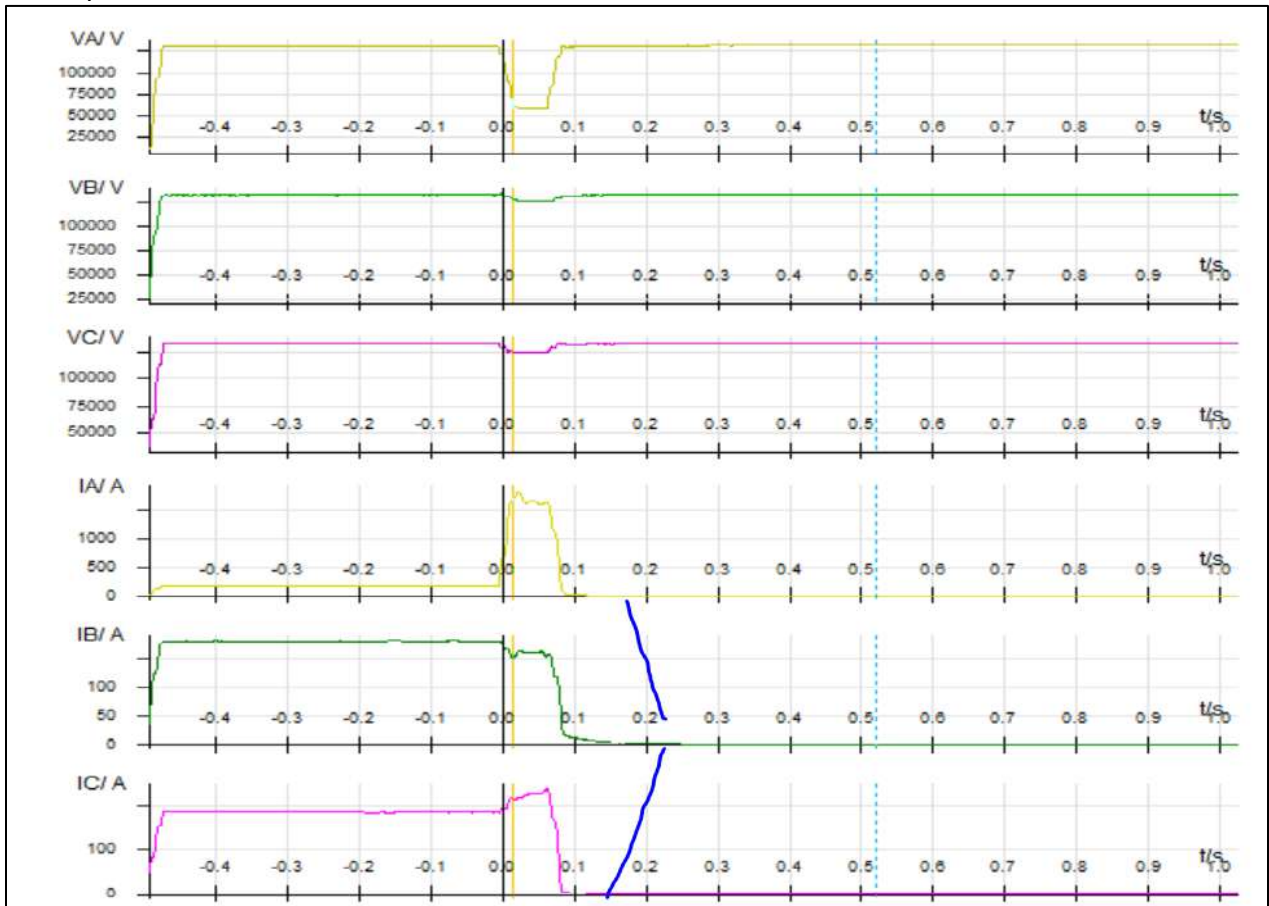
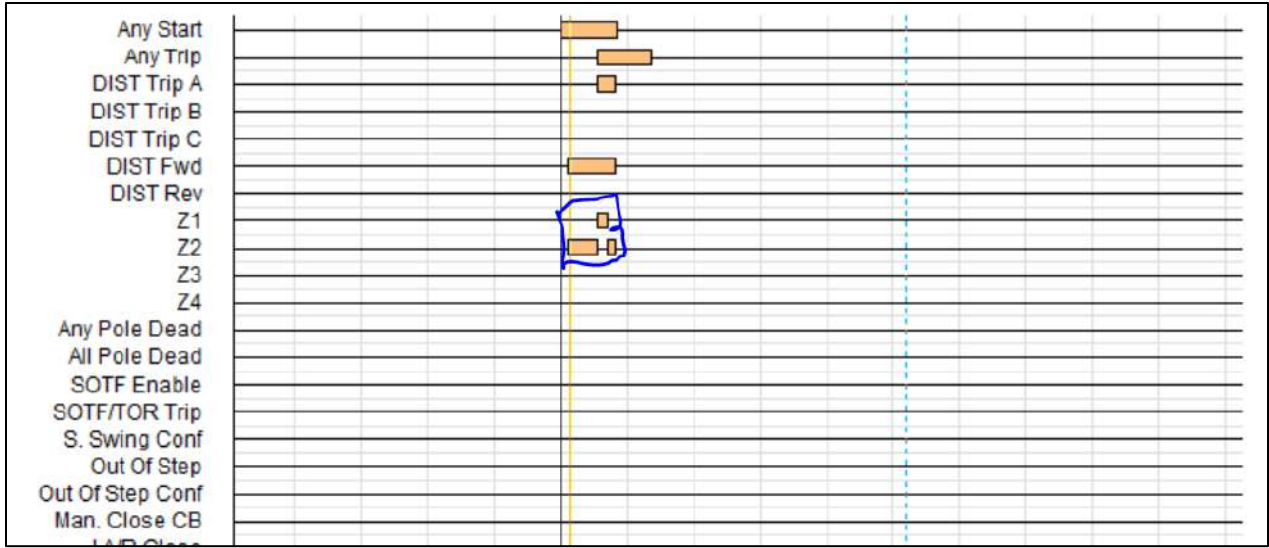
**DR recorded at MUSAHARI end for Darbhanga-Musahari-II:**

Three phase Current at Musahari end became zero

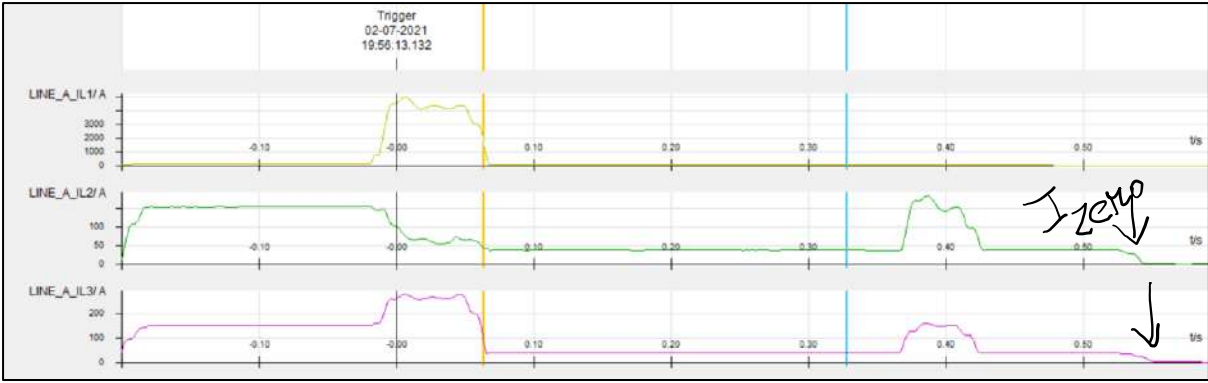
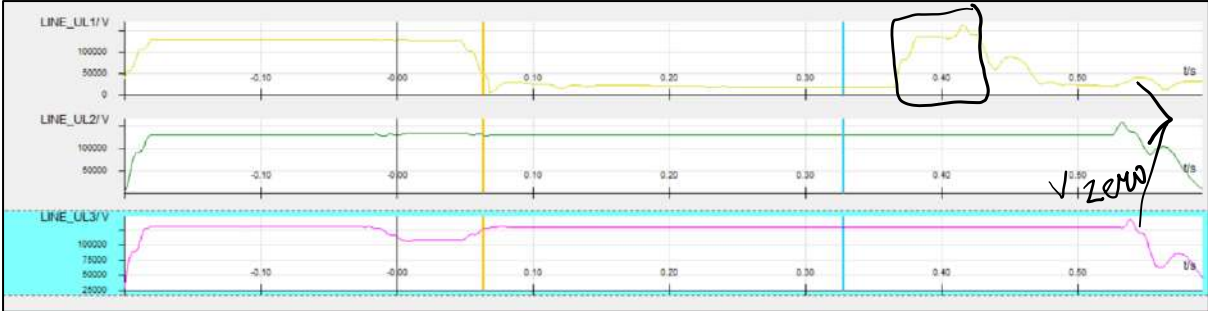
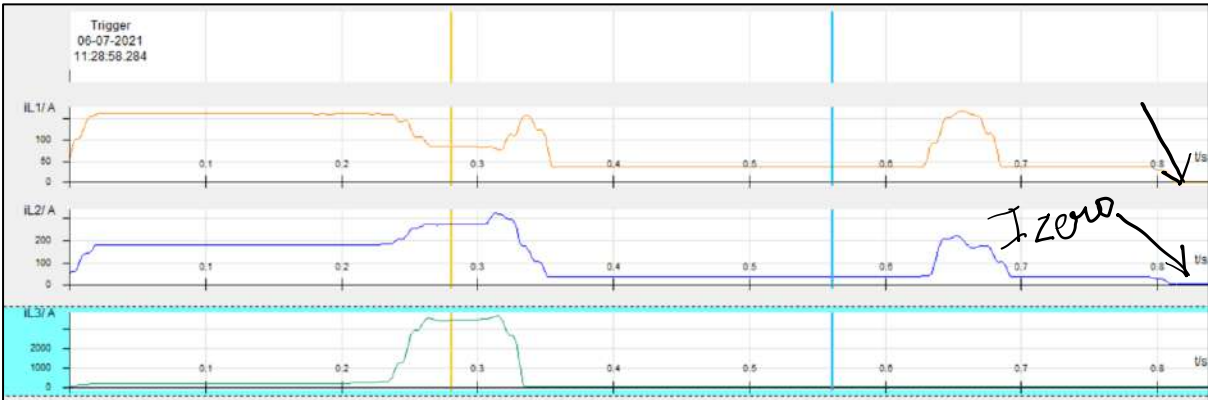
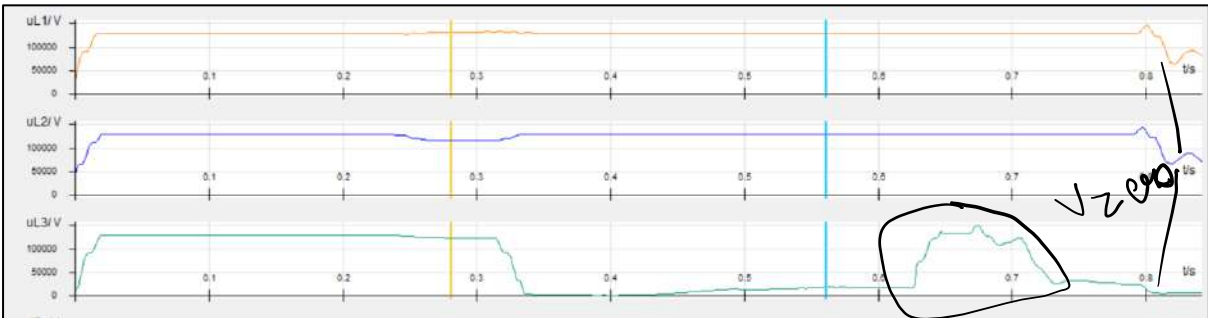
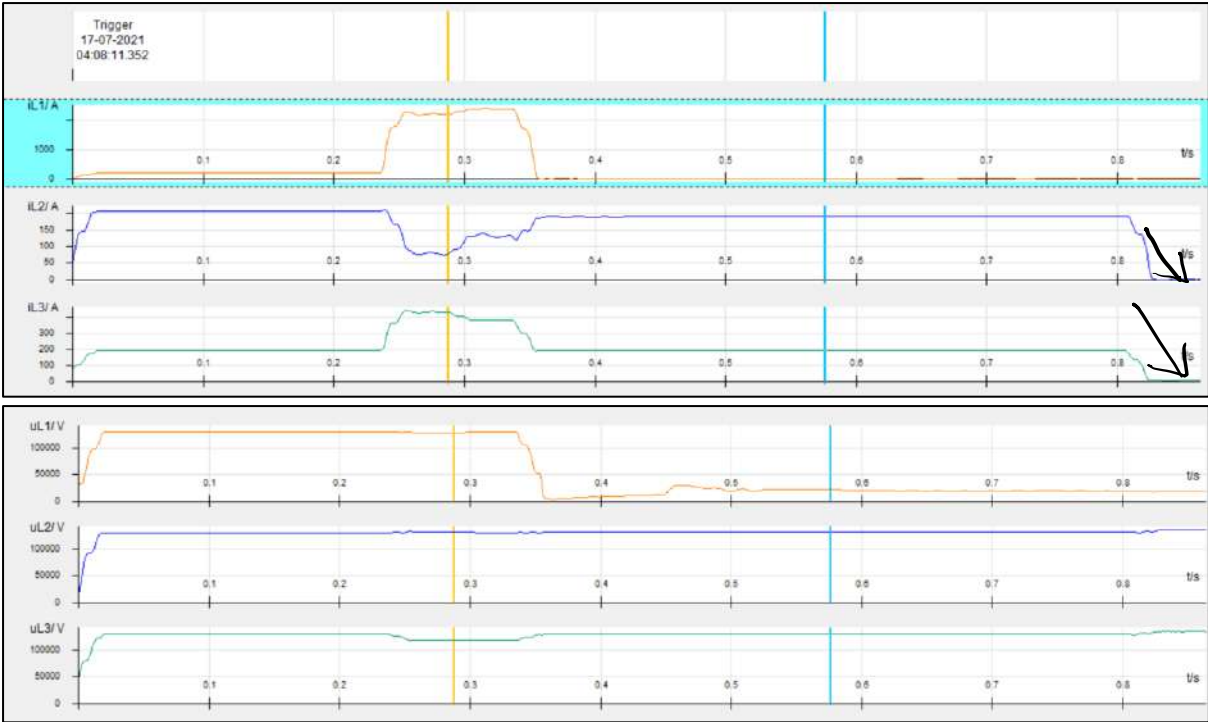
Line current of rest 2 phases are becoming zero which can be observed from below attached DRs for all cases.

**Issue of Auto reclose** can also be seen in below attached DR that ,A/r is not occurring as rest 2 phases are being opened, this can be properly analysed for root cause identification and mitigation.

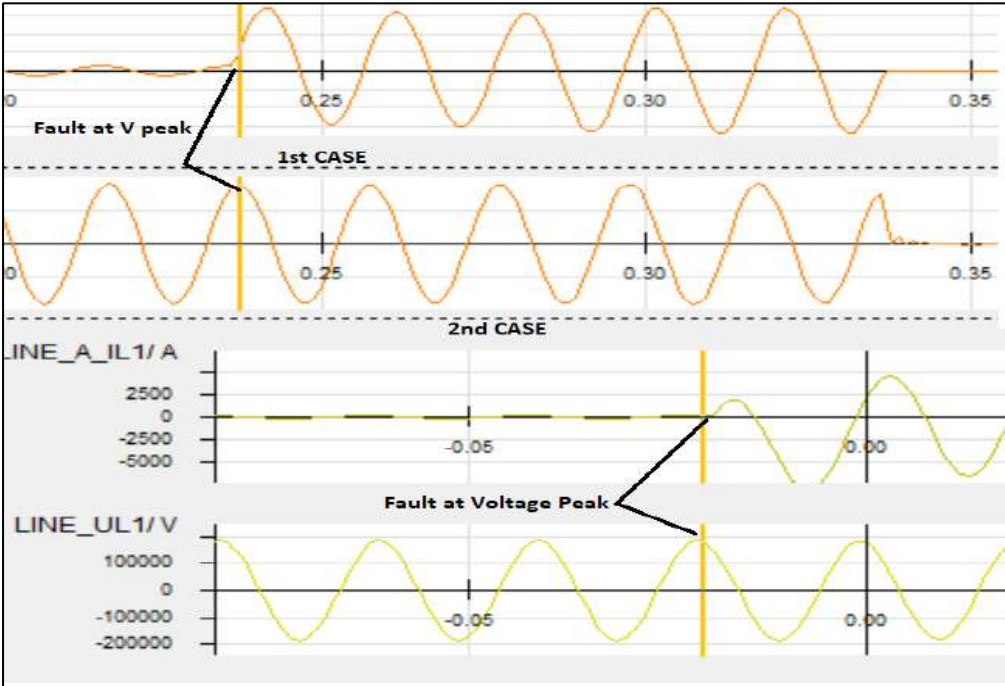
**Fault due to Arc over / Tree Fault:**

From DR signature analysis it is observed that in all cases, fault seems to be due to vegetation issue as all faults are occurring at voltage peak as arc over is occurring at voltage peak due to high electrical stress. Fault currents are symmetrical and have no Dc offset due to vegetation fault occurring at peak and with increasing nature of current.

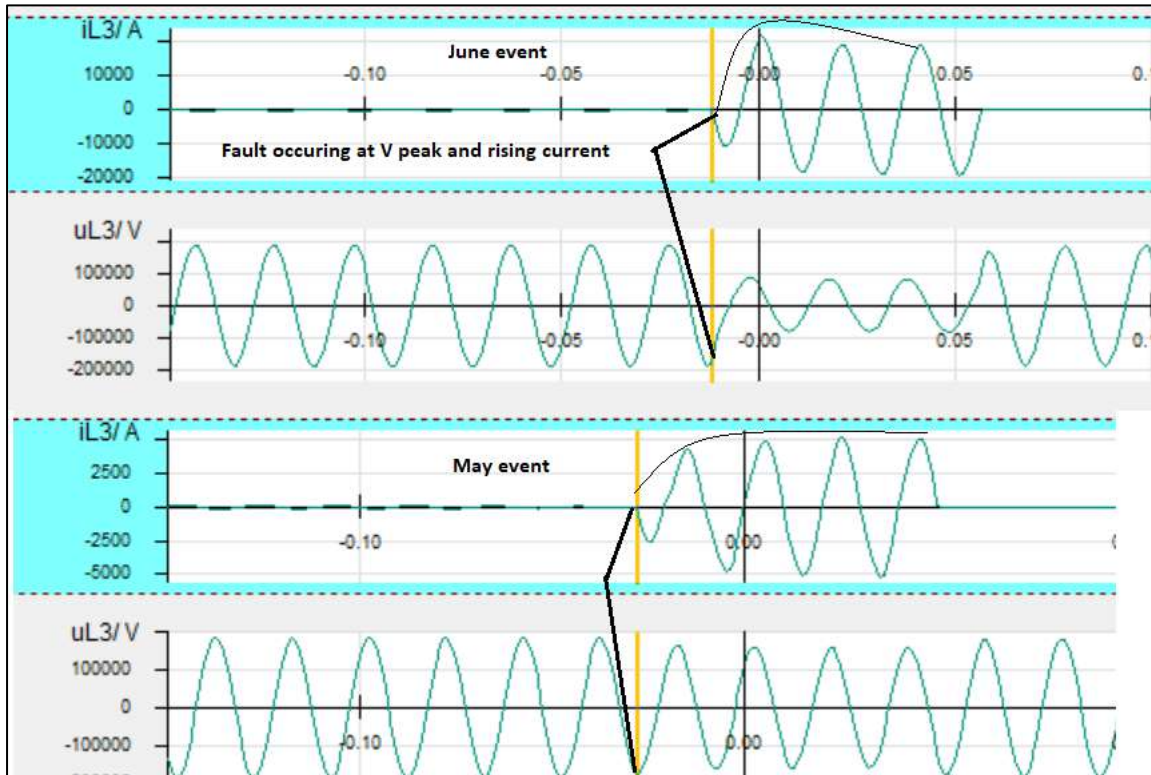
For Korba line DR shown for two event same thing observed for all cases.

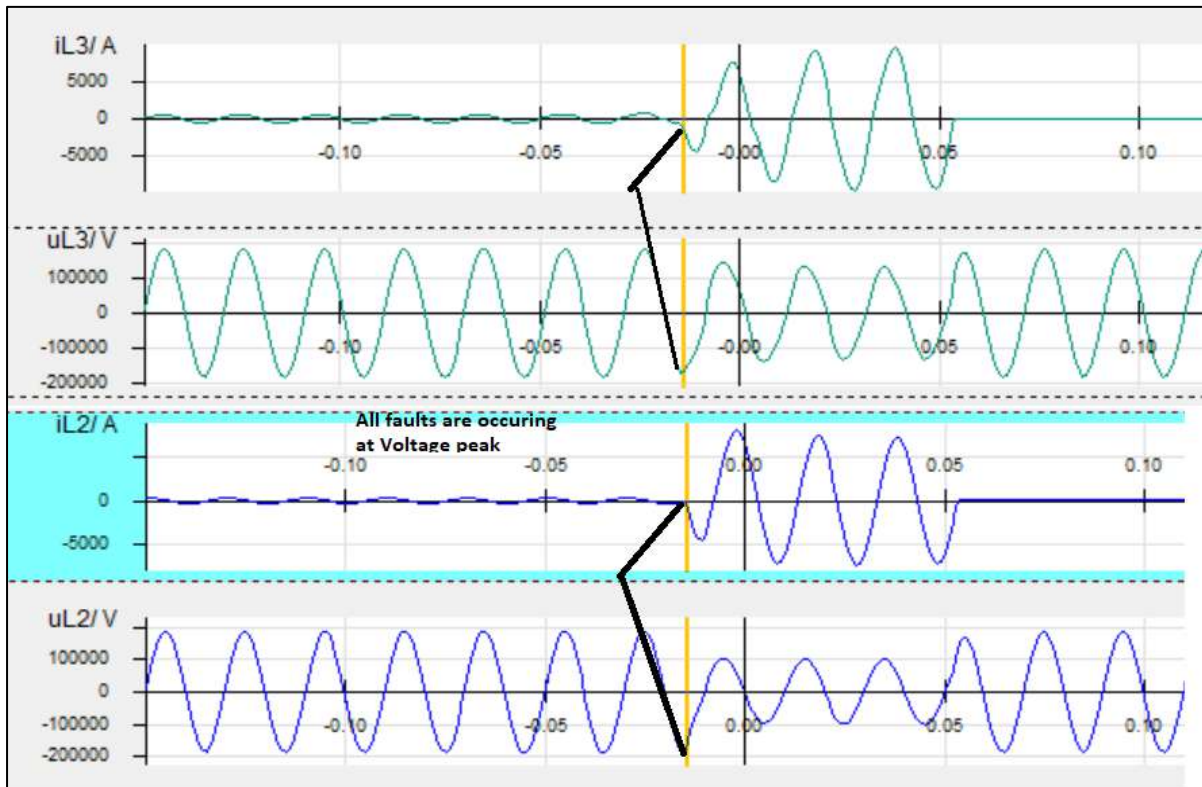
For Raigarh line DR shown for two event same thing observed for all cases.
