**107 वीं पीसीसी बैठक
का
कार्यवृत्त
Minutes
of
107th PCC Meeting**

Eastern Regional Power Committee

MINUTES OF 107th PROTECTION COORDINATION SUB-COMMITTEE MEETING HELD ON 22.10.2021 AT 10:30 HOURS

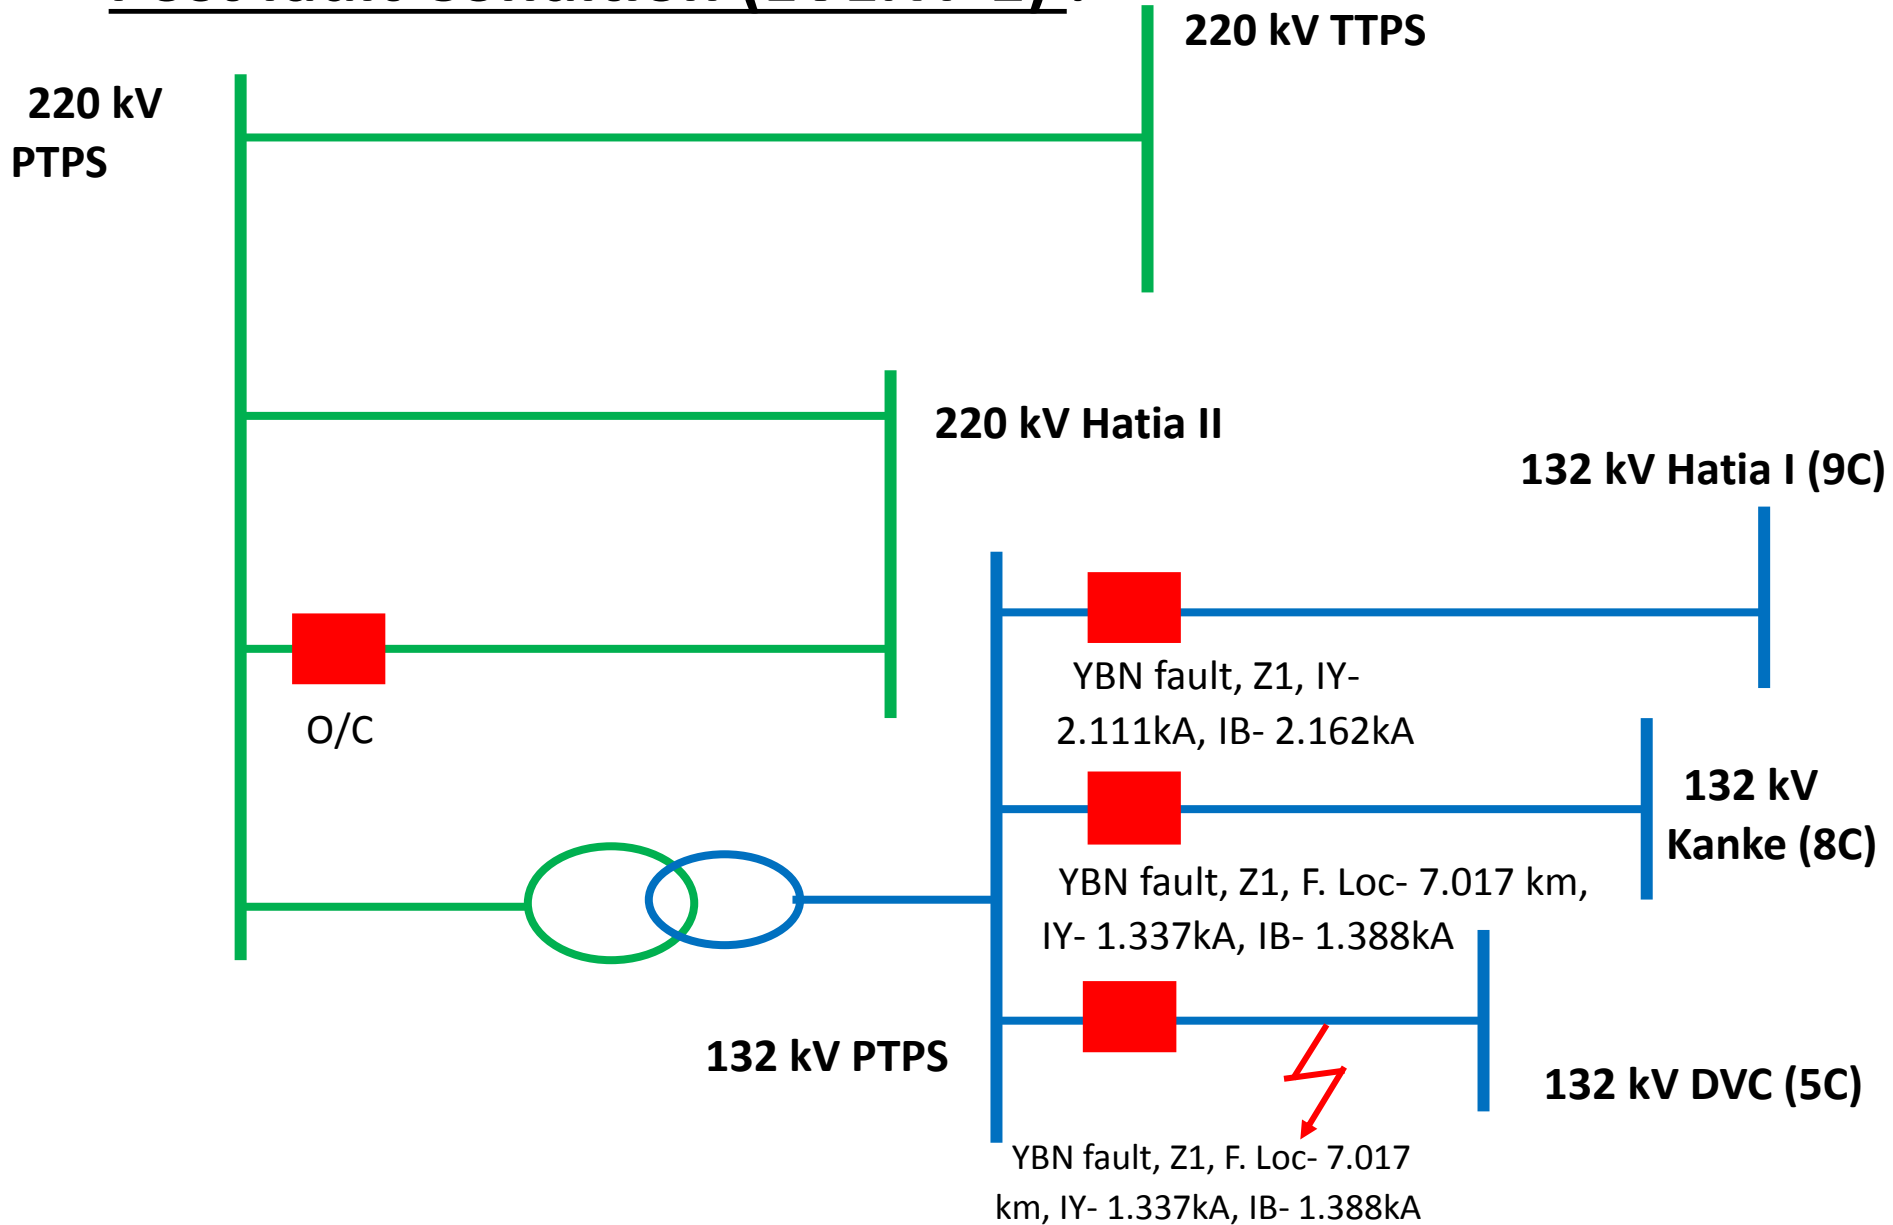
Y phase jumper snapped at tower no -1

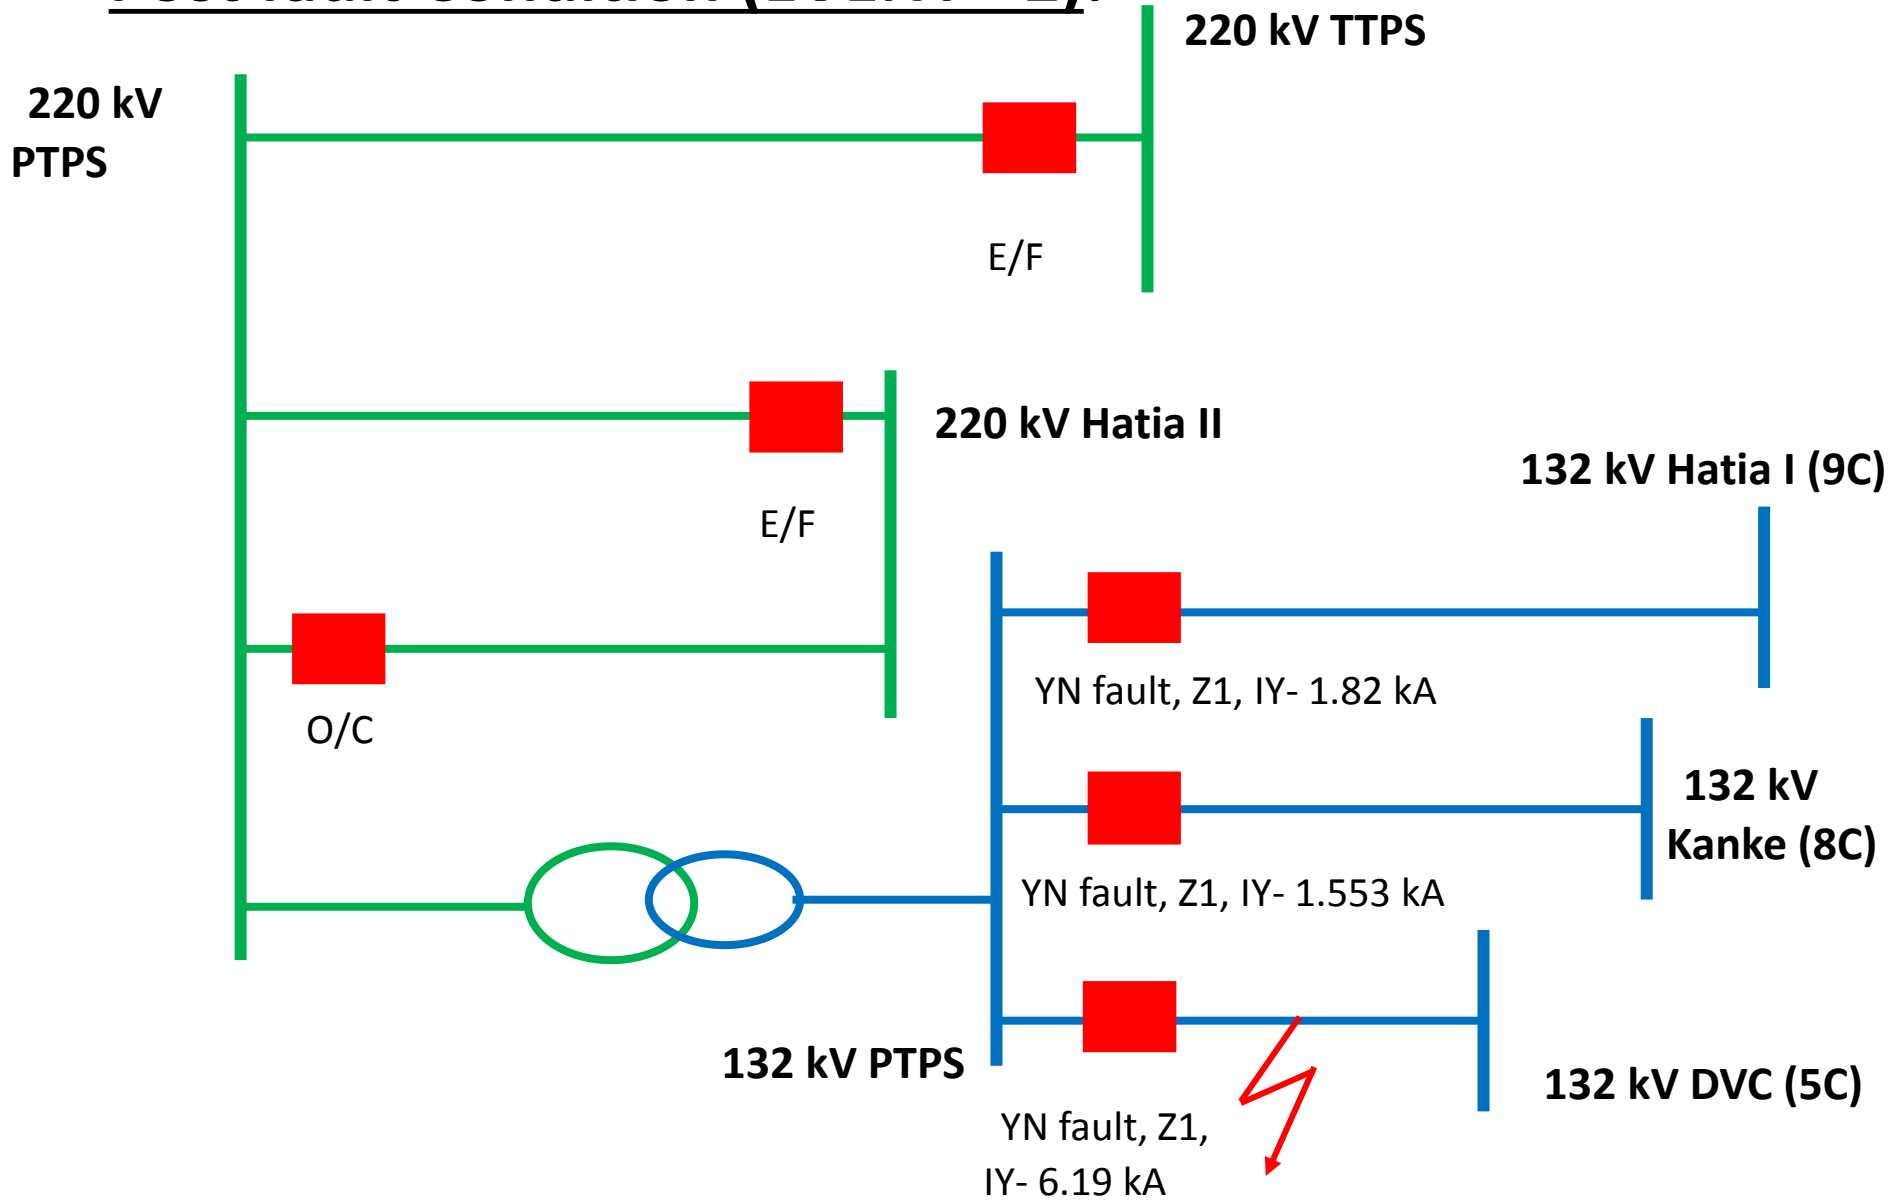
Y phase jumper snapped at tower no -1

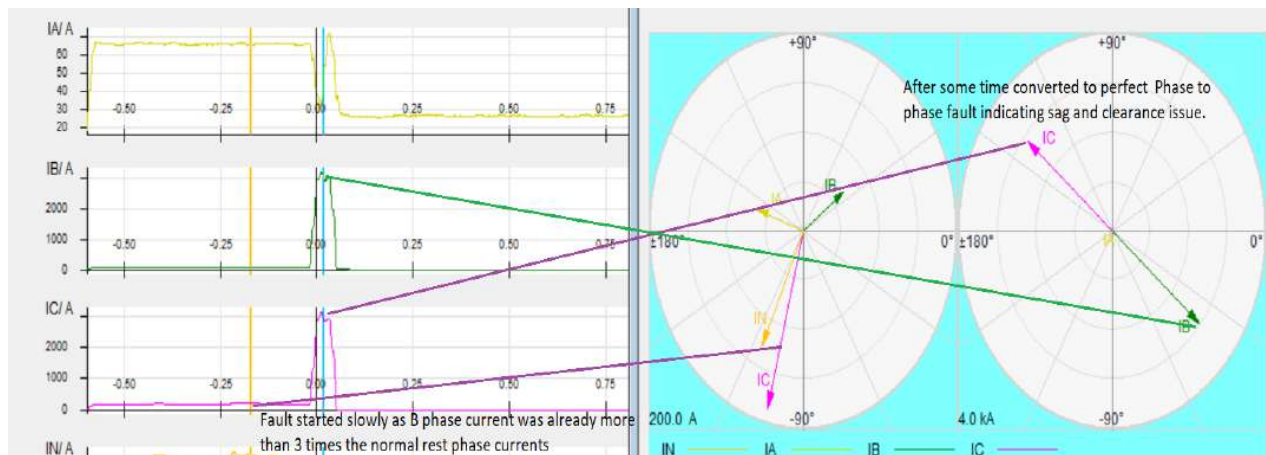
Same phenomenon as mentioned above is observed in almost all cases, which indicates that the fault is **occurring due to sag and clearance issues**, hence proper line patrolling and healthiness of line should be maintained, same kind of fault nature was also observed in this line few months ago which was resolved by, jumper tightening and tree pruning at some locations. This needs to be looked into again and taken care.

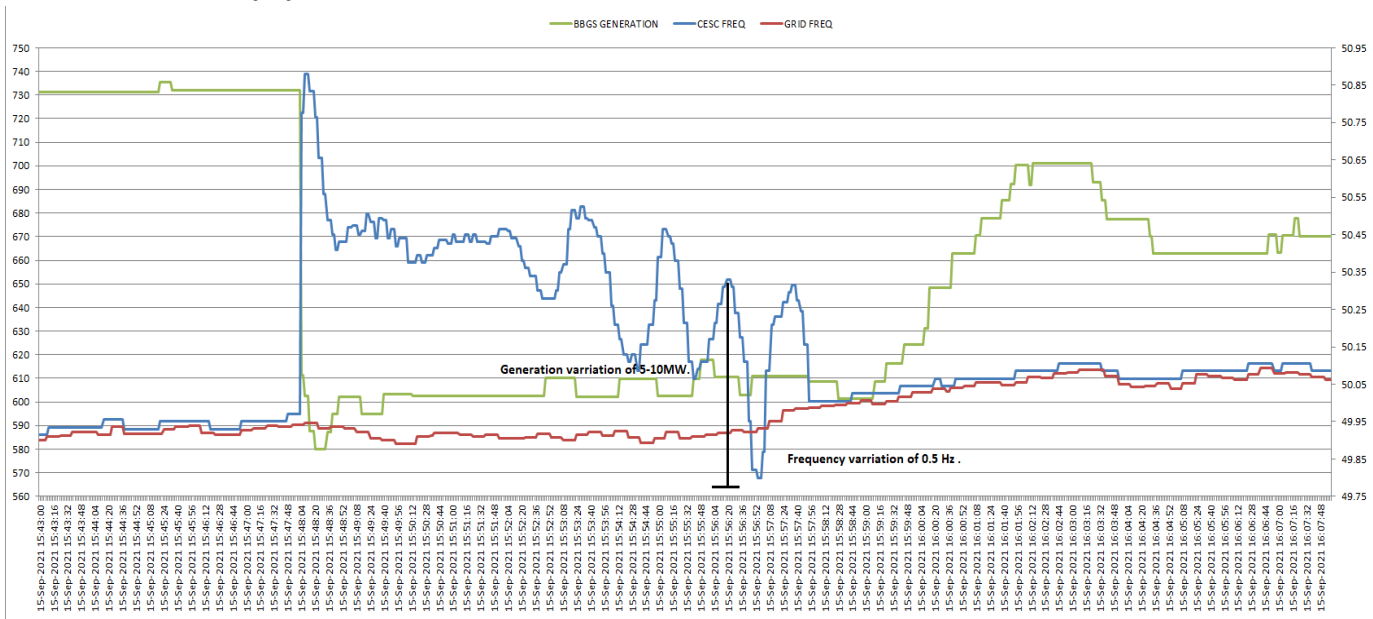
EVENT 3: Variation on 15th September Islanding: SCADA plot with 2 second resolution

Same pattern of Frequency variation observed. Governor performance during Islanding needs to be checked. In 15th September event also Budge-budge generation is oscillatory this needs to be checked and also any cyclic load variation for the same to be looked.

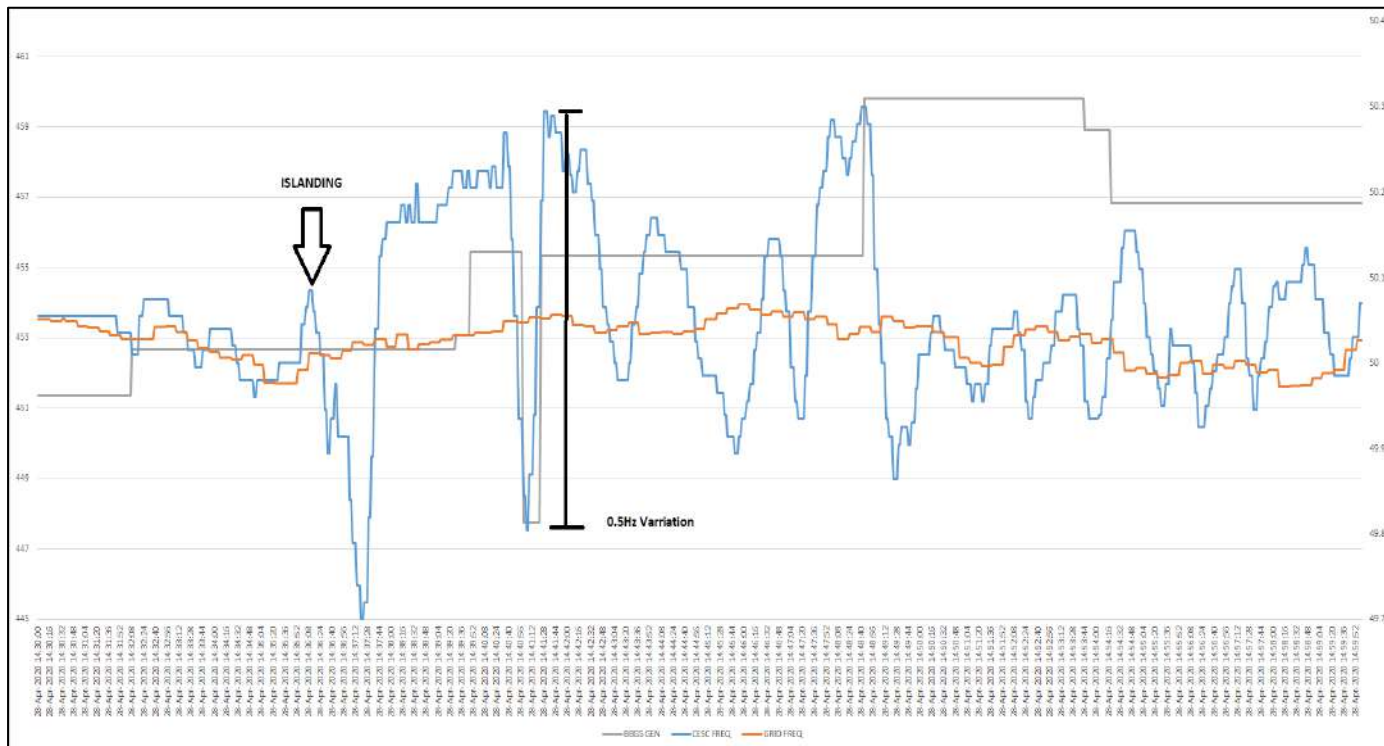
EVENT 4 :PAST ISLANDING ON 28 APRIL 2020:

In the 2020 Event also same very low frequency oscillatory variation observed

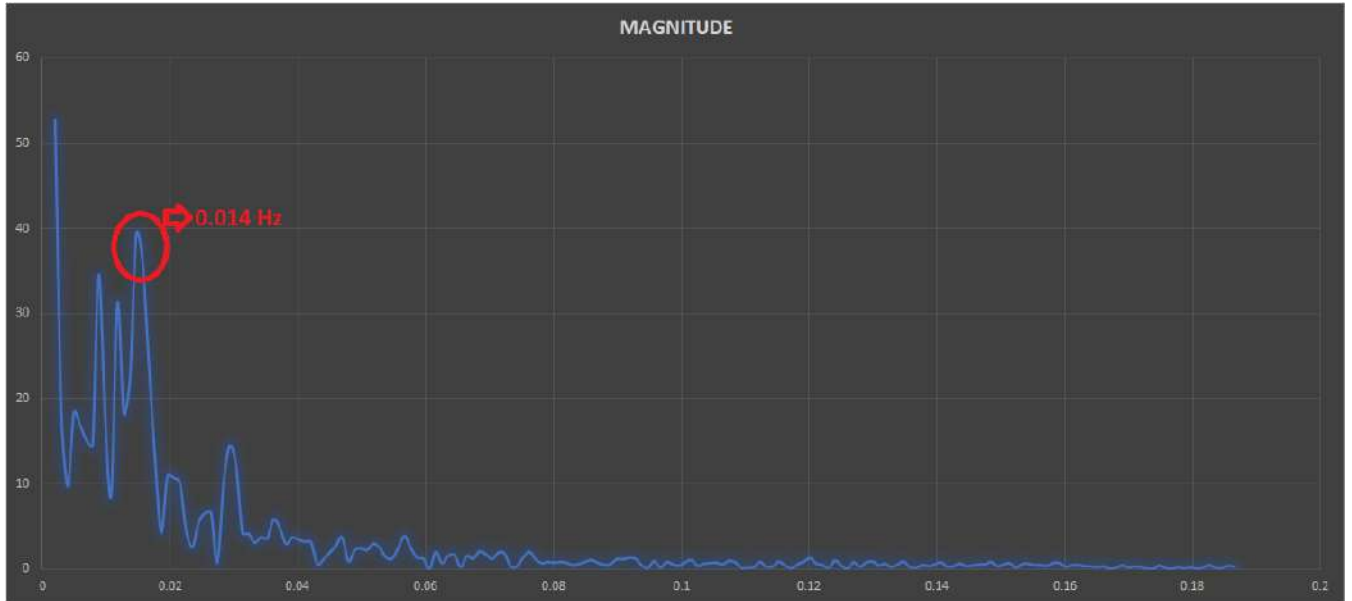
Oscillation Frequency as observed from FFT Spectrum: Very low frequency of 0.014 Hz observed

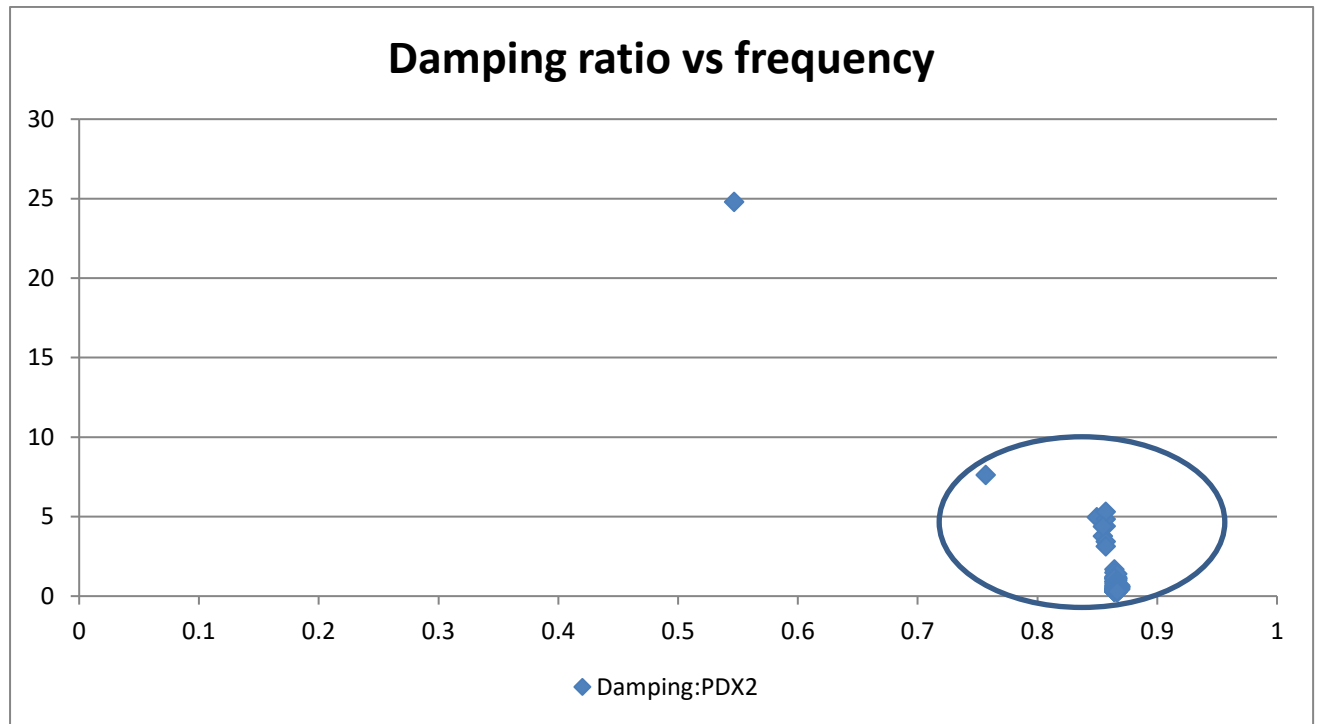
Critical modes as observed from below plot can be seen as between 0.8-0.9Hz with damping ratio less than 5%

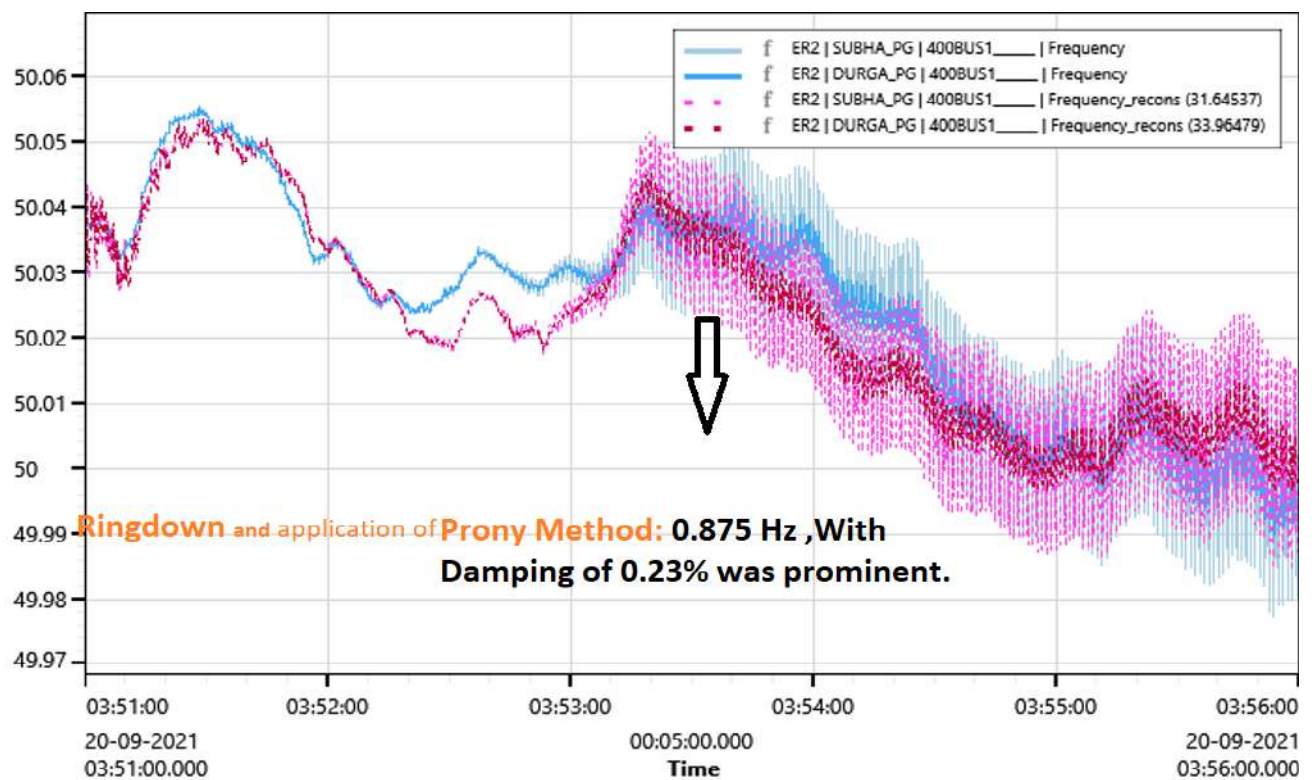
Ringdown and application of Prony Method: 0.875Hz with Damping ratio of 0.23 Hz

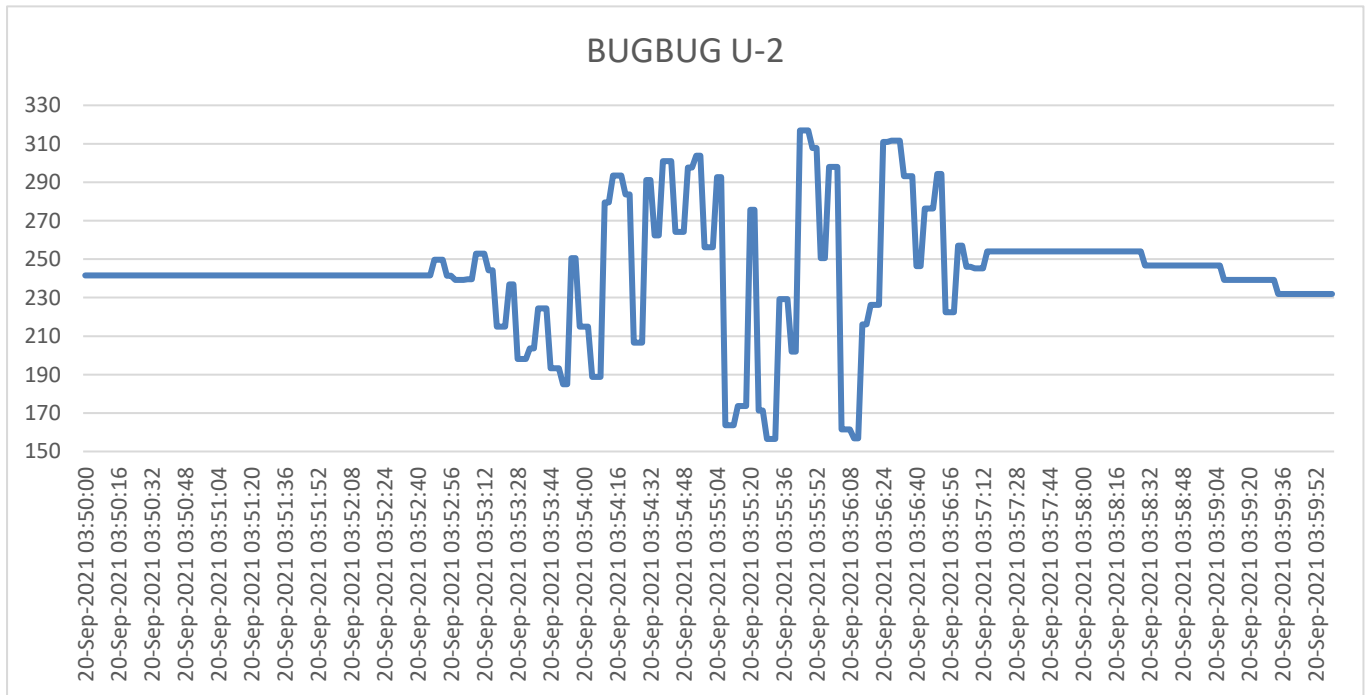
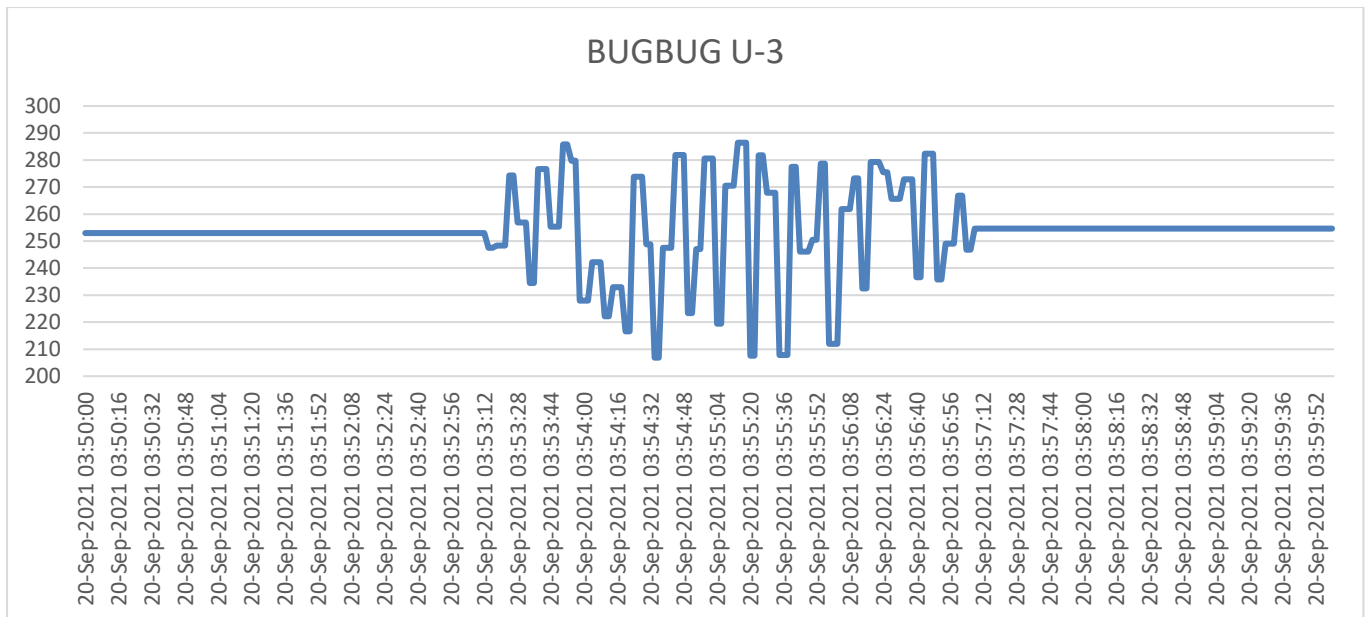
Unit wise variation of Budge-budge Plant:

It was most prominent in Budge-budge units: 140 to 160 Mw variation observed in each unit ,which is maximum and hunting of these units seems to be the source of oscillation .CESC also observed the hunting in these units.

As observed from the above plots maximum variation in MW oscillation was observed for Budge-budge units ,which appears to be the source of oscillation as the Mw variation damped out ,oscillation was also damped .

At 03:46 Hrs BUDGE-BUDGE unit -1 was taken out due to suspected ash bridging over bottom ash hopper and after 8 minutes of taking unit 1 out hunting started .

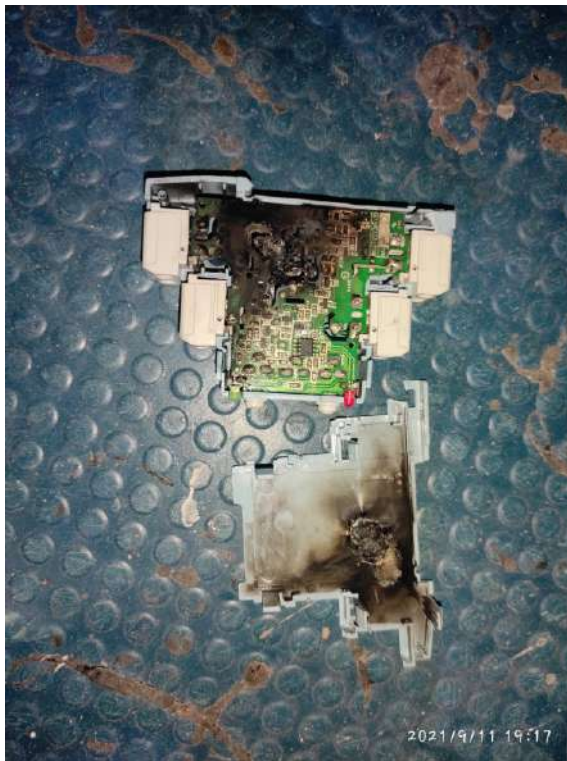
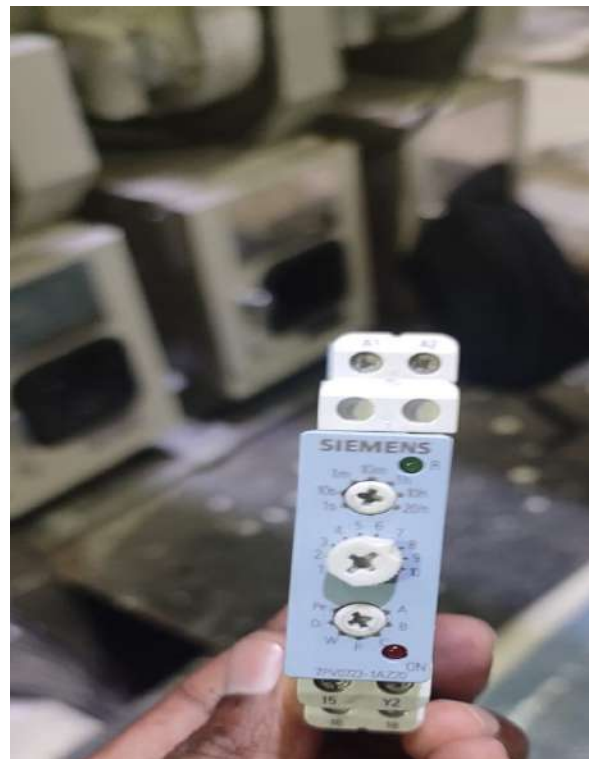
Picture of faulty Timer relay (KGD1-T4Y):

Due to burning of timer relay (KGD1-T4Y) the trip contacts got shorted and '+ve' was extended to GD trip relay (KGD1-4Y) as shown below.

- 1) Faulty timer replaced with new spare. 220KV Bus-I and other connected feeders restored.

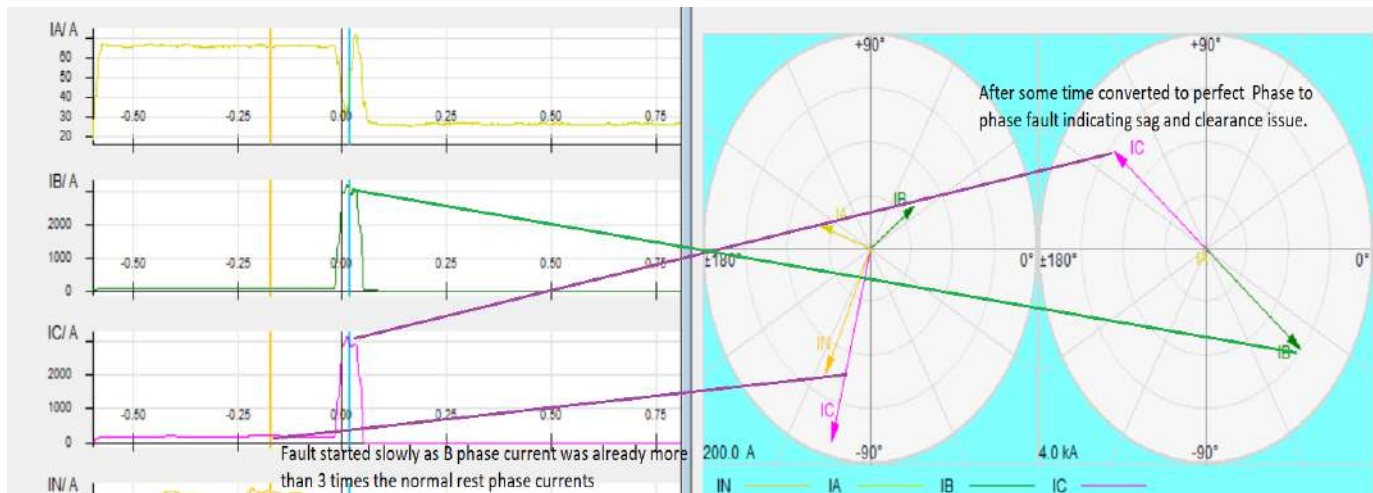
Same phenomenon as mentioned above is observed in almost all cases, which indicates that the fault is **occurring due to sag and clearance issues, hence** proper line patrolling and healthiness of line should be maintained, same kind of fault nature was also observed in this line few months ago which was resolved by, jumper tightening and tree pruning at some locations. This needs to be looked into again and taken care.
