Minutes
of
108th PCC Meeting

EASTERN REGIONAL POWER COMMITTEE

MINUTES OF 108th PROTECTION COORDINATION SUB-COMMITTEE MEETING HELD ON 16.11.2021 AT 10:30 HOURS

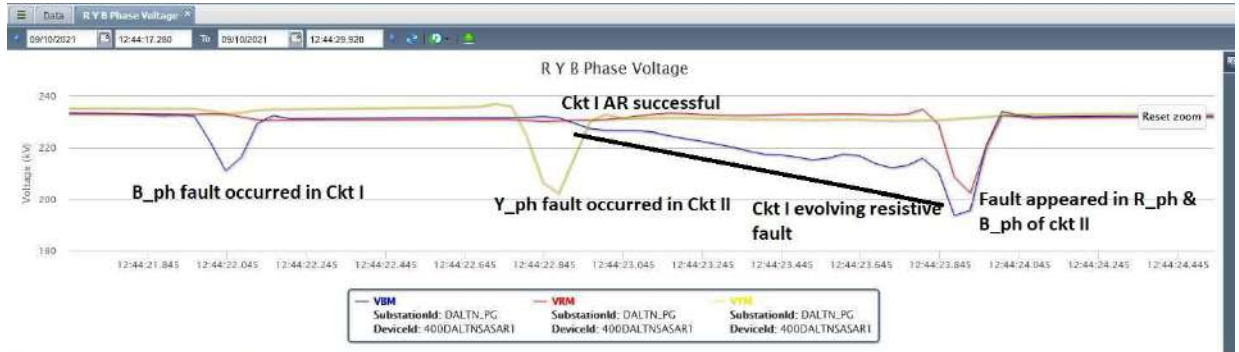
Figure 3: PMU snapshot of 400/220 kV Daltonganj S/s

समय	नाम	उप केंद्र 1 रिले संकेत	उप केंद्र 2 रिले संकेत	पीएमयू पर्यवेक्षण
12:44	220 kV Daltonagnj-Chatra-1	B_N, Z I, 28 km	Didn't trip	22 kV dip in B_ph
	220 kV Daltonagnj-Chatra-2	Y_N, 69 km, 1.3 kA	Didn't trip	31 kV dip in Y_ph

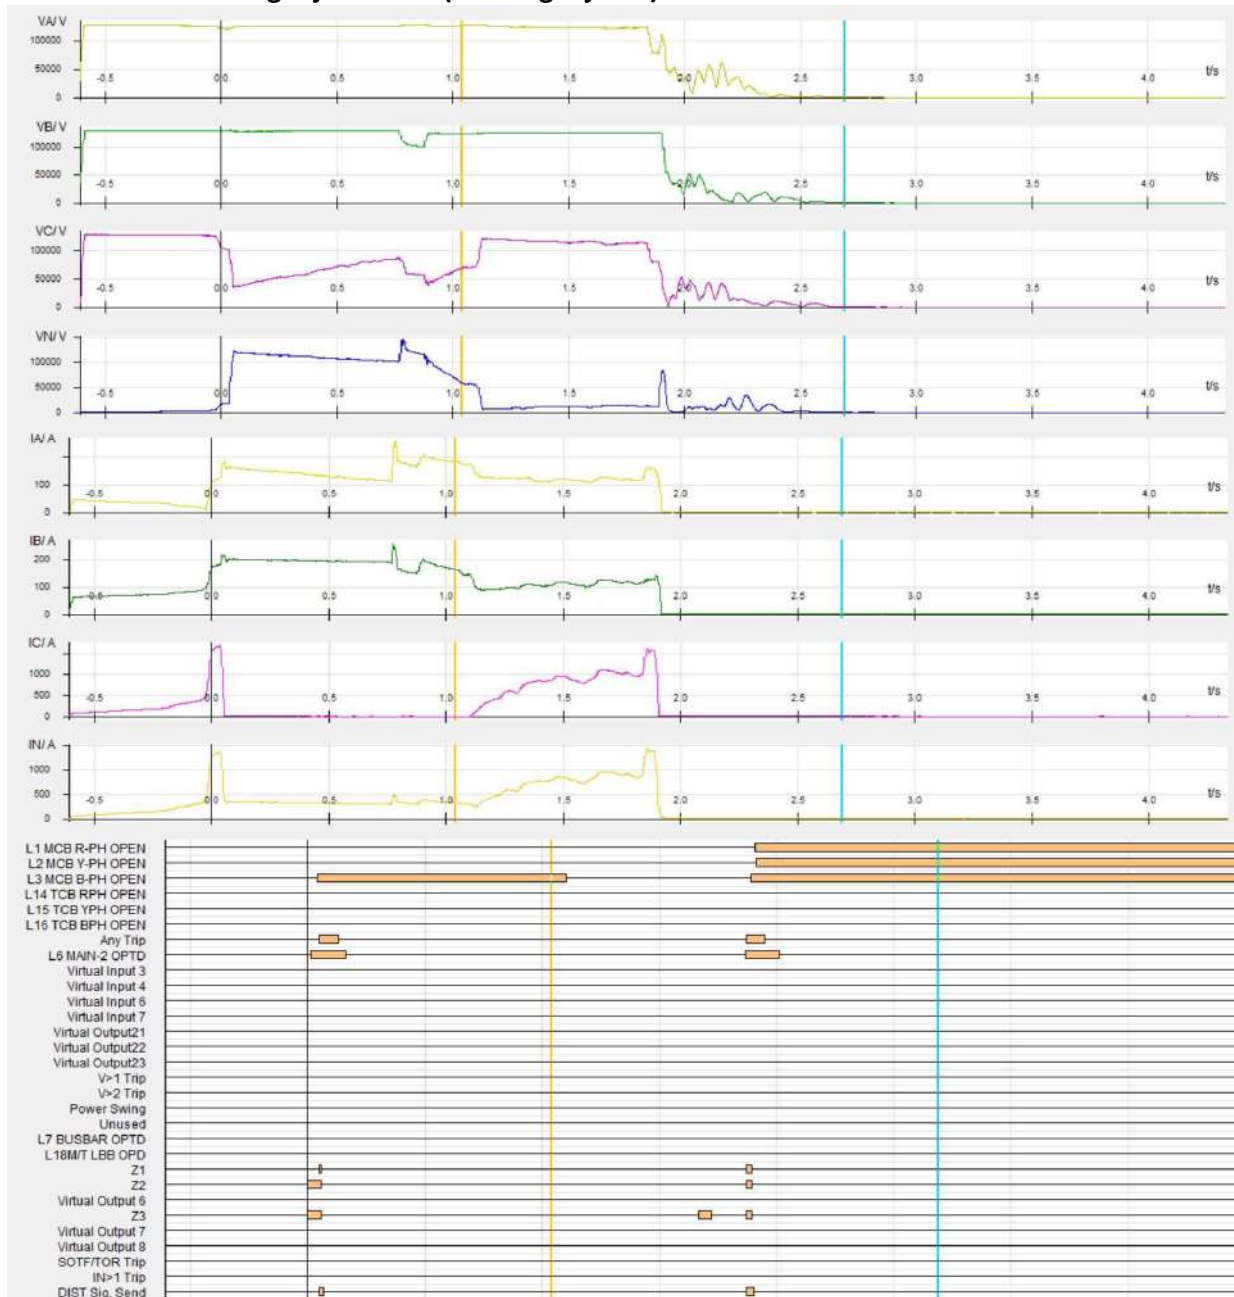
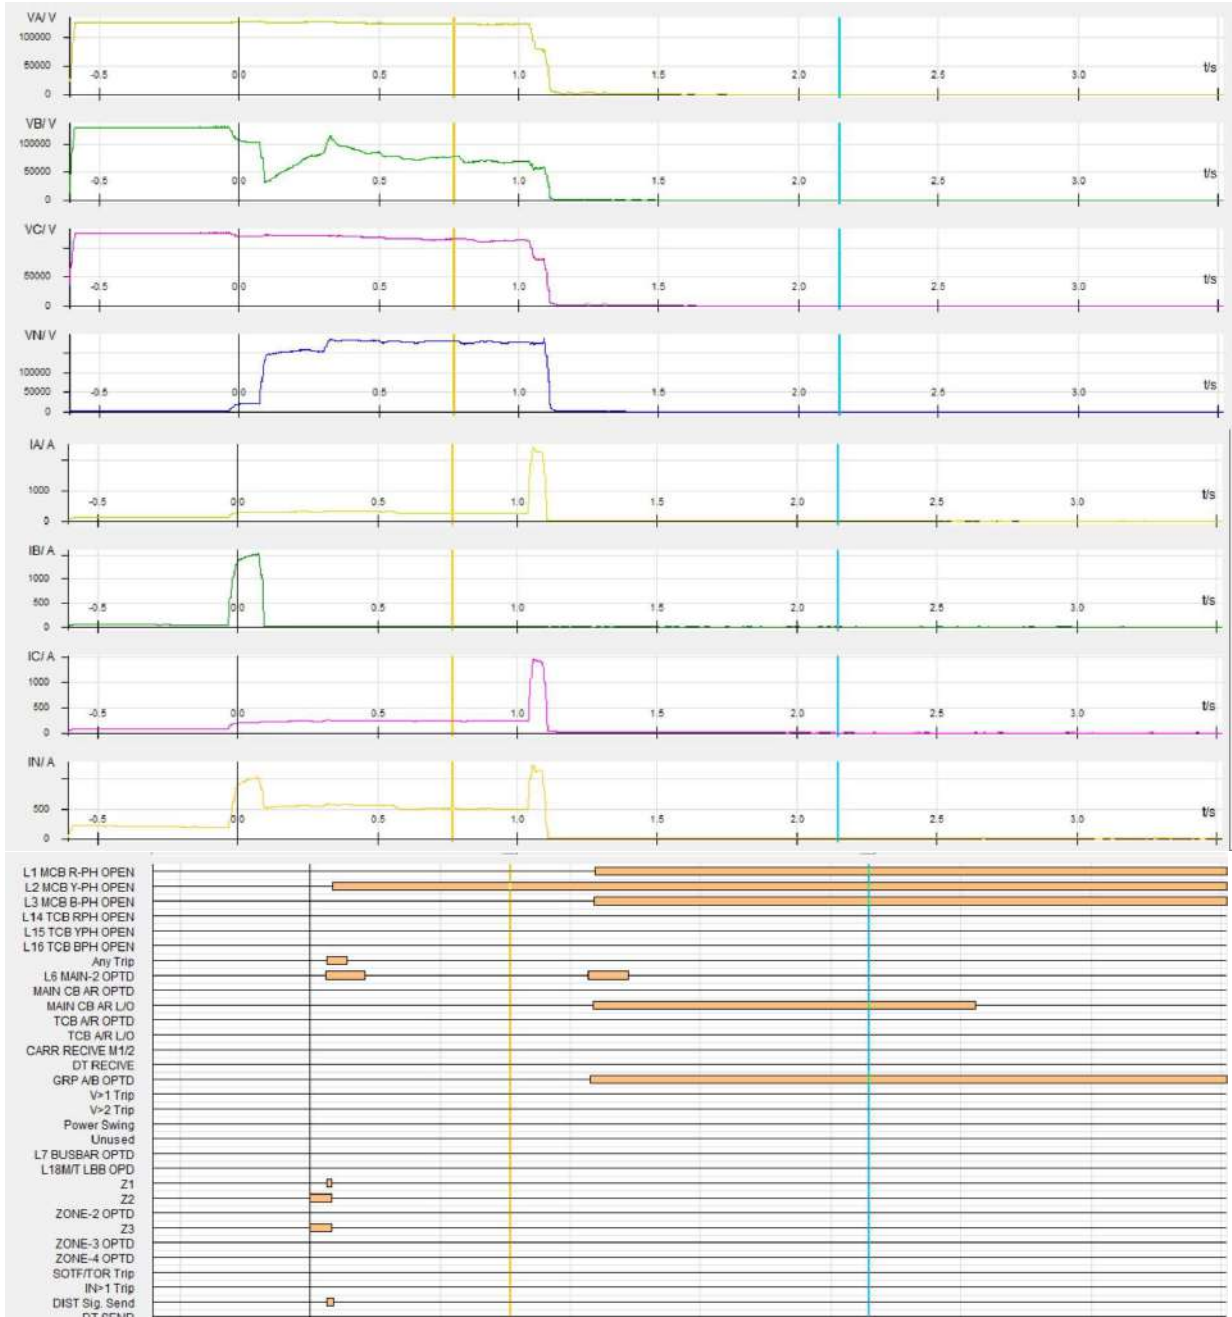
- As informed, both lines didn't trip from Chatra. PLCC status maybe checked.
- Voltage induced in both lines after fault clearance is indicative of arcing which persisted till all three phases opened. Root cause of the fault maybe analysed and findings may be shared.

Annexure 2: DR recorded

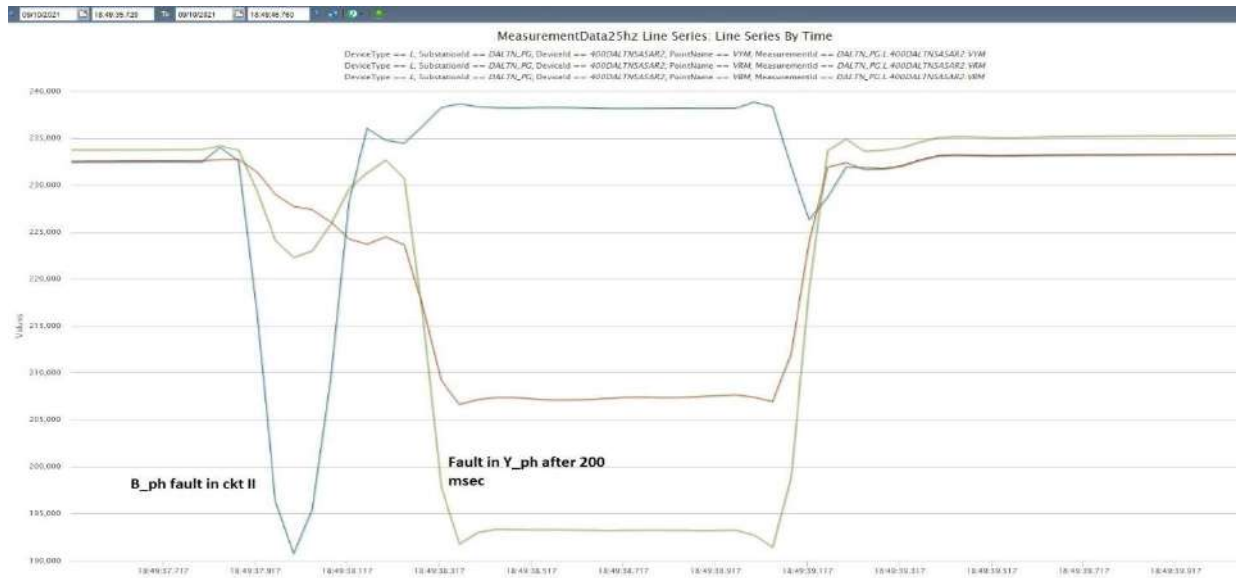
Figure 3: PMU snapshot of 400/220 kV Daltonagnj S/s

समय	नाम	उप केंद्र 1 रिले संकेत	उप केंद्र 2 रिले संकेत	पीएमयू पर्यवेक्षण
18:49	220 kV Bus-1, Bus 2 at Garhwa (New)	-	-	25 kV dip in R_ph, 40 kV dip in Y_ph and 42 kV dip in B_ph
	220 kV Daltonagnj-Garhwa(New)-1	B_N, 1.16 kA	-	
	220 kV Daltonagnj-Garhwa(New)-2	B_N, 24.5 km, 1.91 kA	-

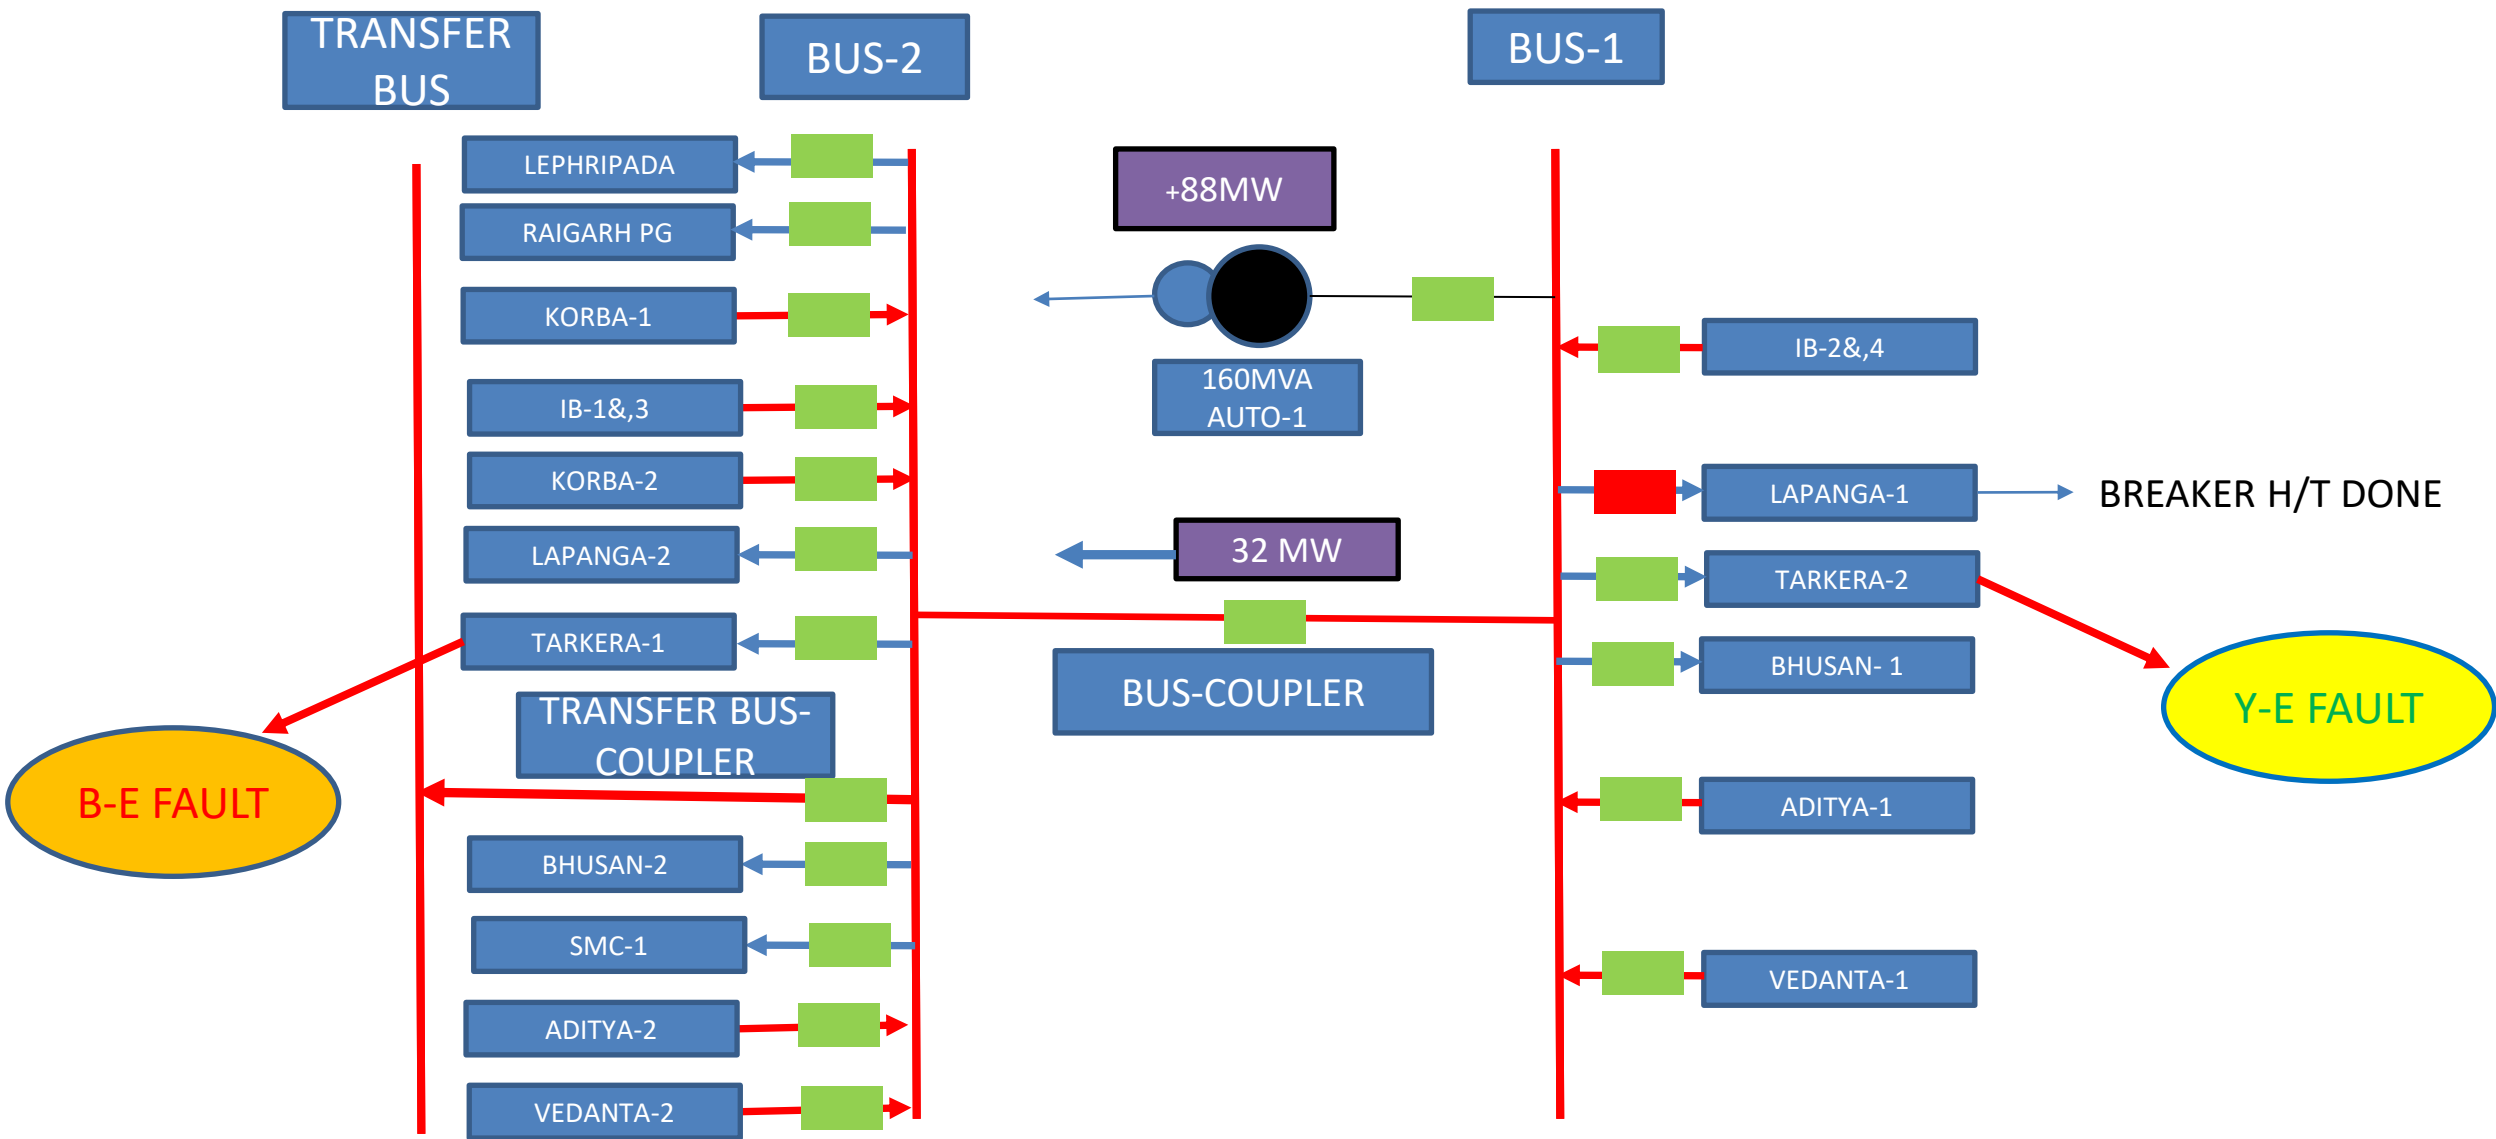
ALL FEEDERS/TRF IN BUS-1 & BUS-2 TRIPPED, Bus-1(AT-1,IB-2 &4,Lapanga-1, Tarkera-2, Bhusan-1, Aditya-1,Vedanta-1) Bus-2(Lephripada,Raigarh PG,Korba-1, IB-1 & 3,Korba-2Lapanga-2, Tarkera-1, Bhusan-2, SMC-1, Aditya-2, Vedanta-2)

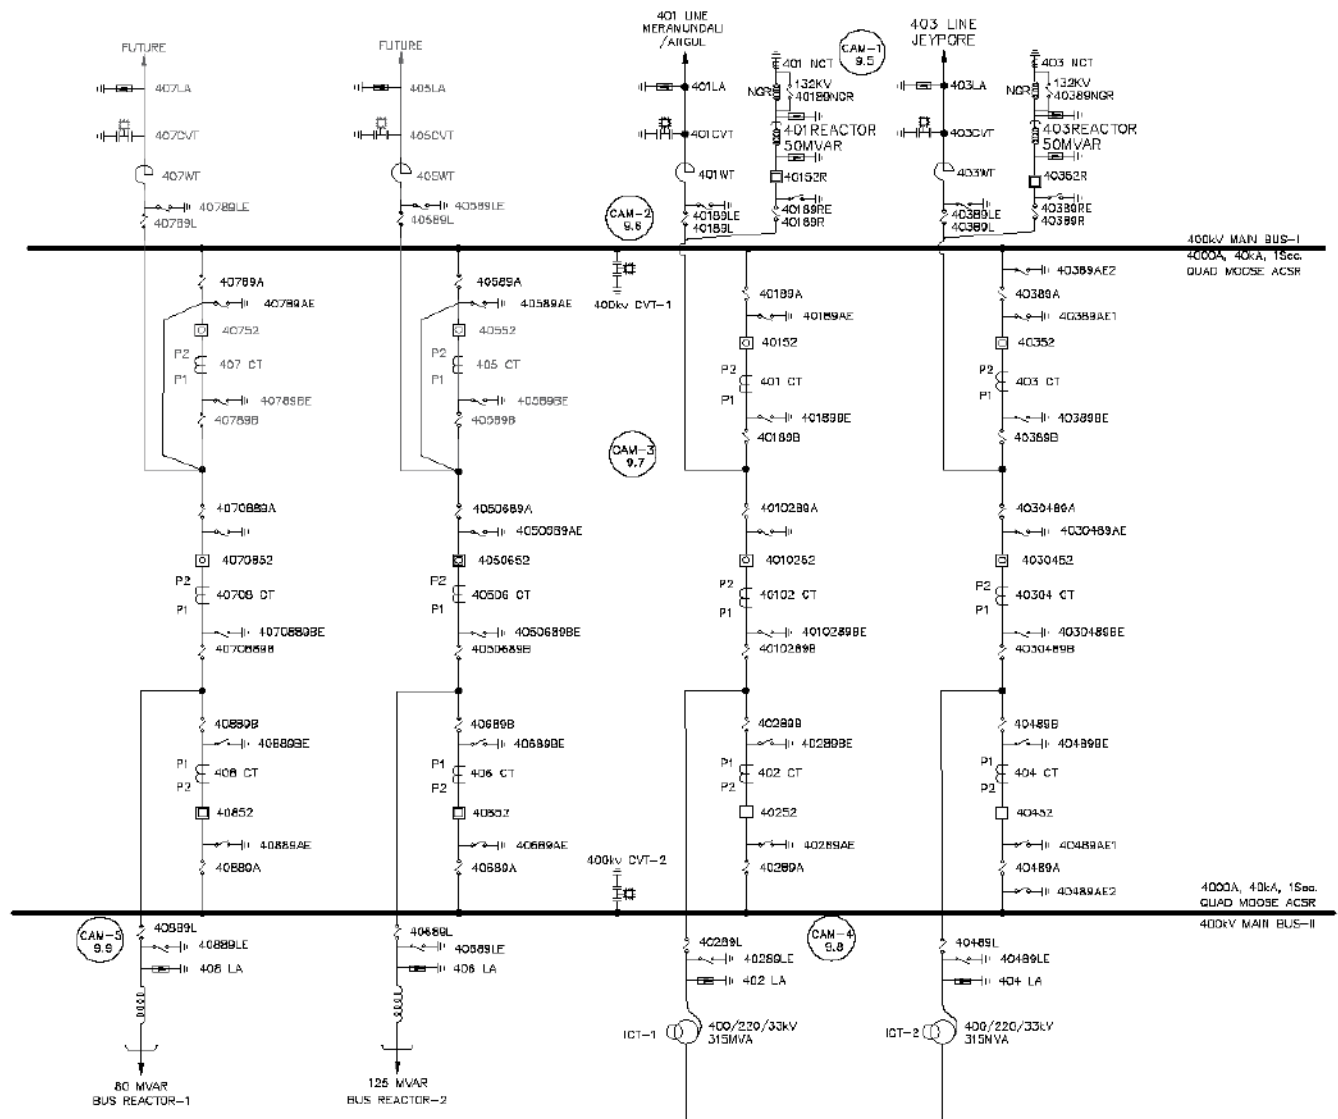
Fig-1

400KV Busbar-1 of Balangir tripped on 22.10.2021 at 13:06:58 Hrs with the indication of Breaker failure protection. Before proceeding please refer to the 400KV SLD of Balangir ss at **Fig-1**.

The 80MVAR Bus Reactor-1 was in shutdown for maintenance (408 and 40708 CB were OFF). As a part of maintenance, PRV trip was given from PRV of BR-1 for checking group trip relay 86 operation of Main and Tie CB. Tie Bay 86 relays operated and instantaneously Busbar-1 got tripped (refer to Event log at **Fig-2**). The Breaker failure signals were persisting from Future bay 407 and future bay 405 in Both MCU (BB protection system is centralized MCU and Bay unit system of Siemens). So the **BB-1 Trip command was persisting**.

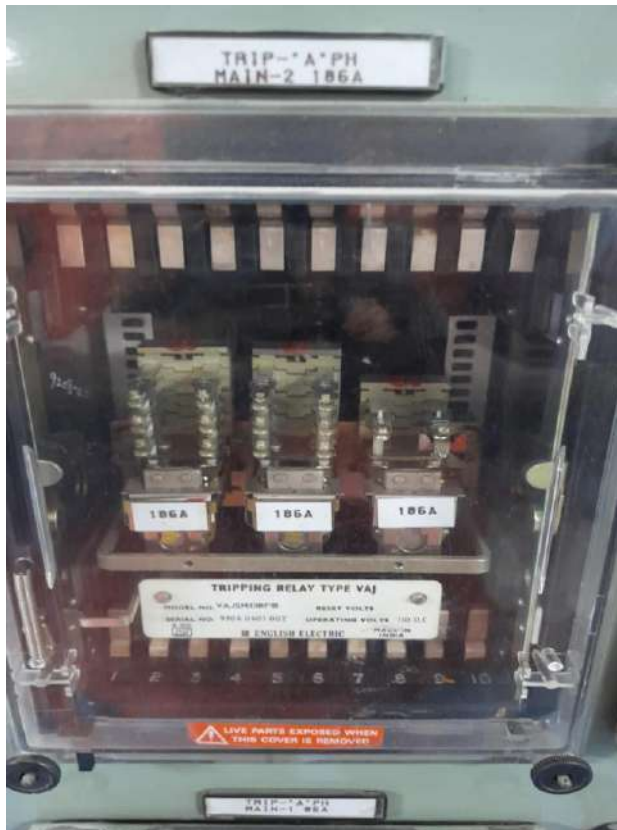
1) 186A relay (MVAJSM, make: EE) found faulty in 400KV Malda-New Purnea Ckt.-I which initiate the tripping command to TBC LBB relay.

186 A relay replaced.

1. 186A relay replaced with healthy spare.
2. All feeders are normalized accordingly.

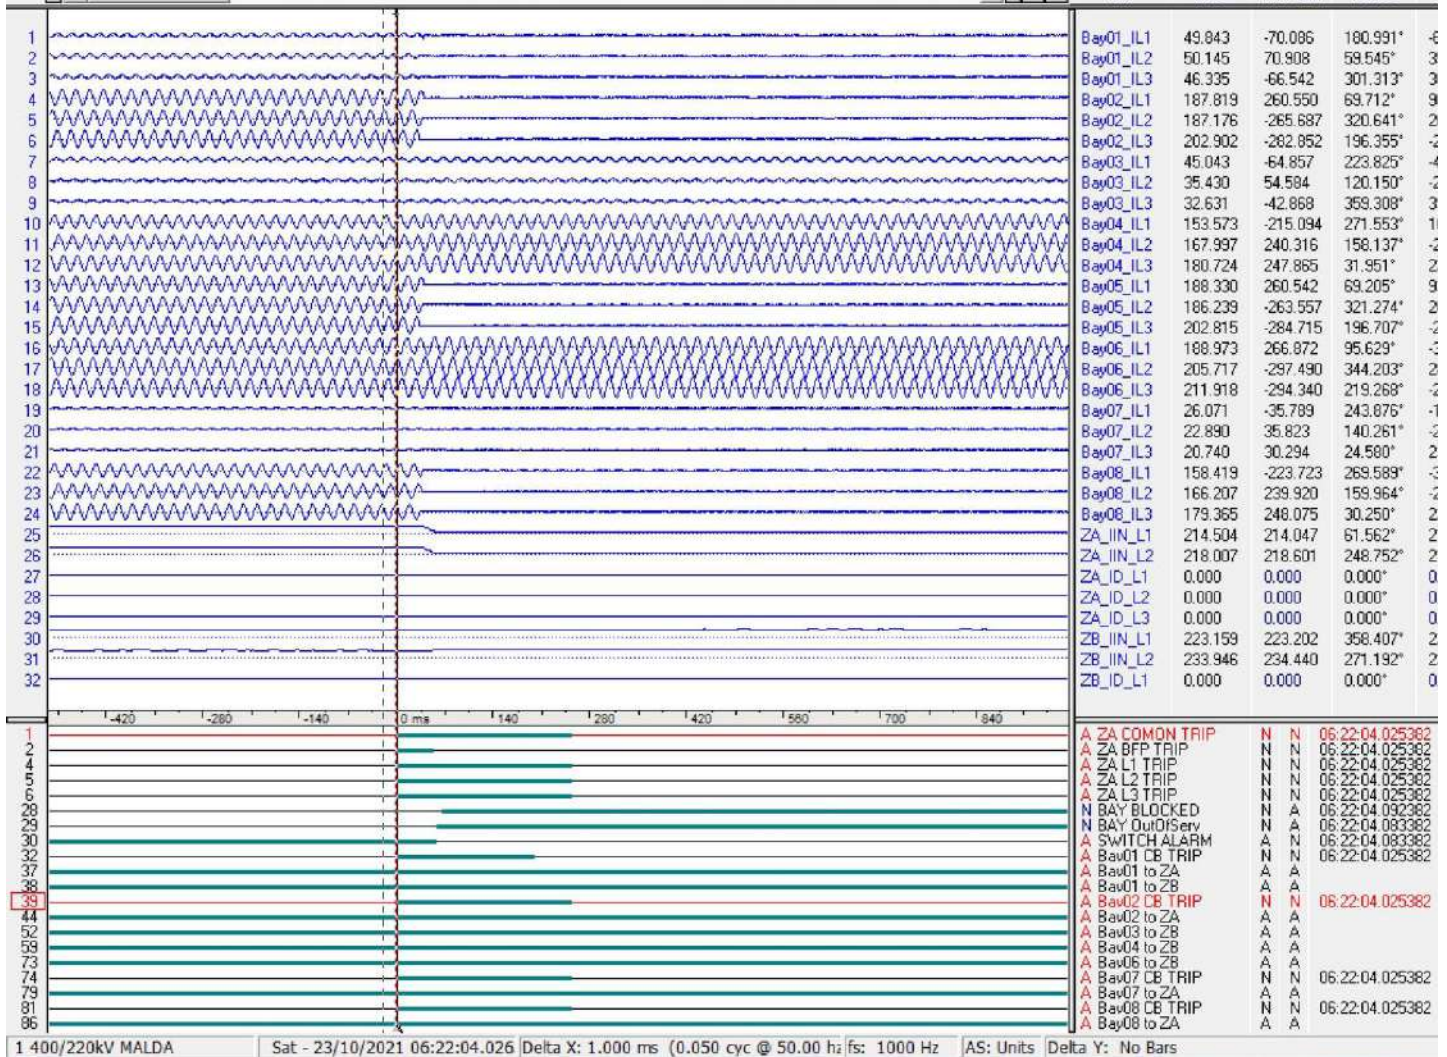
TRIP DR:

Contact became high resistive

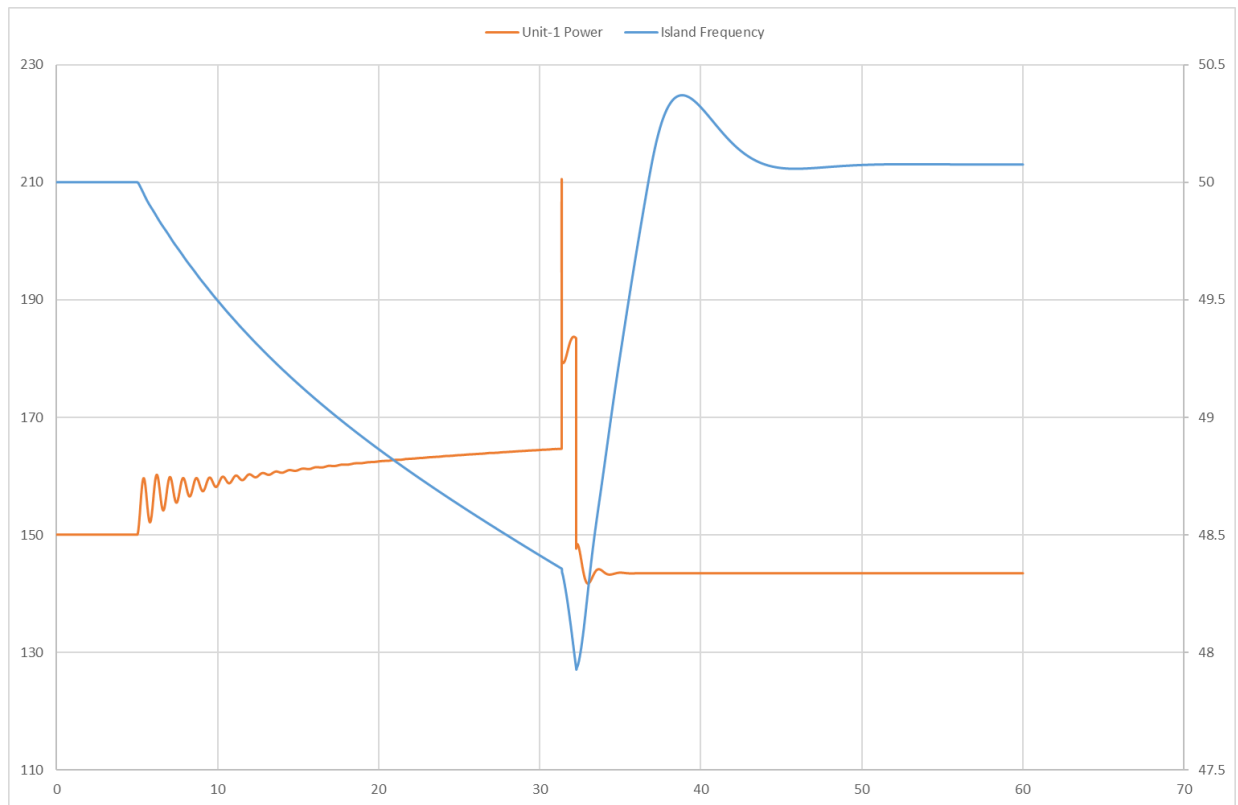
Scenario-1: Maximum generation & Maximum load

1. In max generation max load scenario there is 114 MW surplus generation inside the Island if both unit is considered. However if one unit is considered then the island is 35 Mw deficit.
2. Here one unit inside the island is tripped immediately after island is formed.
3. With this setting island frequency stabilizes around 50.07 Hz

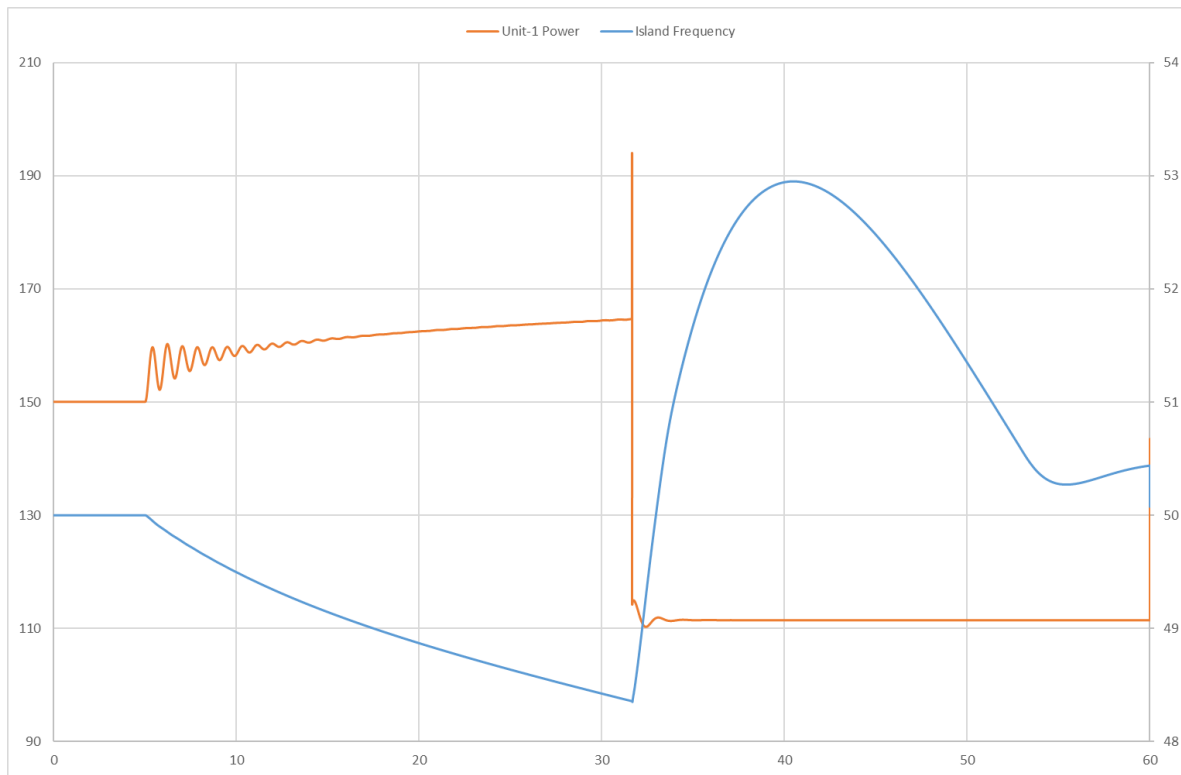
Scenario-2 : Maximum generation & Minimum load

1. In max generation min load scenario there is 190 MW generation surplus inside the Island
2. Therefore after island formation frequency start raising at faster rate, as the inertia of the island is low.
3. One unit is therefore tripped immediately
4. The island is survived with 50.43 Hz frequency.

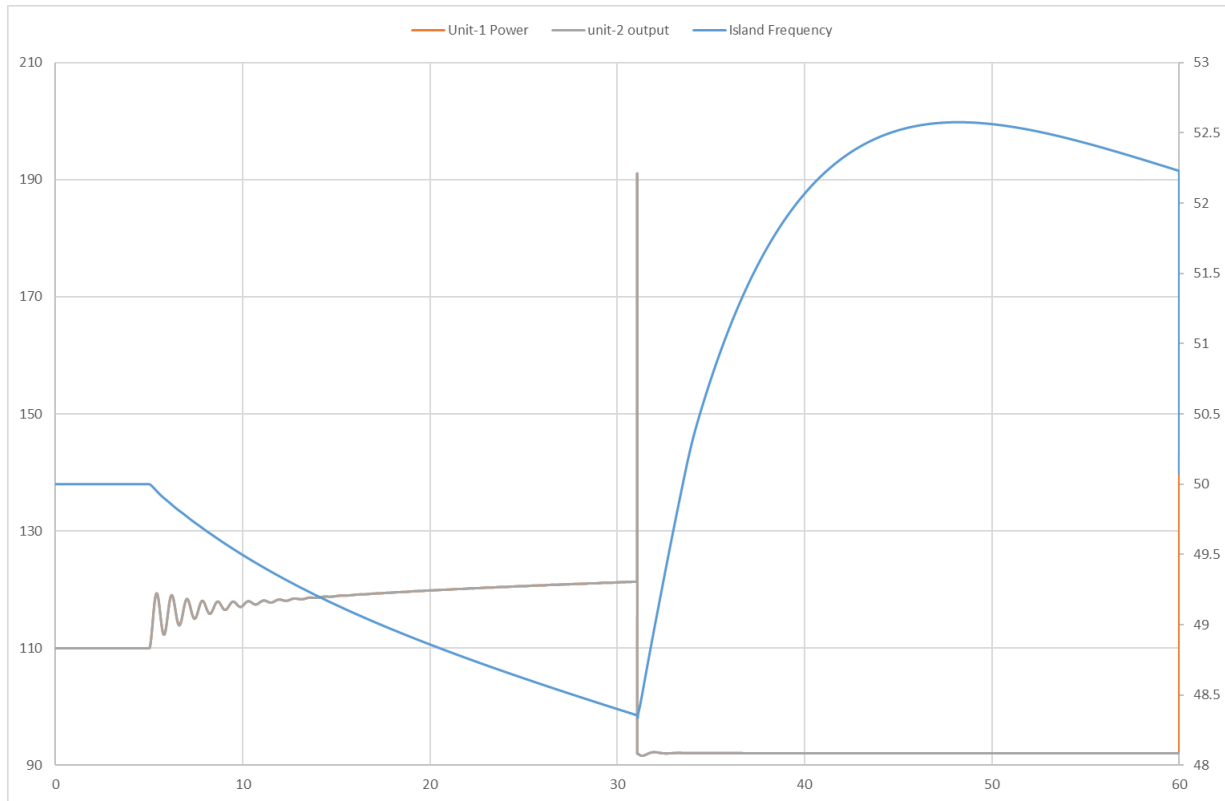
Scenario-3: Minimum generation & Maximum load

1. In min generation max load scenario there is 34 MW generation surplus inside the Island
2. Therefore after island formation frequency start rising fast, as the inertia of the island is low.
3. With this setting finally island frequency stabilizes around 52 Hz.
4. Here Both the unit survived

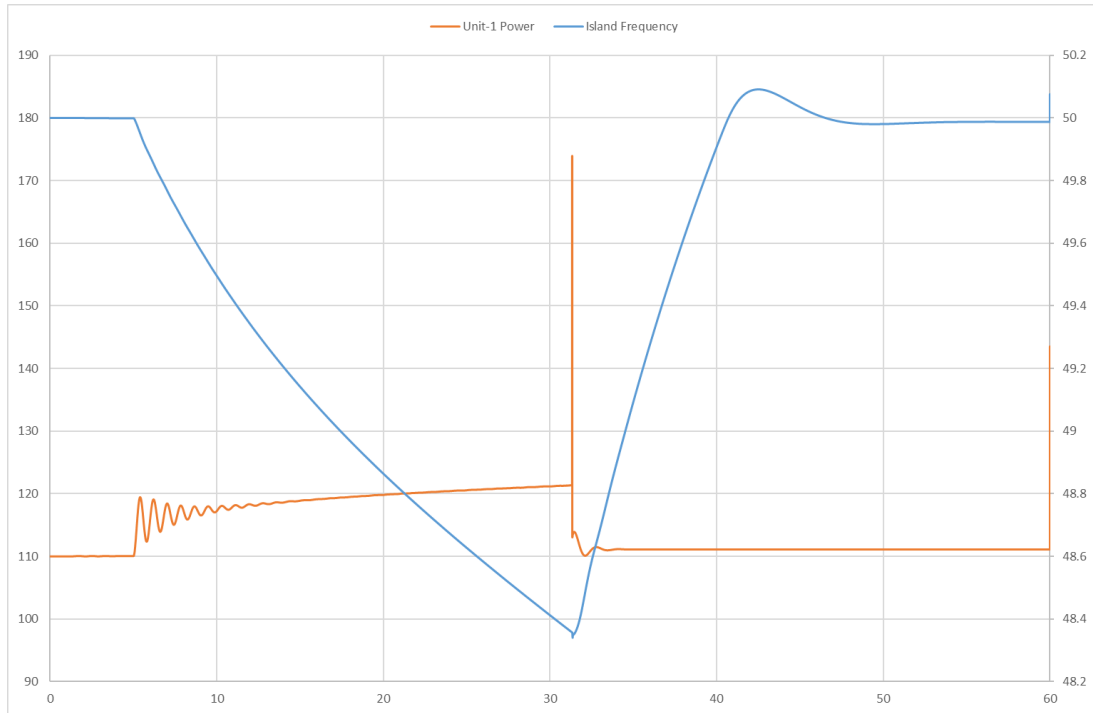
Scenario-4: Minimum generation & Minimum load

In scenario fourth the island is 111 MW generation surplus.

1. In min generation max load scenario there is 111 MW generation surplus
2. Therefore, one unit is tripped and the island is stabilized at 49.98 HZ.
