Sub: Minutes of the 112th PCC meeting held on 11.03.2022.

Minutes
of
112th PCC Meeting

EASTERN REGIONAL POWER COMMITTEE

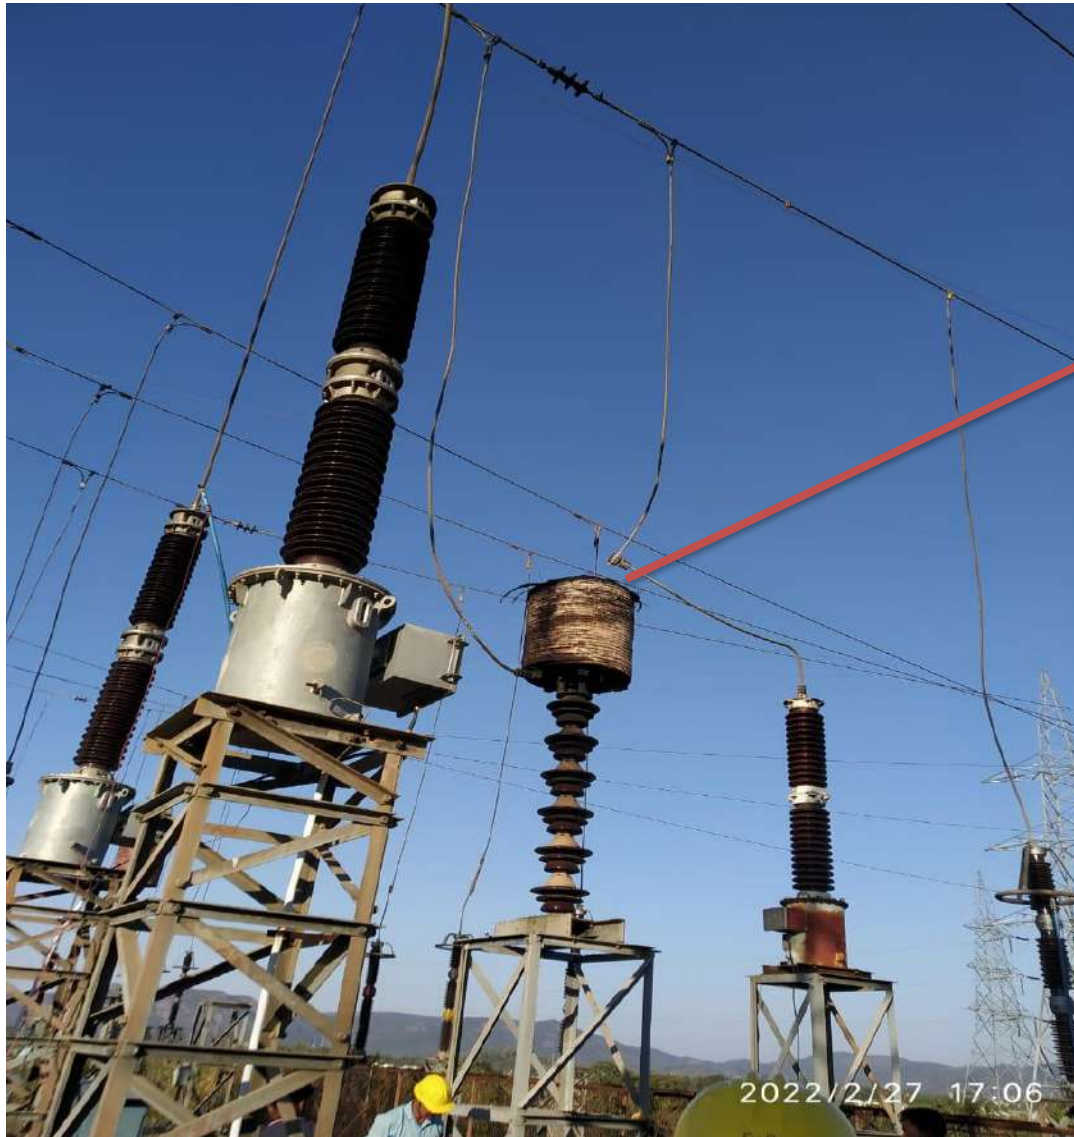
Laxmipur-1 feeder Wave Trap at Jayanagar GSS

- It was informed that due to long fault clearing time of around 43 seconds, R phase wave trap got burnt at Jayanagar S/S.*

1. Line fault of 220KV Jayanagar-Laxmipur Circuit-1 not cleared due to non-tripping of its TIE-CB after command initiated by relays . Also the CB did not tripped by TNC switch . Observed that the CB is in gas lockout mode and the gas pressure of Y-phase limb was near to lockout border line. Due to this all remote end feeders affected and fault continued up to long time. At 12:45 Hrs due to rise in atmospheric temperature the lockout mode gone and tie CB tripped through TNC switch.
2. As per the information of Grid operation team, the defective annunciation module misled to get the status of Gas lockout.
3. Due to long fault clearing time, wave trap of R-Phase (at Jayanagar End) burnt.
4. Fault continued up to 43sec due to delay in fault clearance from Upper Koaab/Balimela P/H ends.

R-ph
Wave
Trap

1. SF6 Gas pressure filled up to desire level in the Y-phase limb of Laxmipur-1 Tie CB.
2. Damaged Wave trap of R-phase removed from the structure.
3. Faulty feeder (220KV Laxmipur-1) kept in shutdown condition for necessary check-up at fault location point.
4. Faulty annunciation module replaced with old one.

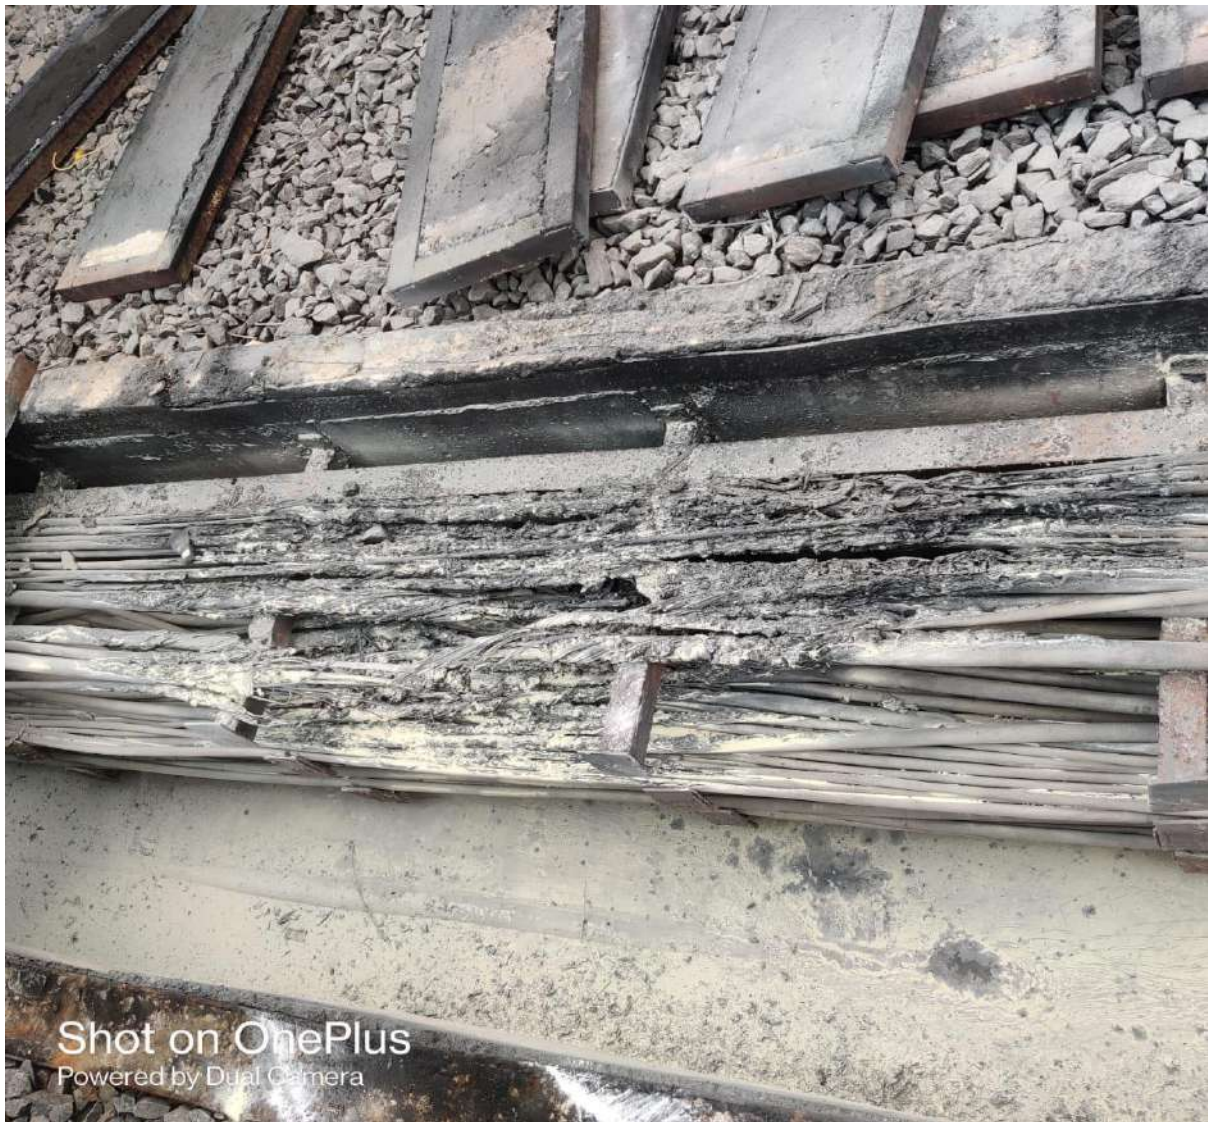
On physical inspection at site no actual operation was observed, further smoke was observed from common cable trench for Bus Reactor I & II. on visual inspection inside cable trench many control cables and power cables were found damaged. Among damaged cables 02 nos of 3.5 C 70 sq mm cables were found punctured and caught fire, due to collateral damage many control cables were damaged and insulation failure led to dc earth fault resulting in tripping of elements (31 no's of control cables) .

Damaged cables were emanating from MLDB and ELDB to NLP & ELP of switchyard, MCCB of MLDB & ELDB panel was found tripped.

- Fire in Cable trench was extinguished immediately by using DCP fire extinguisher.
- To avoid further untoward incidence DC supply to the feeders and AC supply for remaining cables were isolated.
- Damaged portion of cables was removed and healthy portion was joined using cable loops as temporary measure.

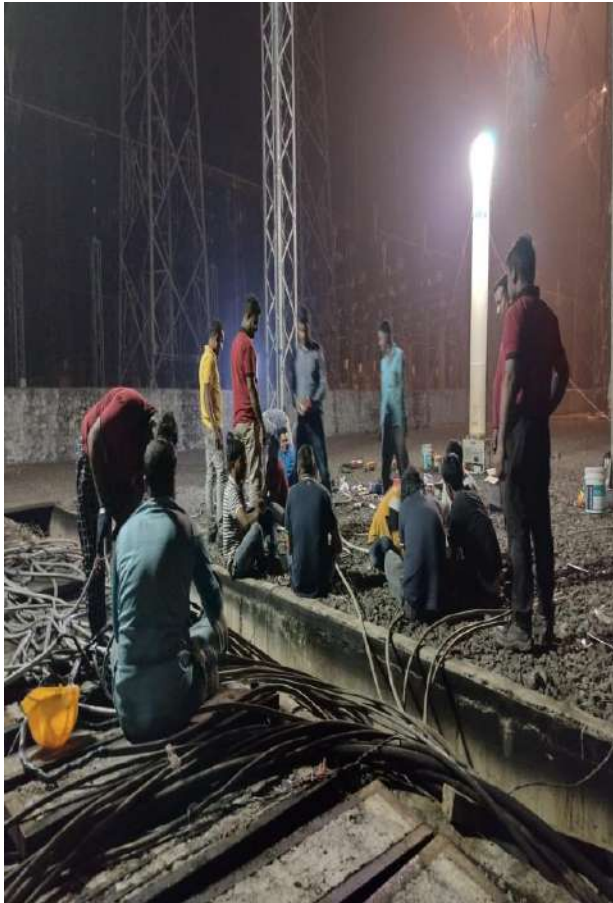
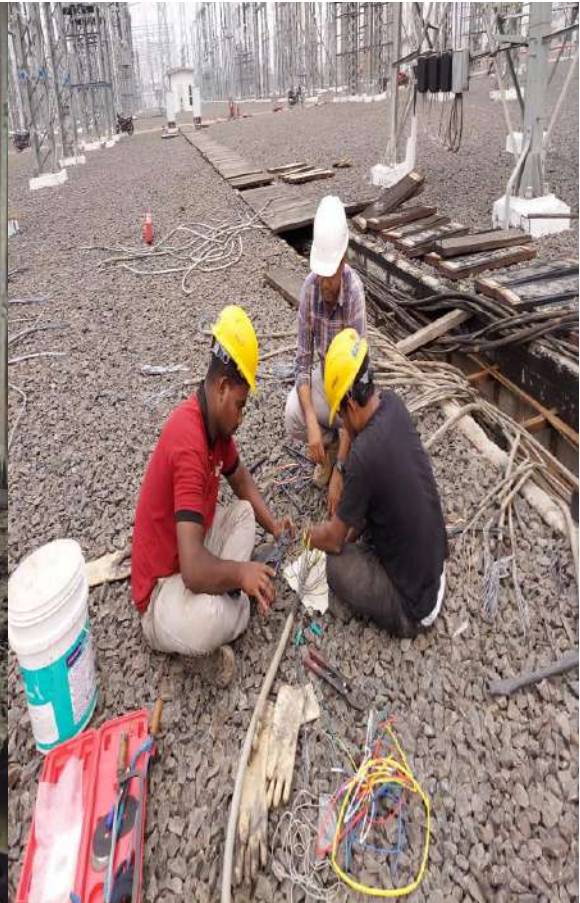
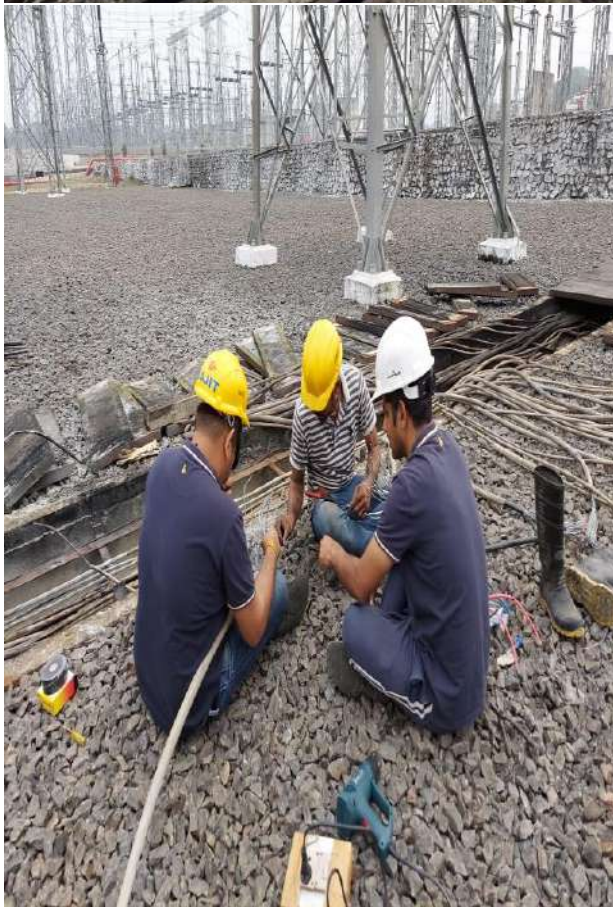
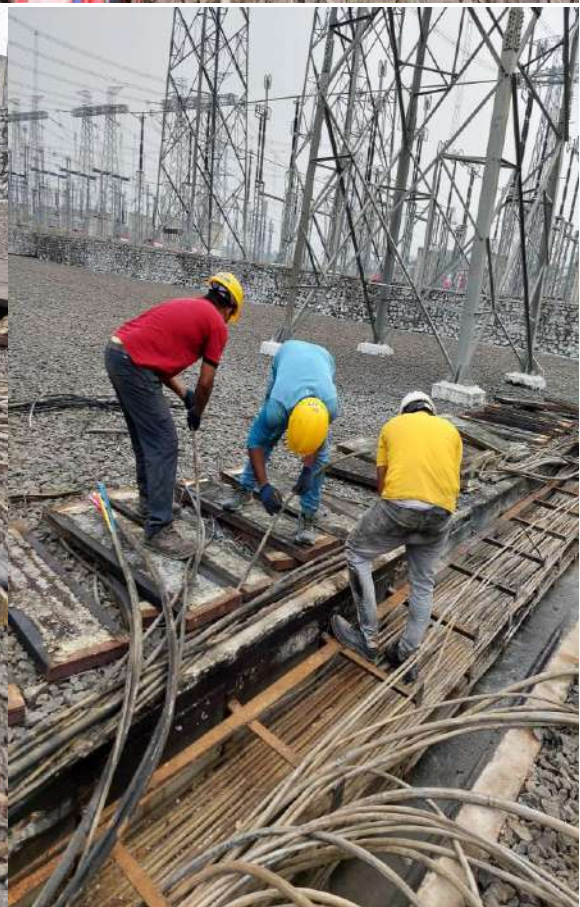
- Due to degradation of Insulation, Insulation failure might have caused the fire breakout in trench and damaged neighbouring cables.
- Therefore, periodic IR Measurement of cables may avoid such disaster.
