Agenda  
for  
**119<sup>th</sup> PCC Meeting**

## **AGENDA FOR 119<sup>th</sup> PROTECTION COORDINATION SUB-COMMITTEE MEETING TO BE HELD ON 18.10.2022 AT 11:00 HOURS AT ERPC, KOLKATA**

#### **ITEM NO. B.1: Total Power failure at 220 kV CTPS A and CTPS B (DVC) S/s on 24.09.2022 at 10:55 Hrs**

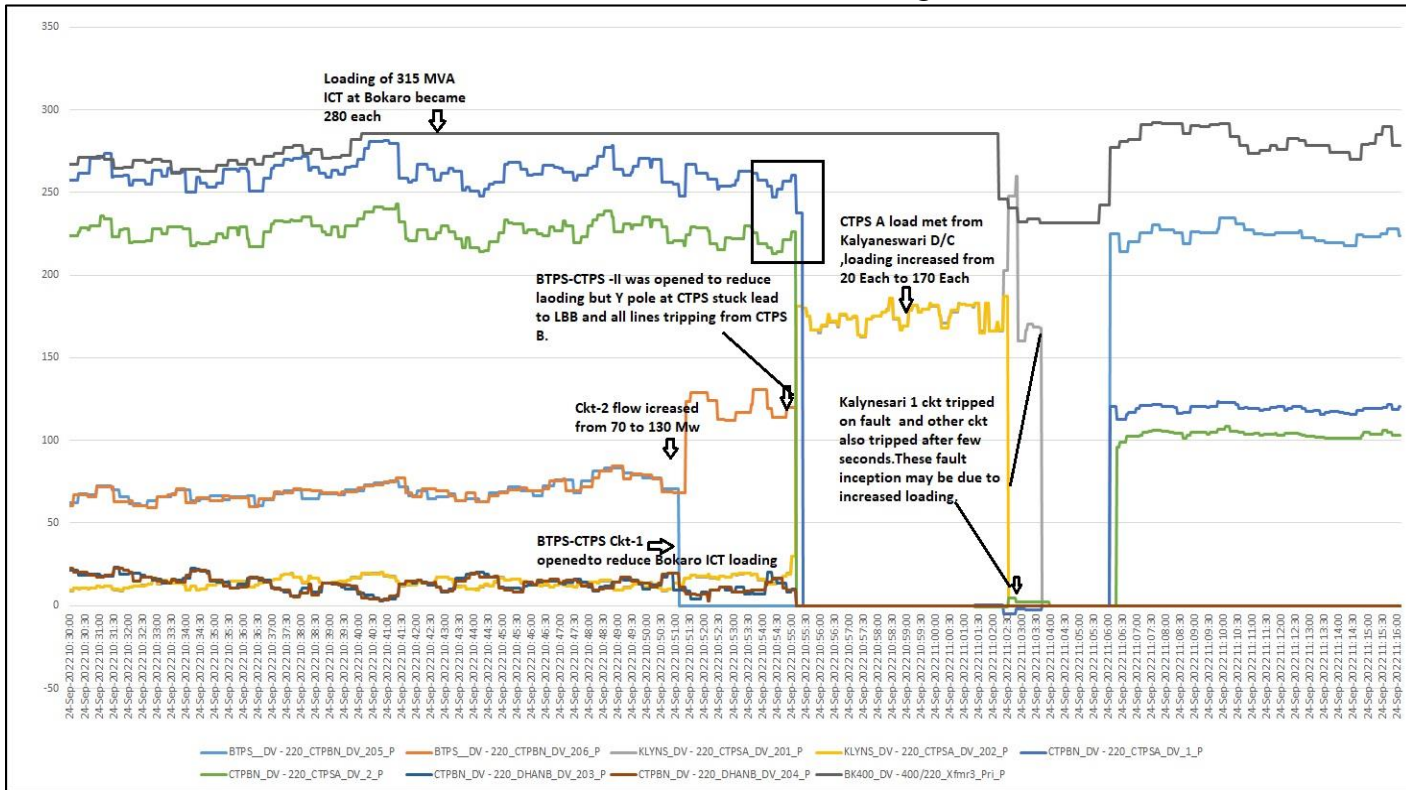
Power flow SCADA plot for the event.

- Loading of 2\*315 MVA ICT at Bokaro touched up to 280 MW each and to reduce the loading of ICT ,BTPS-CTPS (B)-I was opened at 10:50 Hrs ,but ICT loading did not reduced as load was shifted to ckt -2 as observed from above scada plot .
- At 10:55 Hrs ckt-2 was also opened but Y pole CB at CTPS (B) got stuck and did not opened which can also be seen from below PMU plot of line current plot. Y phase current became zero after 3 seconds ,Probably after PD operation.

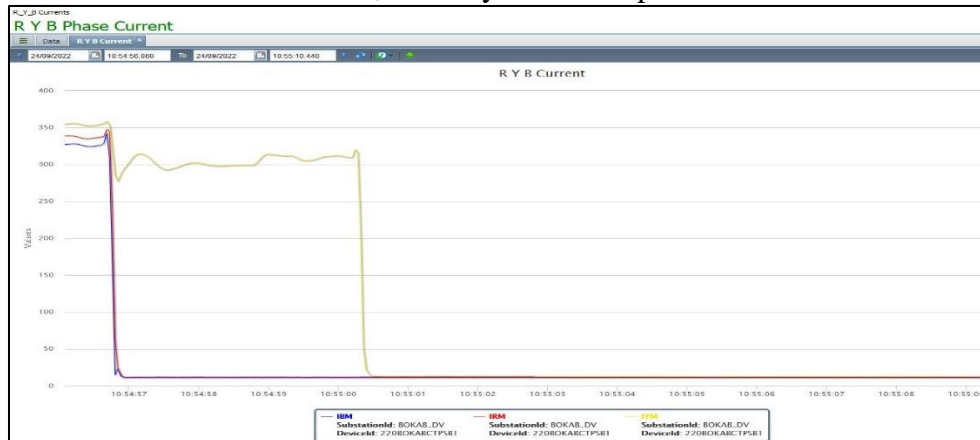
- Under such condition of stuck one pole of breaker PD should have operated and tripped the remaining phase but apart from this all other lines with main bus-1 and 2 at CTPS B tripped.

- Reason for the same was due to stuck breaker condition, Broken conductor protection operated and resulted into lockout relay operation which further initiated Operation of LBB as Y pole was stuck and LBB gave tripping command to each element from Main Bus -1.

- But it also gave tripping command to all the elements from Main bus -2 as there is DMT scheme it was later known that, ST#8 was at MB#2 but both CT switching relays of MB-1 & MB-2 of this bay was operated condition hence It caused tripping of all bays of MB-2 through 96 relays. Supervision and different schemes may be explored to avoid both CT switching overlap with both buses. **DVC to explore till implementation of low impedance busbar.**

- Operation of Broken conductor protection needs to be checked in detail as it led to lockout relay operation and initiation of LBB which led to bus tripping.

- Broken conductor operates on the ration of  $I2/I1 > 20\%$  as one pole was only stuck so  $I2=I1$ .
- Since sensitive settings have been employed, it can be expected that the element will operate for any unbalance condition occurring on the system for example, during a single pole auto reclose cycle. Hence, a long time-delay is necessary to ensure co-ordination with other protective devices. **Normally 4- 5 second time-delay is provided for Broken Conductor Protection.**

- As Y pole tripped after 3 seconds, Broken conductor protection should have not operated, Generally Broken conductor is used for only alarm purpose. So it can be used for only alarm instead of tripping. **DVC to explain and check.**

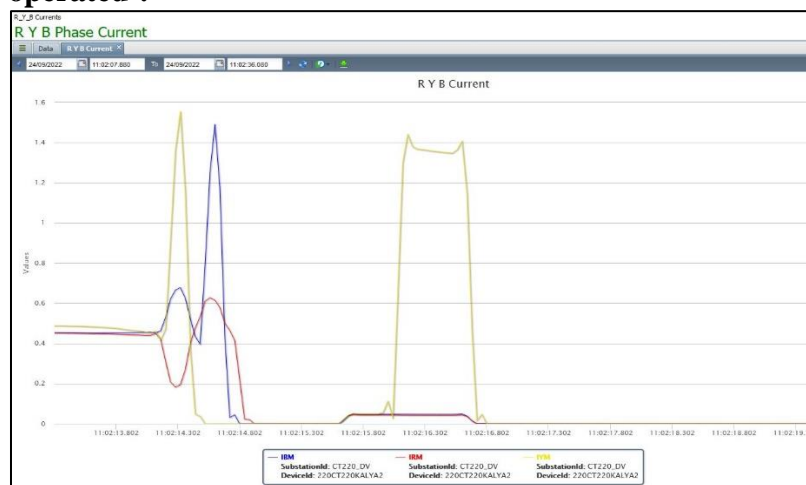
- Y-B phase fault occurred in Kalyaneswari ckt-2 and all 3 phases tripped and after 1 second 3 phase auto reclose occurred and all 3 phases got closed then again after 300 ms Y phase fault appeared persisted for approx. 600 ms and got cleared after that with all 3 phase opening .Suspected fault occurrence in this line 2 appears to be due to sag ,clearance issue with increased loading .**DVC may explain the nature of fault and protection operated ?**

- With tripping of Kalyaneswari Ckt-2 the other remaining circuit loading went upto 300 Mw as can be seen from SCADA as well as pmu but later after 30 seconds it reduced to

190 -200 Mw and after a minute this line also developed a R-Y phase fault possibly due to sag and clearance caused by Overloading. **DVC to check this aspect and explain the nature of fault and protection operated?**

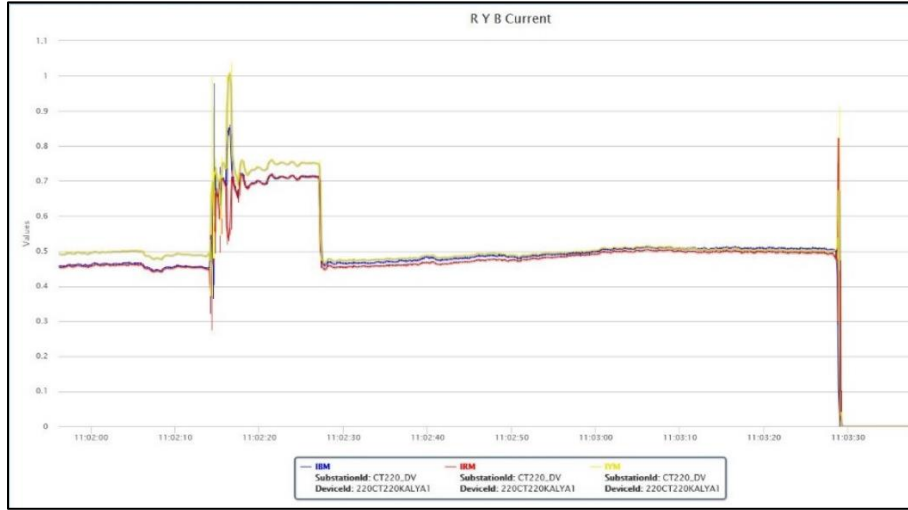
- With tripping of CTPS A-Kalyaneswari D/C complete ,CTPS A substation also became dead.
- Fault inception due to high loading may be checked as it occurred in both the lines of kalyaneswari , proper maintenance ,Row , clearance may be ensured to avoid such faults .

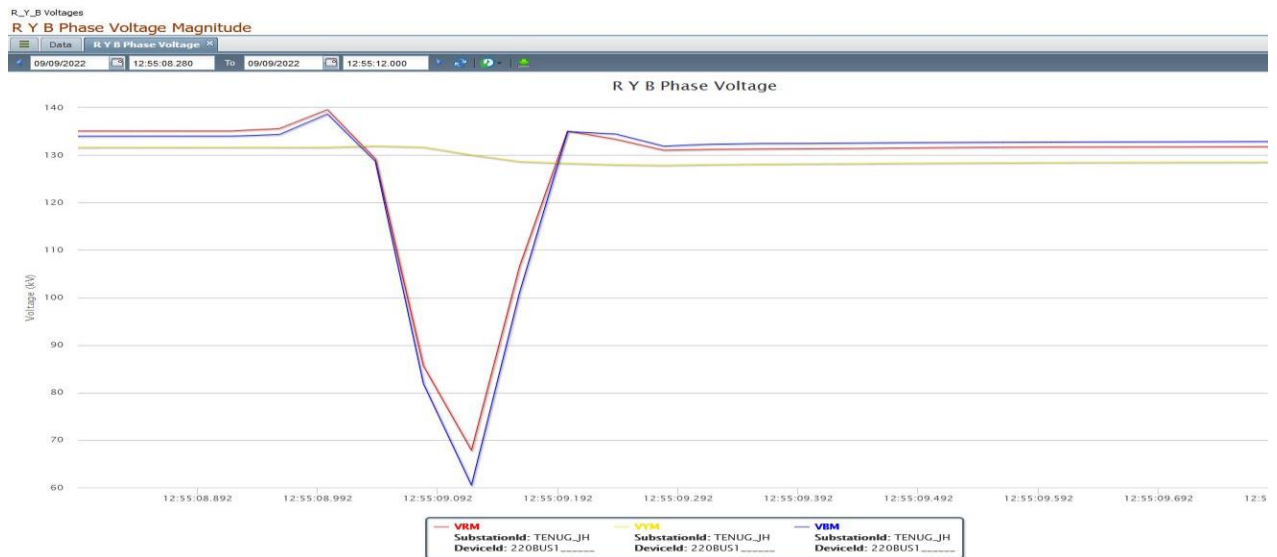
Figure 3: PMU voltage snapshot of 220 kV Tenughat S/s

- 220 kV Tenughat-Govindpur D/c tripped due to R\_B\_N fault within 100 msec.
- 210 MW U#2 at Tenughat tripped at the same time on O/c E/F. DR of Unit may be submitted.
- Earlier also, Units at Tenughat tripped on O/c immediately during any fault. Review of Hi-set O/c was recommended in earlier PCC meetings also. Status of the same maybe updated. **TVNL may explain.**
- 220 kV Govindpur-Dumka-1 also tripped at the same time. Details of the same maybe submitted.

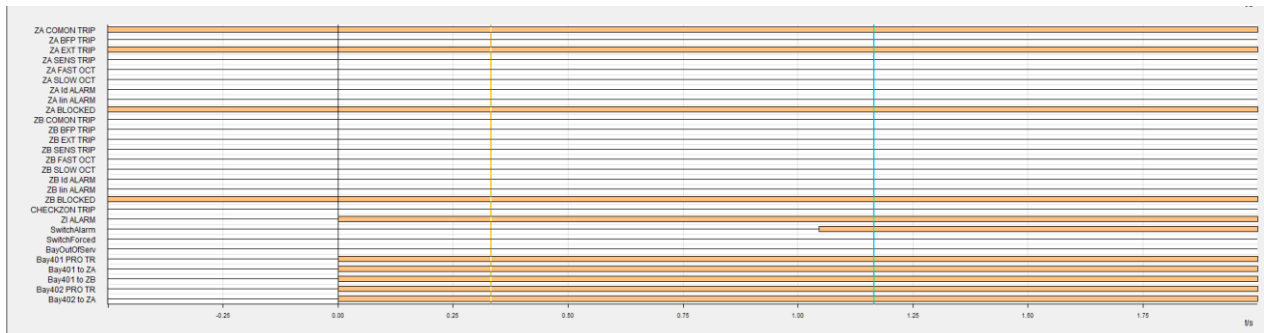
DR of 400 kV Bus-2 at Chandwa

- During testing work in 400 kV Bus-1 at Chandwa, 400 kV Bus-2 tripped. No fault observed from PMU data.
- External trip command triggered as per DR. PG ER-1 may share root cause analysis of the incident along with lessons learnt.

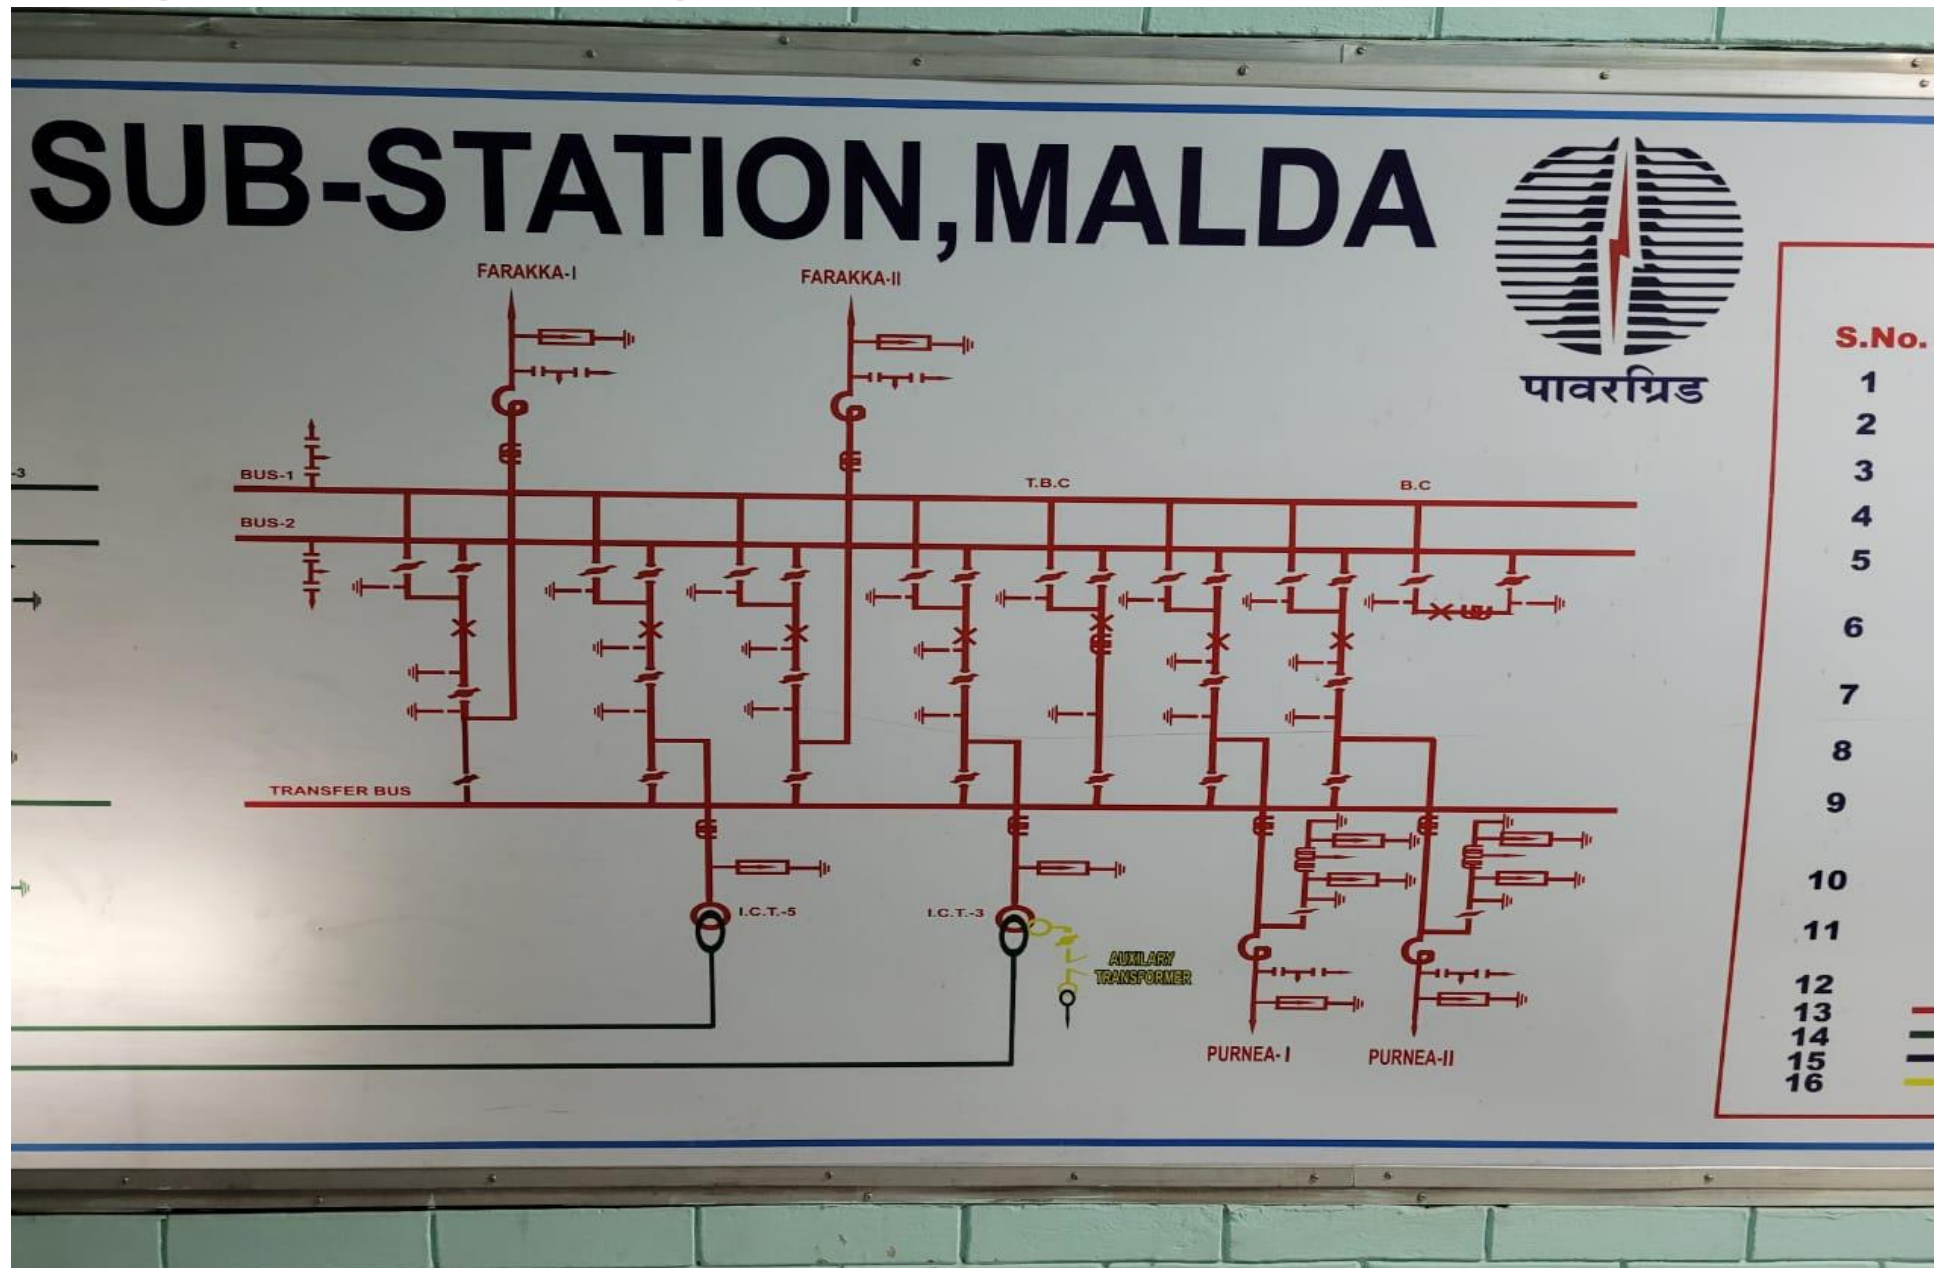
# Single line Diagram of 400 kV BUS

- Malda Substation is almost 40 years old. 400 kV Bus coupler CB and isolator and Purnea-I & II Isolators have crossed their useful life and require replacement.
- Also the control cables for bays are very old and their insulation level have degraded significantly. This causes DC earth fault in the substation.
- In both the 2022 and 2018 event DC earth fault is the primarily responsible for the mal operation. DC earth fault led to wrong status of B/C CB , consequently the bus bar protection mal operated during external fault.
- Check zone feature was disabled in REB670 relay by default. This was also one of the reason for Bus Bar mal operation.
- As many useful engineering drawing are lost during 1998 flood, therefore operation of Malda substation is very much challenging and require highly skilled manpower for its safe operation.

- As the Bus coupler bay is very old it may be replaced at the earliest along with control cable.
- Old control cable may be replaced.

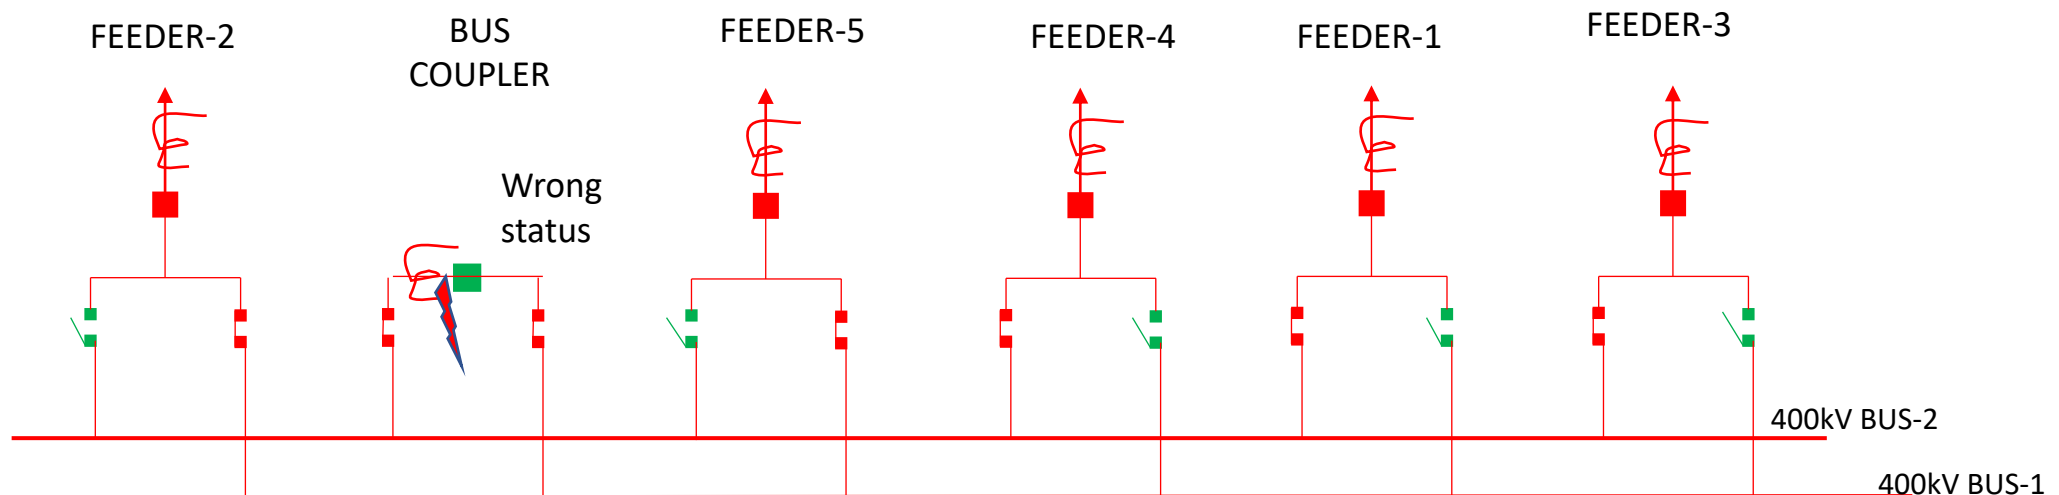
- The status of the Bus coupler made “forced close” using soft logic. That’s means now the B/C CB status will not be decided based on Auxiliary contact. The possible cons of this arrangement is that when BC will be under shut down and a fault happen between CT and CB(as shown) then both the Bus will be tripped, where as ideally only Bus-2 should trip
- However as switching of BC is planed activity and such fault are very rare that’s why it will not pose any serious lack. Also during B/C shutdown the setting can be changed.

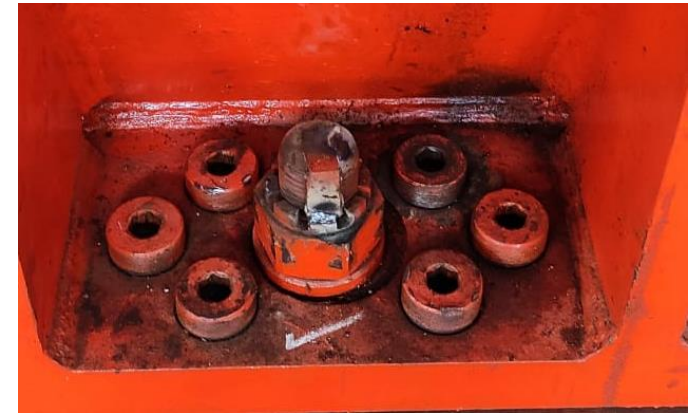
- Farakka STPP unit 6 tripped on 20-06-2022 due to turbine vibration. Later it was taken under annual overhauling. Then unit was revived on 15-08-2022. However, Unit tripped again 23-08-2022 due to vibration problem.
- NTPC informed that 2 out of 14 bolts of generator (shown in right side) were damaged and alignment was disturbed.
- LP turbine blade also got damaged and same is replaced.
- The reason for second tripping is vibration issue of next bearing.
