Agenda
for
120th PCC Meeting

EASTERN REGIONAL POWER COMMITTEE

AGENDA FOR 120th PROTECTION COORDINATION SUB-COMMITTEE MEETING TO BE HELD ON 16.11.2022 AT 10:30 HOURS THROUGH MS TEAMS ONLINE MEETING PLATFORM

ITEM NO. B.1: Repeated Disturbance at 220 kV Chatra(JUSNL) S/s

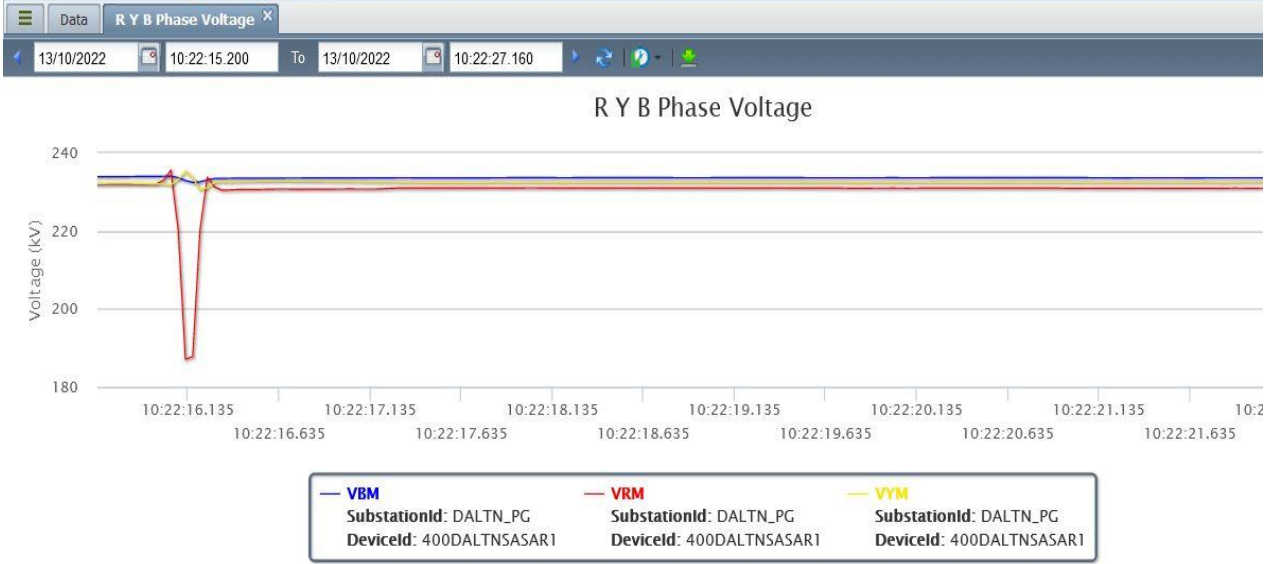
Figure 1: PMU snapshot of 400/220 kV Daltonganj S/s

Event 1: At 10:22 Hrs on 13.10.2022, 220 kV Daltonganj-Chatra-1 tripped due to R_N fault. Total power failed at Chatra S/s as it is being fed radially through only one circuit. 220 kV Daltonganj-Chatra-2 is LILLOed at Latehar, however, 220 kV Latehar-Chatra is not charged yet. 17 MW load loss reported at Chatra by Jharkhand SLDC.

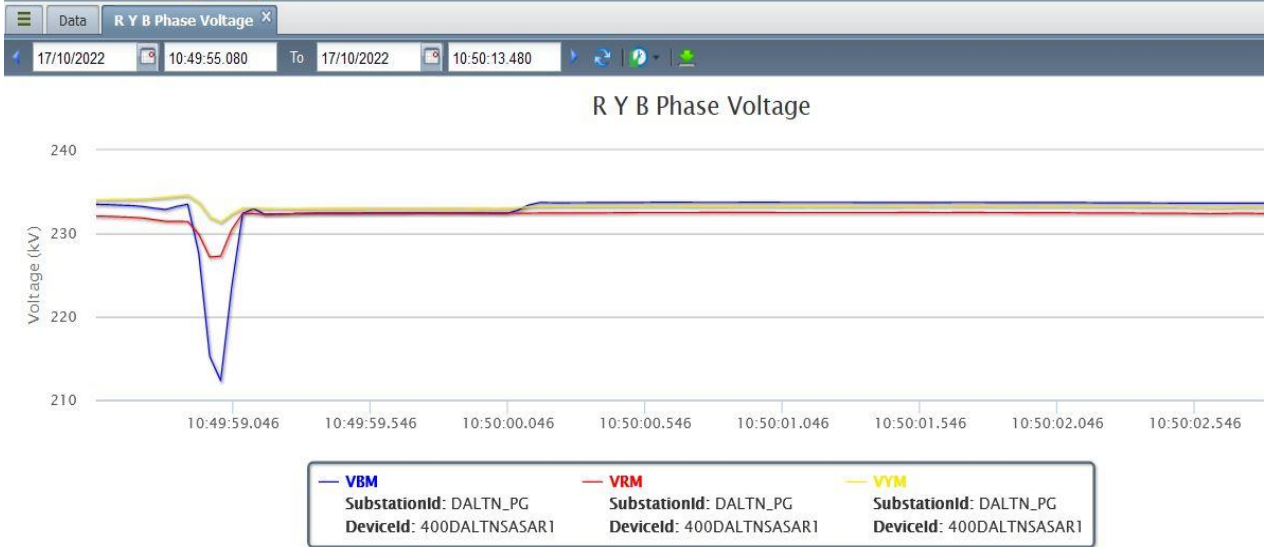
Figure 2: PMU snapshot of 400/220 kV Daltonganj S/s

Event 2: At 10:50 Hrs on 17.10.2022, 220 kV Daltonganj-Chatra-1 tripped due to B_N fault. Total power failed at Chatra S/s as it is being fed radially through only one circuit. 220 kV Daltonganj-Chatra-2 is LILoed at Latehar, however, 220 kV Latehar-Chatra is not charged yet. 17 MW load loss reported at Chatra by Jharkhand SLDC.

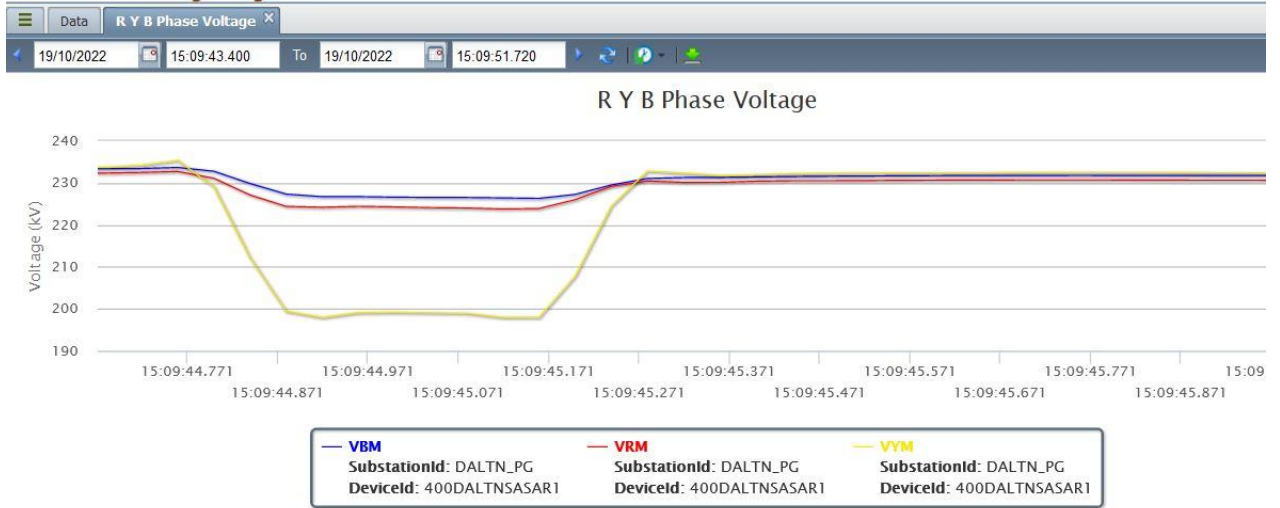
Figure 3: PMU snapshot of 400/220 kV Daltonganj S/s

Event 3: At 15:09 Hrs on 19.10.2022, 220 kV Daltonganj-Chatra-tripped due to Y_N fault. Total power failed at Chatra S/s as it is being fed radially through only one circuit. 220 kV Daltonganj-Chatra-2 is LILoed at Latehar, however, 220 kV Latehar-Chatra is not charged yet. 10 MW load loss reported at Chatra by Jharkhand SLDC.

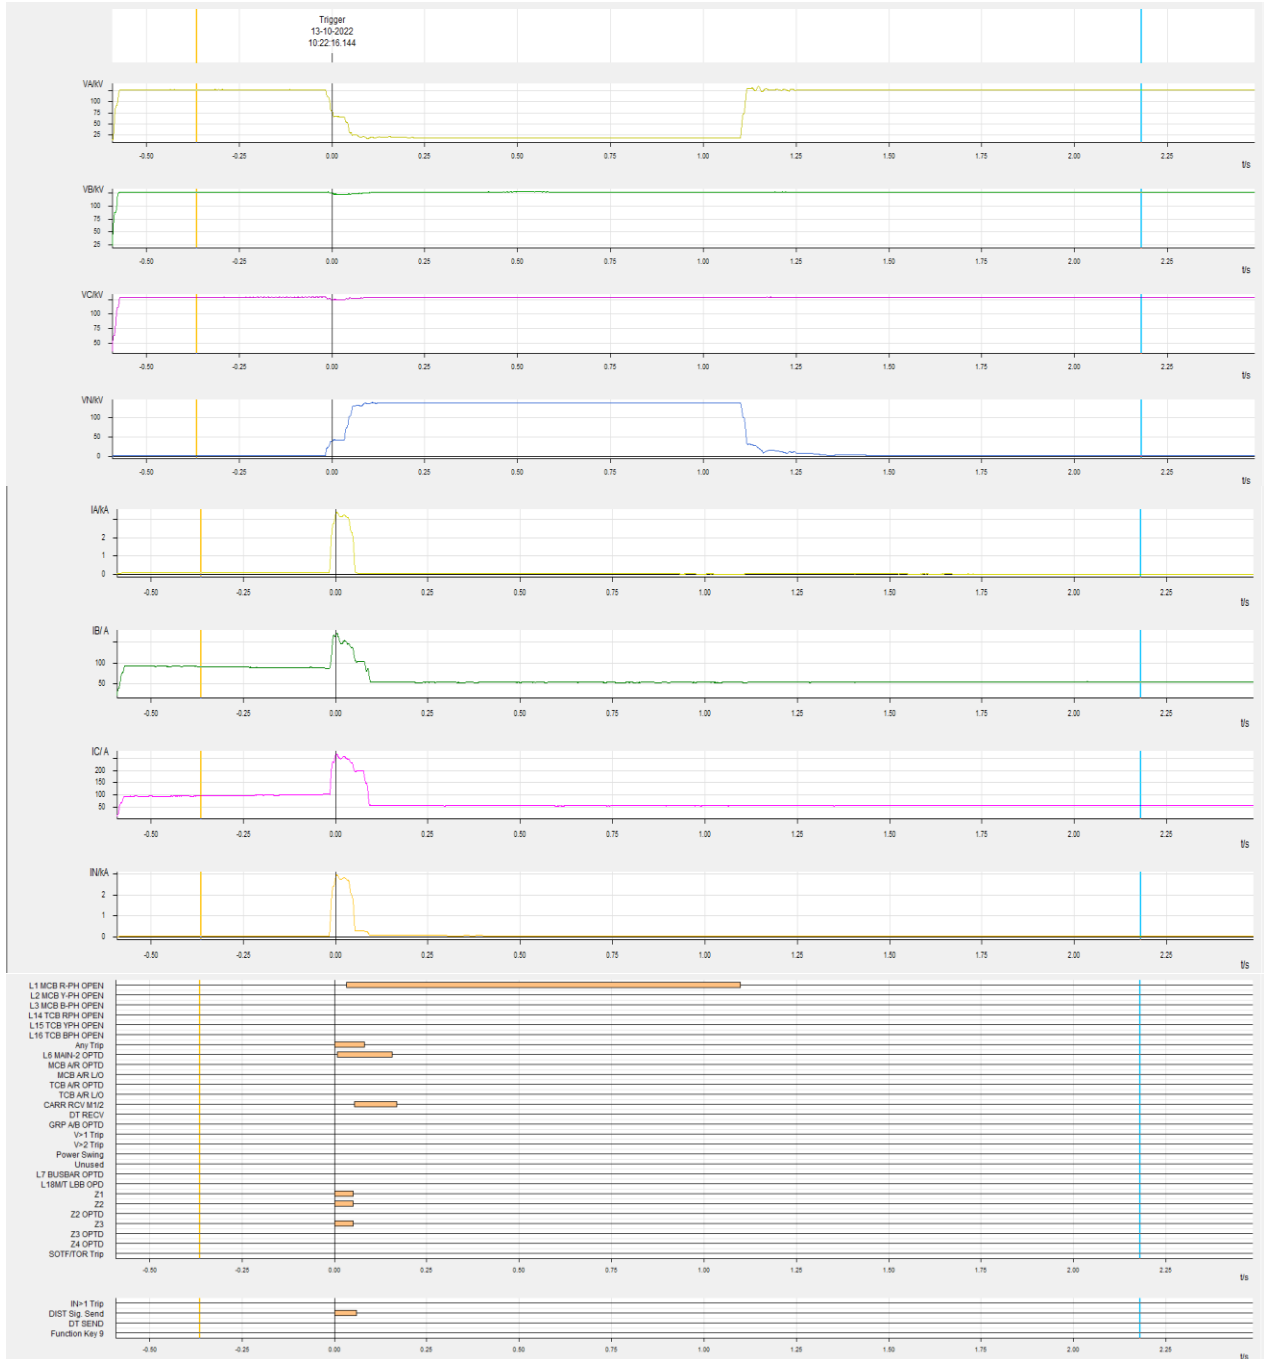
DR of 220 kV Daltonganj-Chatra-1 (Daltonganj end)-Event 1

- In 1st and 2nd event, A/r was successful from Daltonganj only. Issue of Non-A/r at Chatra end has been flagged multiple times. JUSNL may update.
- In 3rd event, fault was cleared from Daltonganj in Zone-2 time, suggesting failure of carrier protection. JUSNL may explain.
- Both LILO portions of 220 kV Daltonganj-Chatra-2 at Latehar has not been charged yet, hence affecting reliability of power supply at Chatra. JUSNL to explain the reason for delay in charging of the line.
