Agenda for **122nd PCC Meeting**

EASTERN REGIONAL POWER COMMITTEE

AGENDA FOR 122nd PROTECTION COORDINATION SUB-COMMITTEE MEETING TO BE HELD ON 16.01.2023 AT 10:30 HOURS THROUGH MS TEAMS ONLINE MEETING PLATFORM

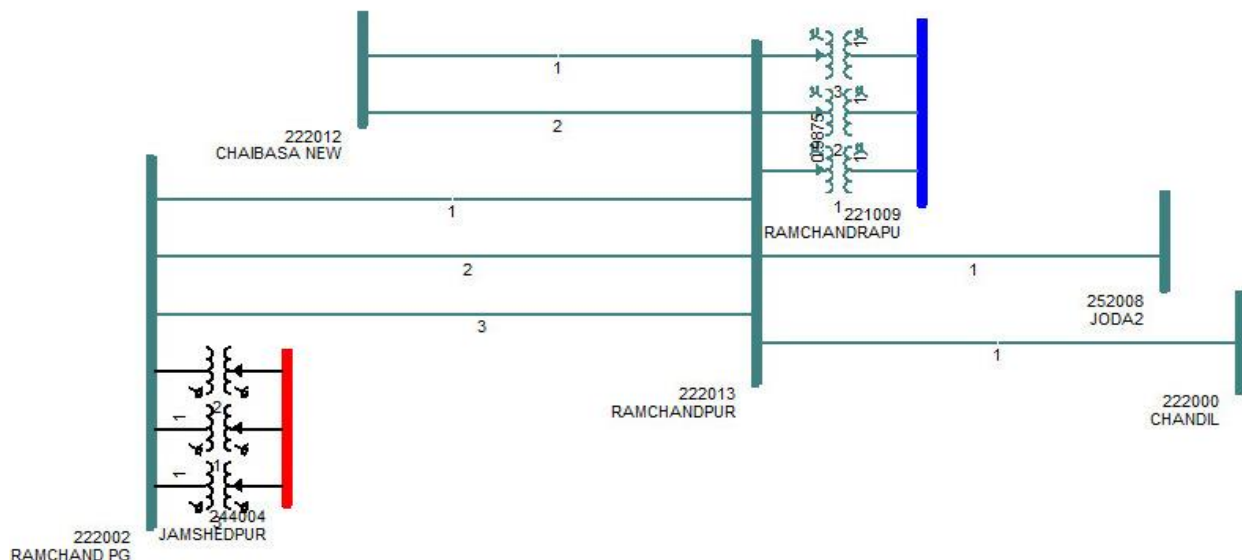
On 17.12.2022 at 10:45 hrs, there was CT burst for B phase of 220 kV Ramchandrapur-Chaibasa-1 at Ramchandrapur leading to operation of Bus Bar protection. Subsequently 220 kV Bus-1 got tripped. At 11:23 Hrs, 220 kV Main Bus-2 was made off by tripping remaining feeders as a precautionary step in order to extinguish fire caused by CT blast. Consequently, total supply failed at Ramchandrapur.

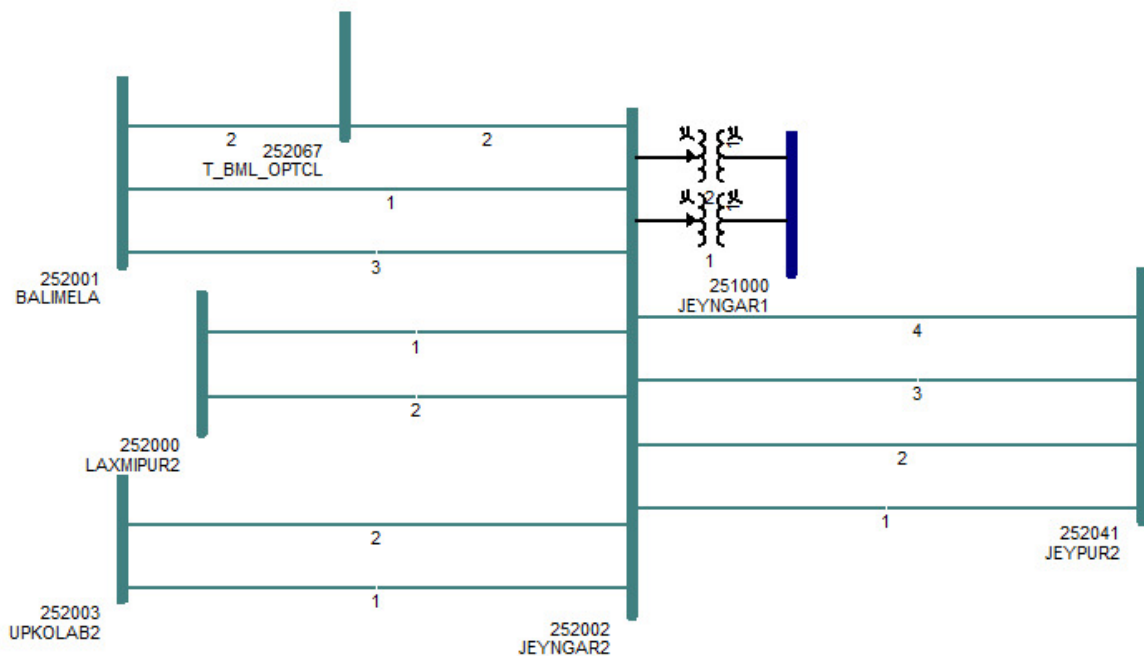
On 24.12.2022 at 12:05 Hrs, 220/132 kV Jayanagar and 220 kV Balimela S/s became dead. One running unit, U#5 at Balimela got tripped during the event. As per PMU, there was a high resistive fault in R phase which got persisted for around 5 seconds and subsequently evolved to a R_B_N fault.

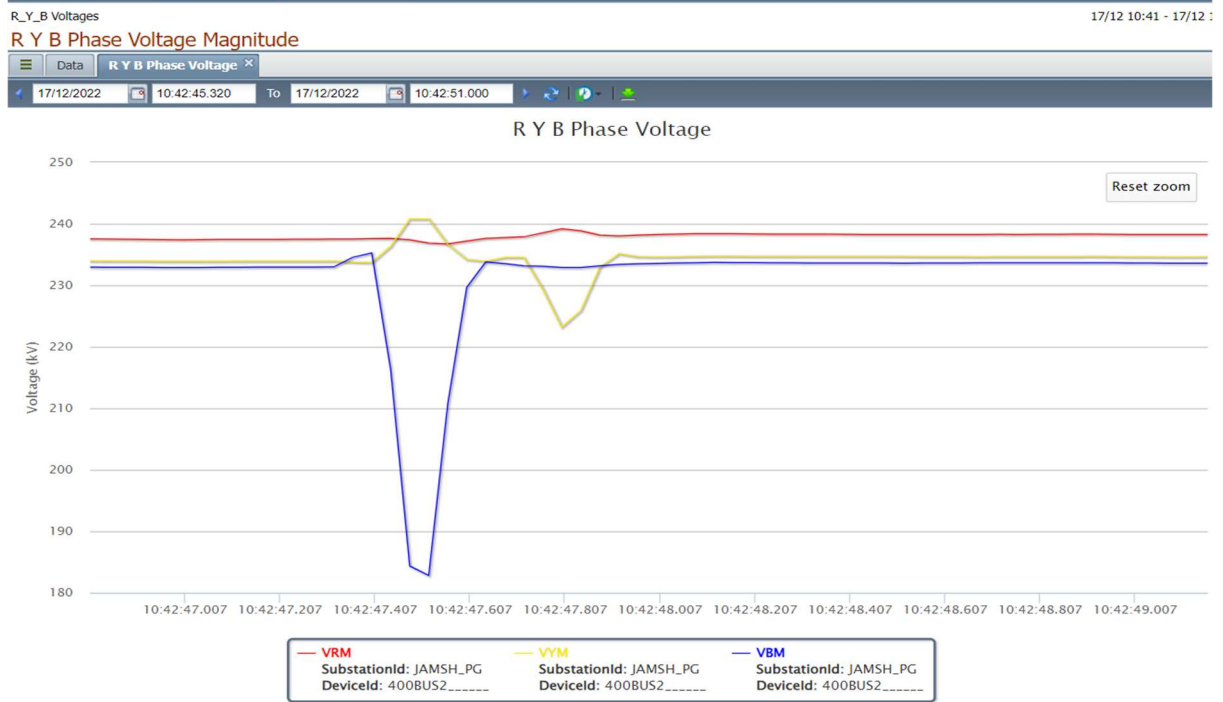
Figure 3: PMU snapshot of 400/220 kV Jamshedpur S/s

समय	नाम	उप केंद्र 1 रिले संकेत	उप केंद्र 2 रिले संकेत	पीएमयू पर्यवेक्षण
10:45	220 kV Bus-1 at Ramchandrapur	Bus Bar protection operated	-	Around 50 kV dip in B_ph voltage at Jamshedpur. Fault clearance time: 200 msec
	220 kV Ramchandrapur-Jamshedpur 1, 3		-	
	220 kV Ramchandrapur-Chaibasa-1		Chaibasa: Didn't trip	
	220 kV Ramchandrapur-Chandil		-	
	220 kV Ramchandrapur-Joda		-	
	220/132 kV ATR-3 at Ramchandrapur		-	
11:23	220 kV Bus-2 at Ramchandrapur	Hand-tripped	-	-
	220 kV Ramchandrapur-Chaibasa-2		-	
	220/132 kV ATR-2 at Ramchandrapur		-

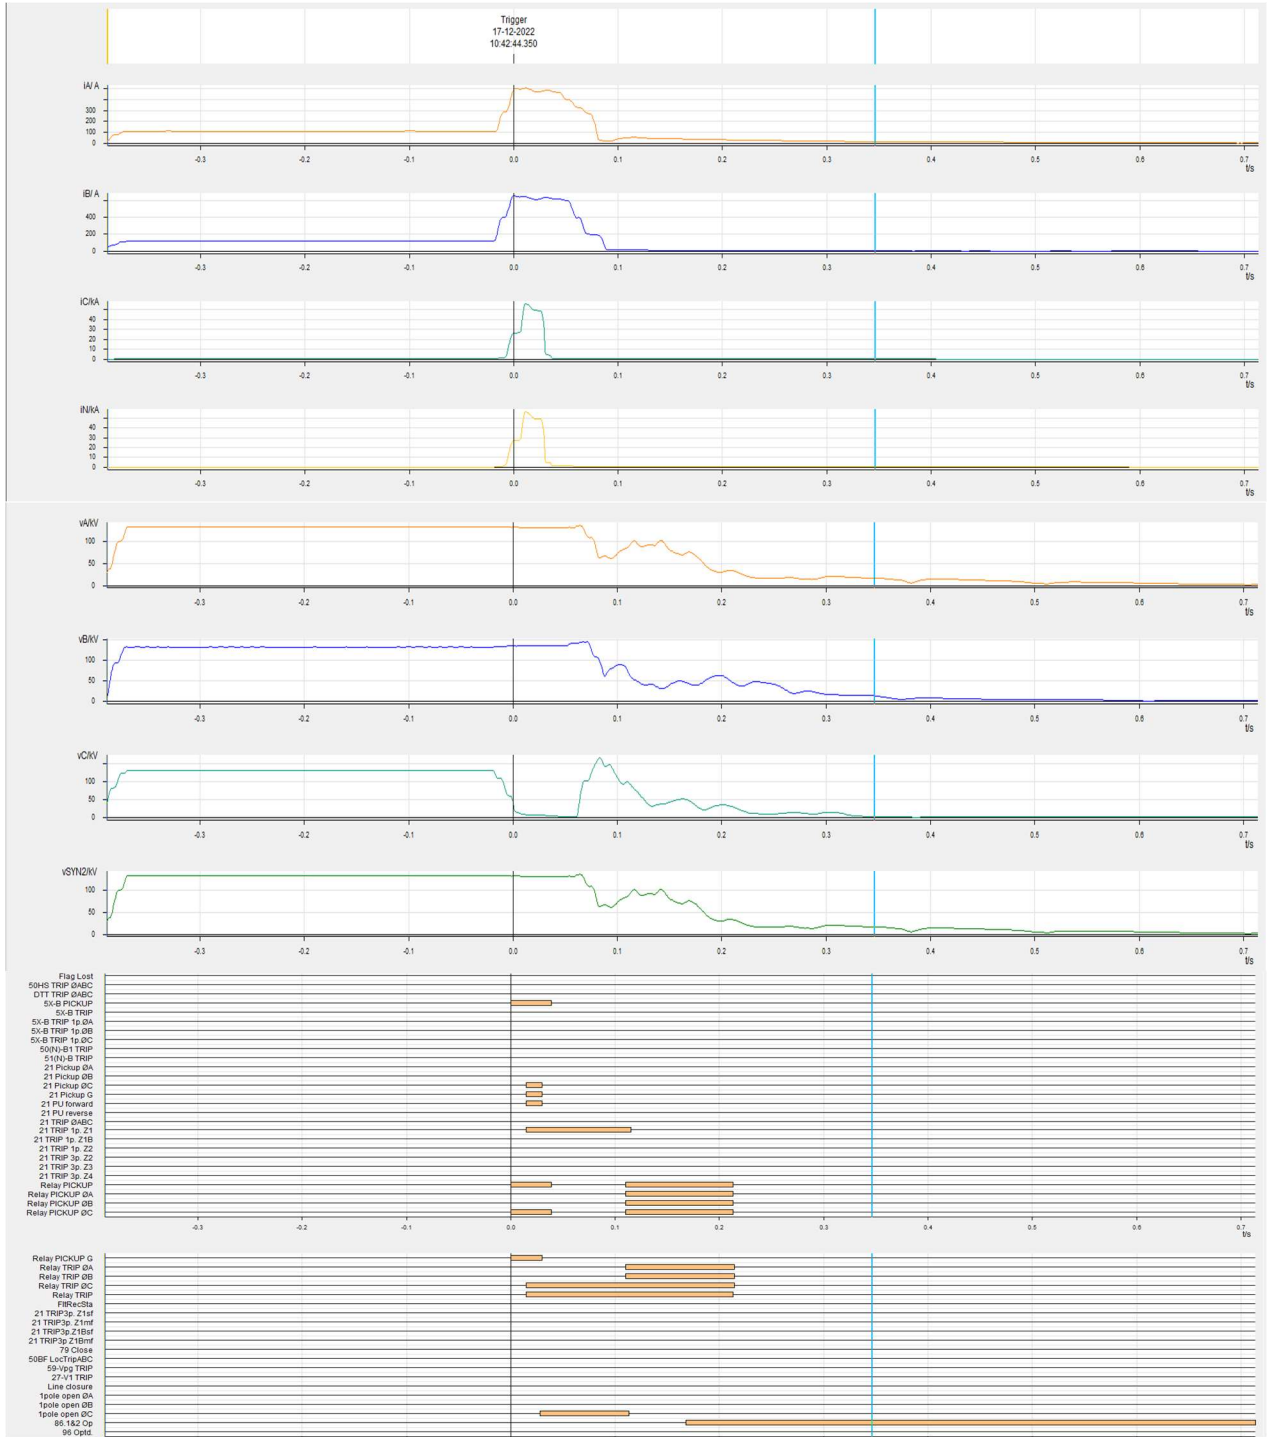
DR of 220 kV Ramchandrapur-Chaibasa I (Ramchandrapur)

At 10:45 hrs, B_ph CT of 220 kV Ramchandrapur-Chaibasa-1 burst at Ramchandrapur, leading to operation of Bus Bar protection and 220 kV Bus-1 tripped. At 11:23 Hrs, 220 kV Main Bus-2 was made off by tripping remaining feeders as a safety precaution and to extinguish fire caused by CT blast. Consequently, total supply failed at Ramchandrapur. 296 MW load loss reported at Adityapur, Rajkharsawan, Jadugoda and Golmuri

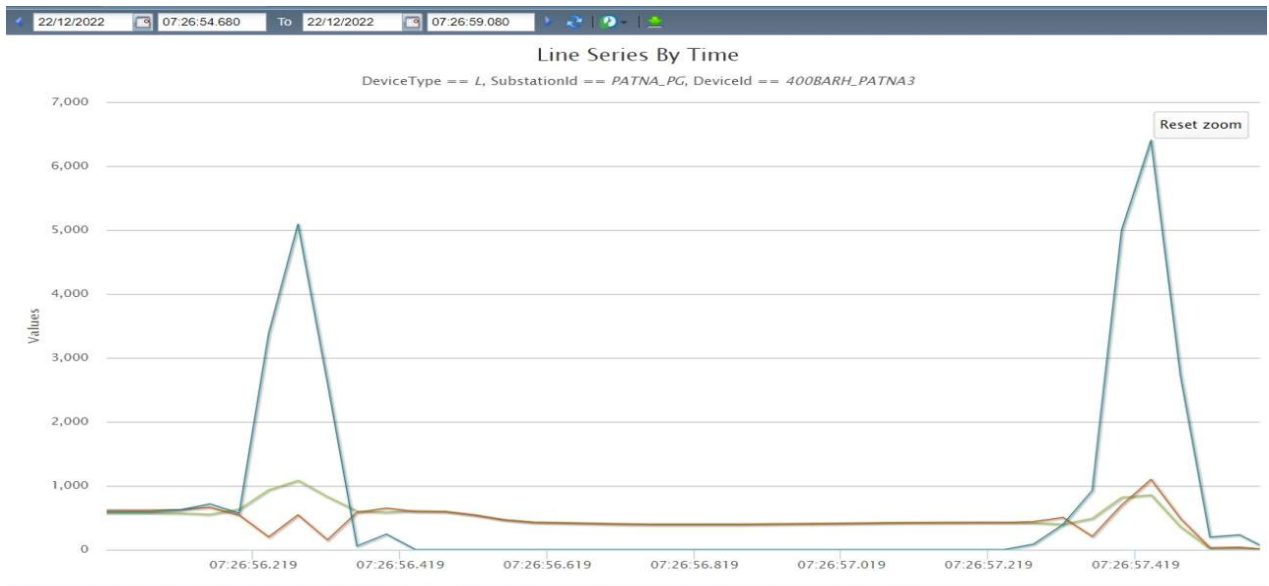
Figure 3: PMU Current snapshot of 400 kv Barh-Patna-3 at Patna S/s

समय	नाम	उप केंद्र 1 रिले संकेत	उप केंद्र 2 रिले संकेत	पीएमयू पर्यवेक्षण
07:26	400 kv Barh-Patna-3	Barh: B_N, 18.5 km, 25.06 kA	Patna: B_N, 68.9 km, 8.6 kA	5 kA fault recorded at Patna. Fault clearance time 100 msec. Other two phase at Barh remained closed.
	660 MW U#1 at Barh	GT tripped

- At 07:26 Hrs, 400 kV Barh-Patna-3 tripped due to B_N fault. A/r attempted from Patna after 1 second but failed due to persisting fault
- At Barh end
 - voltage in R_ph (healthy phase) spiked momentarily to 570 kV. Double earthing reported at Junction box and relay panel.

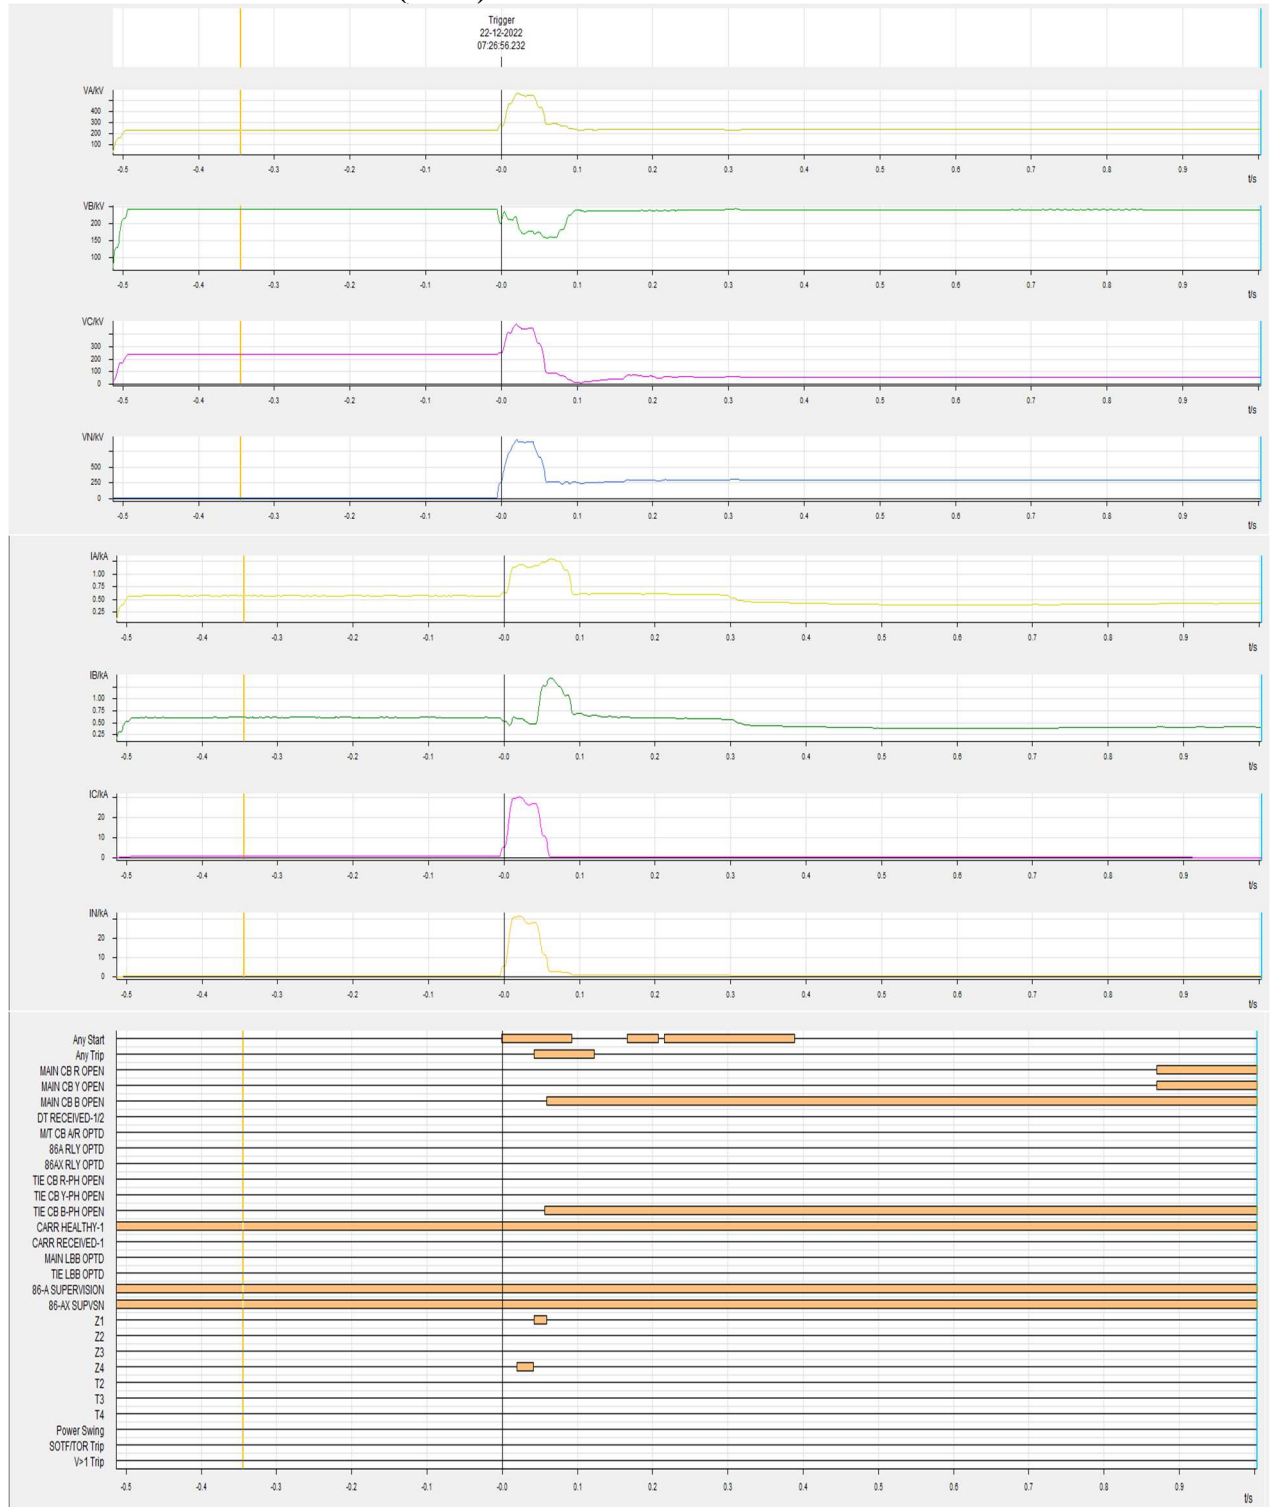
DR of 400 kV Barh-Patna-3 (Barh)

- After 850 msec, other two phase of main bay at Barh opened. Reason for opening of other two phase before failed A/r attempt could not be ascertained. **Barh may explain.**

- Other two phase of tie bay at Barh remained closed for around 12 seconds. As reported, no A/r attempt was taken as CB status was **CB not ready**. 86 relay operated after 12 seconds. This relay was found having sluggish response with a delay of 10-15 seconds. The same was replaced.

2. On further analysis it was observed that all three poles of main breaker at Barh end had opened whereas R, Y pole of tie breaker remained closed and tripped after a delay of 12 seconds.

- b. Auto-reclosure operation was attempted. It was successful for main breaker of Barh-Patna 3, but unsuccessful for tie breaker.
 - c. On further analysis it was observed that 'CB not ready' status was being read by the auto-reclosure relay (KAVR) which ultimately led to auto reclose lockout and 3-phase tripping.

- d. Secondly, 86 relay operation due to auto reclose lockout was having a sluggish response. The relay operated after approximately 10-15 seconds.
 - e. The relay wiring and 86 relay was checked thoroughly. No problem in wiring was detected. For safety precaution, 86 relay was replaced.

3. On 23.12.2022, shutdown was taken for analysing the discrepancy in Barh-Patna tie breaker at Barh end.
 - a. Tie breaker was initially tested for pole discrepancy. Problem was found in breaker interpole cabling of B phase. The problem was rectified, and pole discrepancy circuit was made through.

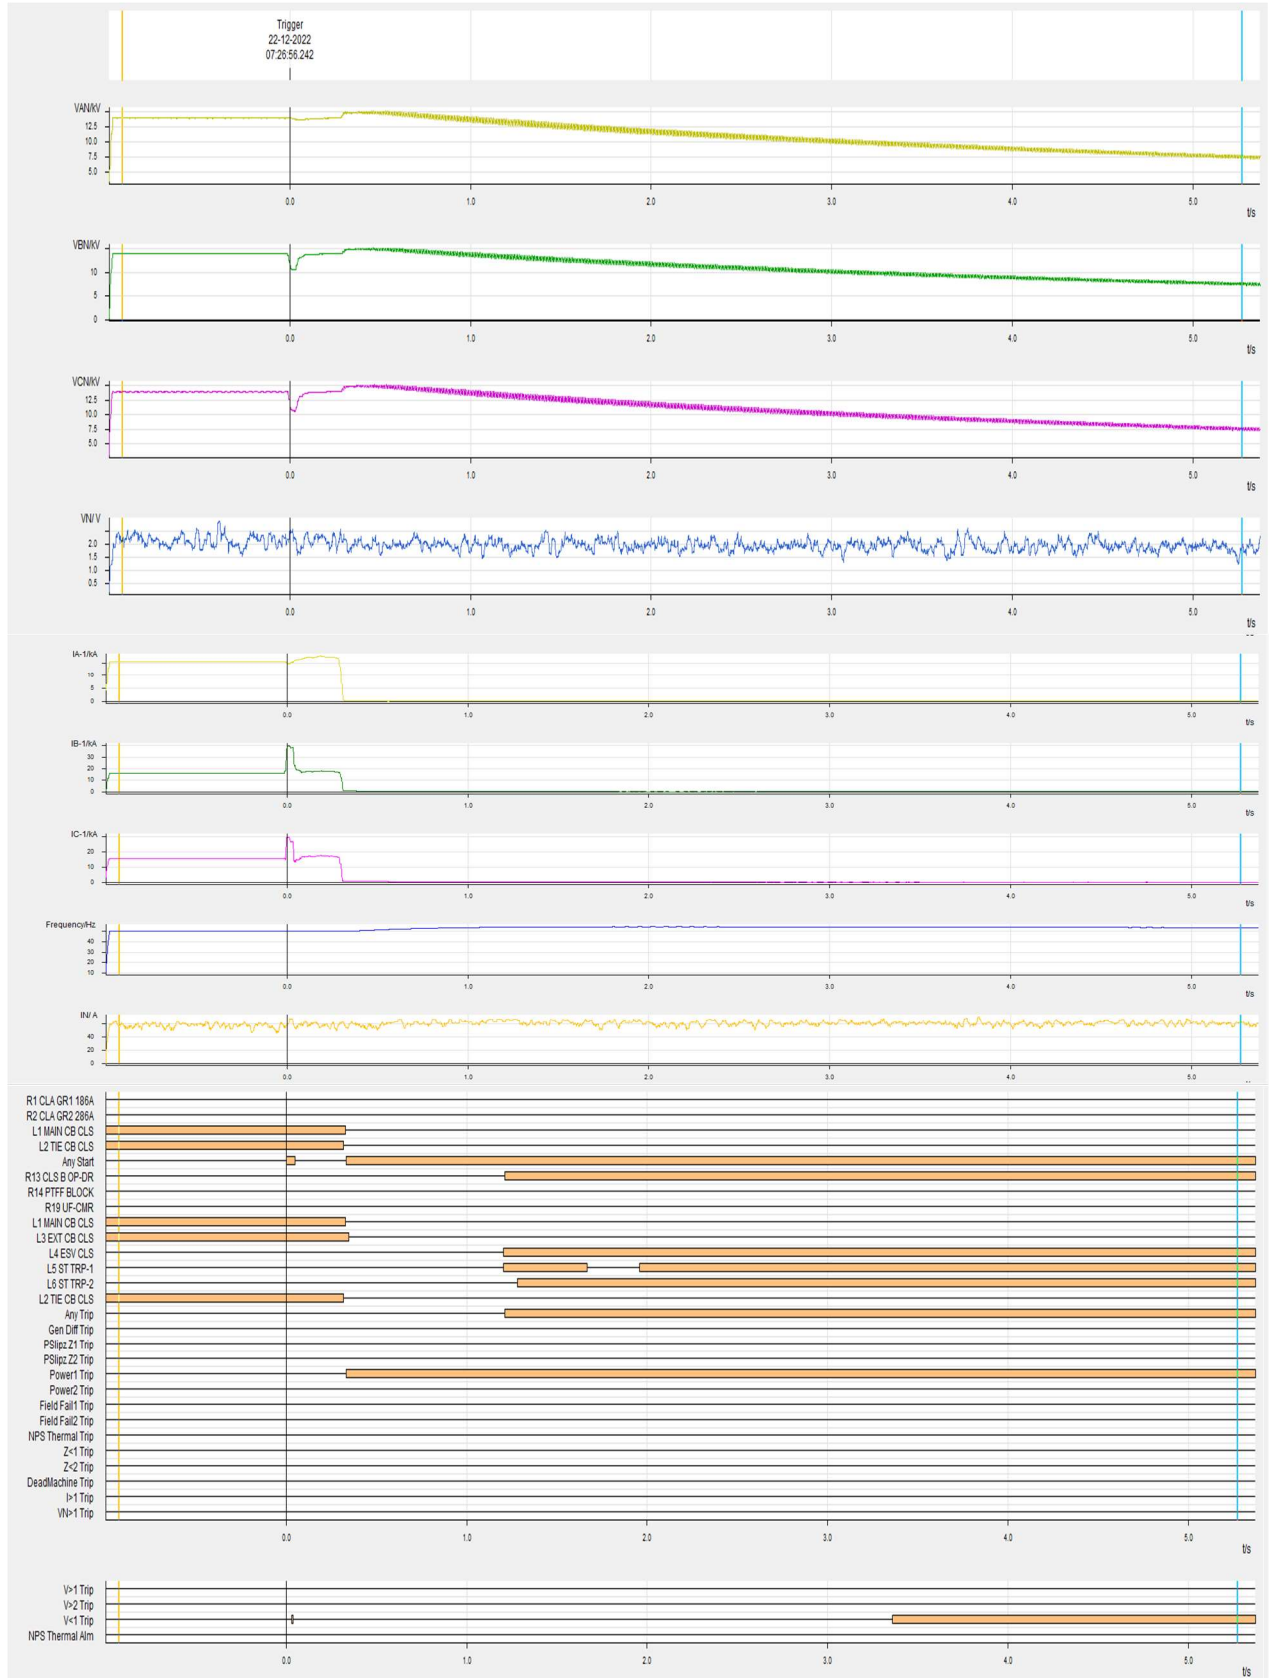
DR of U#1 Barh

- **U#1 at Barh**
 - U#1 tripped as its GT tripped on Buchholz protection. As reported by NTPC Barh, Buchholz relay might have operated spuriously as heavy fault current might have increased transformer vibration and its Buchholz relay have mercury float switch with history of maloperation. The same has been replaced with magnetic reed switch.

3. At this very instance, Unit#1 at NTPC Barh tripped on Class-A protection. As per SCADA event log, it was observed that Generator Transformer#1B phase Buchholz relay had operated. As per event log it was also observed that Buchholz operation event reset within 40 milliseconds.

4. After inspection in GT#1B, no gas accumulation was observed in Buchholz relay. Oil sampling from transformer tank top and bottom was done and sent for DGA.

9. As a remedial action, Buchholz relay with magnetic reed switches have been replaced in the Generator Transformer.

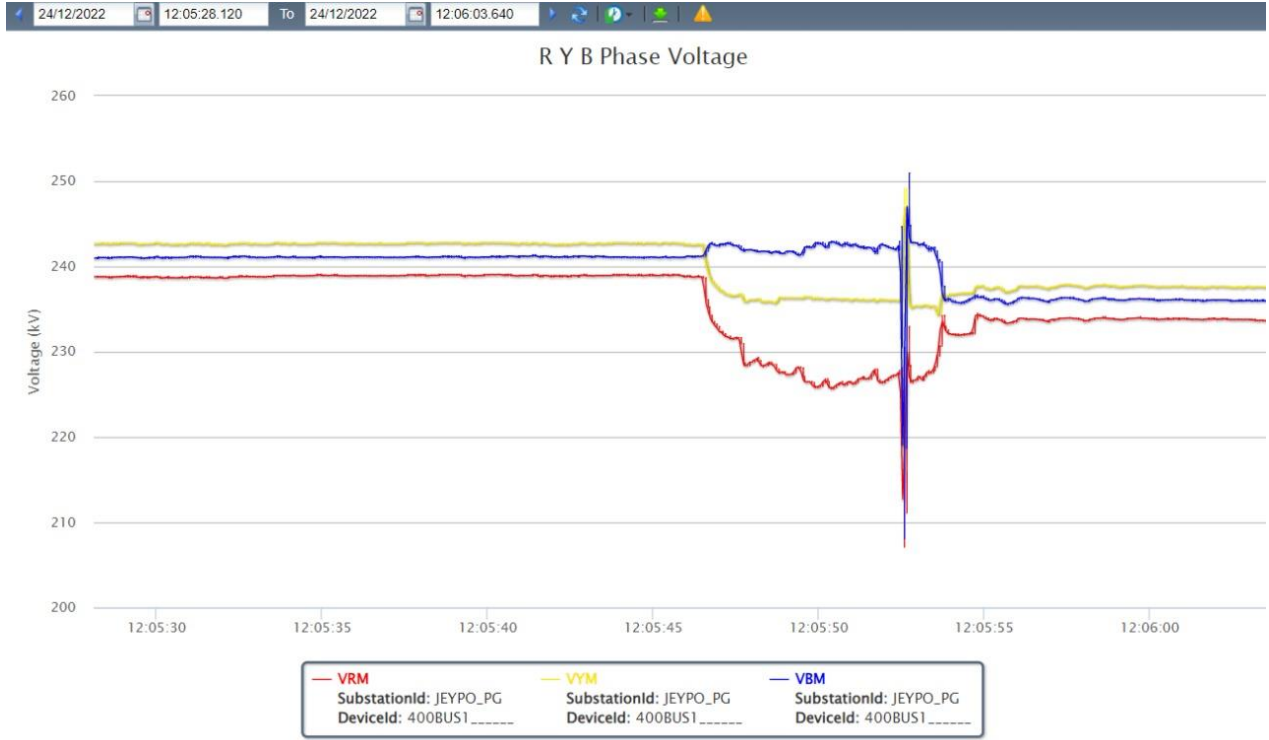
Figure 2: PMU voltage snapshot of 400/220 kV Jeypore S/s

13	160MVA Auto-1	Tripped with Over flux protection	132KV system not disturbed due to availability of source from machhkund P/H and Tentulikhunti GSS
14	160MVA Auto-2	Tripped with Over flux protection

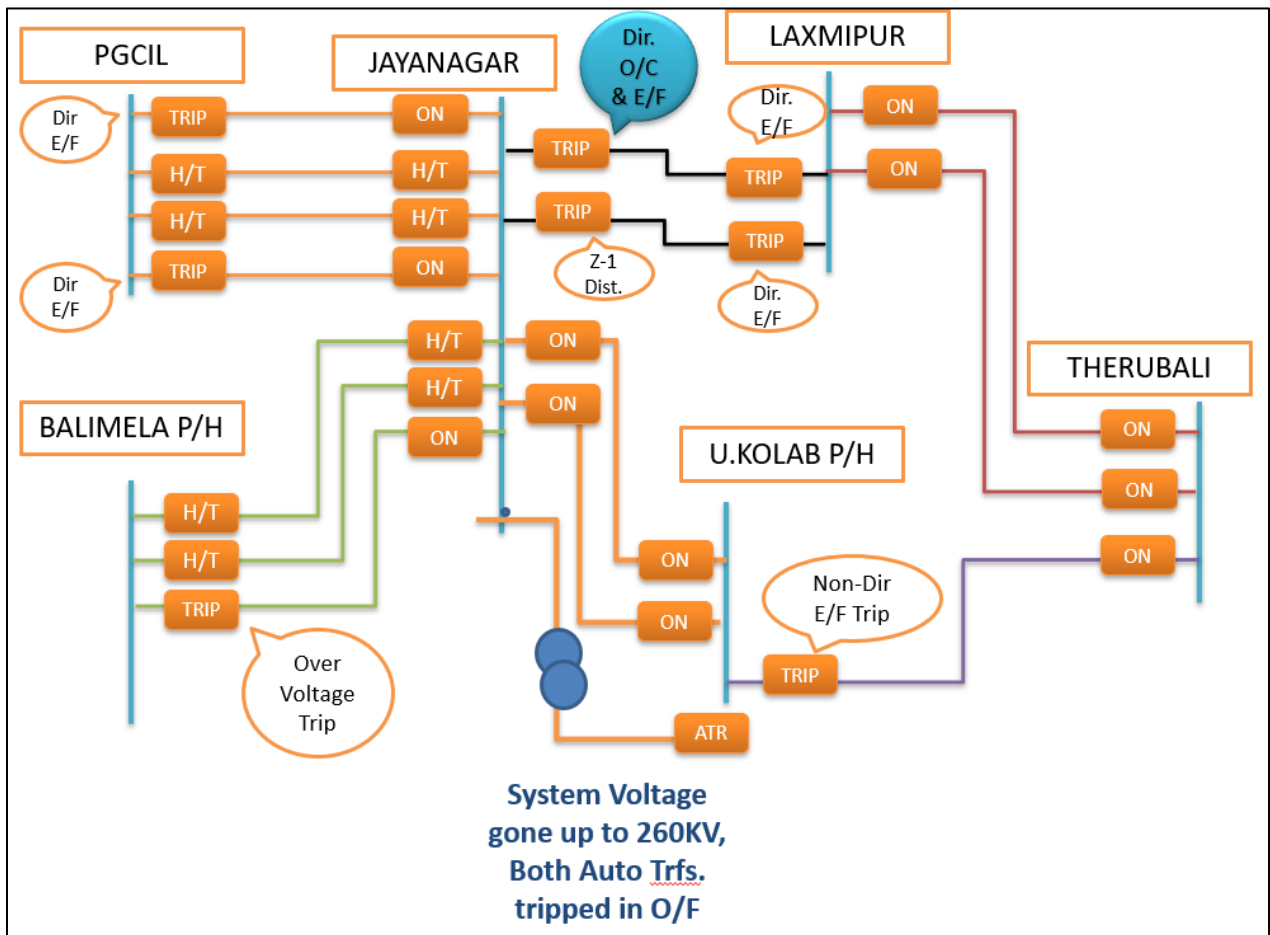
- As reported, at 12:05 Hrs there was R phase fault in 220 kv Jeynagar – Laxmipur -1 (R phase wave trap burnt) the nature of fault was of high resistive nature and fault current was slowly rising as can be seen from above PMU plot .

- At the same time 220 kv Jeynagar – Laxmipur -2 developed B -phase to earth fault may be due to smoke, made a conducting path and line tripped from Jayanagar end in Zone-1 and from Laxmipur end in directional E/F after a long delay. **Distance Protection should have also sensed the fault from Laxmipur of ckt -2 as B phase fault was sudden and also as visible from DR Line voltage persisted for a long time even after opening of breaker from Jayanagar end and . OPTCL to explain.**

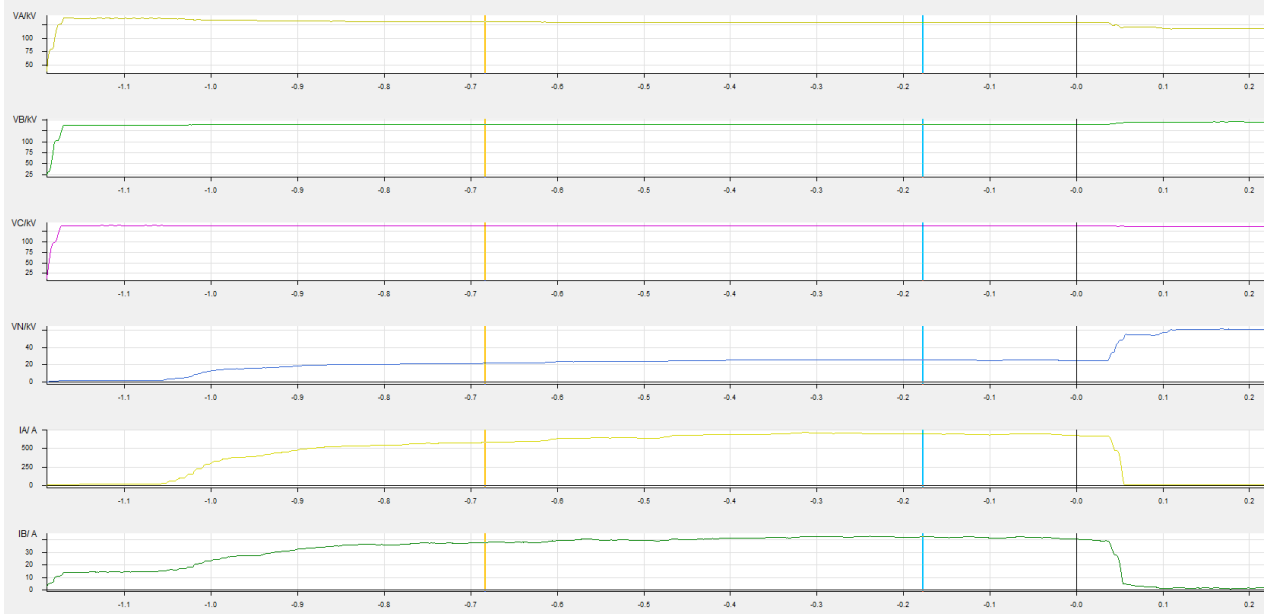
Jeynagar-Laxmipur-1 at Laxmipur end:

At 12:05 Hrs on 24th December 2022, R_ph wave trap of 220 kV Jaynagar-Lakshmipur-1 burnt at Jaynagar end. Total power failure occurred at 220/132 kV Jaynagar, 220 kV Balimela, Upper Kolab S/s. 220 kV Bus-1 at Jeypore (PG) along with 400/220 kV ICT-1 & 3 also tripped. 40 MW load loss occurred at Jaynagar. Two running units at Upper Kolab and one unit at Balimela tripped leading to 90 MW generation loss (Upper Kolab-40 MW, Balimela-50 MW).
