Eastern Regional Power Committee

Sub: Minutes of the 127th PCC meeting held on 22.06.2023

Minutes of 127th PCC Meeting

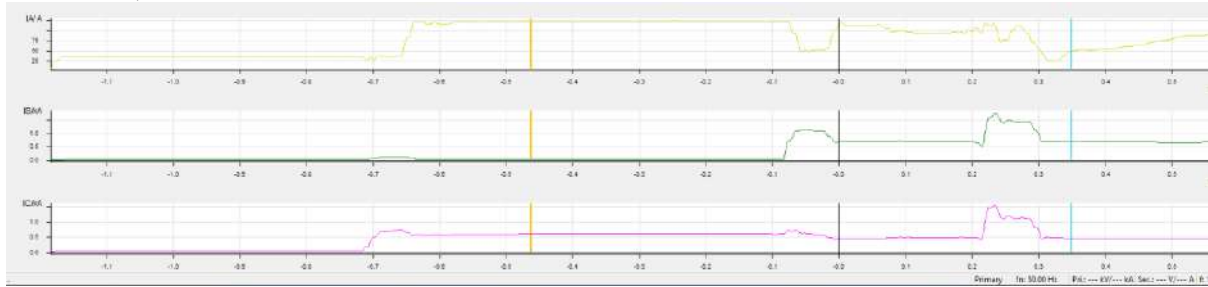
at Therubali end. Y phase converted to Y-B, sensing fault in zone-3 but dropped due to current reduction ,

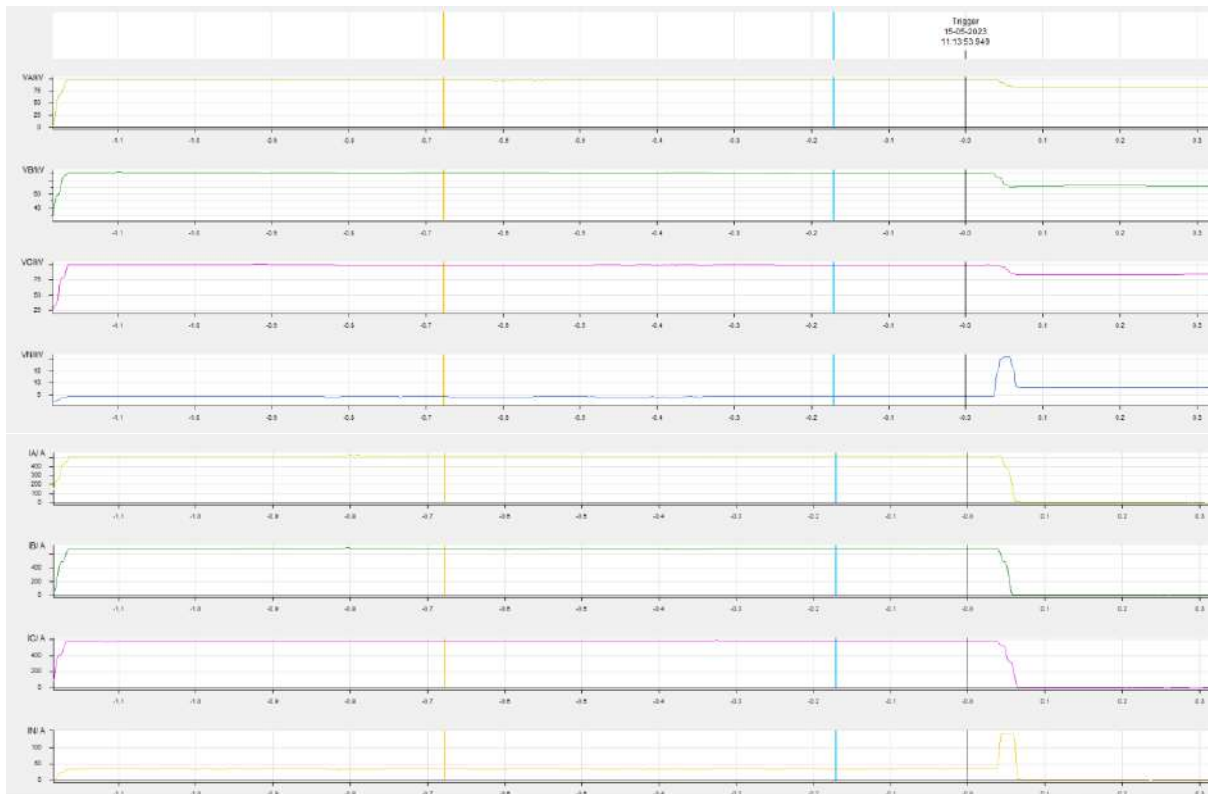
11:13:53:943 at T+11: Laxmipur end :Y-B phase fault and F/C , 600 amps and IN=600 Amps persisted for 11 seconds and line tripped from Laxmipur end after 11 seconds Line current zero but line voltage was persisting which means breaker was closed from Therubali end .Tripped on I>1, why it took 11 seconds to operate , Overcurrent protection setting to be checked , and if DEF enabled it should have also operated, both things to be checked.

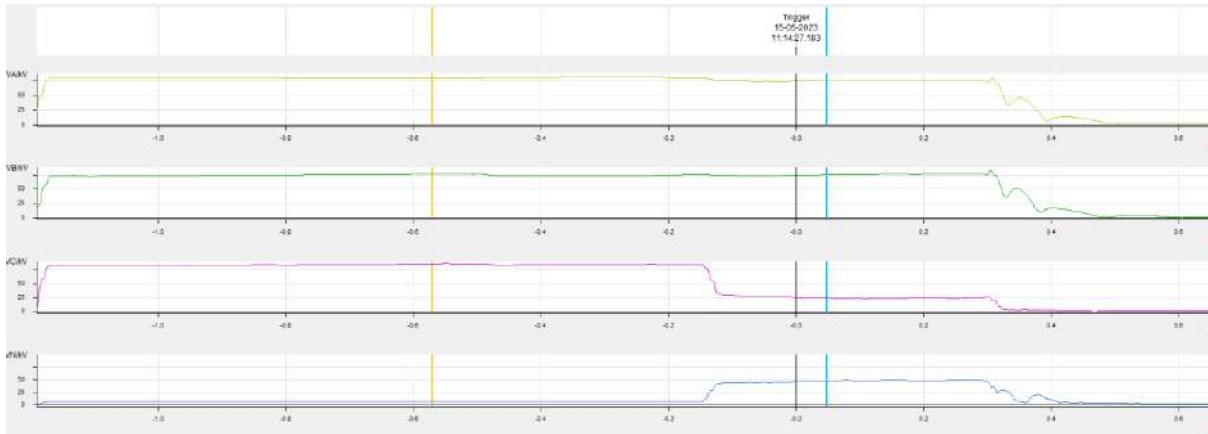
11:14:27:183 at T+45:

At Laxmipur end finally Line voltage became zero which means breaker also opened from Therubali end after 45 seconds.

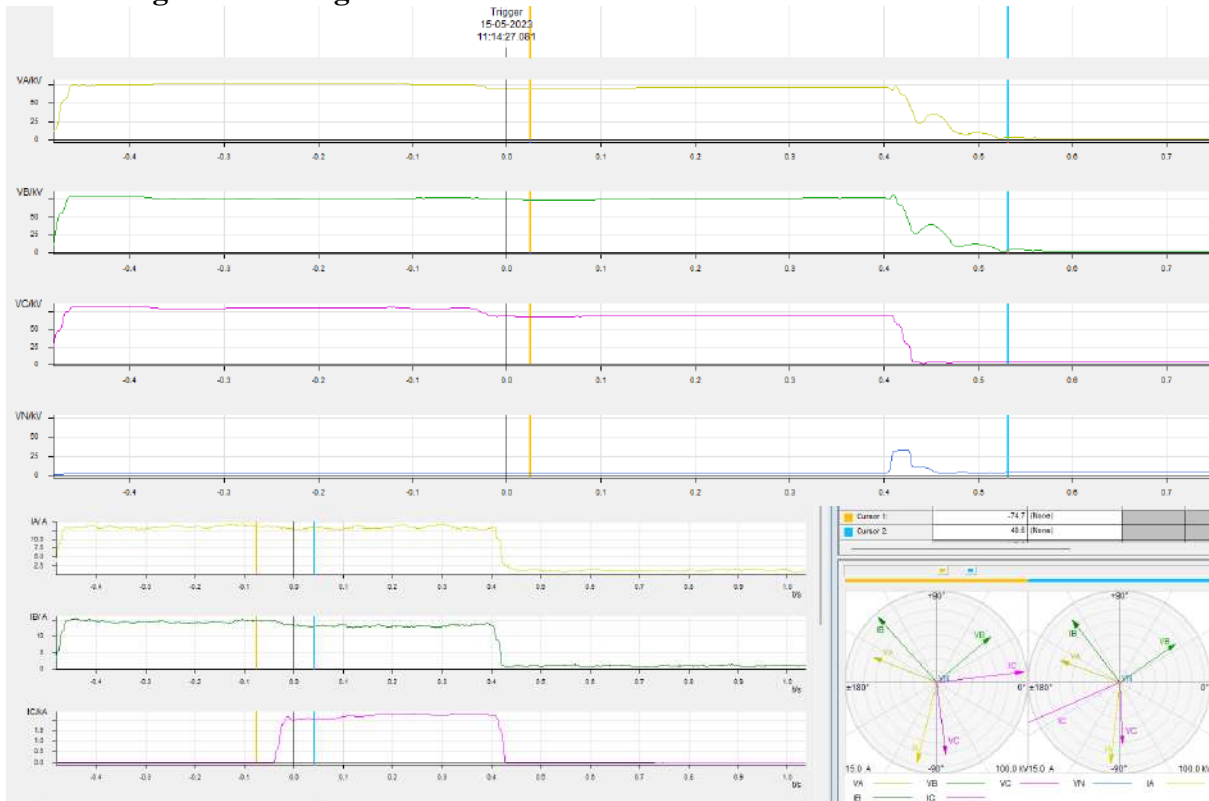
At Therubali end : Therubali Laxmipur-1 at Therubali end tripped in Zone-4. Initially only charging current was flowing as line tripped from Laxmipur end which is evident from DR, V & I 90 degree apart, but suddenly B phase fault appeared in zone-4 and current reversal also took place and it tripped in z-4.

If breaker tripped from laxmipur how it got path to feed current in reverse even if both lines touch via opgw snapping fault current path should be forward to Therubali.

Line is 65 Km and Z-4 distance in relay is 41 km, this may be checked as z-4 reach seems to be set at higher much higher.

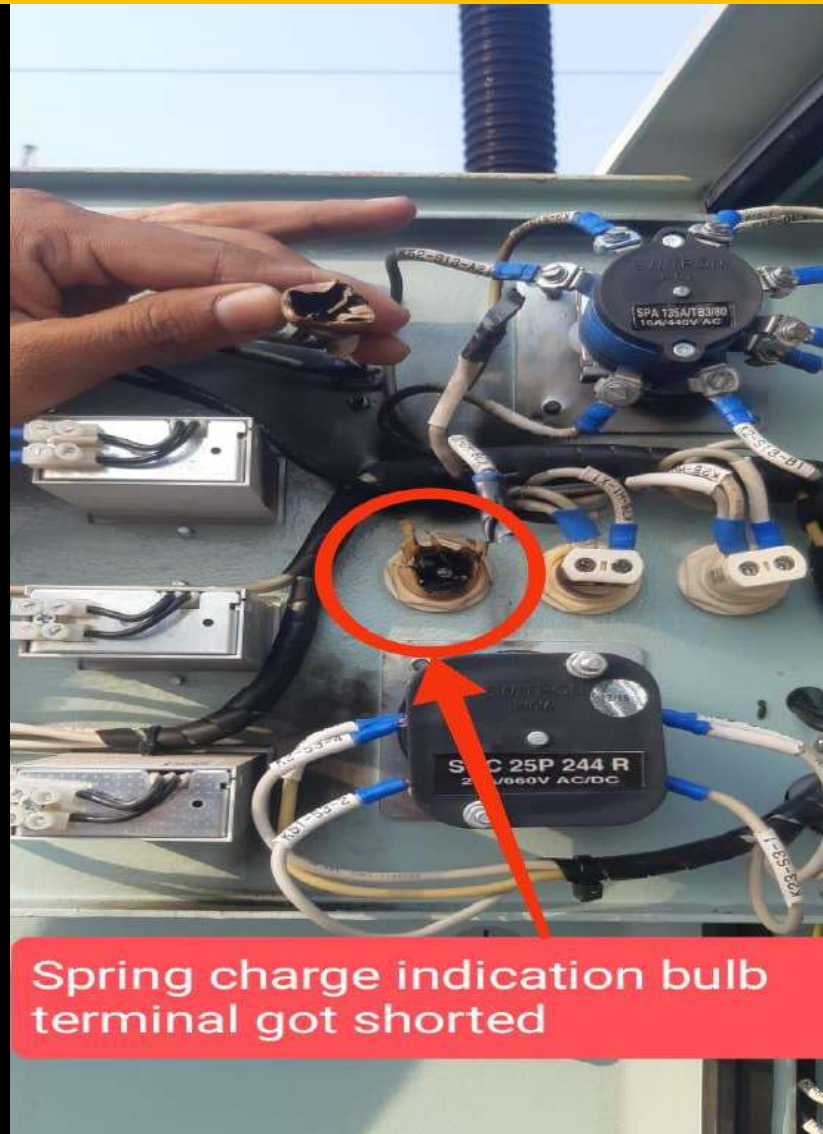
Laxmipur-2 feeder Main Breaker (Siemens) at Theruballi GSS

Main and tie CB of 220 kV Therubali-Laxmipur-2 at Therubali end did not operate during the fault in the line. On detailed investigation it was found that spring charge indication bulb terminal got shorted in the main CB which caused fuse blown of control circuit in CR panel and resulted in failure of DC supply to the panel. This ultimately led to non-operation of breaker. OPTCL representative explained that as the fault current feed by individual 220kV feeders i.e Upper Kolab/Indravati 1,2 3& 4/Bhanjanagar 1&2/ Narendrapur 1 &2 is very less, so fault continued upto 70 sec due to delay in fault clearance from ends.

Spring charge indication bulb terminal got shorted

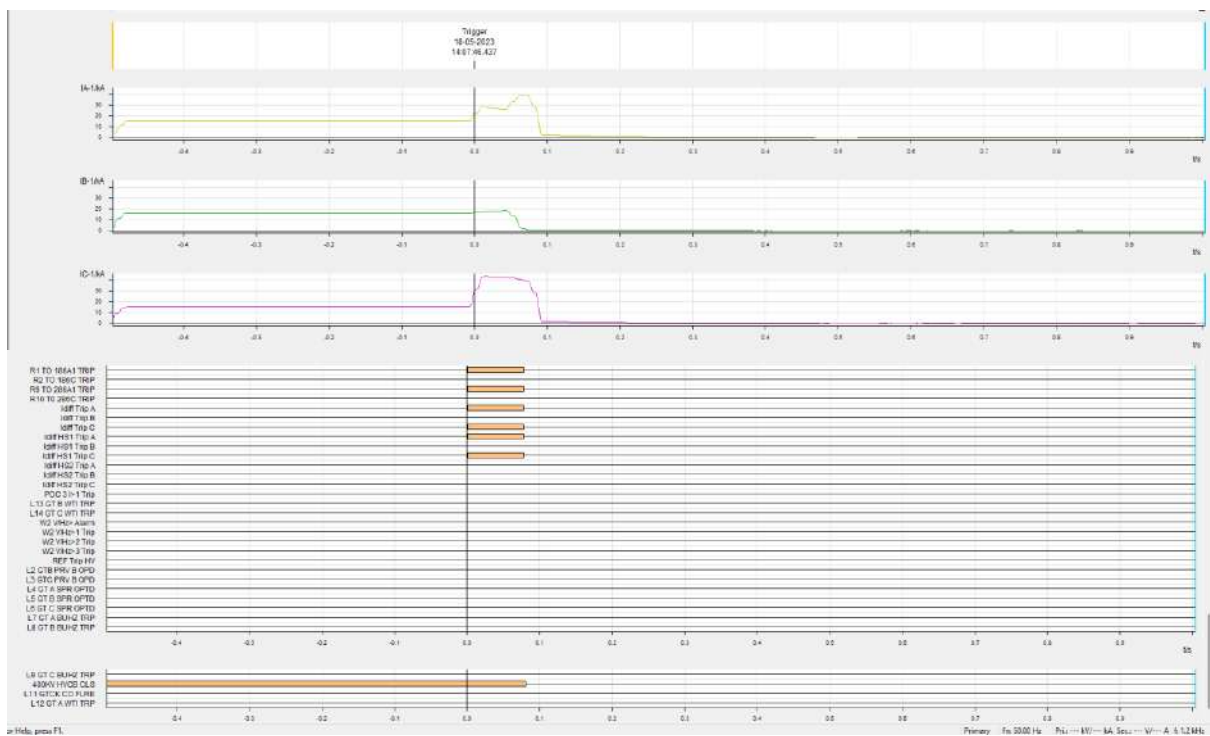
DR of GT#2 at JITPL

The disturbance occurred due to failure R and Y phase LA and BPI of GT#2. This failure occurred due to heavy storm during inclement weather condition. Unit # 2 tripped on operation of unit differential protection.

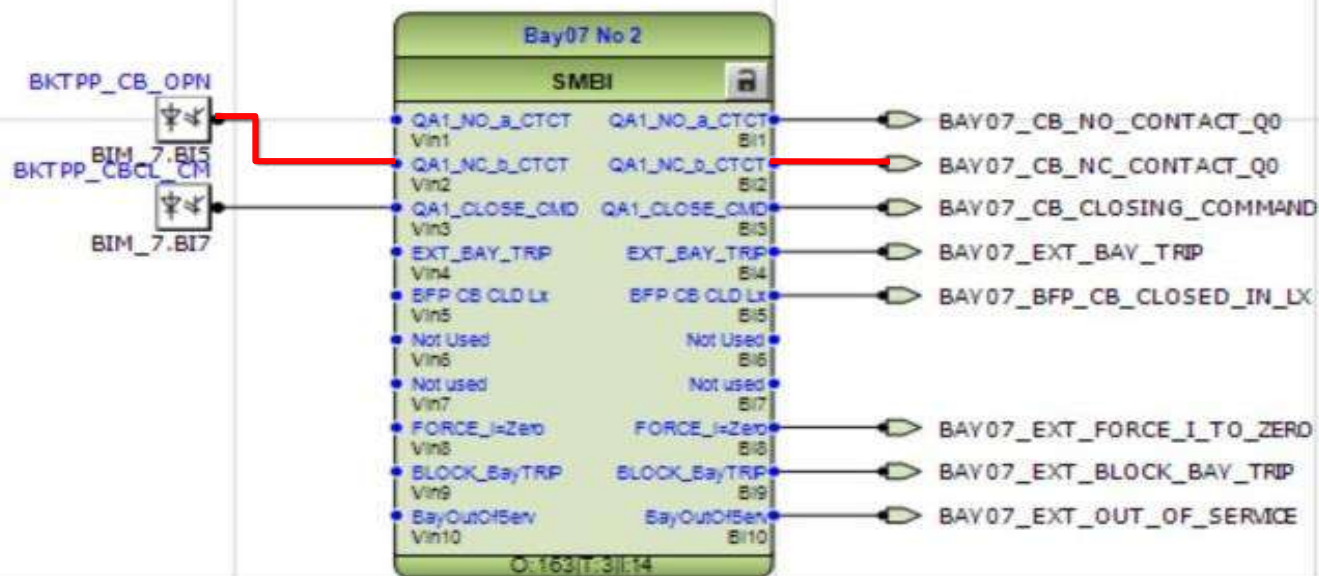
Reason for Busbar tripping

He informed that busbar scheme at Jeerat was configured taking the breaker status into consideration. While charging 400 kV Jeerat-Bakreshwar, BI for close command from control switch got missed as no feedback was received from TNC for which current of said BKTPP bay (4.6 k A) was not taken into consideration for Bus zone -B. Due to mismatch of current in the bus-zone, busbar protection operated with Zone-B indication and all the bays connected to Bus-Zone - B got tripped. Regarding remedial measure, he informed that defective switch would be replaced by availing the shutdown.

- CB open status stays during charging of BKTPP bay.
- CB close command did not come.
- As per relay configuration , current fed by BKTPP bay during charging(4.6 KA) could not be counted to BUS B.

Corrective measures taken

- ▣ CB close command was checked and it was found CB discrepancy switch Close Contact for Busbar relay was found faulty.
- ▣ CB Discrepancy switch will be replaced upon getting shutdown.

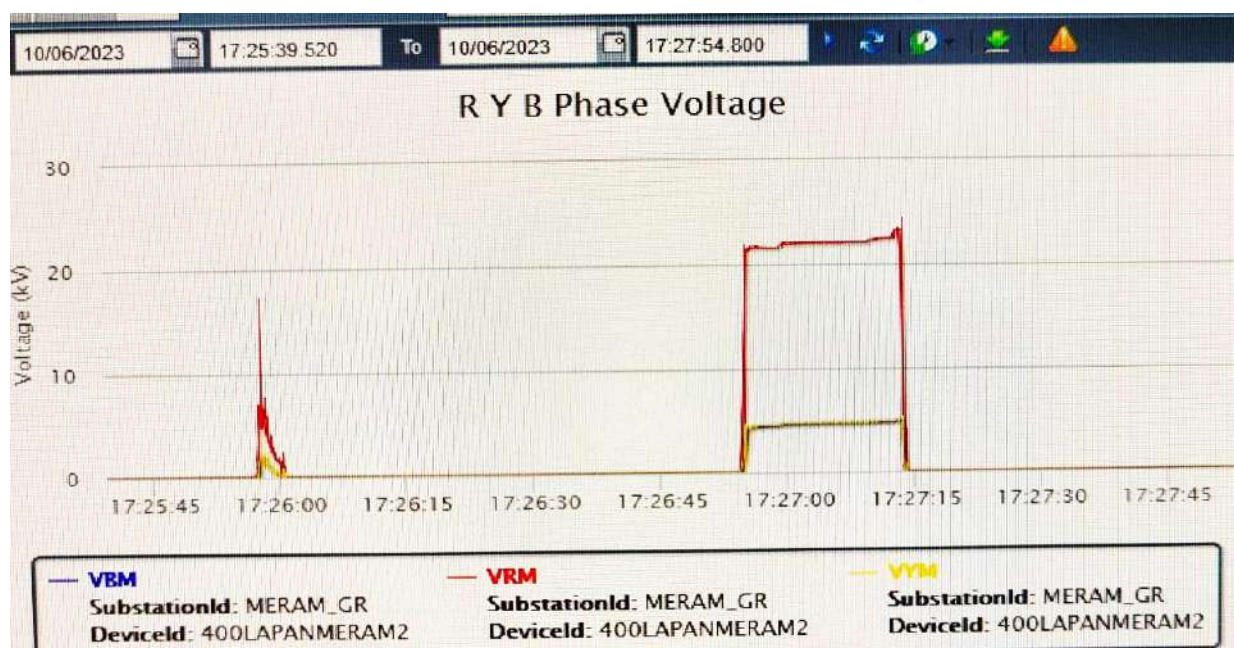
- It appears first line was charged from Meramundali end but line did not hold protection operated perfectly and fault was isolated but later after 1 minute it was again charged from lapanga end and fault persisted till 11 seconds as protection did not operated .
- Below is the Line voltage & current plot at Meramundali end:
- Line voltage appeared shows charging attempt first from meramundali and at the same time line current also appeared which was feeding fault current in YB phase and tripped within 100 ms from meramundali end.
- Then after 1 minute at 17:27 Hrs from lapanga end line was charged as healthy R phase line voltage appeared as Y&B Phase were already broken due to tower collapse and may be only R phase was through. At this instant line current at Meramundali end was zero also indicating charging was done from lapnga .

Induced voltage in circuit -2 as shown below also indicates the same .

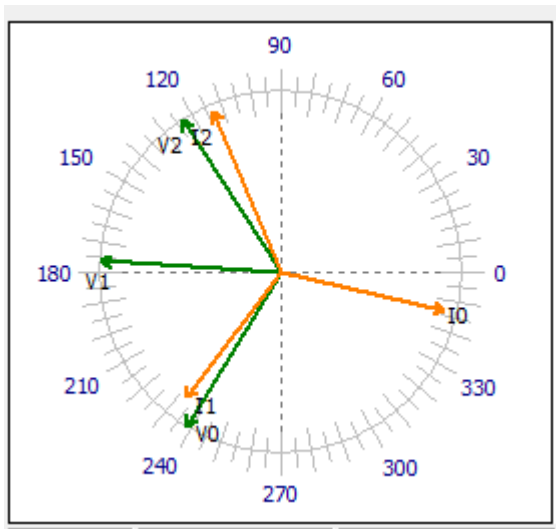
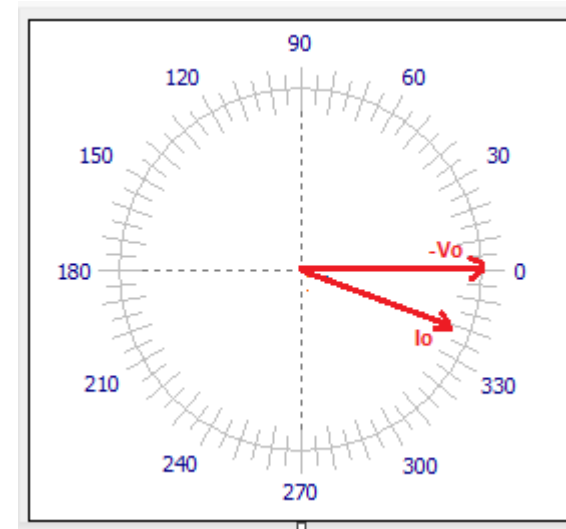
Snapshot of Sequence Components of Back Up relay at Lapanga

It was observed that instead of sufficient fault current, neither distance protection nor DEF operated for 400 kV Meramundali-Lapanga-1 at Lapanga end due to which fault got persisted for 17-18 seconds and led to tripping of other feeders from remote end.

At 17:26:54- Charging attempt taken from **Lapanga** end, however, no protection operated, and fault persisted for around 17-18 seconds.

PCC advised OPTCL for root cause analysis of the event and a report along with DR/EL shall be submitted to ERPC/ERLDC. The issue would be discussed in next PCC Meeting.
