Minutes of **63rd PCC meeting**

Date: 30.01.2018
Eastern Regional Power Committee
14, Golf Club Road, Tollygunge
Kolkata: 700 033

MINUTES OF 63RD PROTECTION SUB-COMMITTEE MEETING HELD AT ERPC, KOLKATA ON 19.01.2018 (FRIDAY) AT 11:00 HOURS

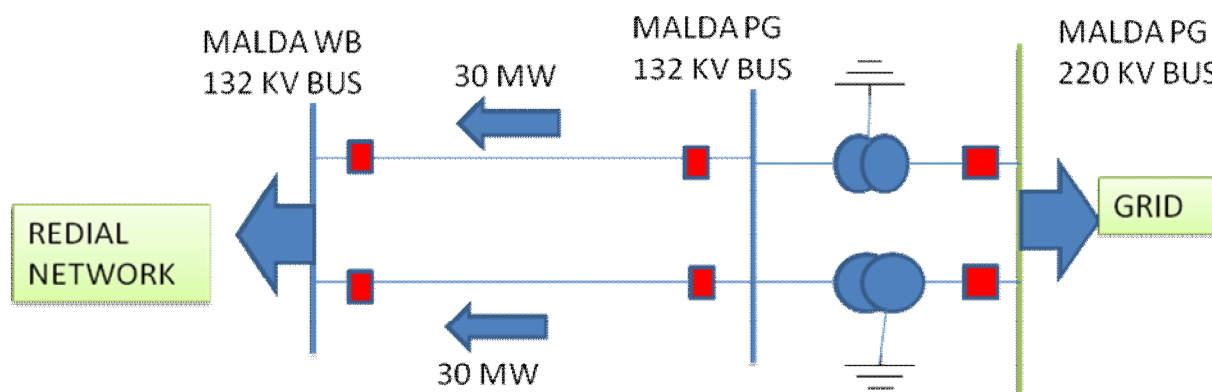
At 06:01 hrs 132 kV Malda(WB) – Malda(PG) - II tripped from WB end only on zone 1 for a R_N fault in line-II. PG end identified the fault in zone 1 but CB failed to clear the fault. As a result, 132 kV Malda(WB) – Malda(PG) - I (R-B-N, 3.69 km from WB end) tripped from WB end on zone 2. 220/132 kV ATR I & II at Malda (PG) also tripped on operation of back up directional O/C relay.

Load loss 55 MW

Fault clearing time as per PMU data is 1050 ms.

- *There was a R-N fault in 132kV Malda(WB)-Malda(PG) line-I and Malda(WB) end has cleared the fault on zone 1 distance protection. Malda(PG) end identified the fault in zone 1 but CB failed to clear the fault due to wiring problem at trip relay.*
- *As a result 132kV Malda(WB)-Malda(PG) line-II got tripped from Malda(WB) end on zone 2 distance protection in 350 ms and 220/132 kV ATR I & II at Malda (PG) tripped on operation of back up directional O/C relay in 1000 ms.*
- *On tripping of 132kV Malda(WB)-Malda(PG) line-II from Malda(WB) end on zone 2, WBSETCL explained that even though no other source was connected at Malda(WB), the zero sequence current found its path via 132/33 KV transformer at Malda(WB) then towards Malda (PG).*

Powergrid informed that wiring of trip relay at Malda (PG) of 132kV Malda(WB)-Malda(PG) line-I has been corrected. They are also planning to implement backup impedance protection for 220/132 kV ATR I & II at Malda (PG) for better coordination with line protection.

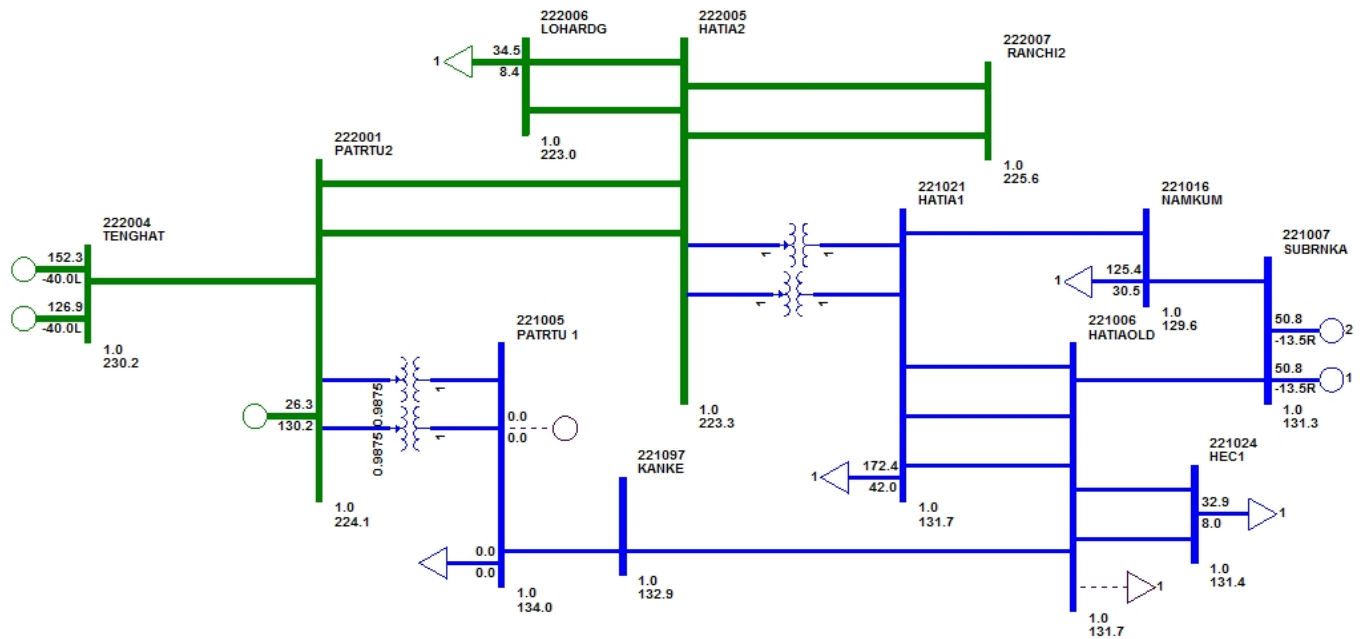
Load loss 145 MW

Fault clearing time as per PMU data is 900 ms.

From the DR plots of Hatia S/s, it was understood that Double Line to Ground Fault (RY-N) occurred near to 220kV bus at Patratu substation. The fault was not cleared from 220kV Patratu S/s. Hence, 220 kV Hatia - Patratu D/C tripped from Hatia end on zone 2. 220kV TVNL-Patratu line tripped from TVNL end on O/C, E/F protection. After tripping of the 220kV lines, 132 kV Hatia-Kanke line got tripped from Hatia end on zone 1.

In 62nd PCC, It was felt that fault in 220kV Patratu S/s should be cleared by Busbar protection but no protection relay has operated including 220/132kV ATRs at 220kV Patratu S/s. Hence the fault got cleared from 220kV Hatia, 220kV TVNL and 132kV Hatia old.
