# Minutes of **72<sup>nd</sup> PCC Meeting**

**Date: 14.11.2018**  
**Eastern Regional Power Committee**  
**14, Golf Club Road, Tollygunge**  
**Kolkata: 700 033**

### **MINUTES OF 72<sup>ND</sup> PROTECTION SUB-COMMITTEE MEETING HELD AT ERPC, KOLKATA ON 29.10.2018 (MONDAY) AT 10:30 HOURS**

# Protection Audit Report of 220/132/33 kV Lalmatia Substation

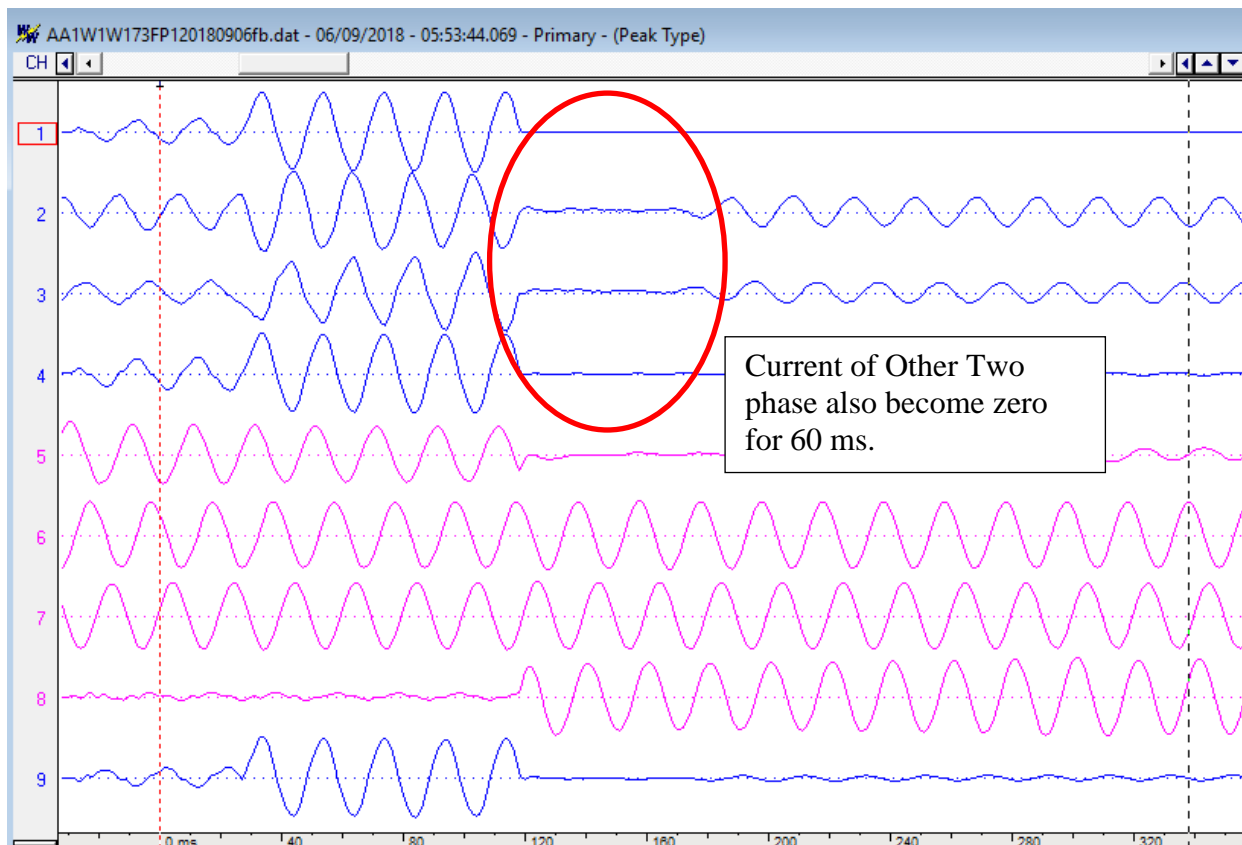
On 06.09.2018, R-phase fault took place in 400 KV Alipurduar-Bongaigaon-I line followed by successful auto reclose. The special observations in this case are as follows:

1. After opening of R phase, the other two phase also become zero for 60 ms then suddenly restored to is normal value.

The event must be investigated carefully for understanding this AC-DC interaction which is very critical for grid security. To analyze this type of events, triggering of HVDC TFR during AC system faults is required.

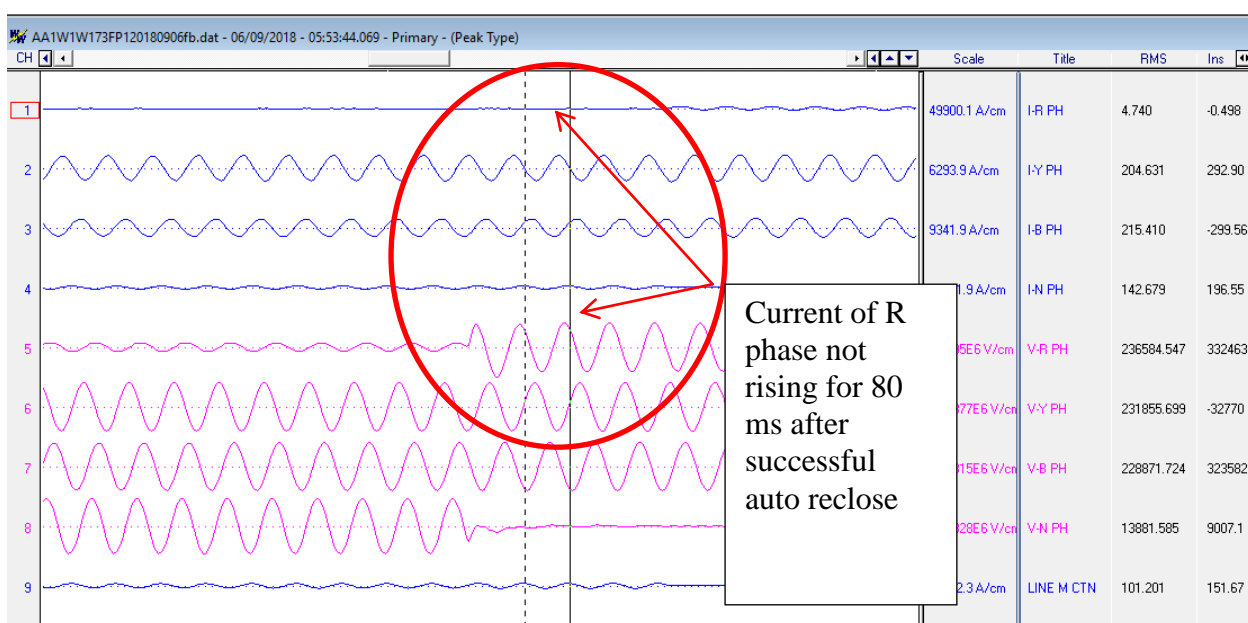
2. After 1 sec, R phase successfully auto reclose but R phase current did not rise for next 80 ms.

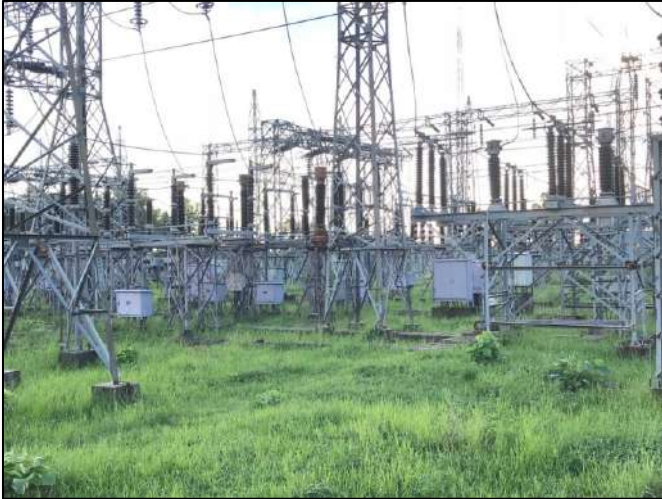
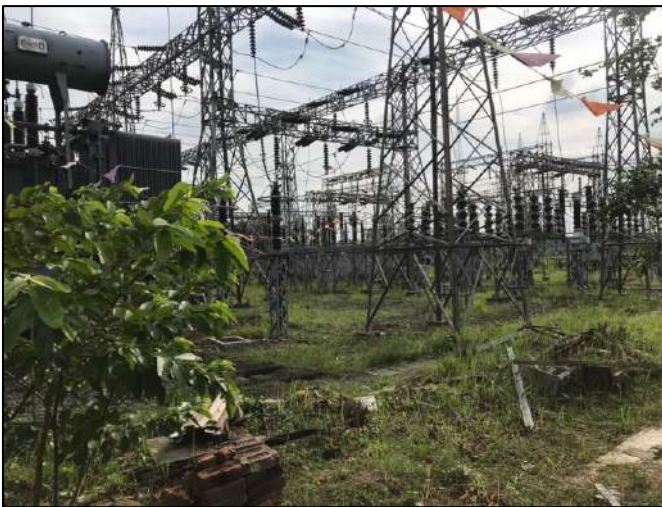
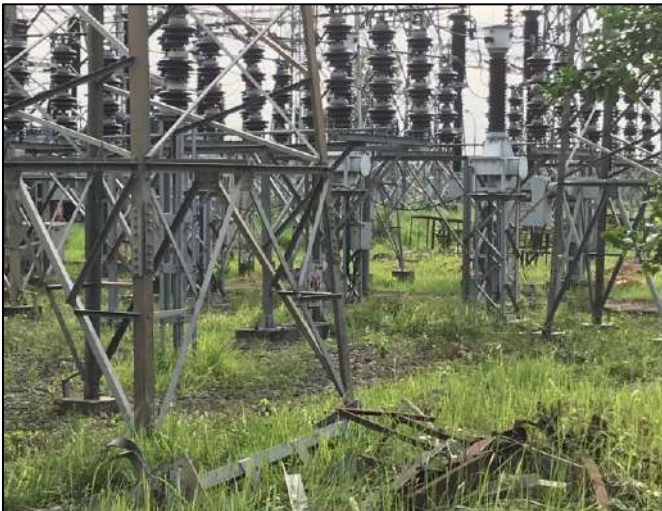
Some Pictures from the substation

**1. Switchyard and its Maintenance:** The whole switchyard was in bad shape. As per the details, the JUSNL part switchyard was commissioned in 1991 (27 years old). Following were observed when switchyard inspection during protection audit was carried out:

- **Old Equipment:** The switchyard equipment's (Isolator/CT/PT/LA/Breaker) are old and rusty and need immediate attention. Adequate spare management is also required for any emergency. The bays which has been commissioned in 2011 onwards were also found in bad shape due to lack of proper maintenance.

- **PCC and Gravelling:** Long grasses and weeds were observed throughout the switchyard. Proper graveling was not observed in entire switchyard which may be hazardous to human safety, equipment health and can cause unwanted tripping. There is a need for proper PCC and Gravelling in switchyard along.

- **132/33 kV Transformers:** Severe oil leakage in one of the 132/33 kV ICT was observed and its oil has also penetrated the panel box of OTI/WTI and can result in unwanted tripping. The ICT panel box also needs proper care as gasket was found to be missing and rainwater can ingress which may also result in unwanted tripping. Silica Gel in 132/33 kV ICTs was found pink and needs to be replaced or recovered by heating. 2 no's of the cooling fan in one of the 50 MVA ICT was not working due to non-replacement of the faulty connector.

- **Bay Equipment Nomenclature:** Proper Bay equipment numbering and phase segregation for identification of equipment have not been done which may result in the wrong operation of equipment and can cause hazard to O & M Personnel.

- **Earthing of LA:** Proper earthing was not provided to Las in the switchyard.
- **O&M Activities:** There was no proper O&M for equipment at the substation. This is the major concern that was observed at the substation. No Records were available for the O&M at the substation level. Even the JUSNL Testing team were not able to tell regarding the O&M plan of the substation and its monitoring.

It may kindly be noted that 220/132/33 kV Lalmatia substation is of vital importance for NTPC Farakka, NTPC Kahalgaon and JUSNL. This substation will help in ensuring the proper coal supply as well as act as a path for the black start during emergency between these two large generating stations. So, there is a need for immediate attention in order to improve the condition of this substation at earliest.
