Minutes of the 1st meeting of the Committee for Analysing the major outages of ISTS elements of Eastern Region held on 13.02.2019 at ERPC Kolkata.

Item No. 1. Outage of 400kV D/C Purnia-Biharsharif line of ENICL.

Item No. 2. Outage of 400kV D/C Patna – Kishanganj line of PGCIL.

Item No. 3. Outage of 400 kV D/C New Ranchi- Chandwa T/L—Powergrid

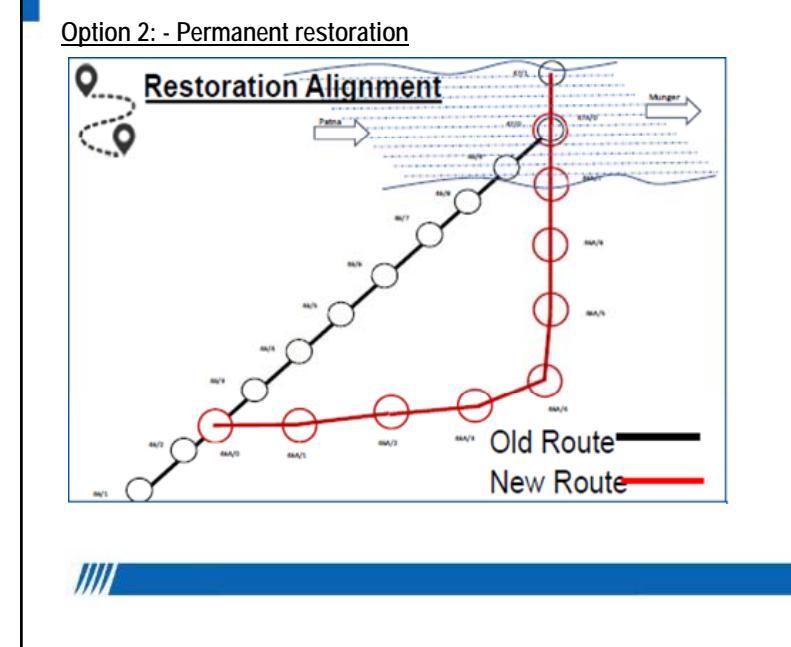
Permanent Restoration Plan due to 46/9 Collapse

• Dismantle 46/9 & 46/8 (collapse Tower) due to further change in course of river

- New River crossing width considered : 4750
 Mtr earlier it was considered as 3250Mtr
- Installing Four more new tower in Pile foundation(47/0A, 46/9A, 46/8A and 46/7A) to prevent it from same incident because of soil erosion.
- Further more installation of five more new tower in open cast foundation will be aligned to existing line on the right bank along with pile foundation.
- Restoration & construction of the same will take more than 9 month.
- Also we have to dismantle the existing tower from 46/3 to 46/7.

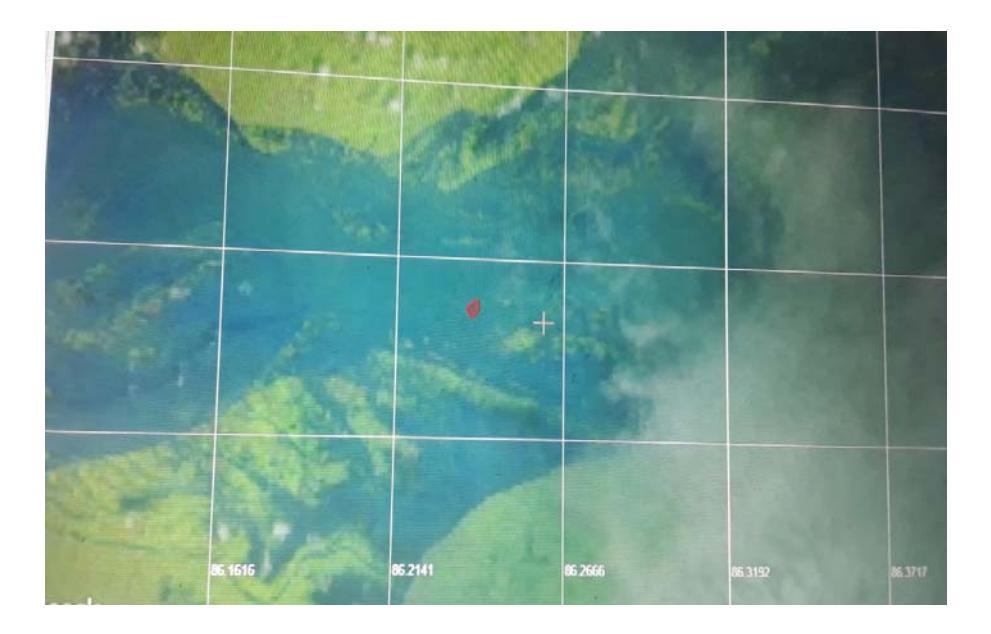
- 2.3 Analysis of Google Map for the change in river course during last five years at the crossing locations has also been done. From the analysis, it is clear that there is continuous river bank erosion towards Patna side bank and the distance of river course from bank location no. 129/0(tower no. 568) has reduced from 576m in Feb-2013 to 105m in Dec-2017. Further, satellite map of 10th Sept-2018 shown below also highlights the heavy soil erosion towards the collapsed tower location (marked as red dot).

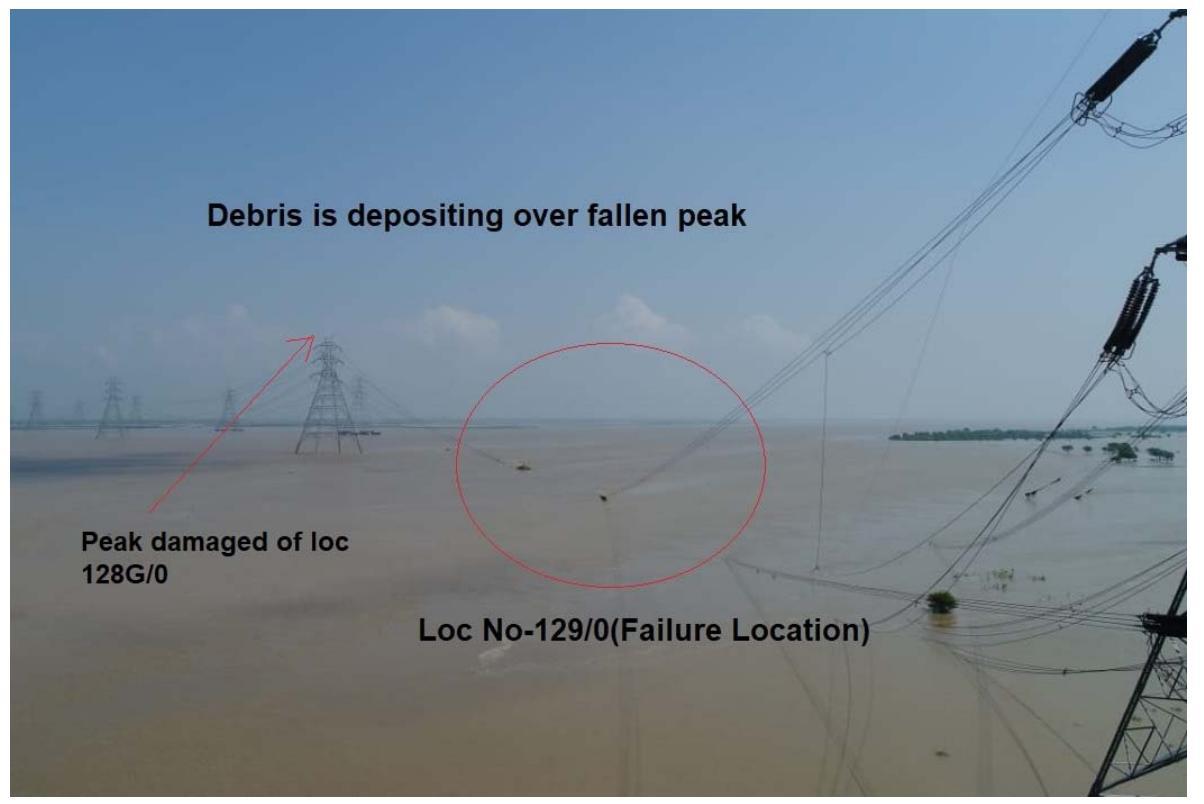
Tower at Loc. No. 128G/0 & 129/0

Loc. no.128G/0(DD+25): This tower is in mid-stream on newly constructed pile foundation. The earthwire peak and one side of bottom cross arm has been damaged. The damage is because of pulling of conductor/earthwire due to tower collapse at loc no. 129/0.

Loc. no.129/0(DD+9): This tower was erected on pile foundation and it was the last pile foundation out of total nine pile foundations casted in this river stretch. The tower has collapsed completely and is fully submerged under water. The location is in main course of the high speed river flow. The deposition of debris from flowing water over tower peak could be seen. This location couldn't be reached during committee visit due to heavy current in the river and the observations were made from approx. 300 meter away from location no. 129/0.

The tower failure location is still in the heavy current of river. The actual damage has been assessed. The entire pile has been damaged and required to be re-casted new pile foundation. In addition to safeguard the line seeing the tendency of change of course of river Ganga and encroaching the right bank, an expert committee has been advised to divert the line on at least on four nos on pile foundation on right bank. For permanent restoration of the line, the 04no piles is being re-casted including one no pile in midstream in Ganga River. The minimum time period for casting the 04 no piles and the restoration of the line may take one year and even more.

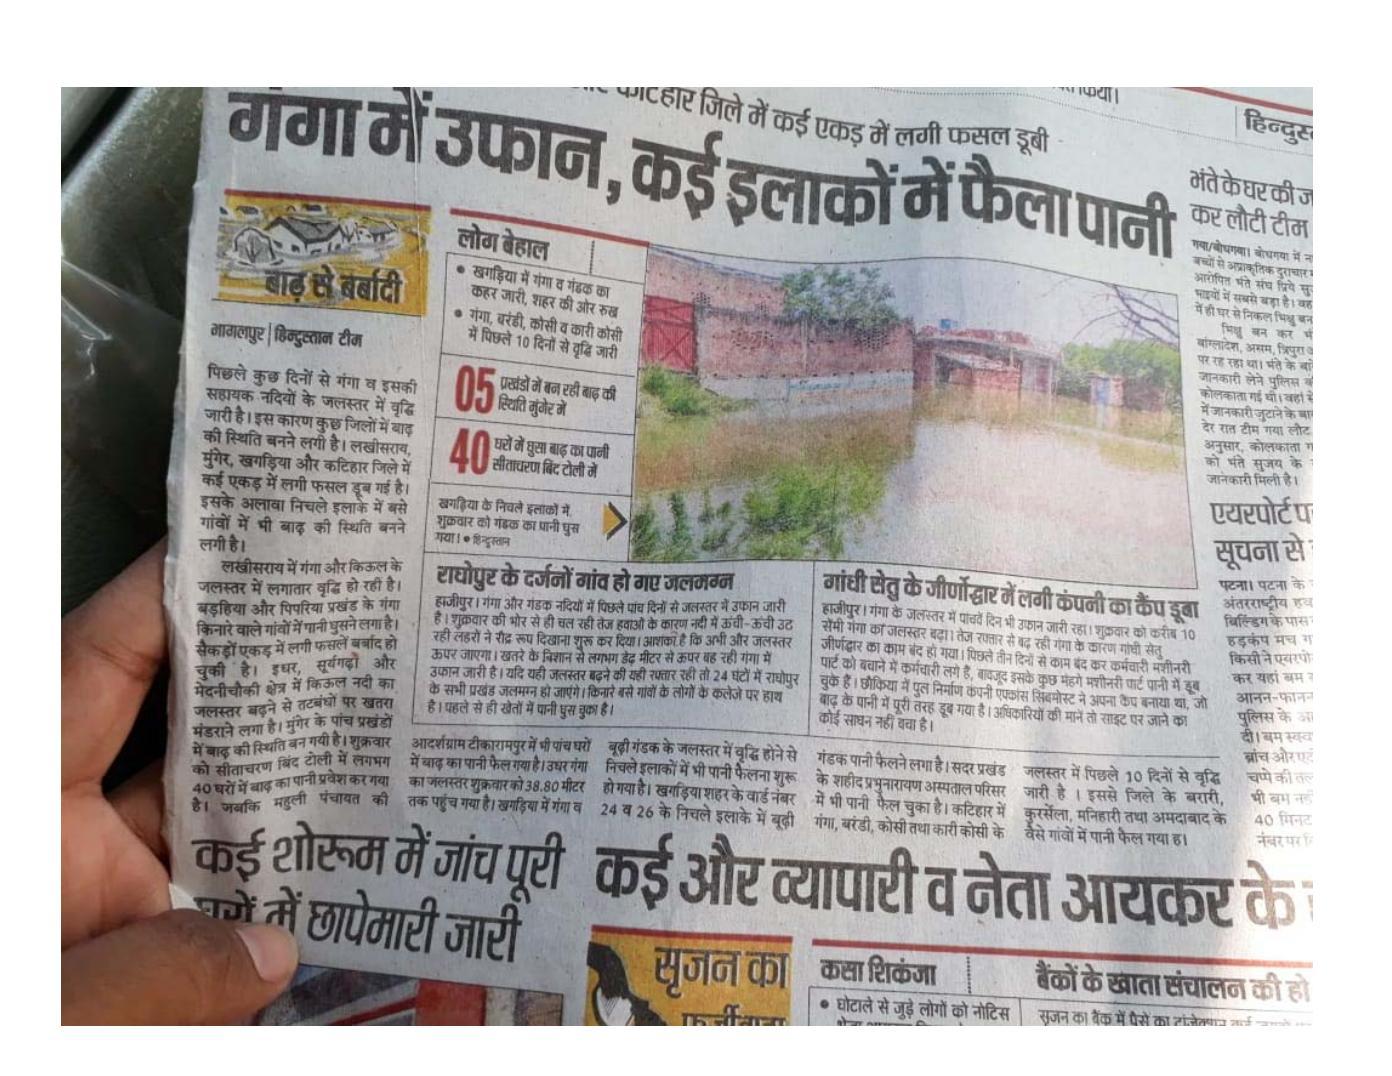
News paper dated 08.09.18

- a. During committee visit, it was observed that lot of trees and houses in the areas near tower locations were submerged in flood water.
- b. Flood and its impact has also been reported in newspaper (paper clipping attached)
- **3.5** Photographs of collapsed towers, damage to trees and newspaper clips are enclosed at annexure –I.

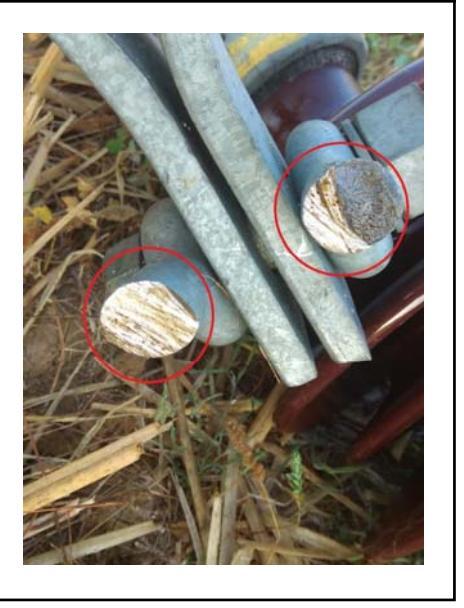
• It was ascertained that the hanger of the bottom conductor was cut by the miscreants on charged line condition and fall of the same had caused the said tripping.

• The bottom phase insulator string got completely damaged and snapping of the conductors of the bottom phase also happened subsequently.

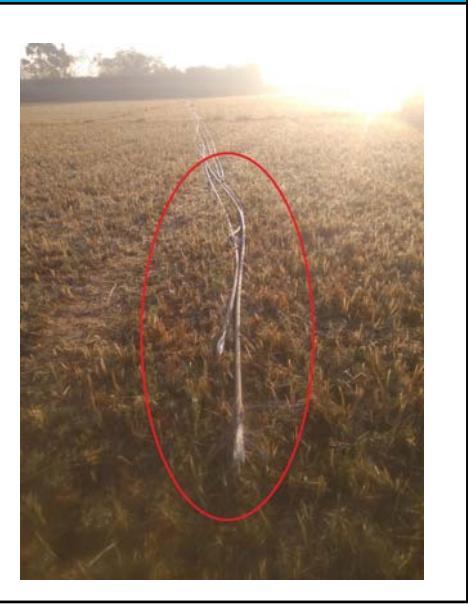
• The snapping of the bottom phase conductor resulted in causing consequential damage to 10 spans of the bottom phase of the said line.

• However, as the patrolling team reached the site early in the morning, the miscreants could not cause any further damage to the line and fled away.

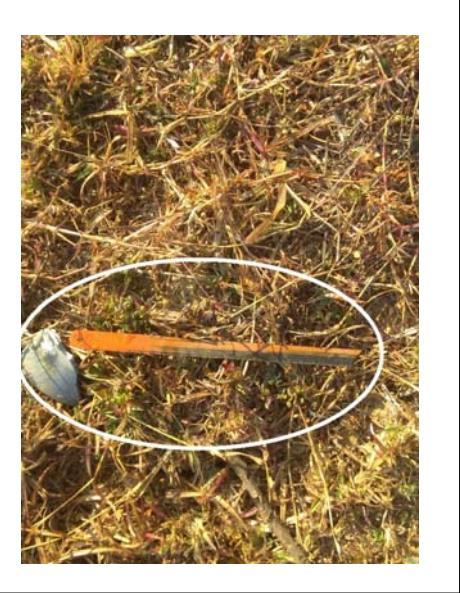
•The sabotage was caused at loc. no. 46 situated at Village-Sukhra, PS- Narkopi, Bedo.

•A FIR regarding the sabotage caused by miscreants in the said line was lodged with the Bedo Police Station on 09.01.2019.

Sabotage of 400 kV D/C New Ranchi- Chandwa T/L : Action Taken							
 The restoration of the said line was taken up immediately on War footing. 							
 All Hardware Fittings in between location no. 40 to 49 was damaged due to the sudden jerk of conductor. 							
 Accordingly, T & Ps were arranged at site on immediate basis and the Bottom Conductor at location no. 46 was repaired including replacement of all hardware fittings and spacers in between location no. 40 to 49 in the 400 kV New Ranchi- Chandwa Ckt-1.
