Minutes
of
92nd PCC Meeting

MINUTES OF 92ND PROTECTION SUB-COMMITTEE MEETING HELD ON 22.07.2020 AT 10:30 HOURS

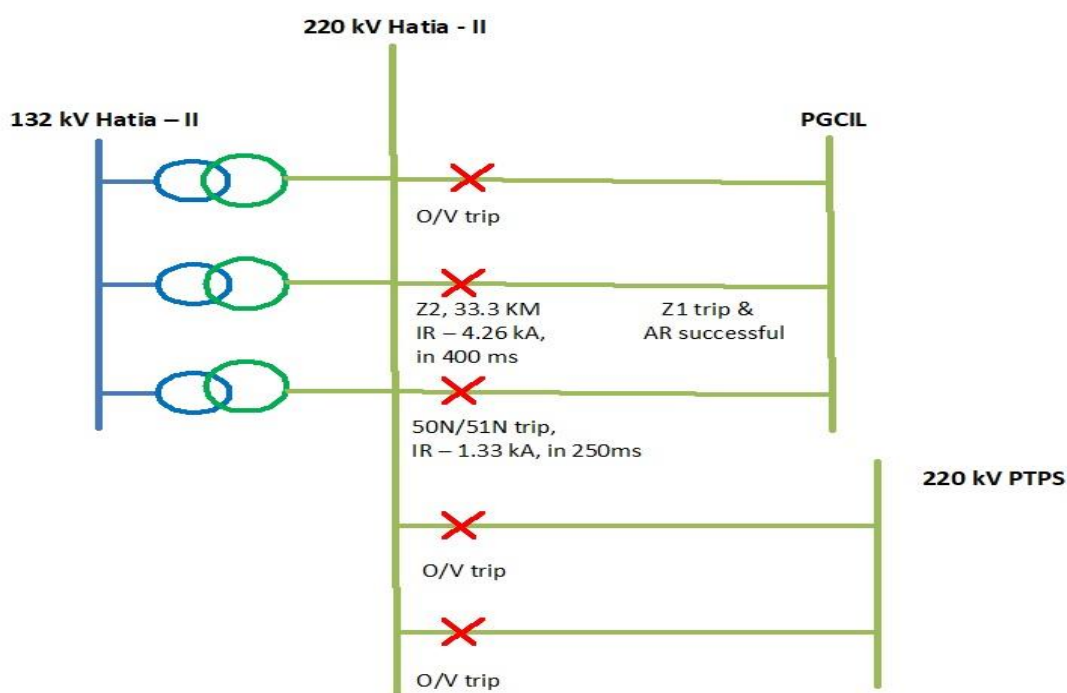
220 kV Ranchi Hatia T/C, 220 kV Patratu-Hatia D/C and 220/132KV 150MVA ICT-1, 2 and 3 at Hatia tripped at same time resulting in total power failure at 220/132 kV Hatia S/S. In Jamshedpur PMU data, one R phase to earth fault has been captured. Fault was cleared at around 400 ms.

In 91st PCC, JUSNL explained that there was a transient fault in 220 kV Hatia(II) – Ranchi (PG) circuit 2 due to bad weather, the line got tripped on zone 2 from JUSNL end and on zone 1 from Powergrid end.

PCC observed that as per the DR the voltage was went upto 190 kV (phase to ground) and opined that SLDC, Jharkhand should take necessary action to control the over voltage in their system so that unwanted trippings of the lines could be avoided.

PCC opined that over voltage may appear due to improper earthing of the substation. PCC advised JUSNL to take the following actions and submit a report to ERPC and ERLDC

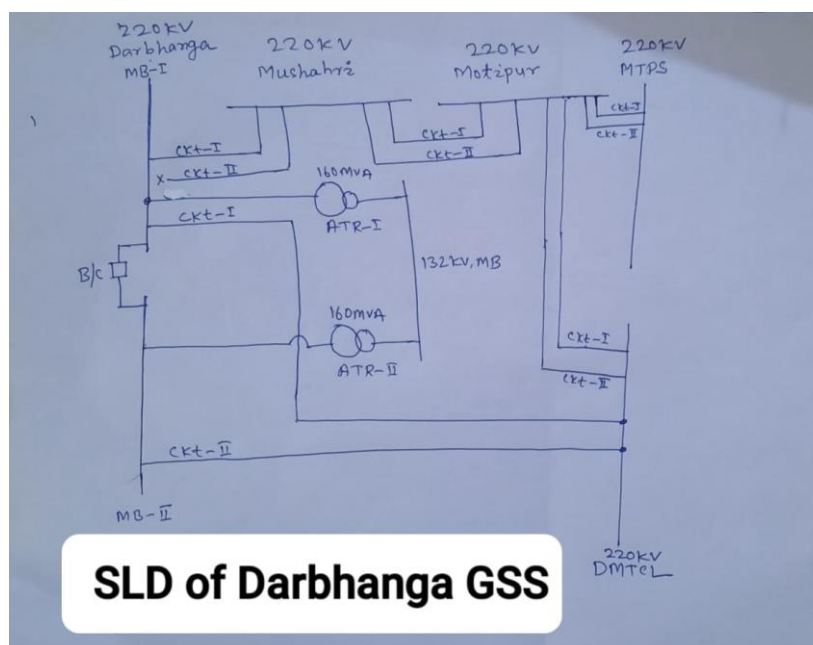
BSPTCL informed that 220 kV Darbhanga (DMTCL)-Darbhanga (BSPTCL) circuit 2 got tripped from BSPTCL end on directional earth fault. Thereafter LBB protection at Darbhanga (BSPTCL) was operated due to loose connection and tripped 160 MVA ATR-2 which was connected to Bus II. As a result, 160 MVA ATR-I and 220 kV Darbhanga (BSPTCL) – Mushahari – 1 also got tripped due to overload.

ERLDC pointed out that when system remains on both buses (MB-1 & MB-2) through bus coupler then the current values are unsymmetrical resulting in abnormal neutral current. But when the system is put on the single bus the currents are in symmetrical.

After detailed deliberation, PCC advised DMTCL to check the reason for non-operation of auto-reclose of 220 kV Darbhanga(DMTCL) – Motipur -1 line from DMTCL end.

PCC advised BSPTCL to take the following corrective actions:

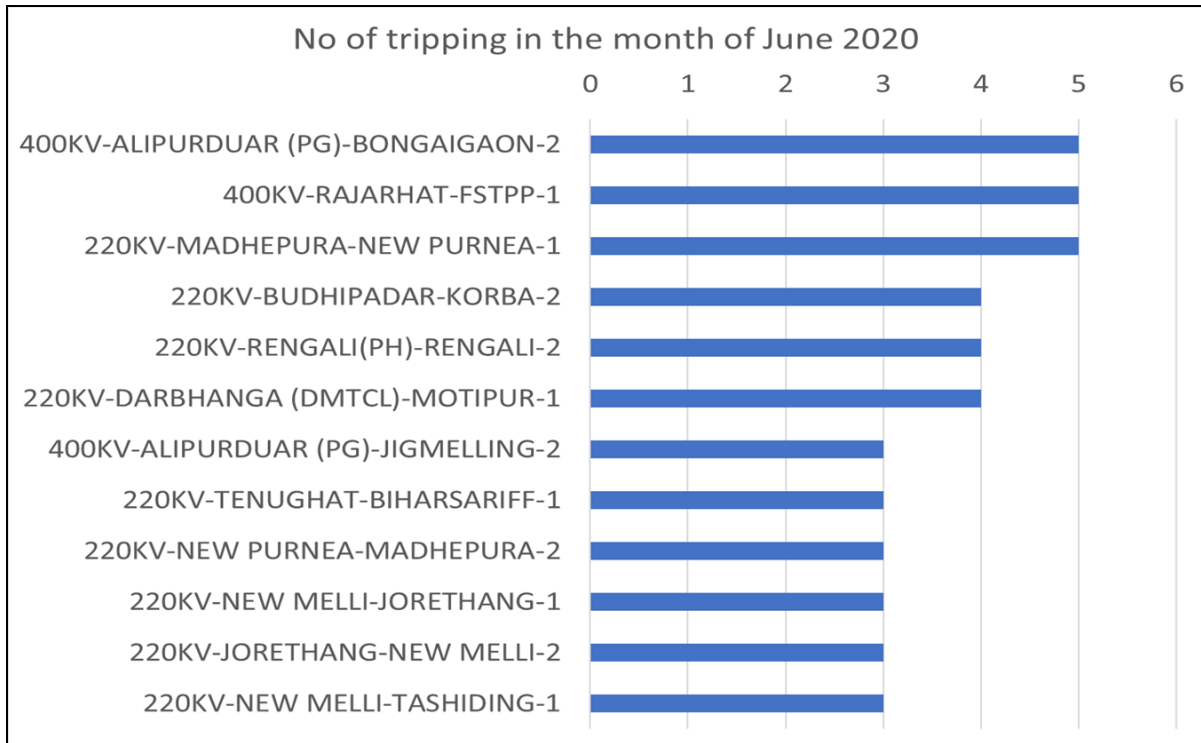
Figure 1: List of the transmission lines which tripped more than two times during the month of May 2020

As shown in Figure 1, there are 12 transmission lines having voltage level 220 kV and above and which tripped more than two times in the month of June 2020. Around 11 and 14 transmission lines having voltage level 220 kV and above tripped more than two times in the month of April and May 2020 respectively. Growing number of repeated tripping of transmission lines is putting grid in grid in vulnerable condition. Repeated tripping of some transmission lines resulted repeated grid disturbances and grid incidents along with load and generation loss.

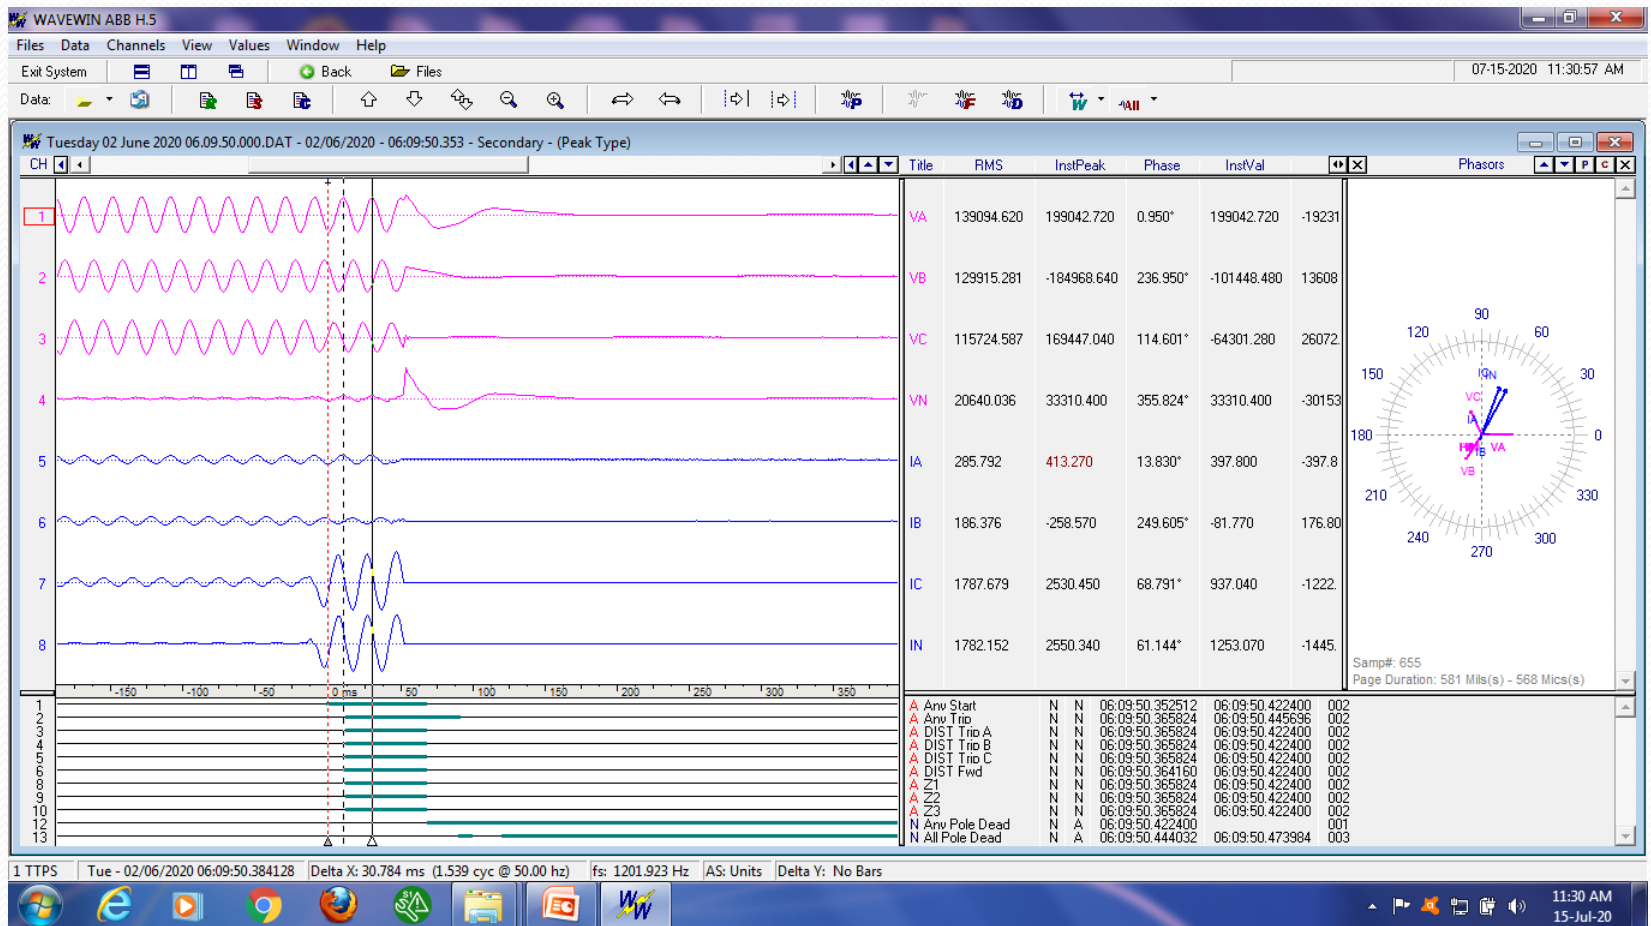
MAIN 1- TTPS-BIHAR SARIFF FEEDER AT TTPS END, Dated 02.06.2020,

SL. NO.	DATE/TIME OF TRIPPING/ SYNCHRONISING	FEEDER TRIPPED	RELAY INDICATION AT TTPS END	Remote end Relay
1	Tripping Date - 02.06.2020, Time 06:08 HRS Synch. Time – 06:57 HRS	T.T.P.S.- B.SHARIFF FEEDER TRIPPED FROM BOTH END	STARTED PHASE - CN, EARTHFAULT, DISTANCE TRIP Z1, FAULT DURATION – 71.55 ms, FAULT LOCATION - 93.30 KM , ZONE - ZONE 1	STARTED PHASE – CN, EARTHFAULT, TRIPPED PHASE ABC FAULT DURATION- 46.59 ms FAULT LOCATION – 96.51 KM FAULT IN ZONE- ZONE 1
<ol style="list-style-type: none"> 1. A/R Is not enabled and relay is configured for Three phase tripping. 2. Any Start at 06:08:55.158; Any Trip ON at 06:08:55.170, Any Pole Dead at 06:08:55.230 & All pole Dead at 06:08:55.251. At 06:08:55.198 after Any Trip ON current in all three phase :- IA – 285.741A, IB – 186.607A, IC – 1784.659A recorded at DR. <i>No any pole was opened prior to fault.</i>

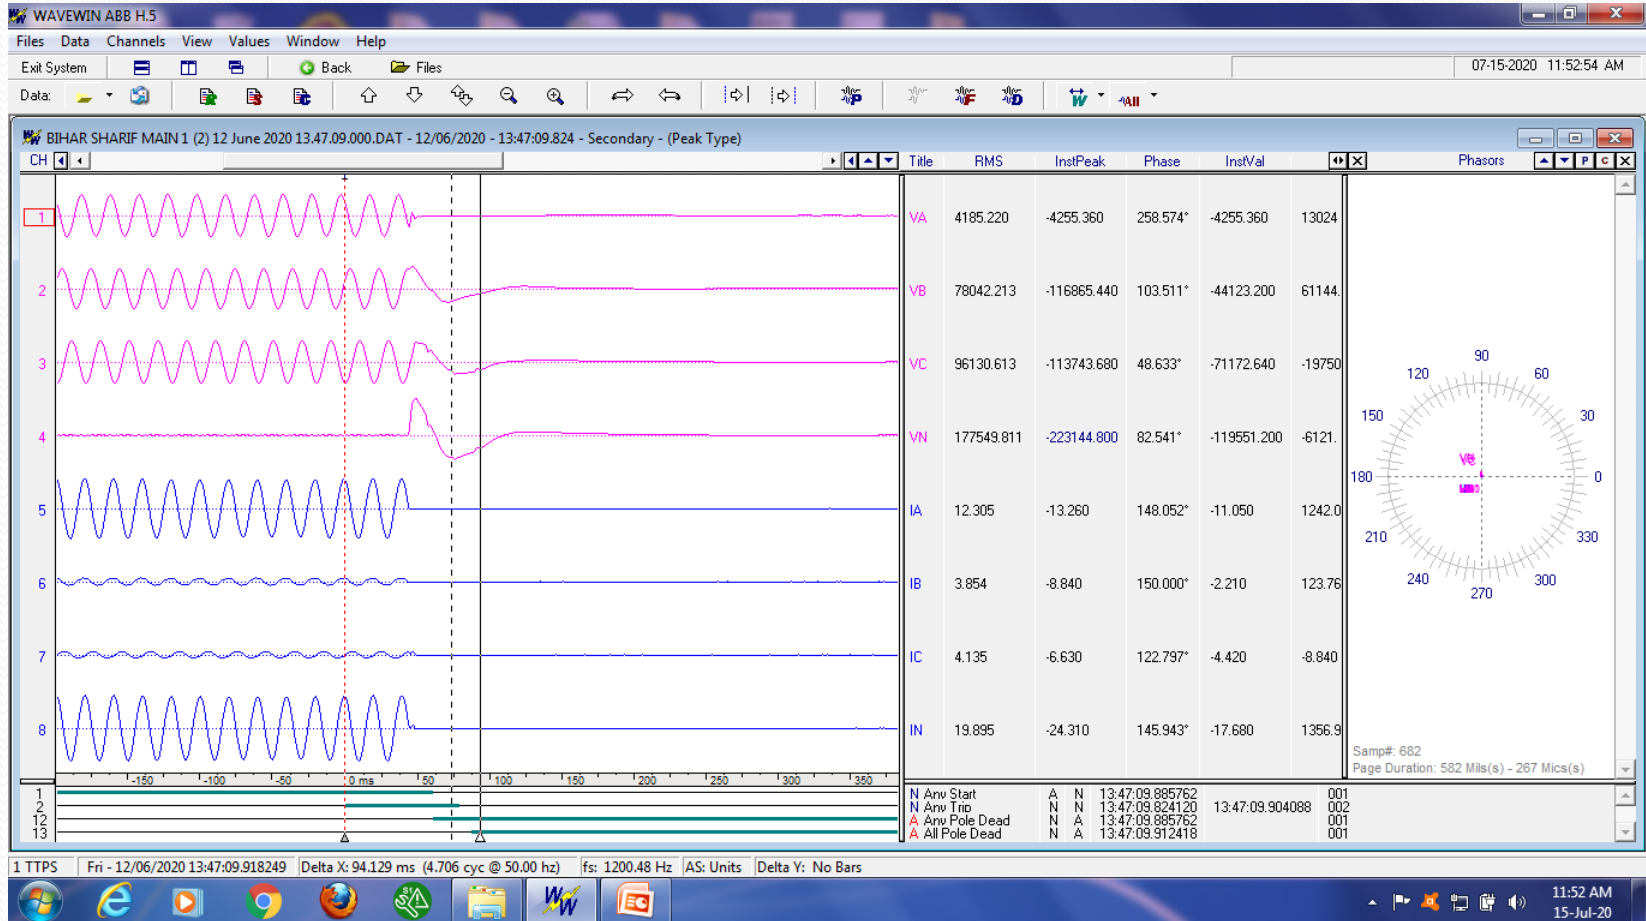
MAIN 1- TTPS-BIHAR SARIFF FEEDER AT TTPS END, Dated 12.06.2020,

SL. NO.	DATE/TIME OF TRIPPING/ SYNCHRONISING	FEEDER TRIPPED	RELAY INDICATION AT TTPS END	Remote end Relay
2	Tripping Date - 12.06.2020, Time 13:46 hrs Synch. Time – 14:33 HRS	T.T.P.S.- B.SHARIFF FROM BOTH END	EARTHFAULT START IN 1, FAULT DURATION – 1.560 s, ZONE - None, Ia-484.7A, Ib-336.5A, Ic-320.2A.	STARTED PHASE - CN TRIPPED PHASE ABC FAULT DURATION- 46.59 ms FAULT LOCATION – 96.51 KM FAULT IN ZONE- ZONE 1
It was high resistive fault, may be touching of tree causing slow increase of current in R phase. Line tripped on Zone-none, Backup over current earth fault, IN > 1 time delay- 1.5Sec. PD was not operated.

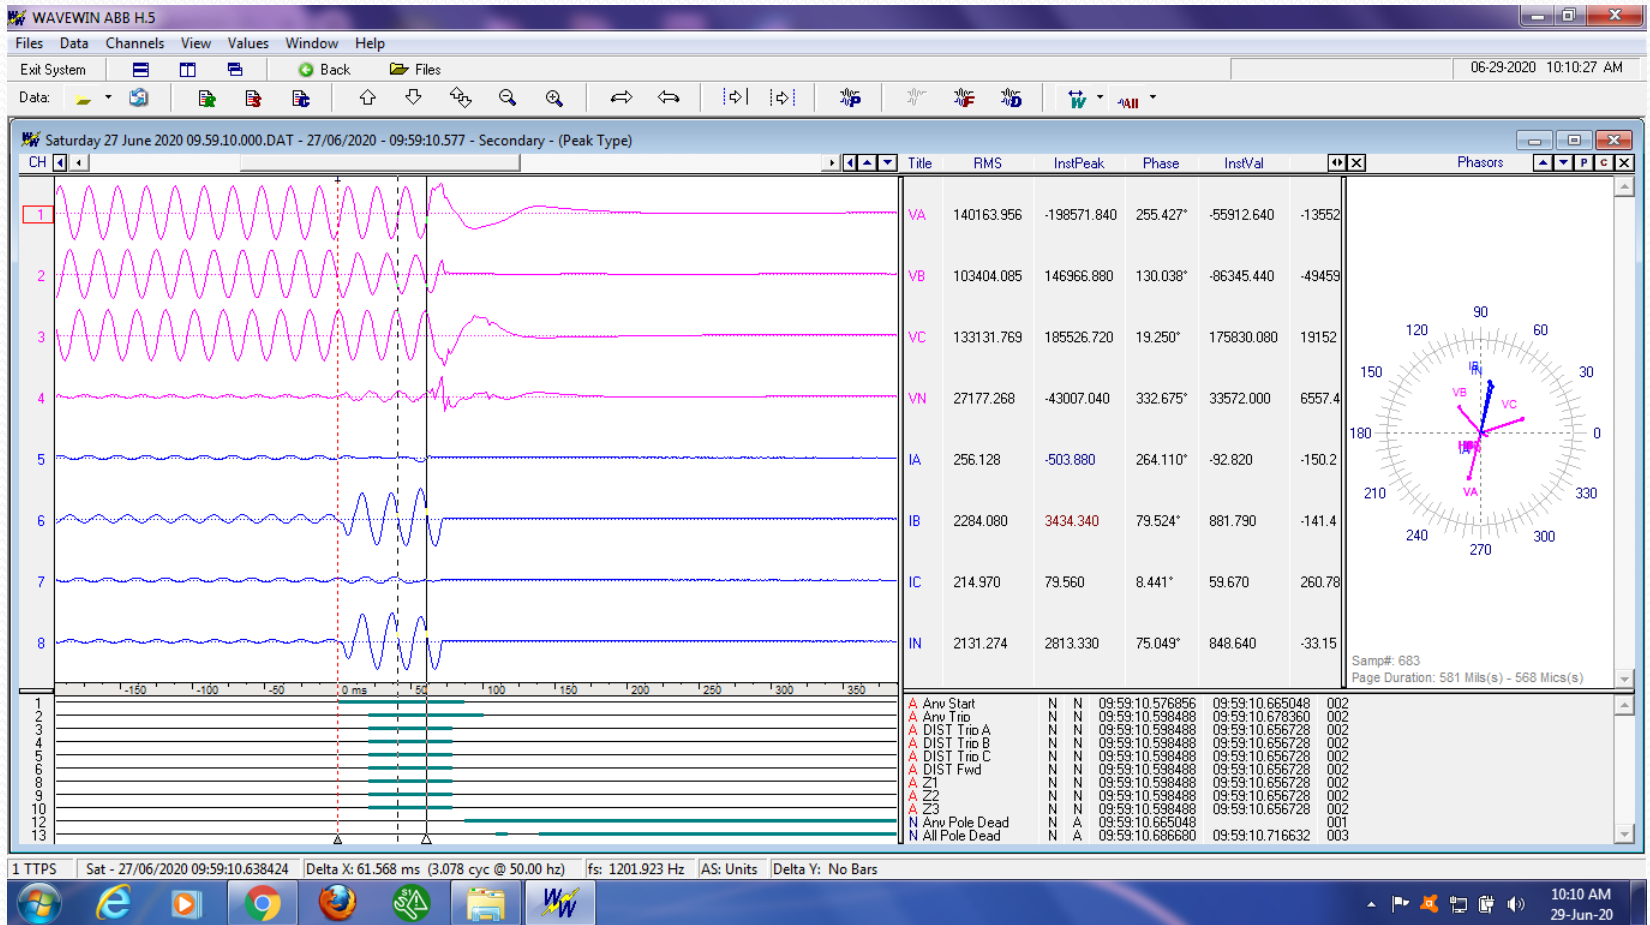
MAIN 1- TTPS-BIHAR SHARIFF FEEDER AT TTPS END, dated 27.06.2020

SL. NO.	DATE/TIME OF TRIPPING/ SYNCHRONISING	FEEDER TRIPPED	RELAY INDICATION AT TTPS END	Remote end Relay
3	Tripping Date- 27.06.2020, Time – 09:59HRS Synch. Time – 10:38 HRS	T.T.P.S.- B/S FEEDER TRIPPED FROM BOTH END	STARTED PHASE-BN, TRIPPED PHASE- ABC EARTHFAULT START IN 1, DISTANCE TRIP- Z1, FAULT DURATION – 88.21 ms, FAULT LOCATION- 76.25 KM ZONE – ZONE 1	STARTED PHASE - BN TRIPPED PHASE ABC EARTH FAULT START IN 1 DISTANCE TRIP Z1 FAULT DURATION- 46.6 ms FAULT LOCATION – 111.9 KM FAULT IN ZONE- ZONE 1
A/R is not enabled and relay is configured for Three phase tripping.

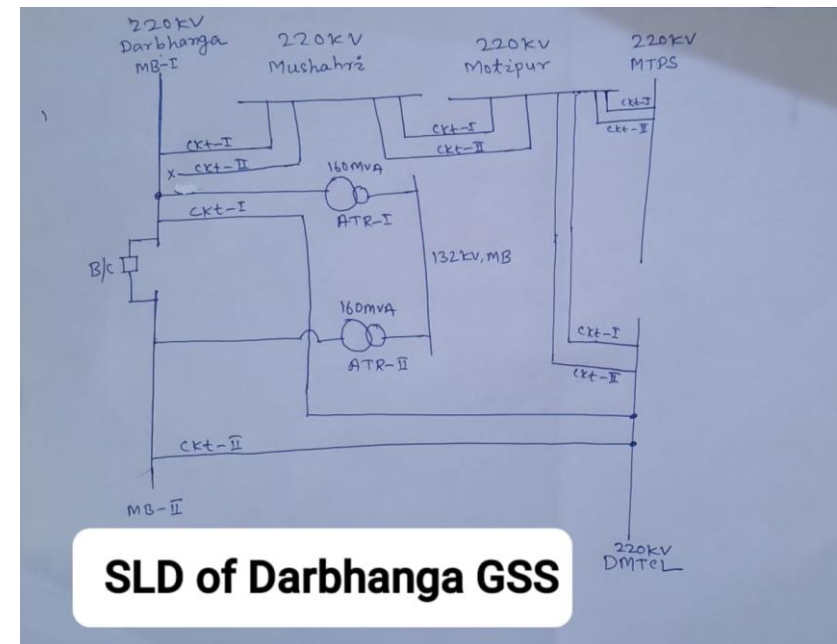
B7. GD at Darbhanga on 10-06-2020

- BSPTCL report
 - At 10:54 Hrs 220 kV Motipur-DMTCL ckt-1 got tripped from both ends.
 - At the same time Darbhanga (BSPTCL)-DMTCL ckt-2 got tripped on Aided D.E.F.
 - Darbhanga (BSPTCL)-DMTCL ckt-1 was intact and not tripped.
 - At the same time 160 MVA ATR-2 got tripped on Earth Fault. DR could not be fetched from Relay resulting tripping of 160 MVA ATR-1 on overload.
 - Simultaneously Darbhanga (BSPTCL)-Mushahari ckt-1 also got tripped from Darbhanga (BSPTCL) end. (DR uploaded)

- Y-Phase PT voltage in Directional Earth Fault Relay of ATR-2 was missing.
- LA test of all bays (220 kv & 132 kv) was done and value of test results for R-Phase HV side of ATR-2 was found abnormal. Instructed for the early replacement.
- It has been observed that when system remains on both buses (MB-1 & MB-2) through bus coupler then current values are unsymmetrical resulting in abnormal neutral current. But when the system is put on the single bus this problem does not exist. We have suggested to put the system on single bus (either MB-1 or MB-2).

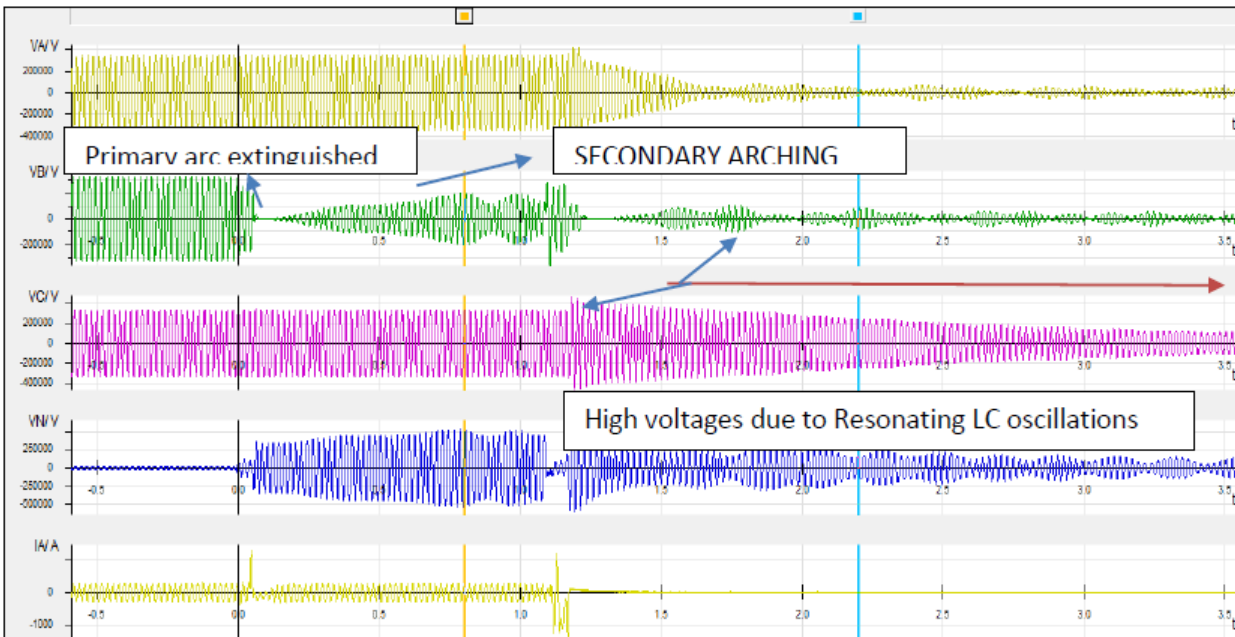
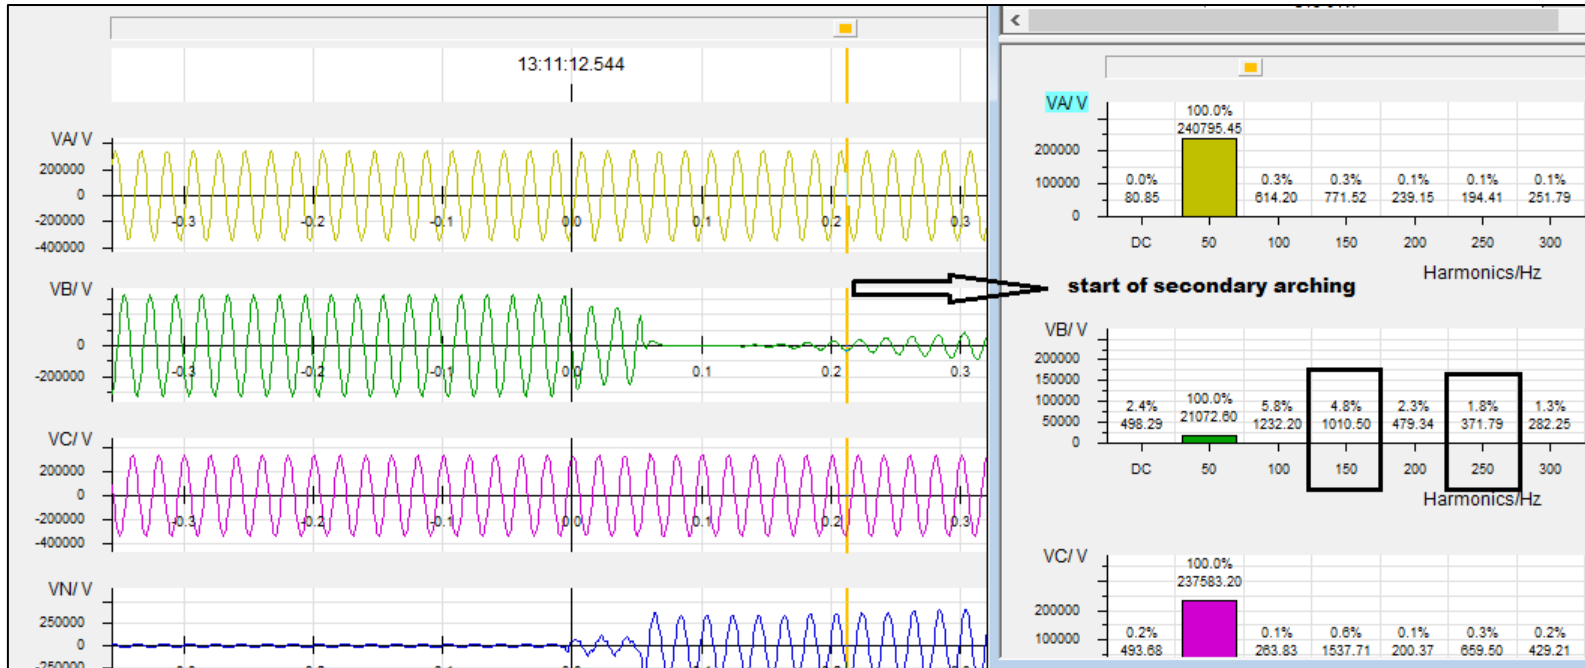
It is hard to say that it failed either due to secondary arcing or there was actual fault ,as at the instant of auto reclose with persisting secondary arcing and growing voltage if we close the breaker it is same as closing to a permanent fault.

Here in the above mentioned case also Line is 100% compensated thus secondary arch current will be more than 50 amps and chances are there that it will persist for large time if not suppressed .

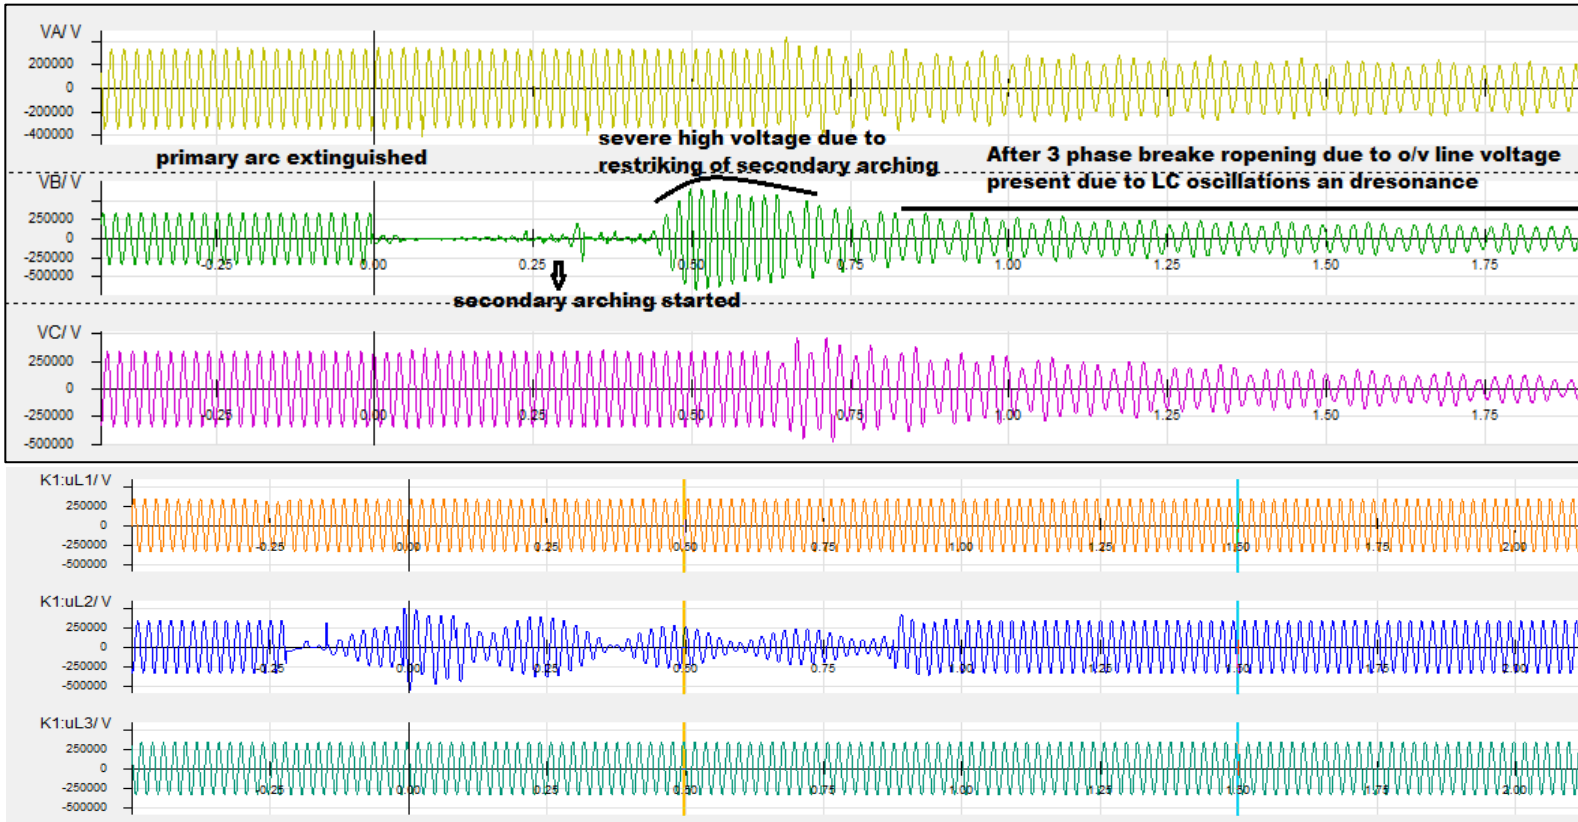
TRIPPING OF 400 KV NPGC-PATNA –I AT 15:14 HRS ON 17/06/2020 DUE TO OV-STAGE II :

Initially there was Y -N fault in the line and Y phase breaker opened instantly but after 400 ms of opening of breaker sever high voltage appeared in the opened phase and all 3 phase opened due to DT receipt with O/V stage 2-operation at Patna end . After 3 pole opening even line voltage in all 3 phase persisted for 5 seconds.

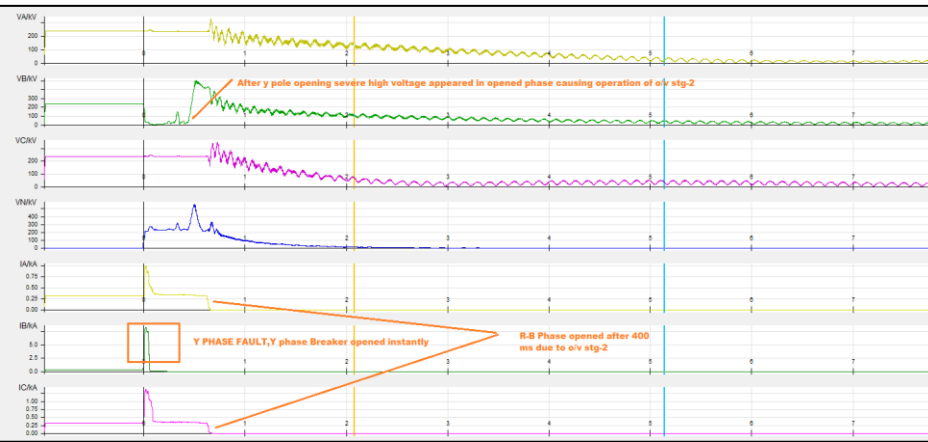
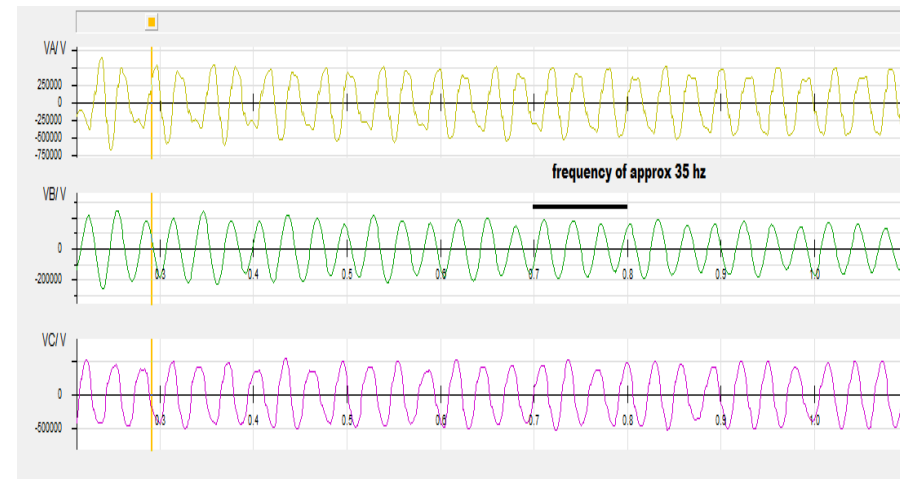
NPGC CASE:

With such amount of voltage LC oscillations also started with frequency of 45 Hz approx. As line is compensated more than 85 % ,Line length is 140Km (90 Mvar) , quad moose with 80 Mvar L/R at Patna end .Thus oscillation frequency of LC resonance is coming around 45 Hz which is observed in Dr plot also
