# Minutes of 105<sup>th</sup> PCC Meeting

**Date:07.09.2021**  
**Eastern Regional Power Committee**  
**14, Golf Club Road, Tollygunge**  
**Kolkata: 700 033**

### **MINUTES OF 105<sup>TH</sup> PROTECTION COORDINATION SUB-COMMITTEE MEETING HELD ON 23.08.2021 AT 10:30 HOURS**

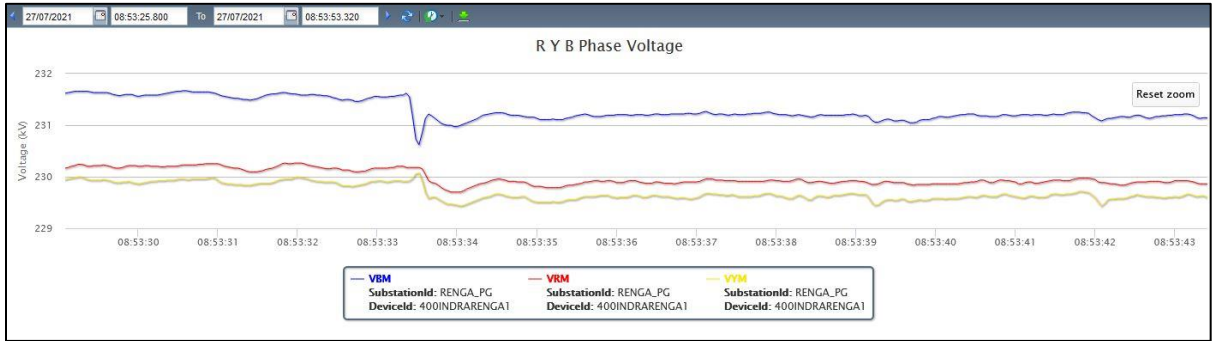
Figure 3: PMU captured at Rengali shows B-Earth fault and slight dip in voltage

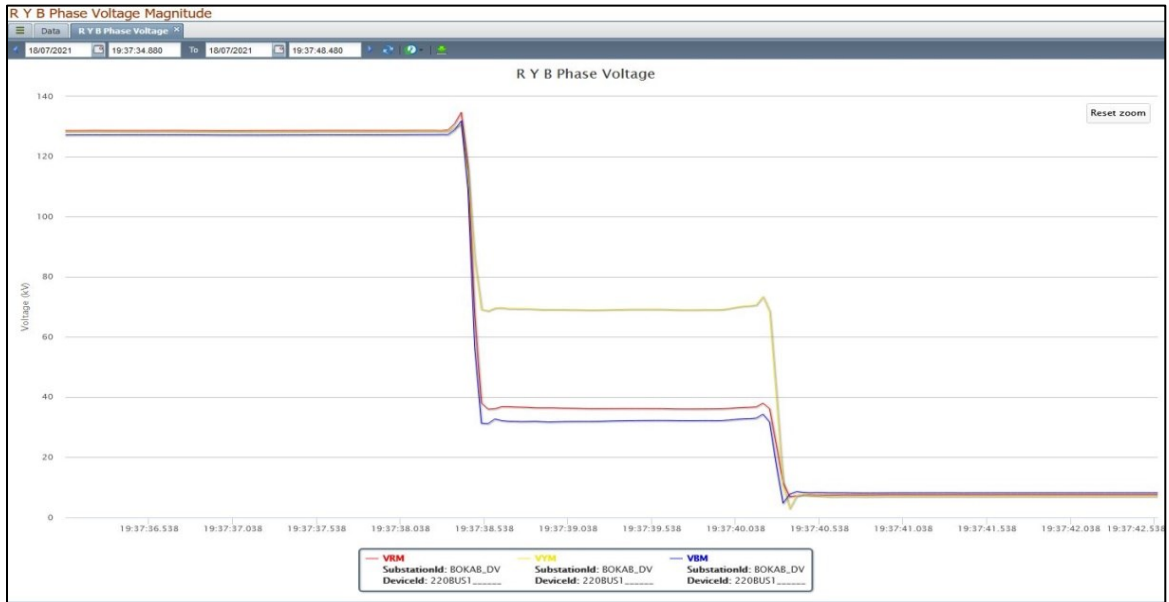
Figure 3: PMU captured at Bokaro shows fault was cleared in around 1.5 seconds after first dip

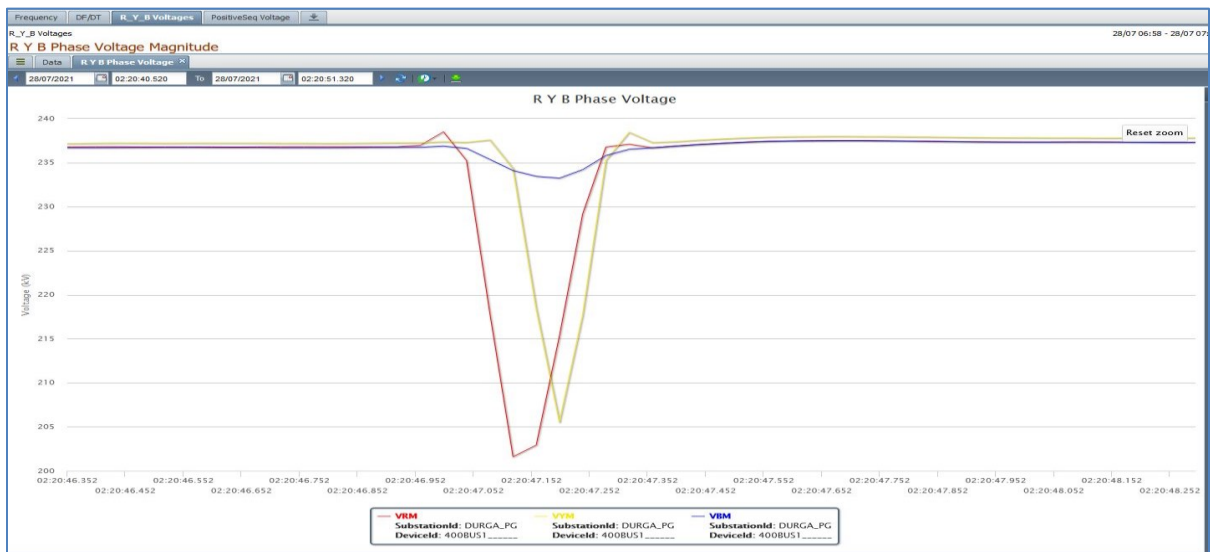
Figure 3: PMU captured at Durgapur shows R-Y-Earth fault cleared in 100ms seconds and dip of around 35 kV.

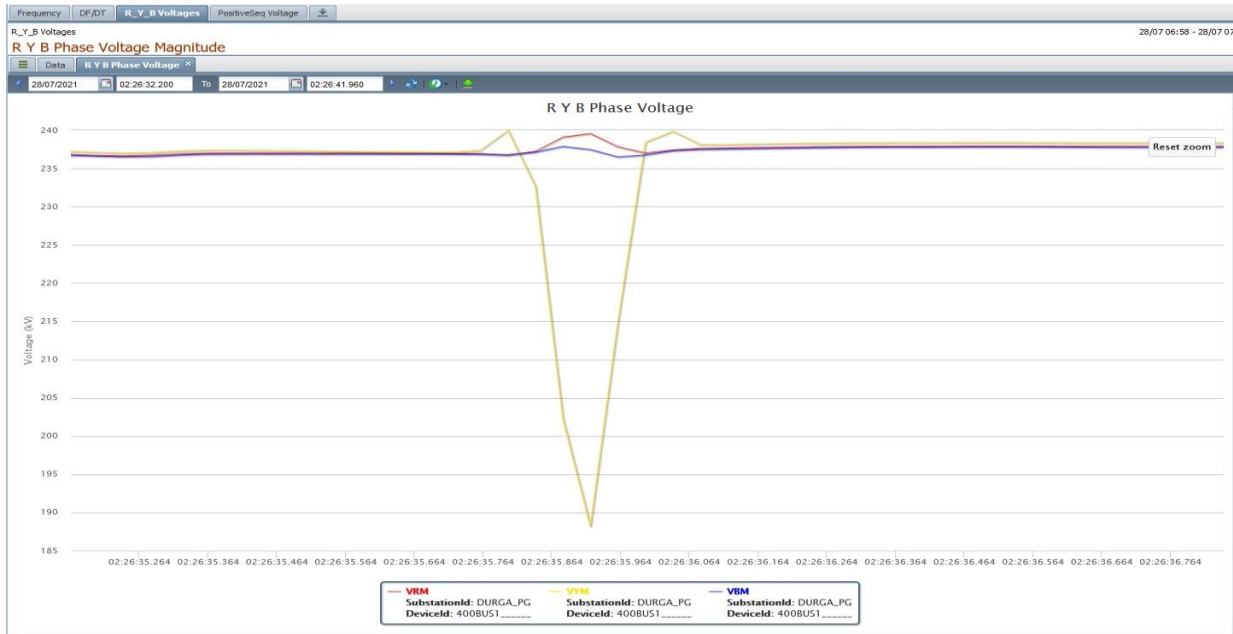
Figure 4: PMU captured at Durgapur shows Y-Earth fault cleared in 100ms seconds and dip of around 48 kV.

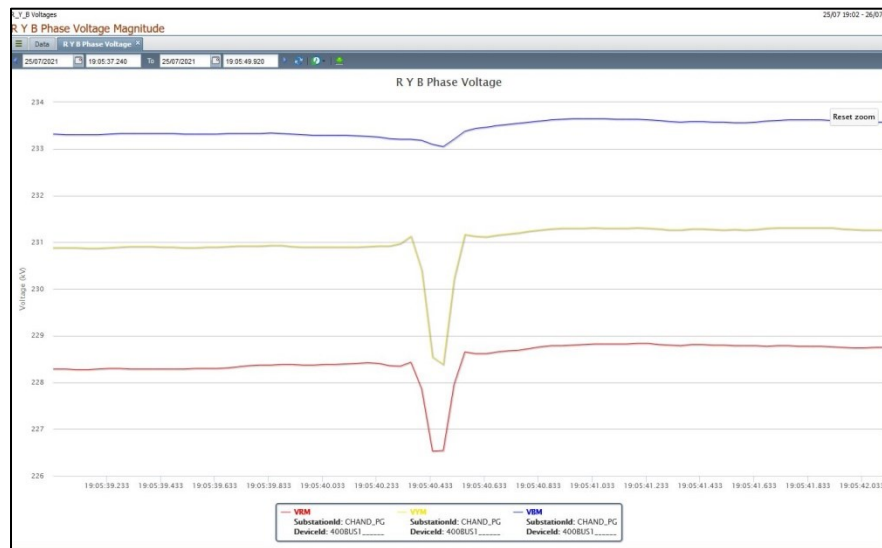
Figure 3: PMU captured at Chandauti shows 3kV dip in R and Y phases indicating fault in R-Y phases.

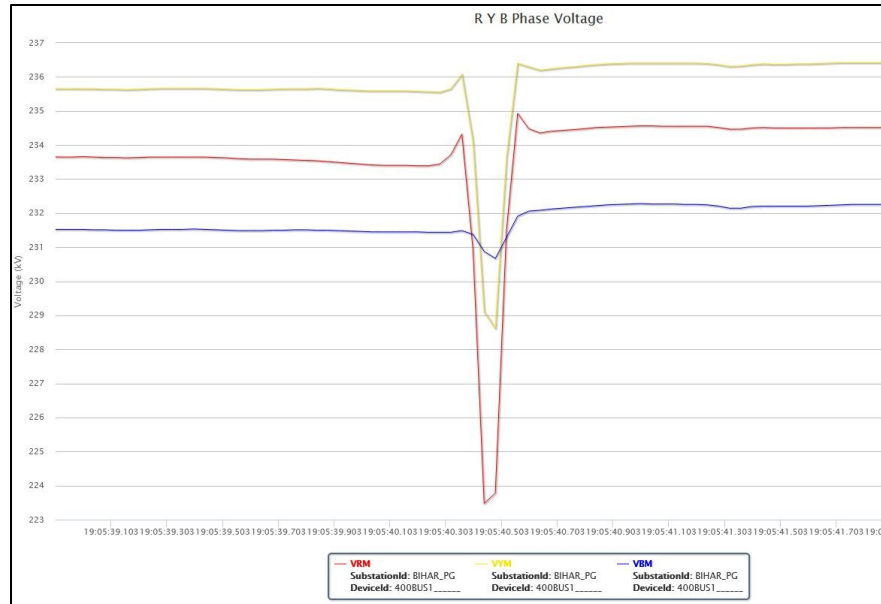
Figure 4: PMU captured at Biharshariff shows 20 kV dip in R and Y phases indicating fault in R-Y phases

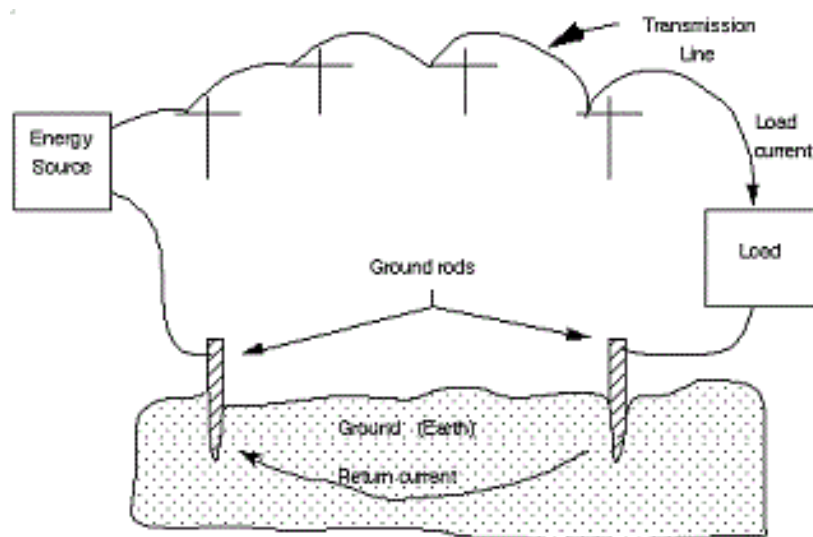
The 220Kv Rengali line was earthed with line earth switches closed at TSTPS end and Rengali end as part of PTW isolation. This has effectively created a parallel path to ground return path. The figure below is shown to illustrate and help visualise the concept of ground return.

1. IN 220KV Rengali line Current of magnitude 438A/367A/315A had flown in R/Y/B phases of the line and voltages of < 0.1kV for more than 1 sec (Due to line earthed at both end phenomena explained above )Which has lead to Operation of SOTF of the line .SOTF is set to operate if  $V < 70\%$  (154kV) of noiminal value and  $I > 5\%$  (50A) of Nominal value.

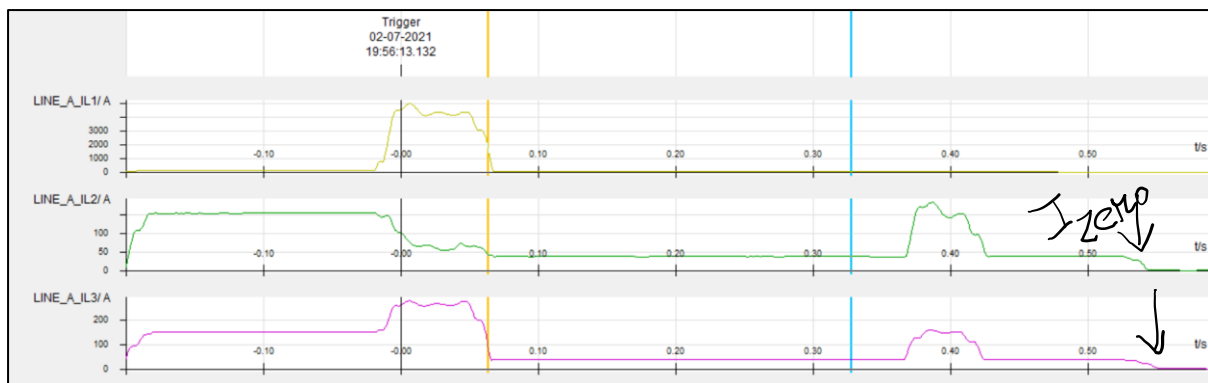
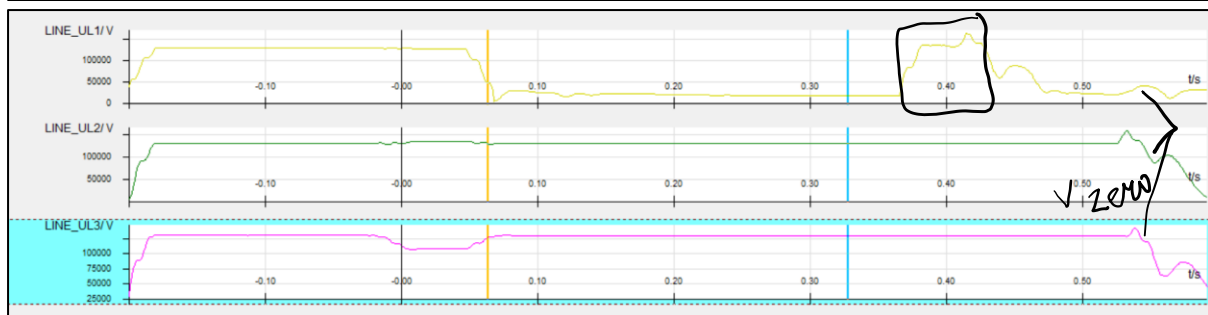
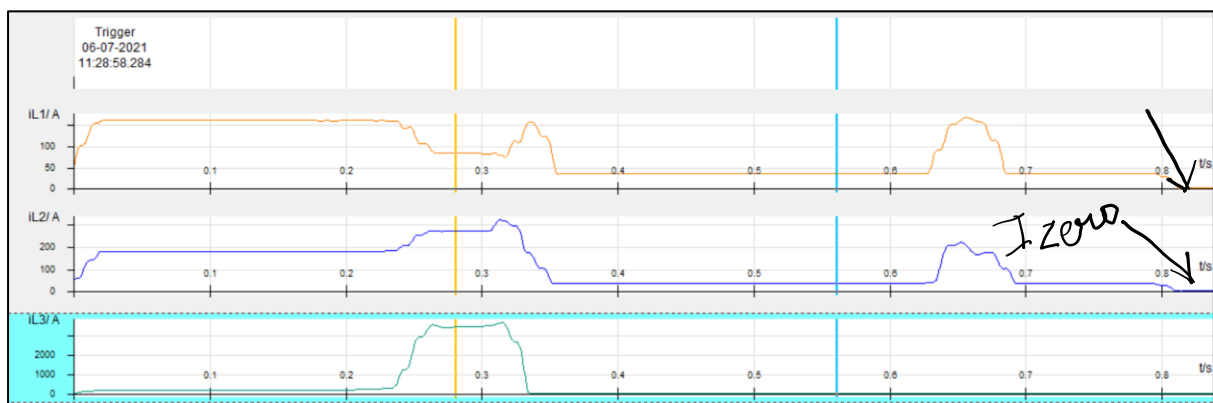
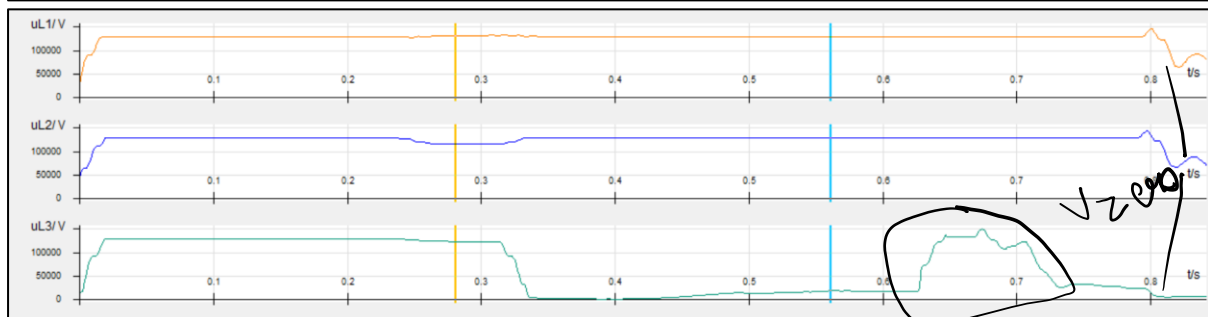
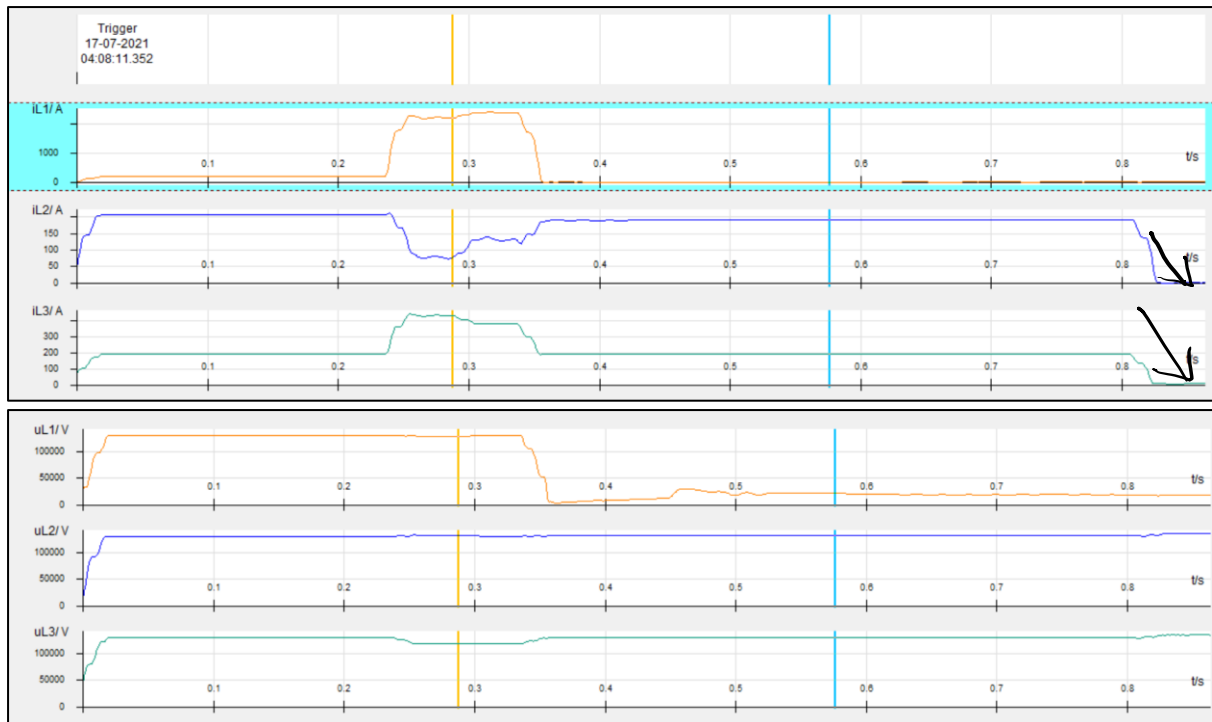
Line current of rest 2 phases are becoming zero which can be observed from below attached DRs for all cases.

**Issue of Auto reclose** can also be seen in below attached DR that ,A/r is not occurring as rest 2 phases are being opened, this can be properly analysed for root cause identification and mitigation.

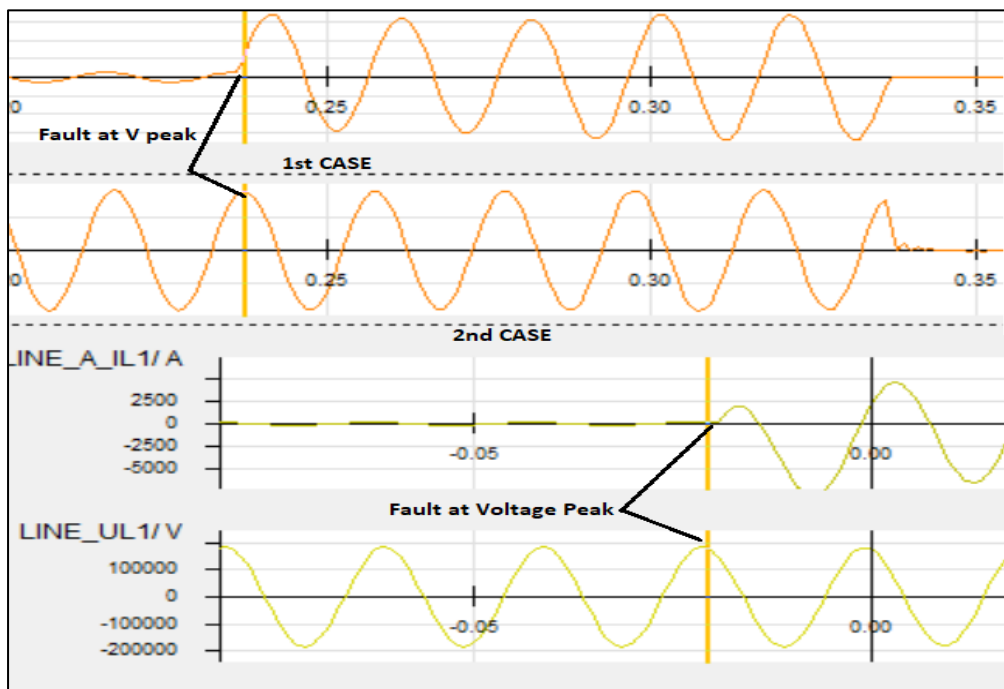
From DR signature analysis it is observed that in all cases, fault seems to be due to vegetation issue as all faults are occurring at voltage peak as arc over is occurring at voltage peak due to high electrical stress. Fault currents are symmetrical and have no Dc offset due to vegetation fault occurring at peak and with increasing nature of current.
