Minutes
of
118th PCC Meeting

Date:20.09.2022
Eastern Regional Power Committee
14, Golf Club Road, Tollygunge
Kolkata: 700 033

MINUTES OF 118th PROTECTION COORDINATION SUB-COMMITTEE MEETING HELD ON 20.09.2022 AT 10:30 HOURS

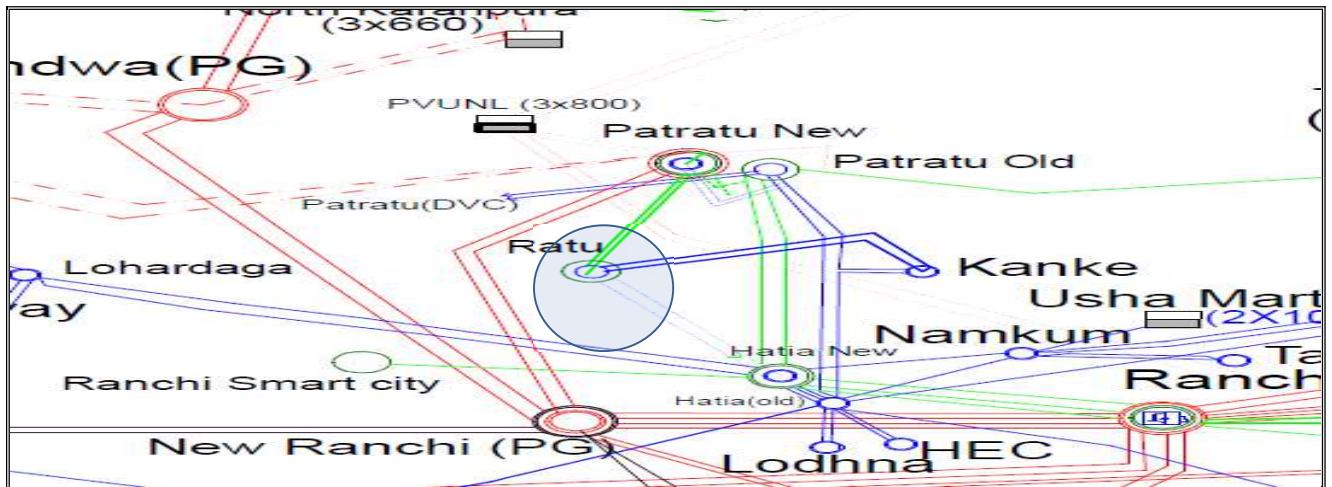
Figure 1: Network across the affected area

At 11:56 Hrs, 220 kV Patratu-Burmu(Ratu) /c tripped due to R_N fault leading to total power failure at 220/132 kV Burmu S/s. 400/220 kV ICT- at Patratu also tripped at the same time. Load loss of 80 MW reported at Kanke and Burmu by Jharkhand SLDC.

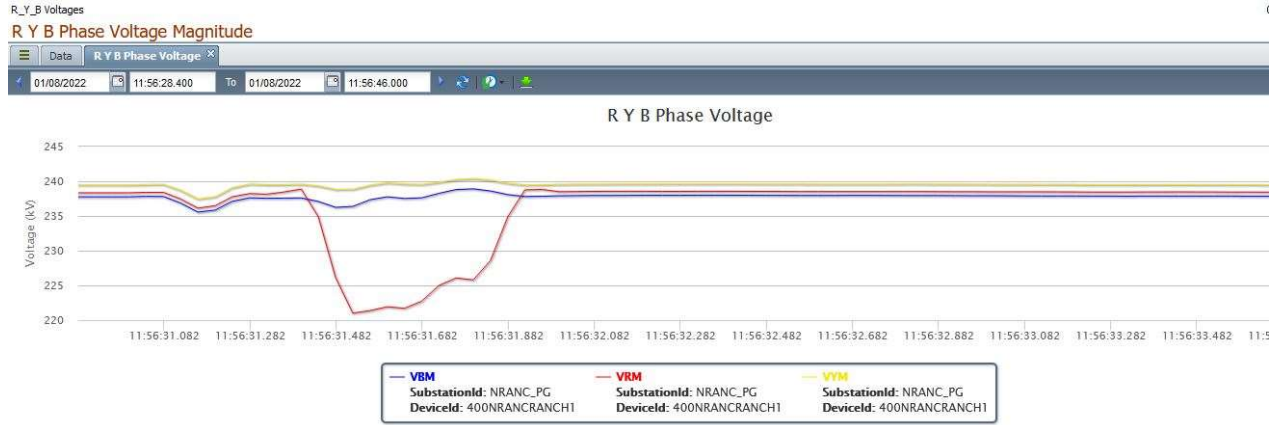
Figure 2: PMU snapshot of 400/220 kV New Ranchi S/s

समय	नाम	उप केंद्र 1 रिले संकेत	उप केंद्र 2 रिले संकेत	पीएमयू पर्यवेक्षण
11:56	400/220 kV ICT-1 at Patratu	BackUp O/c		18 kV dip in R_ph voltage at New Ranchi. Fault clearance time: 400 msec
	220 kV Patratu-Burmu (Ratu)-1	Patratu: R_N, 2.34 kA	Burmu: R_N, 0.95 kA	
	220 kV Patratu-Burmu (Ratu)-2	Patratu: R_N, 2.35 kA	Burmu: R_N, 1.36 kA

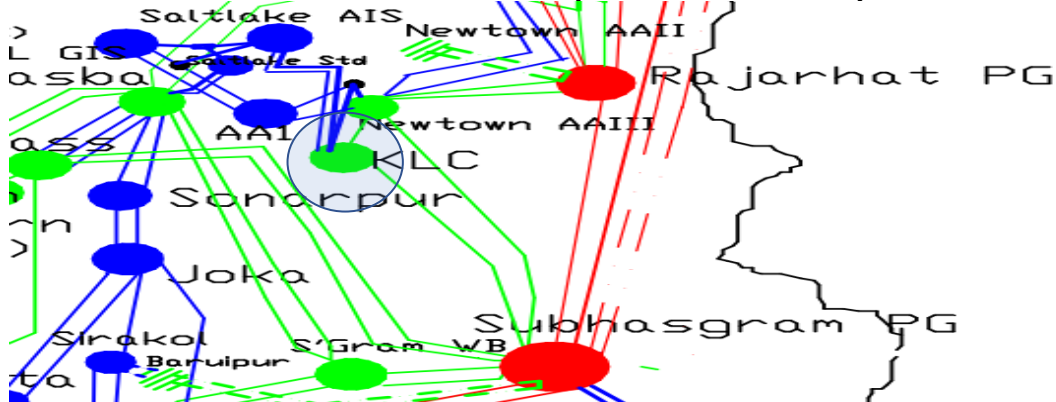
Figure 1: Network across the affected area

At 10:13 Hrs on 26th August 2022, total power failure occurred at 220/132 kV KLC Bantala S/s. As reported, Y_ph PT of 220 kV Bus-1 burst, leading to tripping of all associated feeders and transformers. 56 MW load loss reported during the event by SLDC West Bengal.

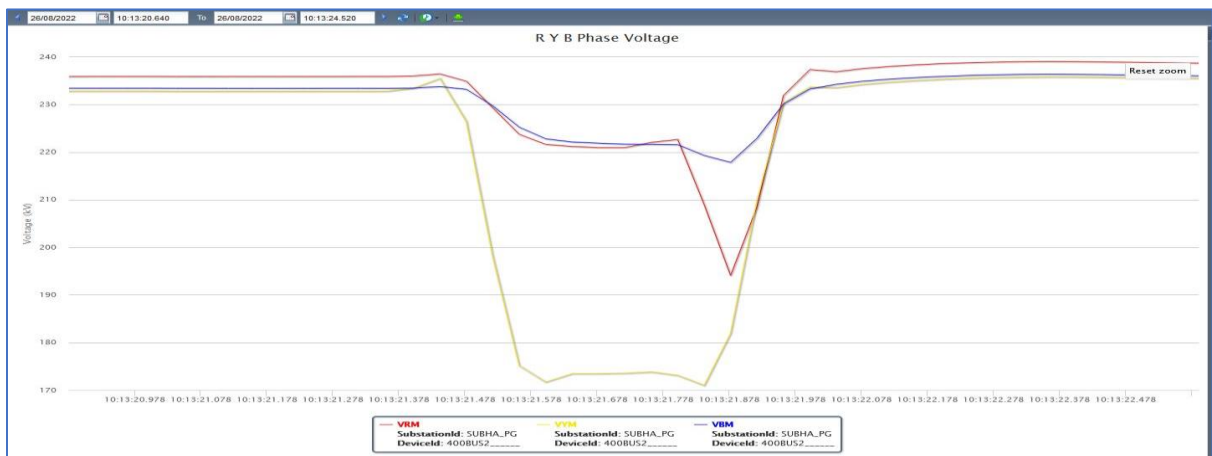
Figure 3: PMU Voltage snapshot of 400/220 kV Subhashgram S/s

समय	नाम	उप केंद्र 1 रिले संकेत	उप केंद्र 2 रिले संकेत	पीएमयू पर्यवेक्षण
10:13	220 kV Bus-1 at Bantala (KLC)	Feeders tripped from remote end		62 kV dip in Y_ph voltage and later 40 kV dip in R_ph voltage at Subhashgram. Fault clearance time: 350 msec
	220 kV Subhahsgram-Bantala (KLC)	Subhashgram: R_Y, Zone-2, Ir: 7.26 kA, Iy: 6.87 kA, 18.96 km	Didn't trip	
	220 kV Bantala (KLC)-NewTown AA 3	Didn't trip	NewTown AA 3: R_Y_N, Zone-2, 13.33 km, Ir: 7.97 kA, Iy: 7.16 kA	
	220/132 kV ICT-1&2 at Bantala (KLC)	-
