**Eastern Regional Power Committee**

**Sub: Minutes of the 119th PCC meeting held on 18.10.2022.**

Minutes  
of  
**119<sup>th</sup> PCC Meeting**

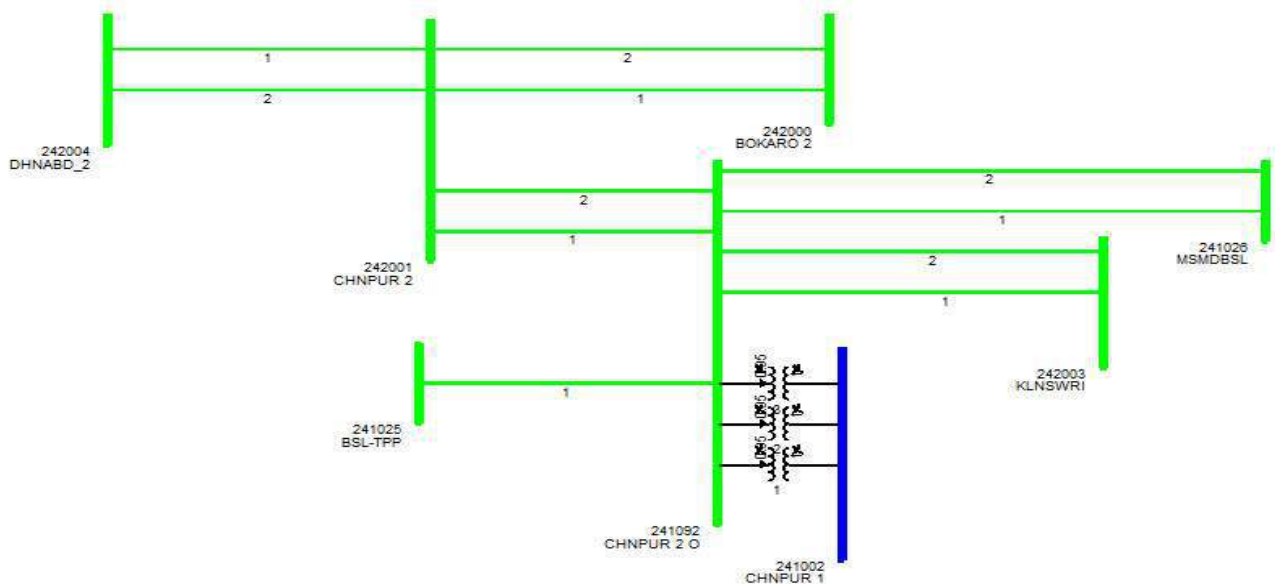
At 11:03 Hrs, 220 kV CTPS A- Kalyaneshwari also got tripped which led to total power failure at 220 kV CTPS A S/s also.

- *Due to stuck breaker condition, broken conductor protection operated and resulted in lockout condition of relay which initiated LBB operation.*
- *LBB relay issued trip command for all elements connected to main Bus-1. But it also gave tripping command to all the elements from Main bus -2. It was later found that, ST#8 was at MB#2 but both CT switching relays of main bus-1 & main bus-2 of this bay was operated condition hence it caused tripping of all bays of main bus-2 through 96 relays.*

- After tripping of 220 kV CTPS -Kalyaneswari -2, loading for circuit-1 increased to 300 MW but after 30 seconds it reduced to 190 -200 MW. Thereafter this line also developed a R-Y phase fault which was cleared by tripping of relay from both end in 100 ms and resulted in total power failure at CTPS A.

Members of PCC opined that broken conductor protection is usually set in alarm mode instead of tripping. PCC observed that the settings adopted by DVC for broken conductor protection is quite conservative and not the usual practice as followed by other utilities. PCC advised DVC to submit the criteria/philosophy behind such setting and further advised to review the setting and the broken conductor protection may be set in alarm mode instead of issuing tripping command.

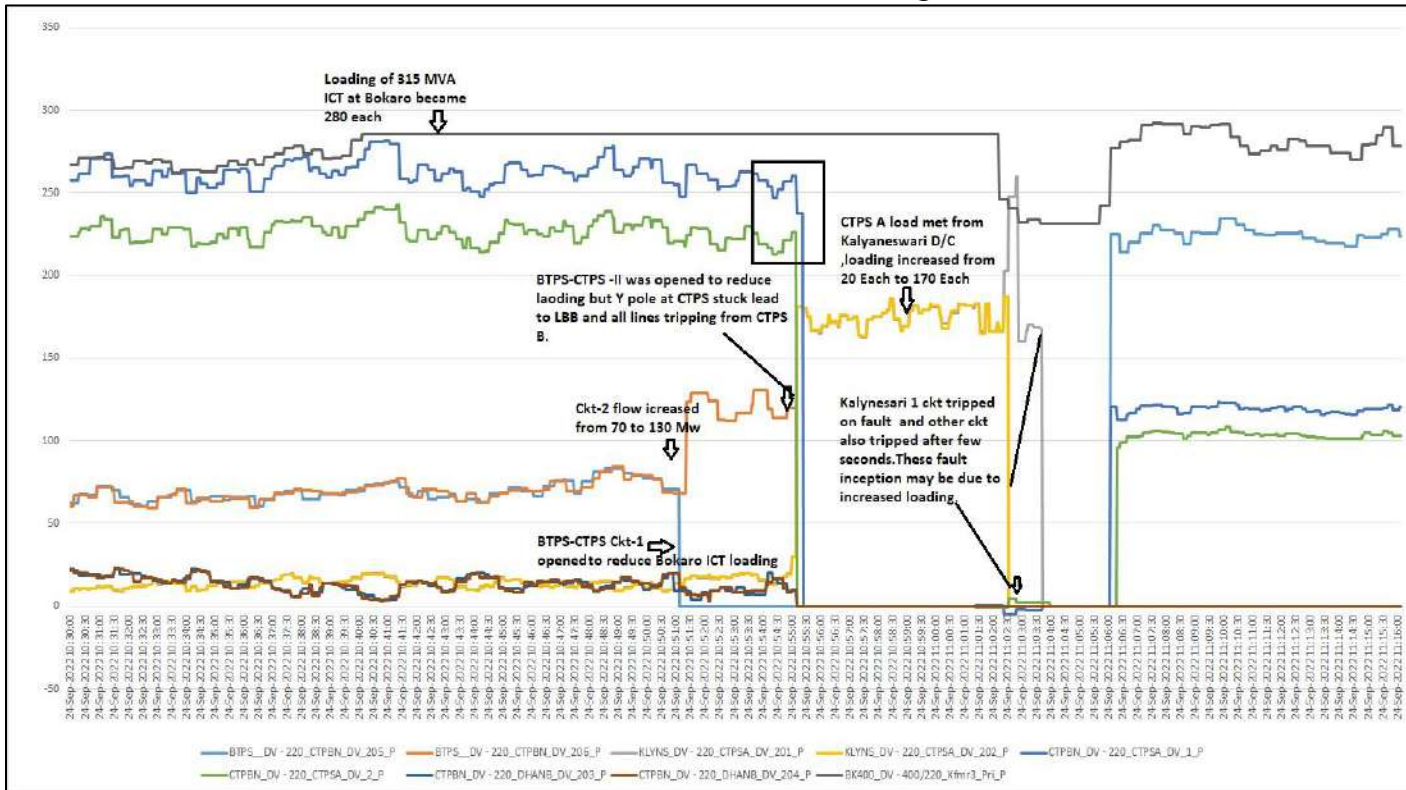
Power flow SCADA plot for the event.

- Loading of 2\*315 MVA ICT at Bokaro touched up to 280 MW each and to reduce the loading of ICT ,BTPS-CTPS (B)-I was opened at 10:50 Hrs ,but ICT loading did not reduced as load was shifted to ckt -2 as observed from above scada plot .
- At 10:55 Hrs ckt-2 was also opened but Y pole CB at CTPS (B) got stuck and did not open which can also be seen from below PMU plot of line current plot. Y phase current became zero after 3 seconds ,Probably after PD operation.

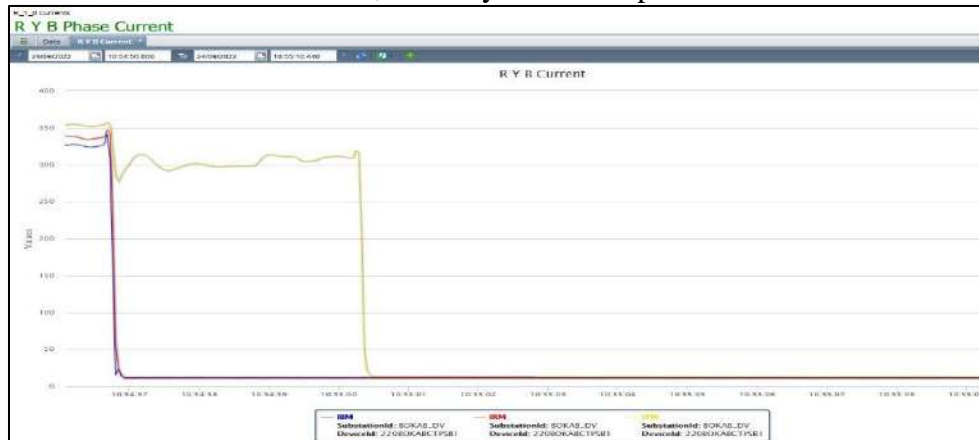
- Under such condition of stuck one pole of breaker PD should have operated and tripped the remaining phase but apart from this all other lines with main bus-1 and 2 at CTPS B tripped.

- Reason for the same was due to stuck breaker condition, Broken conductor protection operated and resulted into lockout relay operation which further initiated Operation of LBB as Y pole was stuck and LBB gave tripping command to each element from Main Bus -1.

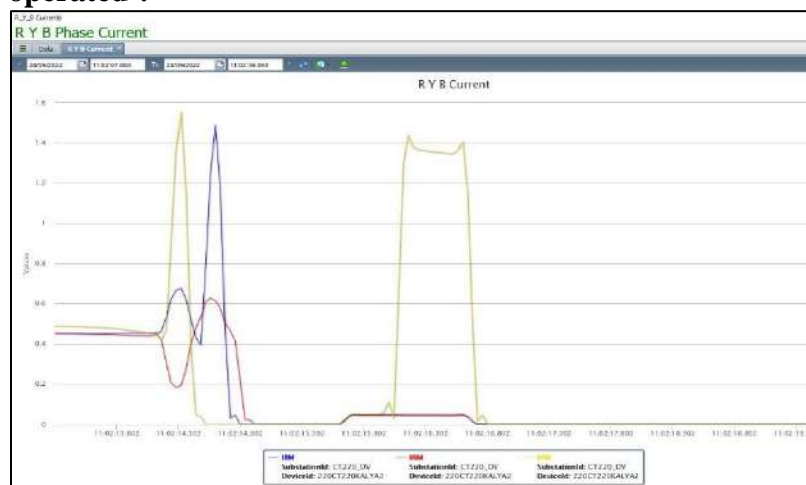
- Y-B phase fault occurred in Kalyaneswari ckt-2 and all 3 phases tripped and after 1 second 3 phase auto reclose occurred and all 3 phases got closed then again after 300 ms Y phase fault appeared persisted for approx. 600 ms and got cleared after that with all 3 phase opening .Suspected fault occurrence in this line 2 appears to be due to sag ,clearance issue with increased loading .**DVC may explain the nature of fault and protection operated ?**

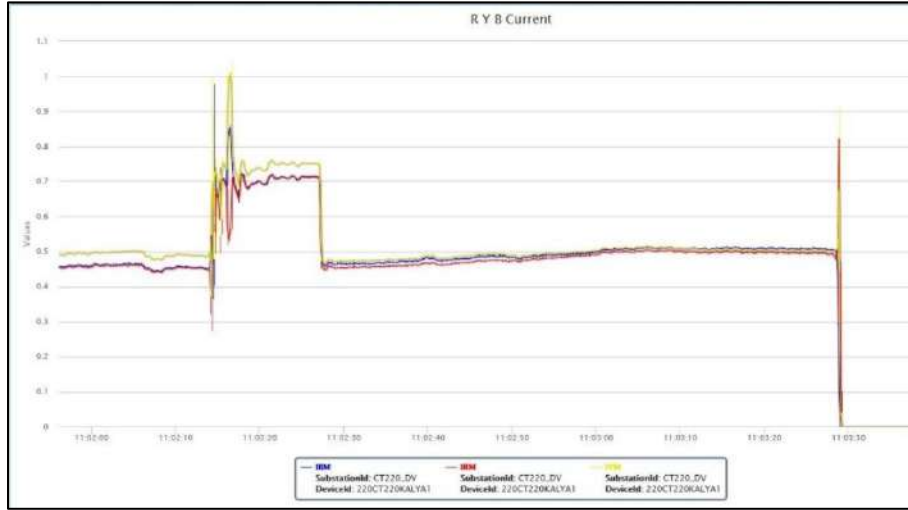
- With tripping of Kalyaneswari Ckt-2 the other remaining circuit loading went upto 300 Mw as can be seen from SCADA as well as pmu but later after 30 seconds it reduced to

190 -200 Mw and after a minute this line also developed a R-Y phase fault possibly due to sag and clearance caused by Overloading. **DVC to check this aspect and explain the nature of fault and protection operated?**

- With tripping of CTPS A-Kalyaneswari D/C complete ,CTPS A substation also became dead.
- Fault inception due to high loading may be checked as it occurred in both the lines of kalyaneswari , proper maintenance ,Row , clearance may be ensured to avoid such faults .

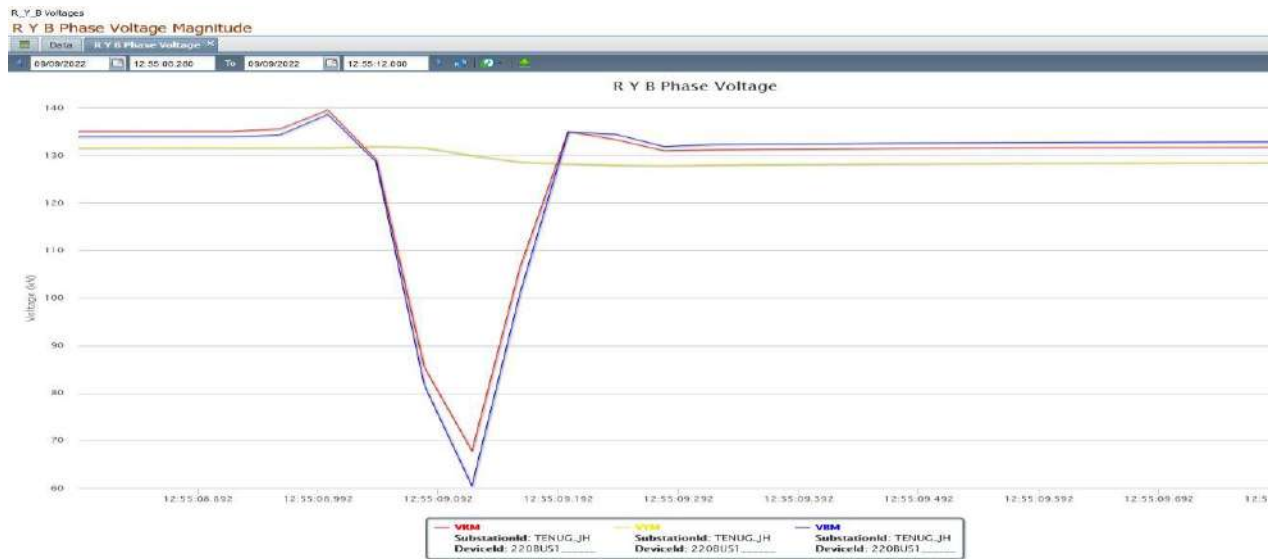
Figure 3: PMU voltage snapshot of 220 kV Tenughat S/s

*During the above disturbance, relay at Dumka end for 220 kV Dumka-Govindpur-1 sensed the fault in zone-3, however tripping occurred within 100 ms as T1(timer of zone-1) had picked up. This is observed from disturbance recorder of the relay.*

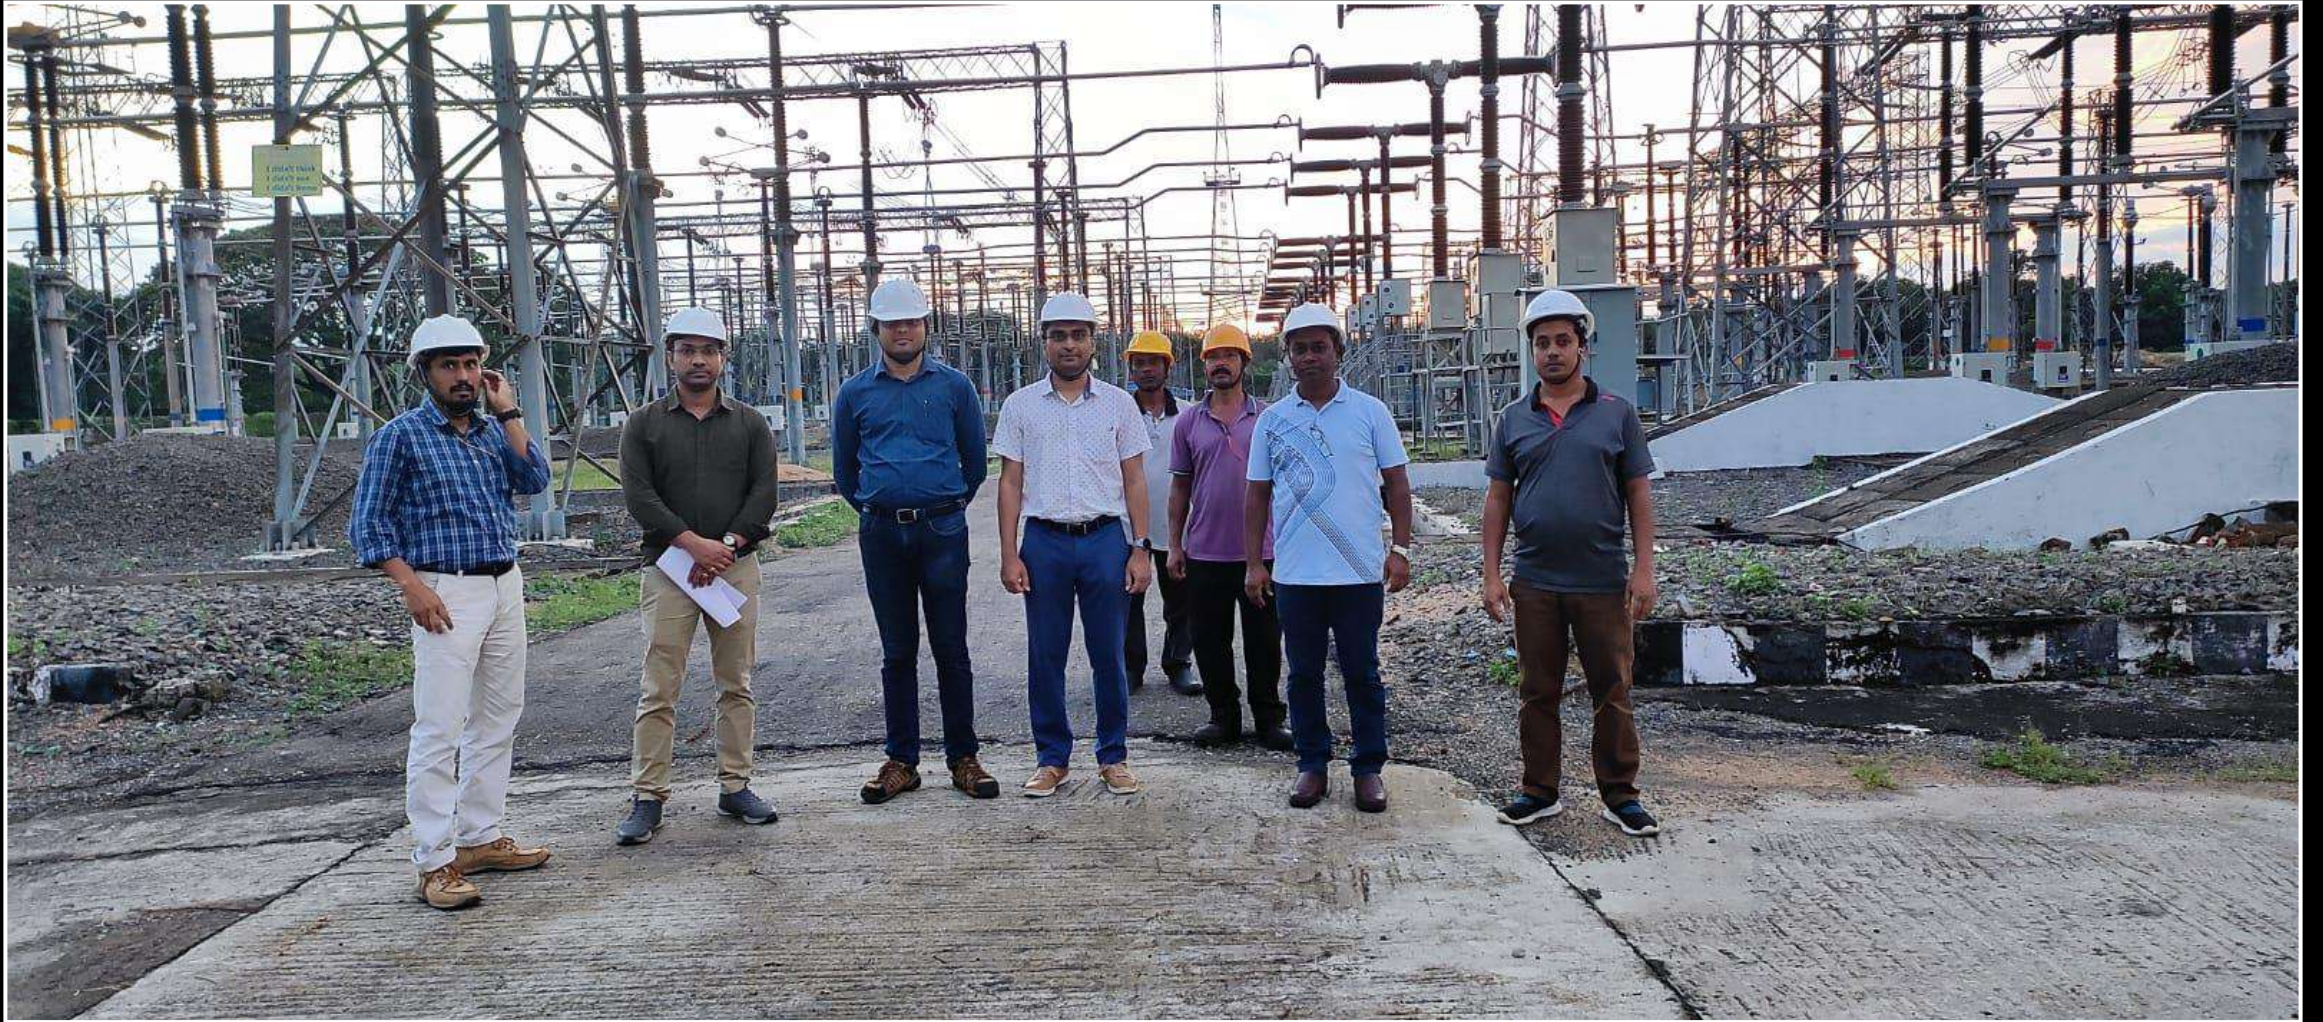
- For Bus coupler replacement both bus shut down is required due to proximity of both main buses. As the observation of the team it is found that as shut down time of individual element could be minimized opening the Bus jumpering of the end bus section where the B/C situated.
- Also the Transfer Bus coupler bay LBB relay is old electromechanical relay, which also maloperated in recent past and needs to be replace. POWERGRID expressed that relay is ready at site for installation and testing they need shut down of any one feeder for checking whether LBB can trigger other line tripping correctly or not.

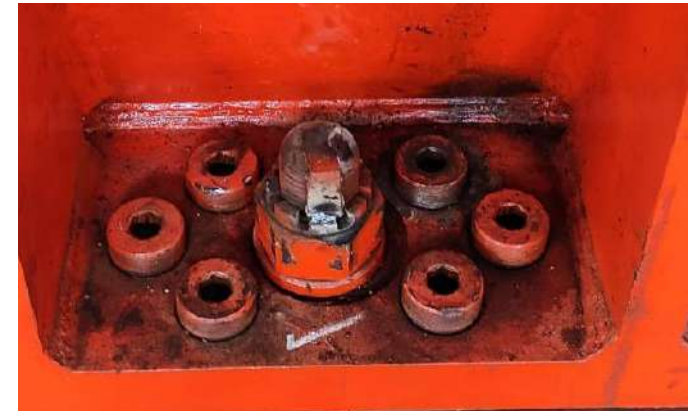
- Farakka STPP unit 6 tripped on 20-06-2022 due to turbine vibration. Later it was taken under annual overhauling. Then unit was revived on 15-08-2022. However, Unit tripped again 23-08-2022 due to vibration problem.
- NTPC informed that 2 out of 14 bolts of generator (shown in right side) were damaged and alignment was disturbed.
- LP turbine blade also got damaged and same is replaced.
- The reason for second tripping is vibration issue of next bearing.
