# Agenda for 121<sup>st</sup> PCC Meeting

**Date:16/12/2022**  
**Eastern Regional Power Committee**  
**14, Golf Club Road, Tollygunge**  
**Kolkata: 700 033**

**AGENDA FOR 121<sup>st</sup> PROTECTION COORDINATION SUB-COMMITTEE MEETING TO  
BE HELD ON 16.12.2022 AT 10:30 HOURS THROUGH MS TEAMS ONLINE  
MEETING PLATFORM**

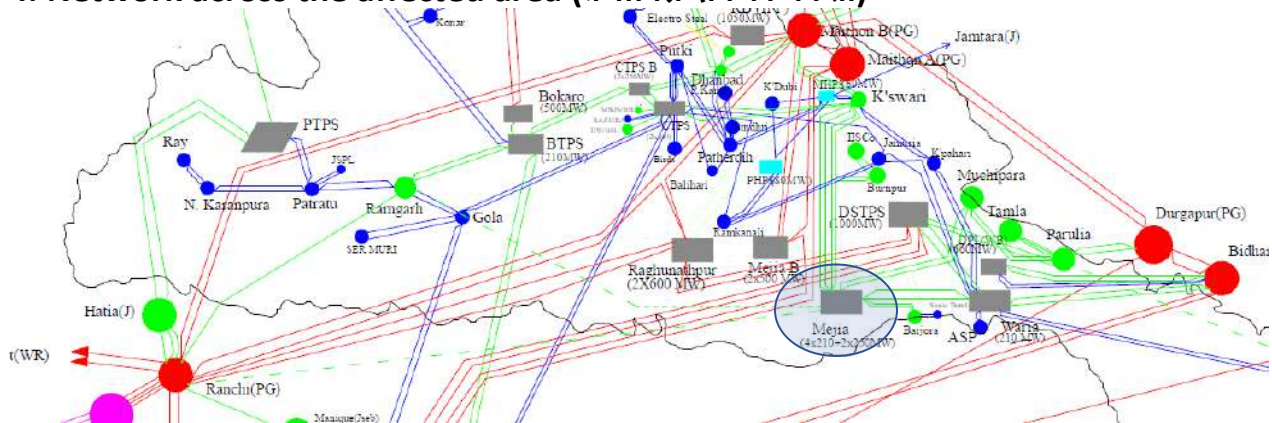
Figure 1: Network across the affected area

At 10:40 Hrs on 20.11.2022, 220 kV Mejia-Durgapur (DVC) tripped due to B\_N fault. At the same time, its LBB relay mal-operated and all elements connected to 220 kV Bus-3 at Mejia tripped. SST#D was connected to 220 kV Bus-4, however, its CT switching relay was defective and isolator status was showing that it was connected to both buses, hence 220 kV Bus-4 at Mejia also tripped. 250 MW U#5, U#6 tripped leading to 366 MW generation loss at Mejia.

- 220 kV Mejia-Ranchi-1
- 220 kV Mejia-Ramgarh-1
- 220 kV Mejia-Durgapur D/c
- U#5, U#6 (250 MW each) at Mejia
- SST#D, SST#E

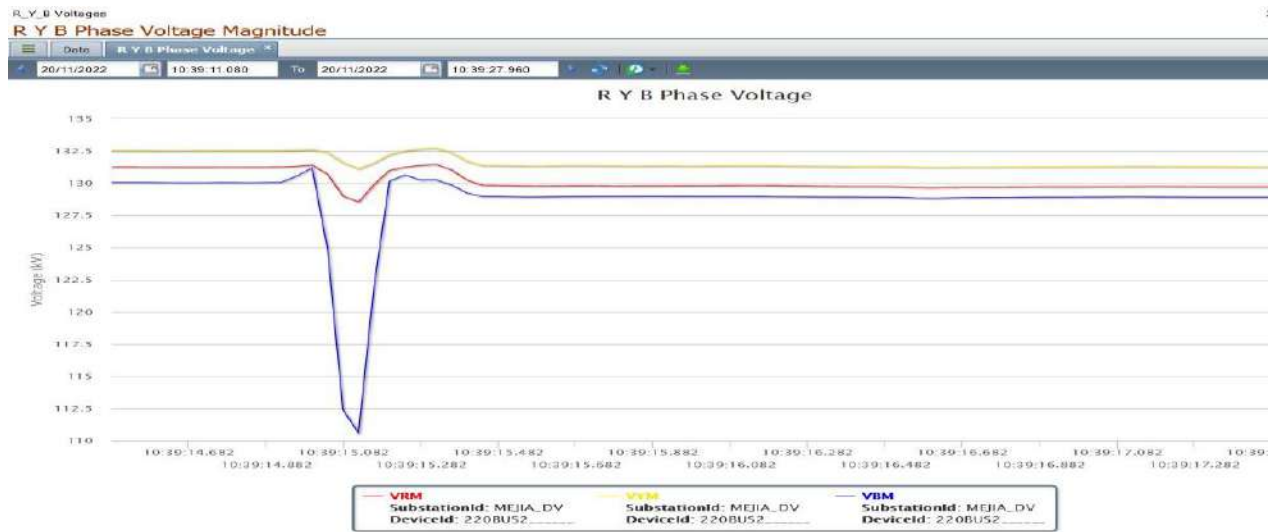
Figure 2: PMU voltage snapshot of 220 kV Mejia S/s

समय	नाम	उप केंद्र 1 रिले संकेत	उप केंद्र 2 रिले संकेत	पीएमयू पर्यवेक्षण
10:40	220 kV Mejia-Ranchi-1	LBB protection	-	20 kV dip in B_ph voltage at Mejia S/s. Fault clearance Time: 100 msec
	220 kV Mejia-Ramgarh-1		-	
	220 kV Mejia-Durgapur-1		-	
	220 kV Mejia-Durgapur-2	Mejia: B_N, Zone-1, 11 km	-	
	U#5, U#6 at Mejia	LBB protection	-	
	SST#D, SST#E		-

- A single-phase fault (B-Earth) struck 220 kV Mejia-Durgapur-1 at 11 km from Mejia which was cleared within 100 msec. However, LBB of this CB operated immediately leading to tripping of all elements connected to 220 kV Bus-3. As reported, LBB relay was found faulty.

- As reported, CT switching relay of 220 kV Bus coupler was also found faulty.
- Detailed report received from DVC is attached at **Annexure-3**.

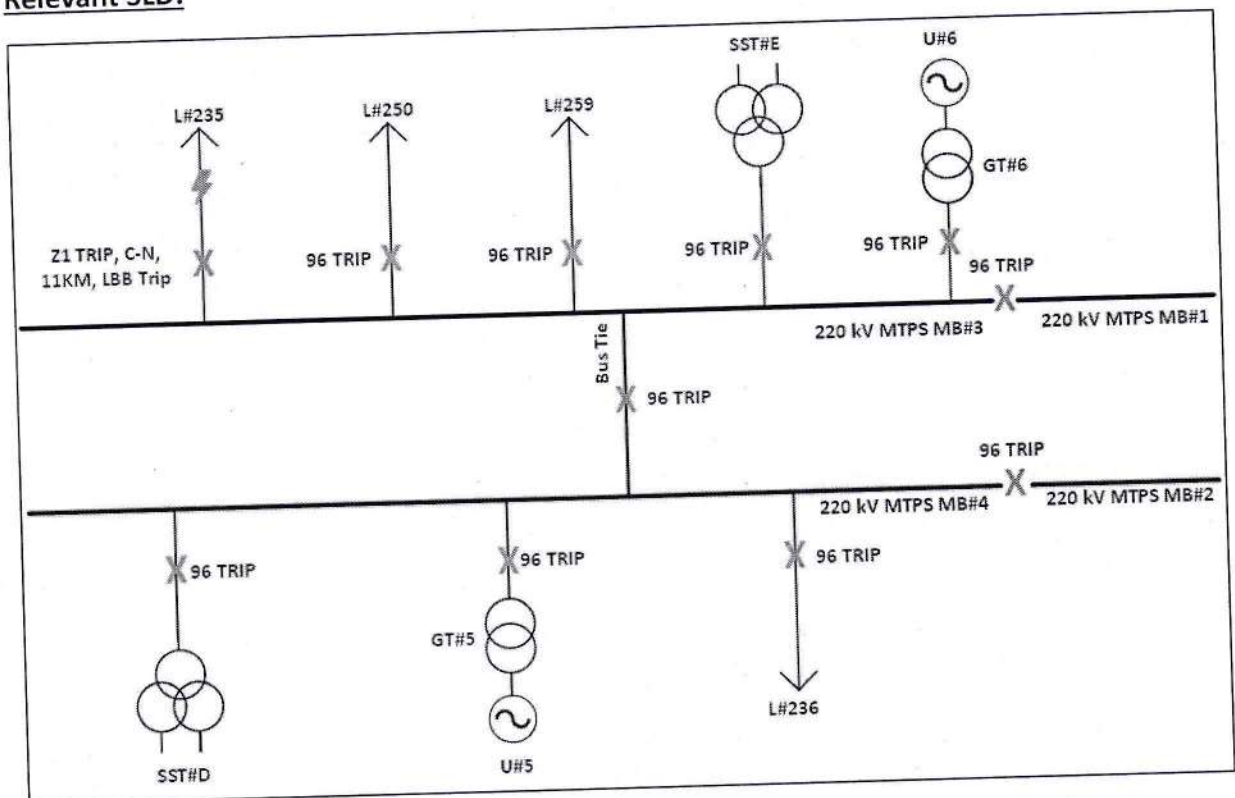
### Relevant SLD:

It was reported that at around 10:40 Hrs 220kV MTPS-Durgapur L#235 tripped through Z1 distance protection from both ends. The fault occurred in the said line at a distance 11 Km from MTPS end. But along with that LBB protection of the concerned bay operated and tripped all bays connected to 220 kV Main Bus # 3 & 4.

- Then last fault record of L#235 LBB Relay (ERL ARGUS-1) was noted down from the display panel as DR downloading provision is not available in this relay. It was observed that CB Fail trip command was issued and recorded current values were  $I_A=0.33I_n$ ,  $I_B=0.45I_n$  &  $I_C=10.7I_n$ . So, it is evident that, LBB relay logged fault current properly but as this fault current was cleared within 80ms, LBB relay should not have issued any CBF trip command.

- c) All settings of this LBB relay were checked thoroughly and were found to be in order.
- d) Then this LBB relay (bearing Sl. No. BR0613291, Type: DCD414B, ARGUS 1) was racked out and tested by secondary injection method. It was found that whenever LBB initiation was given to the relay, relay issued CBF trip command instantaneously irrespective of any current in the relay.

- g) The reason of tripping of MB # 4 along with MB # 3 was improper operation of SST # D 89AX CT switching relay which had shorted the DC buses of MB # 3 & MB # 4. The concerned relay was drawn out and tested. On testing, it was found that the reset coil of the said relay was defective. During disturbance, SST # D was connected to MB # 4 and accordingly 89BX CT switching relay was in operated condition. But as 89AX relay did not reset properly due to its faulty resetting coil, both 89AX & 89BX remained in set condition. Thus, appearance of trip command in MB # 3 has resulted in operation of 96 relays of bays connected to MB # 4.

- h) In addition to this, 89AX CT switching relay of BC # 4 was also found to be defective during testing.

- e) Thereafter a healthy relay (bearing Sl. No. BR1601697, Type: DCD414B, ARGUS 1) was configured with the existing relay LBB settings and tested O.K. i.e. the relay was giving the LBB Trip command 200ms (LBB Timer) after LBB initiation only when the current in any phase was above 20% or 200mA (LBB Pick Up current). The faulty LBB relay was replaced by this healthy relay and the line was normalized.

- a) Malfunction of Easun Reyrolle(ER) make DCD414B relays used for LBB protection at CTPS New 220KV Switchyard had been observed previously too and there the LBB relays in all panels had been replaced by Siemens 7SJ relays. However, at MTPS this was the first occurrence of such mis-operation. Thus, keeping in view of history of malfunction of same make and model relays at CTPS and similar occurrence at MTPS today it has been decided that all existing LBB relays at MTPS Unit # 5 & 6 system are to be replaced by Siemens 7SJ relays in near future.

- c) As a long term measure the existing High Impedance Bus bar & LBB protection scheme needs to be replaced with numerical Low Impedance busbar protection relay with Central & Peripheral unit concept for ensuring reliability.

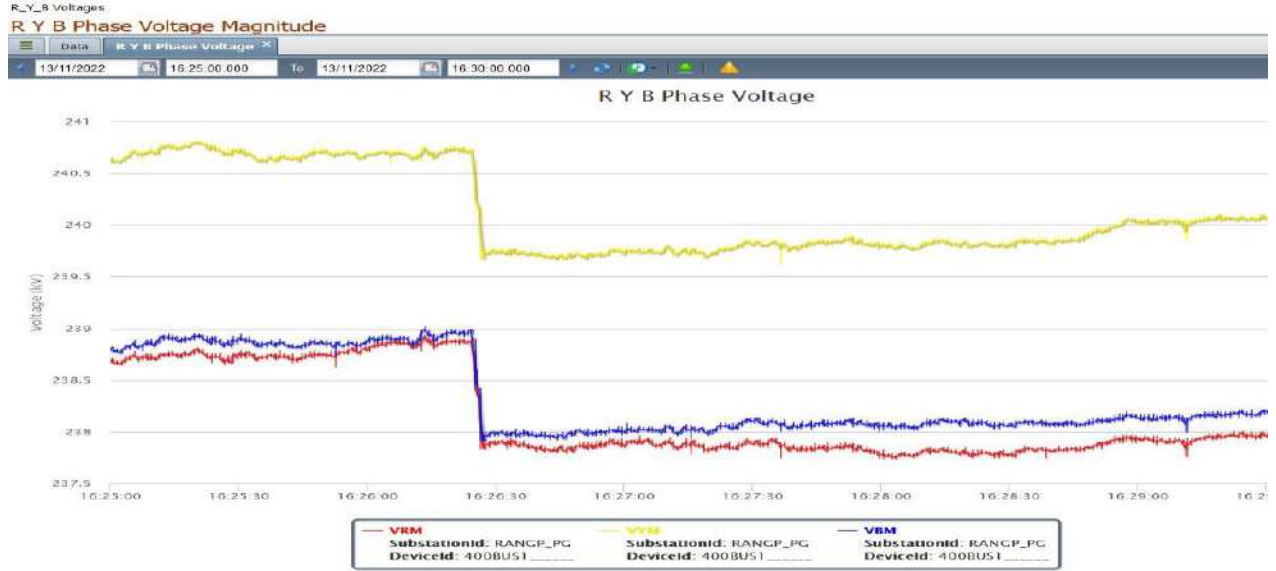
**Figure 1: PMU Voltage snapshot of 400/220 kV Rangpo S/s at 16:26 Hrs**

समय	नाम	उप केंद्र 1 रिले संकेत	उप केंद्र 2 रिले संकेत	पीएमयू पर्यवेक्षण
16:26	220 kV Tashiding-New Melli-1	Tashiding: LBB operated	New Melli: Didn't trip	1 kV dip in each phase at Rangpo at 16:26 Hrs and 1 kV dip in each phase at 16:34 Hrs
16:34	220 kV Tashiding-New Melli-2	Handtripped from Tashiding	New Melli: Didn't trip

- LBB should have given tripping command to both feeders, but it was found that due to loose wiring, bus sectionalizer status was not available and it was considered equivalent to OPEN state.

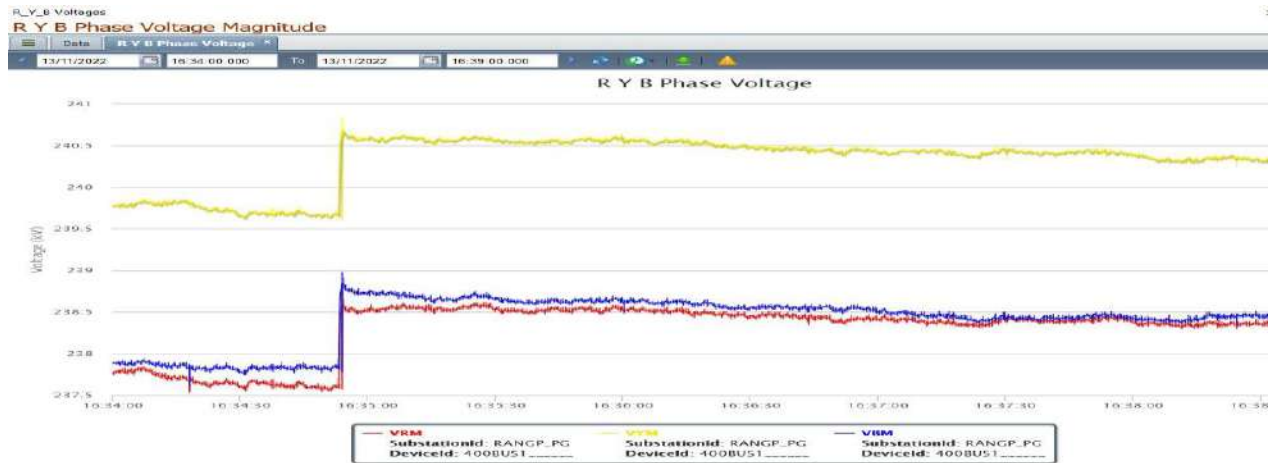
**Figure 2: PMU Voltage snapshot of 400/220 kV Rangpo S/s at 16:34 Hrs**

- As Ckt-2 was still available and breaker of U#1 main bay was still stuck, Unit went into motoring mode and reverse power flow started.
- Generator protection sensed reverse power flow and again gave tripping command to its main bay, however, due to mechanical failure in CB, it did not open. Trip coils were also found to be in burnt condition later as continuous tripping command triggered for opening the breaker.

- At 16:34 Hrs, 220 kV Tashiding-New Melli-2 was manually hand-tripped from Tashiding to avoid any damage to U#1.
- Detailed report received from Tashiding is attached at Annexure-3.

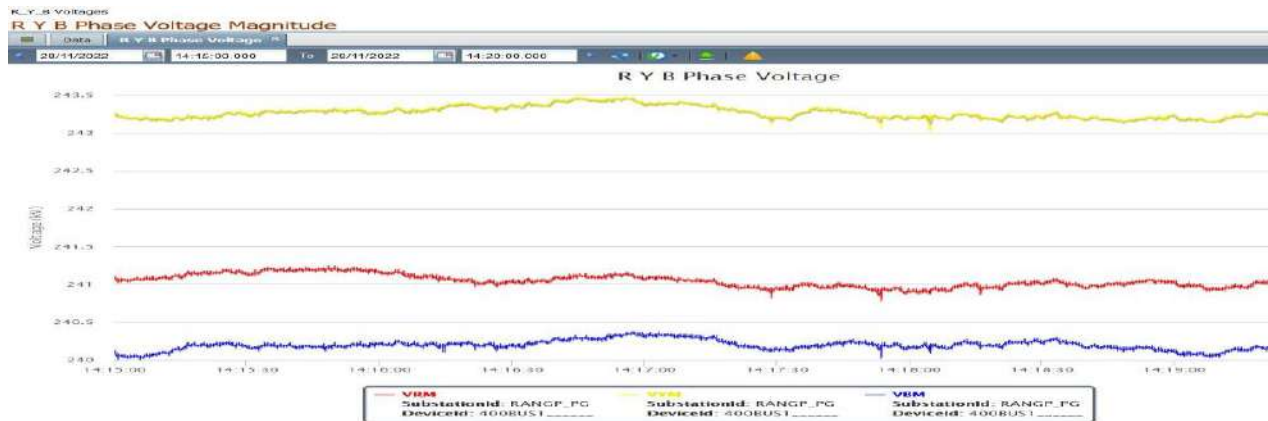
**Figure 2: PMU Voltage snapshot of 400/220 kV Rangpo S/s**

**Event 2:** At 14:16 Hrs on 28.11.2022, while testing bus bar protection scheme at Tashiding, tripping command extended to 220 kV Tashiding-New Melli D/c and total power failure occurred at Tashiding. No generation loss or load loss occurred.

समय	नाम	उप केंद्र 1 रिले संकेत	उप केंद्र 2 रिले संकेत	पीएमयू पर्यवेक्षण
14:16	220 kV Tashiding-New Melli-1	Tashiding: Master trip operated	New Melli: Didn't trip	No fault observed from PMU data
	220 kV Tashiding-New Melli-2		New Melli: Didn't trip

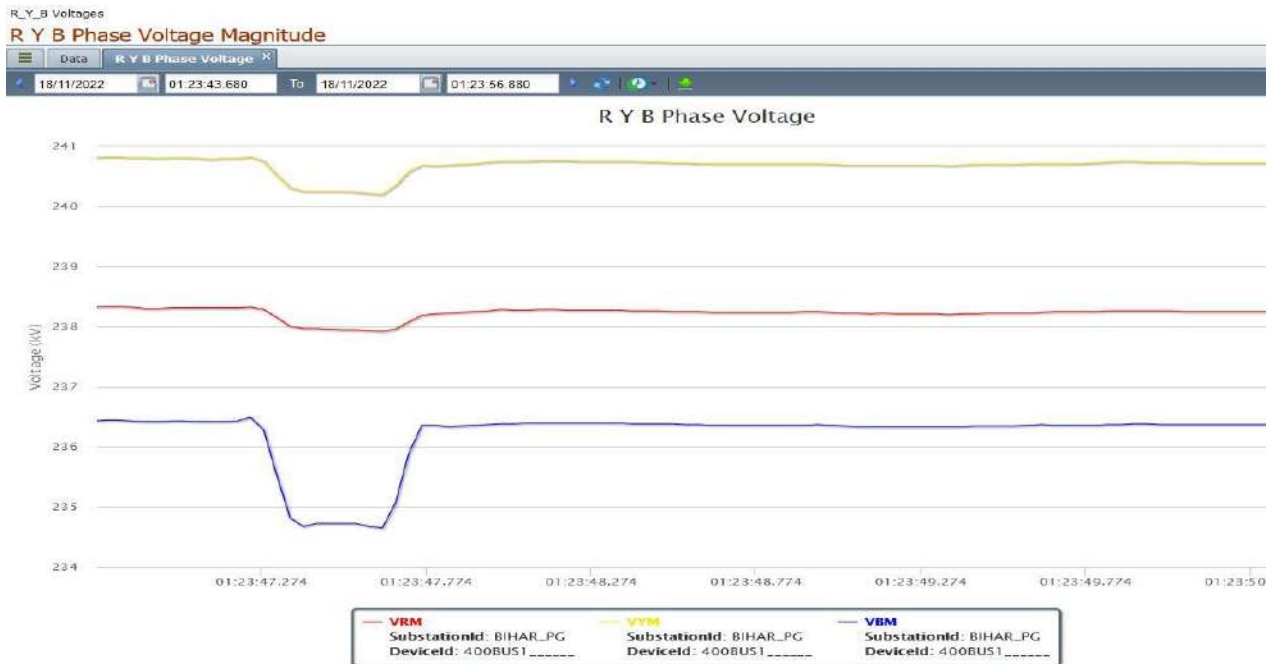
Figure 1: PMU snapshot of 400/220 kV Bihar Sharif S/s

At 01:23 Hrs on 18.11.2022, 220 kV Daltonganj-Chatra-1 tripped due to B\_N fault. Total power failed at Chatra S/s as it is being fed radially through only one circuit. 220 kV Daltonganj-Chatra-2 is LILLOed at Latehar, however, 220 kV Latehar-Chatra is not charged yet. 23 MW load loss reported at Chatra by Jharkhand SLDC.

समय	नाम	उप केंद्र 1 रिले संकेत	उप केंद्र 2 रिले संकेत	पीएमयू पर्यवेक्षण
01:23	220 kV Daltonagnj-Chatra-1	Daltonganj: B_N, 143.5 km, 1.3 kA	Chatra: Didn't trip. 220 kV Bus-2 B_ph PT burst	2 kV dip in B_ph voltage at Biharsharif. Fault clearance time: 350 msec

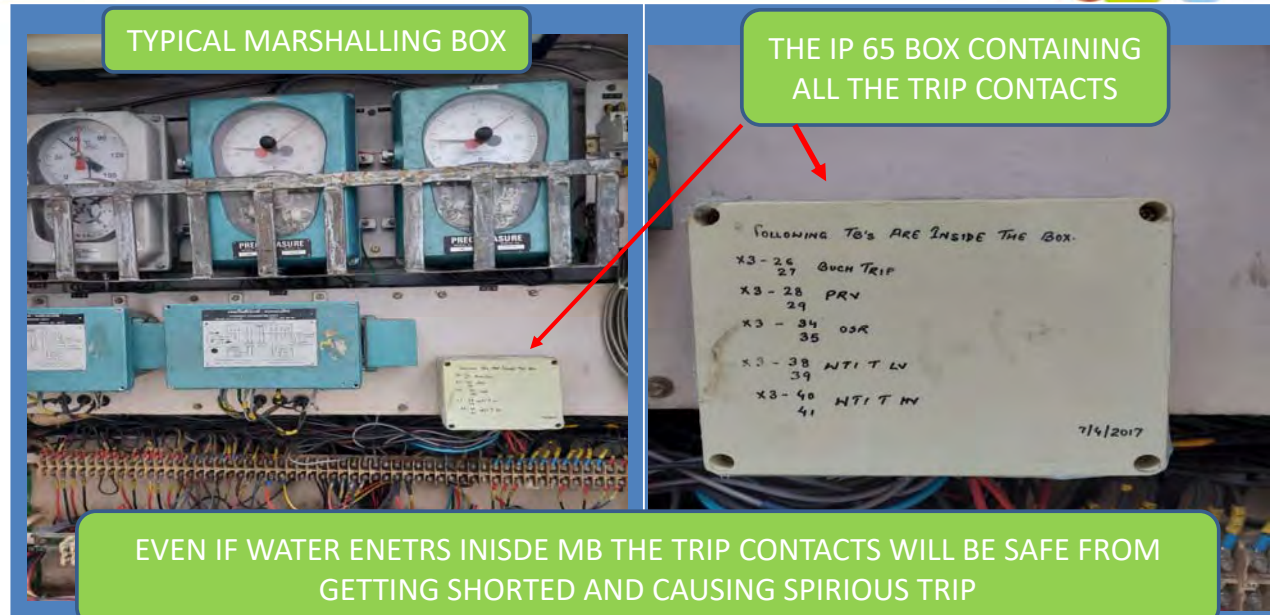
## SOLUTION: BOX INSIDE BOX

- Almost every substation has faced spurious trips of transformer due to moisture ingress in Marshalling Box.
- Most of the transformers have a single Marshalling box where OTI and WTI are present along with the alarm and trip terminal blocks of transformer mechanical devices.
- It's a general practice prior to monsoon to cover marshaling boxes with plastic.
- However, the marshalling boxes are needed to be opened periodically for noting Oil and Winding temperatures when OTI and WTI readings are not available in remote and are not clearly visible from outside the MB.
- Also due to negligence or gasket problem, the door's in MB doesn't close properly
- So always there remain a chance of moisture entering the marshalling box leading to spurious trip of transformer.

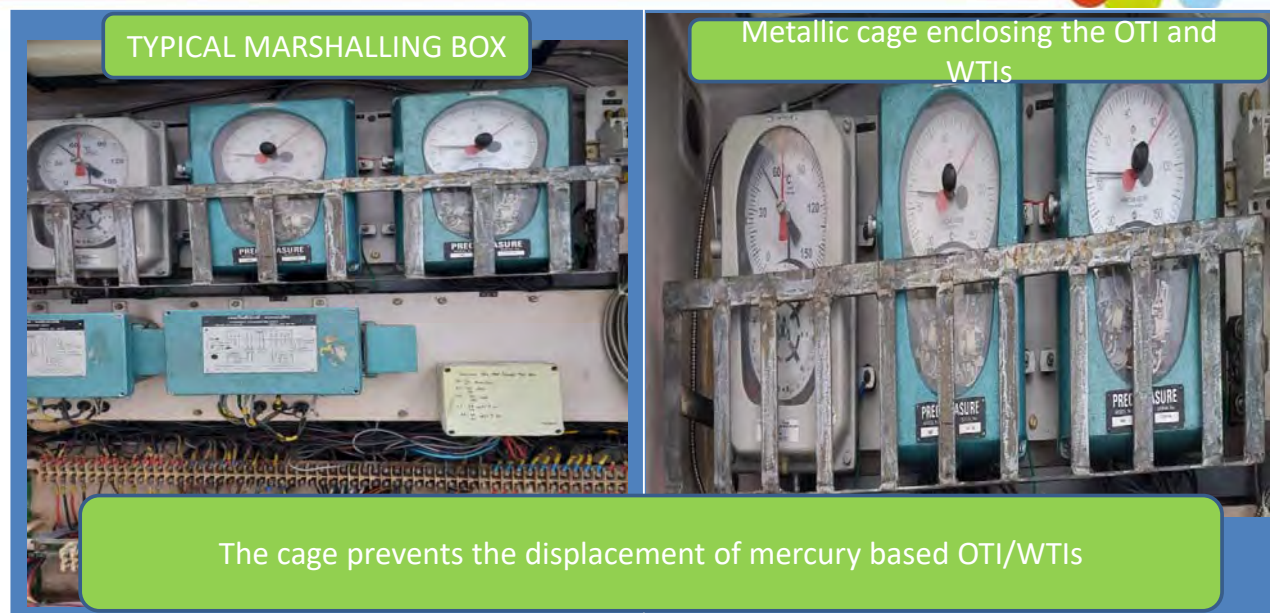
## SOLUTION: CAGE

- In one of the generating station of TATA POWER there had been a bizarre instance of unit trip due to falling of WTI. The vibrating pads of the WTI gave away due to ageing and the WTI got dislocated leading to movement of mercury and making of trip contact.
- Apart from timely replacement of the vibrating pads one of the CAPA point of the trip was fixing of a cage around OTI/WTI. So there is no movement of the WTI/OTI even when vibrating pads are not supporting them.

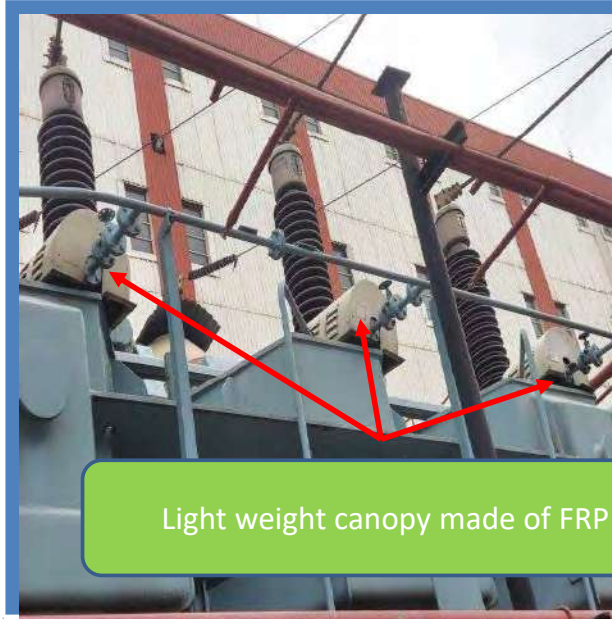
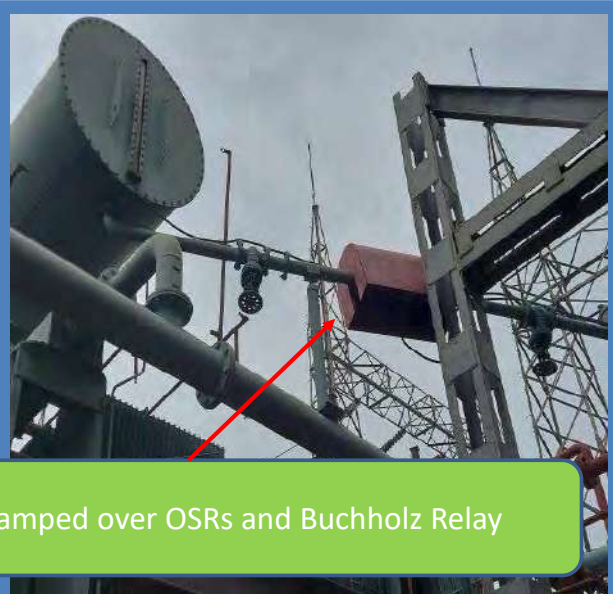
- The most vulnerable portion of moisture ingress are the terminal boxes of transformer mechanical devices. Exposed to the atmosphere, there always remains a chance of moisture/water ingress during rain or accidental operation of deluge system.

Light weight canopy made of FRP clamped over OSRs and Buchholz Relay

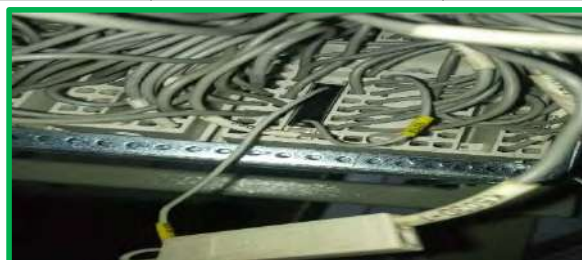
Actual connection photograph

By putting RTXV in series with RXSF1 relay coil, the pick up voltage increase to 80% of rated voltage (220V DC) thus preventing and spurious pick up due to stray voltages.

Without RTXV	With RTXV in Series	Remark
Pick up Voltage	116 V	<b>177 V</b>	Pick up increase by 28% to 80% of rated voltage of 220V DC
