Eastern Regional Power Committee

Sub: Minutes of the 121st PCC meeting held on 16.12.2022.

Minutes
of
121st PCC Meeting

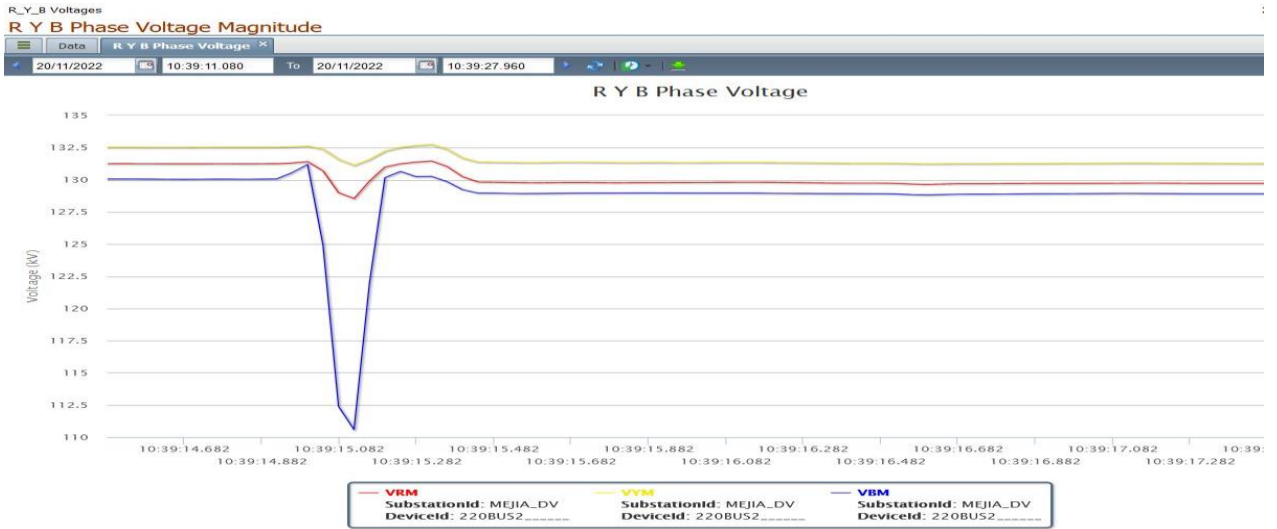
Figure 2: PMU voltage snapshot of 220 kV Mejia S/s

- A single-phase fault (B-Earth) struck 220 kV Mejia-Durgapur-1 at 11 km from Mejia which was cleared within 100 msec. However, LBB of this CB operated immediately leading to tripping of all elements connected to 220 kV Bus-3. As reported, LBB relay was found faulty.

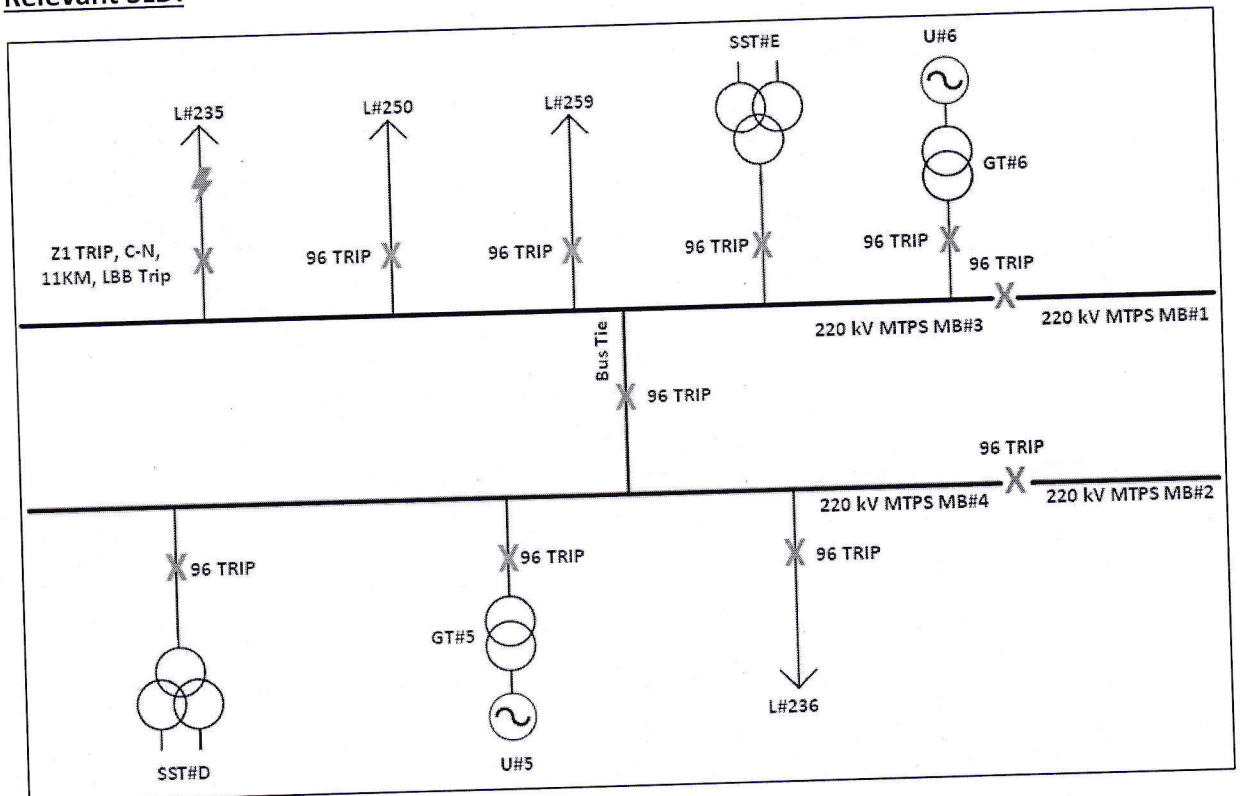
Relevant SLD:

It was reported that at around 10:40 Hrs 220kV MTPS-Durgapur L#235 tripped through Z1 distance protection from both ends. The fault occurred in the said line at a distance 11 Km from MTPS end. But along with that LBB protection of the concerned bay operated and tripped all bays connected to 220 kV Main Bus # 3 & 4.

- g) The reason of tripping of MB # 4 along with MB # 3 was improper operation of SST # D 89AX CT switching relay which had shorted the DC buses of MB # 3 & MB # 4. The concerned relay was drawn out and tested. On testing, it was found that the reset coil of the said relay was defective. During disturbance, SST # D was connected to MB # 4 and accordingly 89BX CT switching relay was in operated condition. But as 89AX relay did not reset properly due to its faulty resetting coil, both 89AX & 89BX remained in set condition. Thus, appearance of trip command in MB # 3 has resulted in operation of 96 relays of bays connected to MB # 4.

- h) In addition to this, 89AX CT switching relay of BC # 4 was also found to be defective during testing.

- a) Malfunction of Easun Reyrolle(ER) make DCD414B relays used for LBB protection at CTPS New 220KV Switchyard had been observed previously too and there the LBB relays in all panels had been replaced by Siemens 7SJ relays. However, at MTPS this was the first occurrence of such mis-operation. Thus, keeping in view of history of malfunction of same make and model relays at CTPS and similar occurrence at MTPS today it has been decided that all existing LBB relays at MTPS Unit # 5 & 6 system are to be replaced by Siemens 7SJ relays in near future.

- c) As a long term measure the existing High Impedance Bus bar & LBB protection scheme needs to be replaced with numerical Low Impedance busbar protection relay with Central & Peripheral unit concept for ensuring reliability.

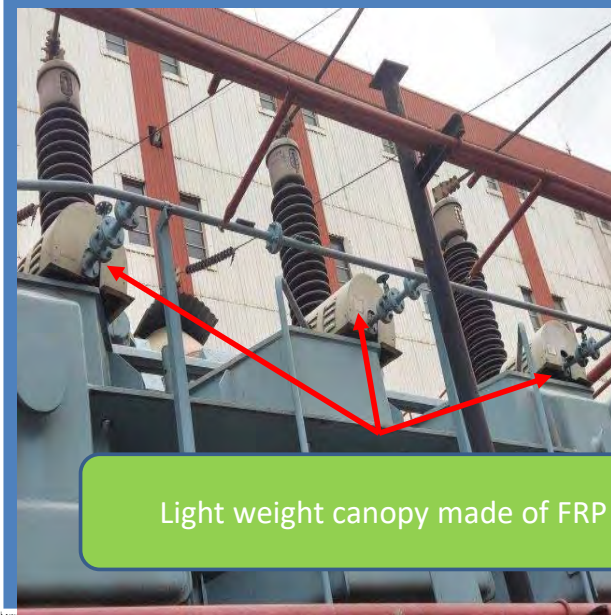
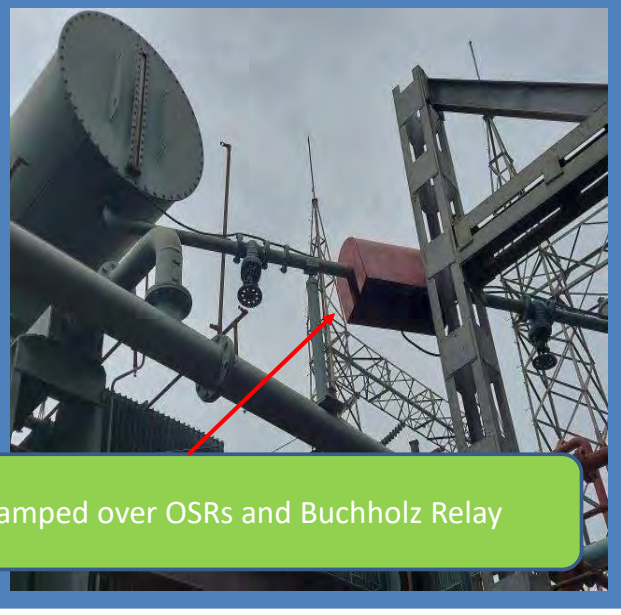
Light weight canopy made of FRP clamped over OSRs and Buchholz Relay

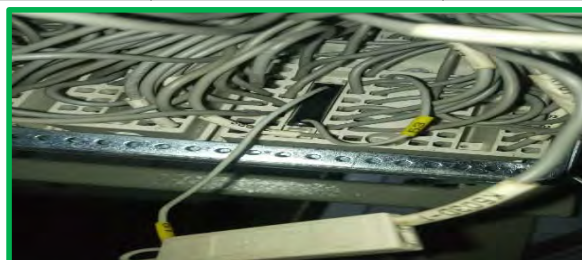
Actual connection photograph

By putting RTXV in series with RXSF1 relay coil, the pick up voltage increase to 80% of rated voltage (220V DC) thus preventing and spurious pick up due to stray voltages.
