Dissolved Gas Analysis

The Health Indicator for Oil Immersed Transformers

By RAJARSHI GHOSH 7th April 2017

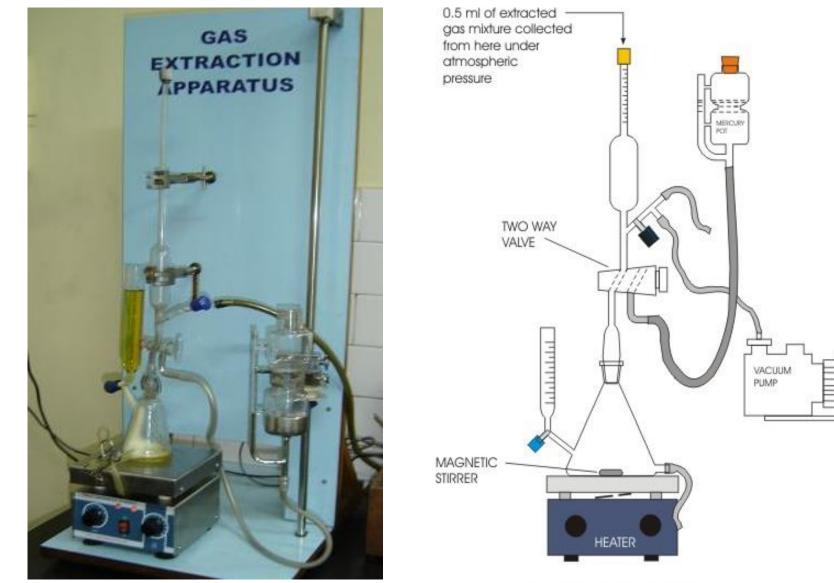
GAS EXTRACTION APPARATUS

Gas Extraction

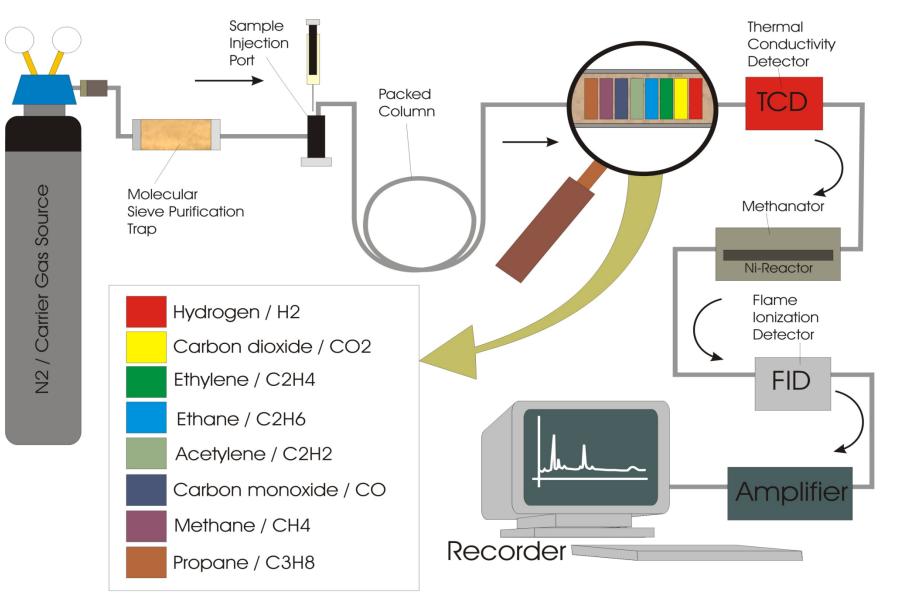
TYPICAL GAS CHROMATOGRAPHIC SYSTEM

DGA Process

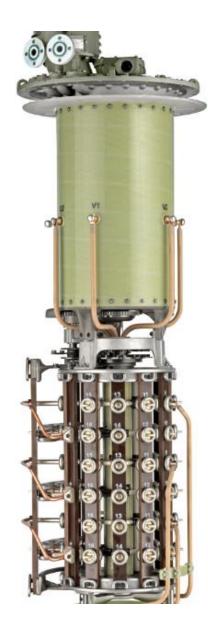
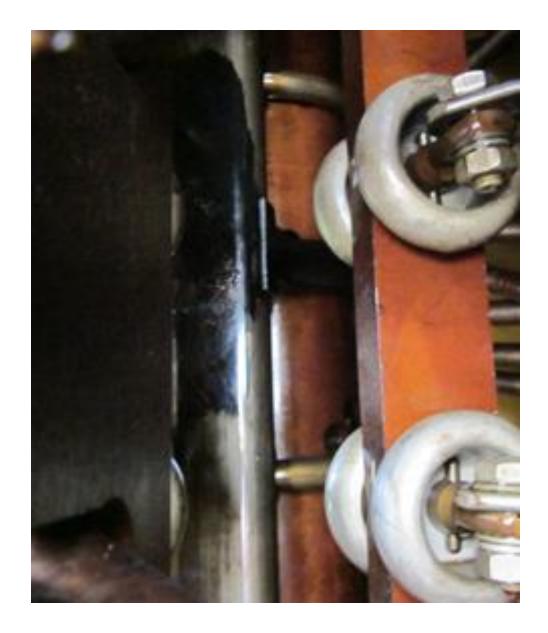
History: The transformer was initially commissioned as T-1 at Kasba Receiving Station and subsequently relocated to East Calcutta S/S as T-3 on 09/02/2012. A few days after re-commissioning as East Calcutta S/S T-3, the transformer tripped by operation of Buchholz relay. Although no visual defects were observed and test results also found satisfactory, high gas content was detected in DGA (see the results obtained on 17/02/12). Subsequently, inspection of active parts carried out after draining of main tank oil, when blackening of odd tap collector contact (on center tube) was observed due to excessive heating. The same was developed due to inadequate pressure of the sliding contact. After shifting the contact to the even tap collector ring, winding resistance measurement carried out and the transformer was energized after satisfactory completion of high voltage tests. Dissolved gas content was monitored very closely for the next few days and finally on 01/03/12, the transformer put on load.

Date	H ₂ (ppm)	CH₄ (ppm)	C ₂ H ₆ (ppm)	C₂H₄ (ppm)	C ₂ H ₂ (ppm)	CO (ppm)	CO ₂ (ppm)	Remarks
13/8/2012	54	66	6	81	0	690	1786	Routine test
1/3/2012	138	75	8	117	46	69	786	Close monitoring
23/2/2012	143	79	9	123	85	55	579	Close monitoring
22/2/2012	53	56	8	105	71	32	627	Others
17/2/2012	272	61	4	59	68	40	311	Post Tripping
9/2/2012	8	0	0	0	0	8	152	Post Commissioning

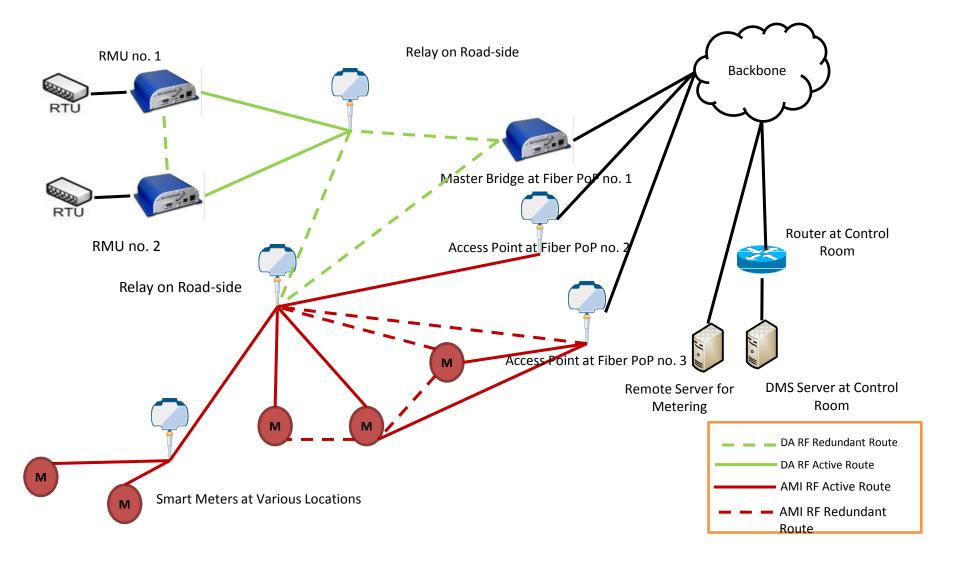
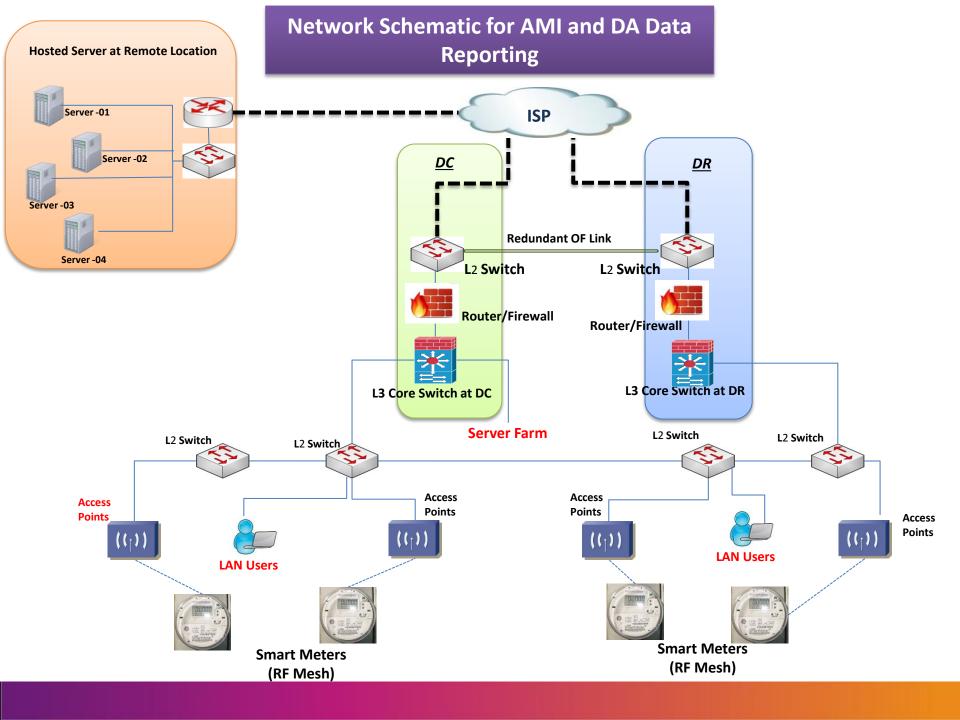
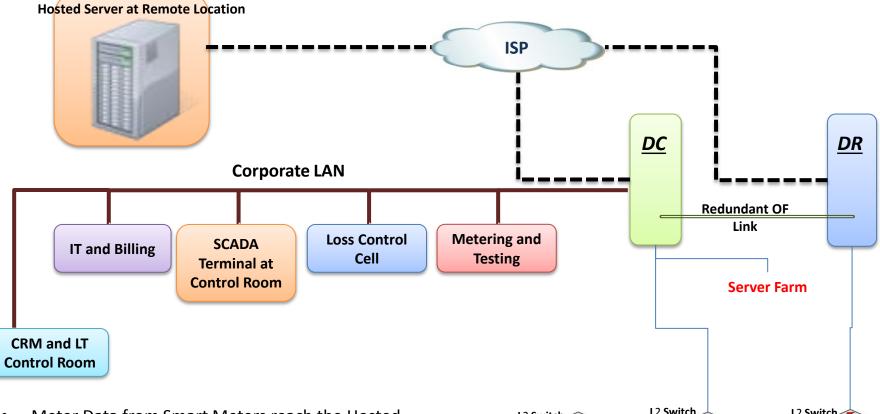
AMI & DA over Wireless Communication Network Schematic

- Meter Data from Smart Meters reach the Hosted Server at remote Location via Access Points over RF and via ISP over OFC based Backbone Network
- The same data is fetched from the Hosted Server by the specific users in the Corporate LAN Bus via the same VPN setup
- DA data reports directly to SCADA Terminal at Control Room via OFC based Backbone Network

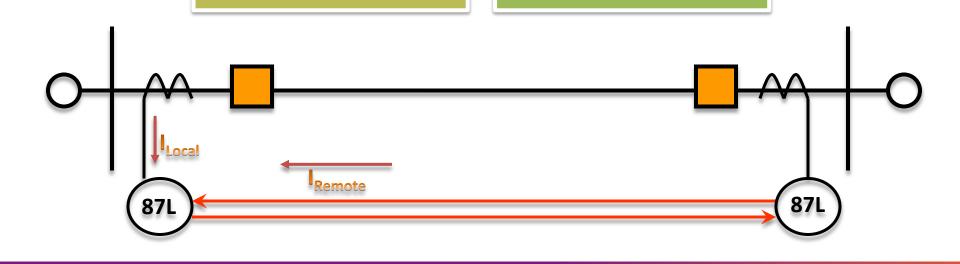
Optical Fiber based Line Differential Protection

Based on digital communication channels such as optical fibers, SONET network, etc.

Compare current flow in & out line terminals

Easy to discriminate internal & external faults

High dependability – instantaneous trip for all internal faults High security – no operation for external faults

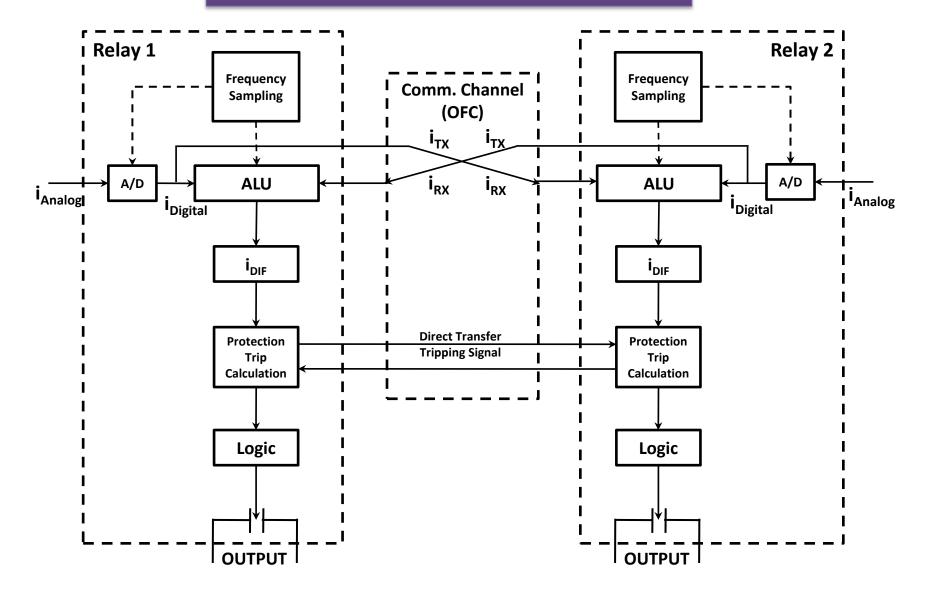
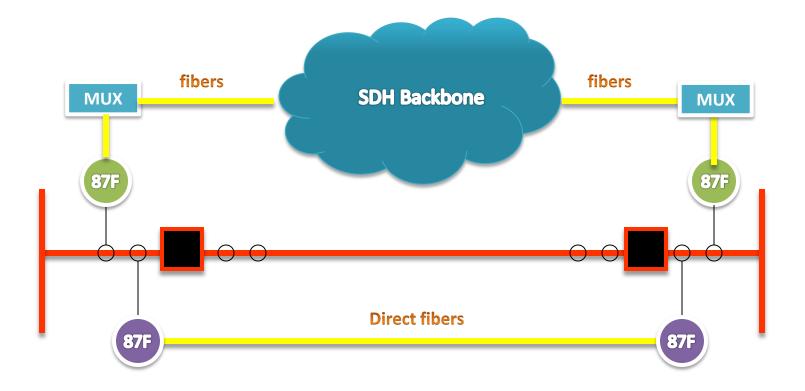
Optical Fiber based Line Differential Protection – Numerical Relay Function

- Numerical Relays capable of sampling analog current input from CTs in zones
- Sampled data transmitted over OFC to remote peer Relay
- Relay receives full set of data from Remote peer Relay
- Operates autonomously
- Issues Direct Transfer Trip signals to Remote peers for tripping of both CBs
- Synchronised via GPS

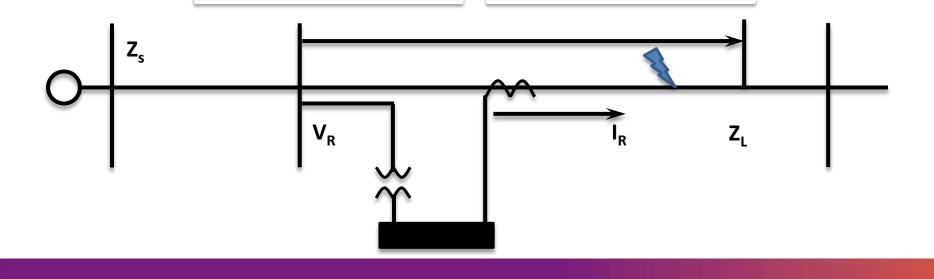
Distance Protection

Uses both Current and Voltage to determine if a fault is within the relay's set zone of protection

Settings based on positive and zero sequence transmission line impedance

Measures phase and ground fault loops

Impedance zone has a fixed impedance reach

Greater instantaneous coverage
