# Agenda for 95<sup>th</sup> PCC Meeting

### **AGENDA FOR 95<sup>TH</sup> PROTECTION SUB-COMMITTEE MEETING TO BE HELD ON 15.10.2020 AT 10:30 HOURS**

##### **ITEM NO. B.1: Disturbance at 220 kV Patratu and 220kV Tenughat Substation on 23.09.2020 at 08:45 hrs and 13:49 hrs**

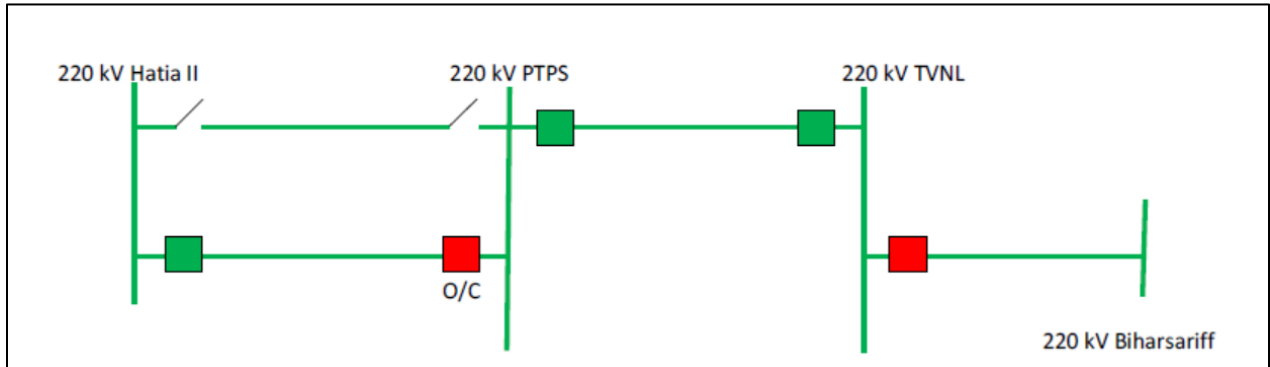
Figure 6: Status of the network of affected area after event 2

- During event 2, 220 kV Patratu – Hatia – 1 was not in service. At 13:49 hrs 220 KV Tenughat-Biharshariff S/C tripped due to B phase to earth fault at 106 km from Tenughat.

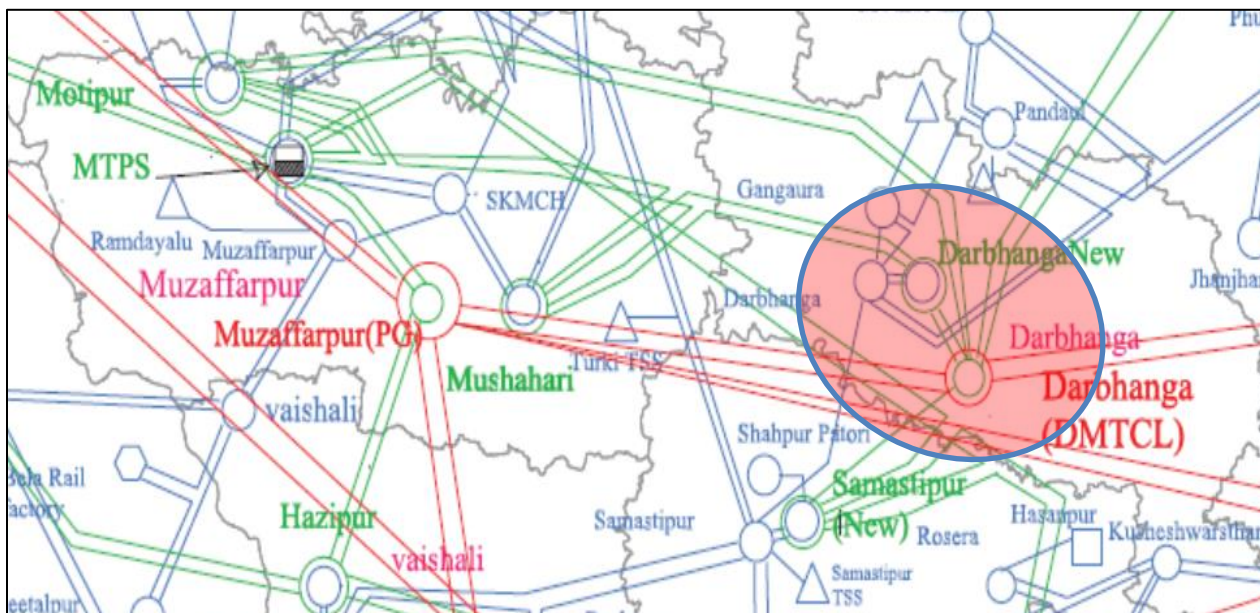
Figure 1: Network across the affected area

- Multiple issues were observed at 220 kV Darbhanga BSPTCL substation in the previous months due to which PCC forum of Eastern Region advised BSPTCL to carryout testing of all its breakers.

- TBC breaker tripped at Darbhanga (BSPTCL) S/S on earth fault protection. BSPTCL informed that DR output could not be retrieved for this tripping incident due to the non-availability of the DR facility in TBC Relay which is Eassun MIT 114. BSPTCL has shared that they would replace all old relays with numerical relays having DR/EL facility. **(BSPTCL may share the timelines for replacing the old relays.)**

- During the field investigation BPI of Y-phase of TBC at Darbhanga (BSPTCL) was found flashed at Darbhanga BSPTCL S/S. The IR value of BPI in all three phases was checked during the investigation and found unsatisfactory. BSPTCL has intimated that they have planned to replace all BPIs. **(BSPTCL may share the timelines for replacement works. BSPTCL may also share the status of the bus bar protection system at Darbhanga (BSPTCL) GIS.)**

- Time setting of Directional Earth Fault relays of 400/220 kV ICTs at Darbhanga (DMTCL) may be checked. **(DMTCL to update)**
- DR/EL configuration may be properly checked and configured at DMTCL end as per the issues observed in event analysis. **(DMTCL to update)**

- BSPTCL may share the timelines for replacement works of BPI and installation of numerical relays at Darbhanga (BSPTCL). BSPTCL may share the status of bus bar protection at Darbhanga (BSPTCL) end. **(Bihar SLDC/BSPTCL to update).**

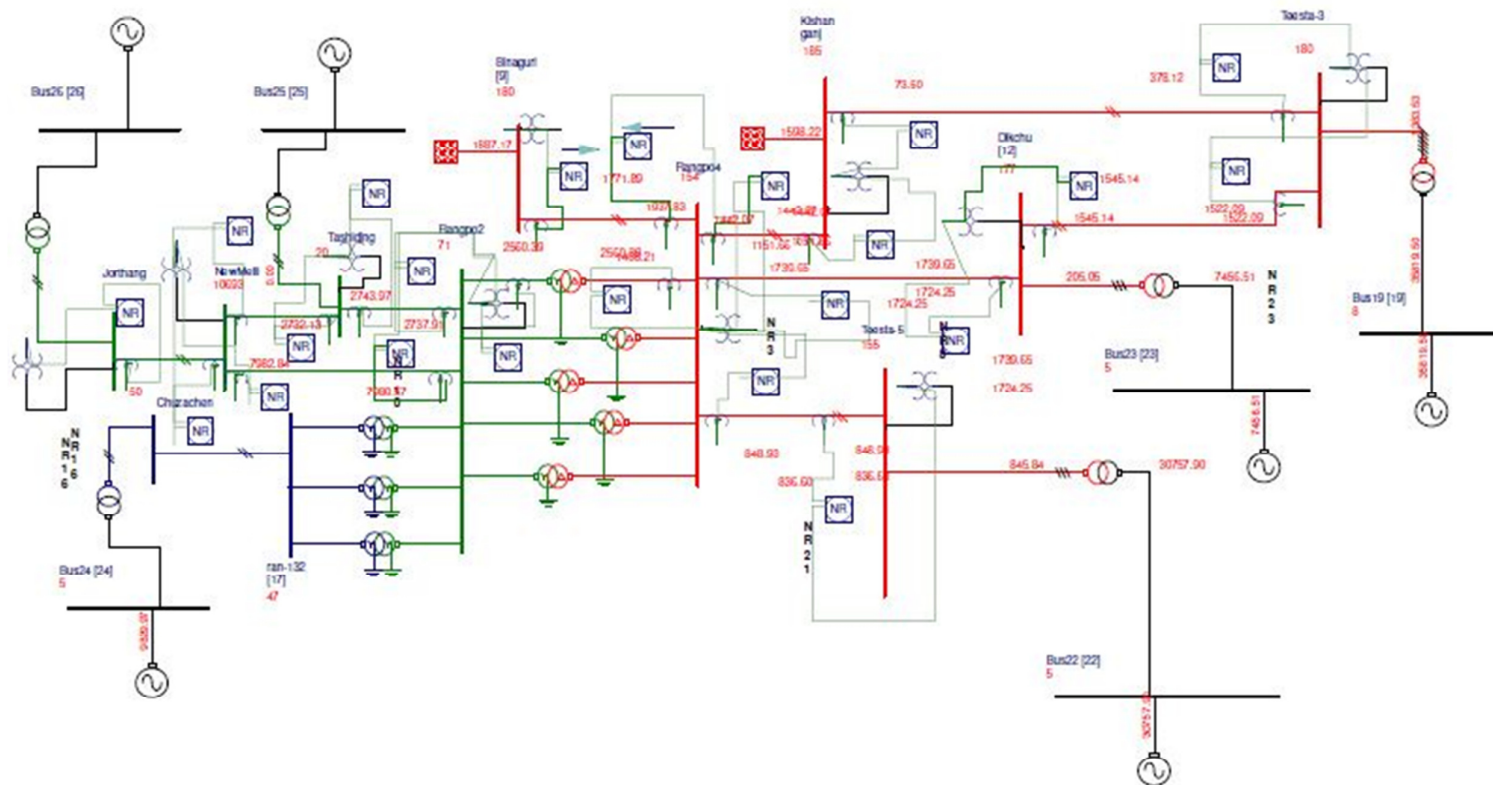
**Network:**

Line	Relay Connected at	CT Ratio in A	Fault Location	Fault Current seen by the Relay	Existing				Proposed			
					Ie> in A (Primary)	Characteristics	TMS/Time Delay	Top (sec)	Ie> in A (Primary)	Characteristics	TMS	Top in sec
Binaguri-Rangpo	Rangpo end	2000/1	Binaguri	4526	200	IEC NI	0.34	0.776	400	IEC NI	0.36	1
Binaguri-Rangpo	Binaguri end	2000/1	Rangpo	2716	200	IEC NI	0.34	0.889	400	IEC NI	0.28	1
Kishangunj-Rangpo	Rangpo end	3000/1	Kishangunj	2933	1200	IEC NI	0.34	2.639	600	IEC NI	0.25	1
Kishangunj-Rangpo	Kishangunj end	3000/1	Rangpo	2200.46	400	IEC NI	0.28	1.13	400	IEC NI	0.25	1
Rangpo- Dikchu	Rangpo end	3000/1	Dikchu	5213.64	-	-	-	-	600	IEC NI	0.32	1
Rangpo- Dikchu	Dikchu end	3000/1	Rangpo	3440	600	DT	1.5	1.5	600	IEC NI	0.38	1.5
Rangpo- TeesthaV	Rangpo end	2000/1	Teestha V	6531.16	200	IEC NI	0.375	0.85	400	IEC NI	0.42	1
Rangpo- TeesthaV	TeesthaV end	2000/1	Rangpo	6909.83	-	-	-	-	400	IEC NI	0.42	1

Kishangunj-Teestha III	Kishangunj end	2000/1	Teestha III	1381	400	IEC NI	0.28	1.562	400	IEC NI	0.18	1
Kishangunj-Teestha III	Teestha III end	2000/1	Kishangunj	2859.84	-	-	-	-	400	IEC NI	0.3s	1
Dikchu-Teestha III	Dickchu end	3000/1	Teestha III	2482.1	400	DT	1.5	1.5	400	IEC NI	0.40	1.5
Dikchu-Teestha III	Teestha III end	3000/1	Dikchu	5264.25	-	-	-	-	600	IEC NI	0.32	1
Rangpo 220Kv Bus												
Rangpo-Tasheding	Rangpo end	1600/1	Tasheding	2241.47	320	IEC NI	0.35	1.23	320	IEC NI	0.34	1.2
Rangpo-Tasheding	Tasheding end	800/1	Rangpo	361	160	DT	1.2	1.2	160	IEC NI	0.14	1.2
Rangpo- Newmelli	Rangpo end	1600/1	Newmelli	4600.56	320	IEC NI	0.35	0.895	320	IEC NI	0.47	1.2
Rangpo- Newmelli	Newmelli end	1600/1	Rangpo	635.22	320	IEC NI	0.5	5.07	320	IEC NI	0.12	1.2
Tasheding-Newmelli	Tasheding end	800/1	Newmelli	2714.22	160	IEC NI	0.24	0.577	160	IEC NI	0.50	1.2
Tasheding-Newmelli	Newmelli end	1600/1	Tasheding	3200.38	320	IEC NI	0.5	1.485	320	IEC NI	0.40	1.2
