# EASTERN REGIONAL POWER COMMITTEE

## MINUTES OF 30<sup>th</sup> PROTECTION SUB-COMMITTEE MEETING HELD AT ERPC, KOLKATA ON 16.04.2015 (THURSDAY) AT 11:00 HOURS

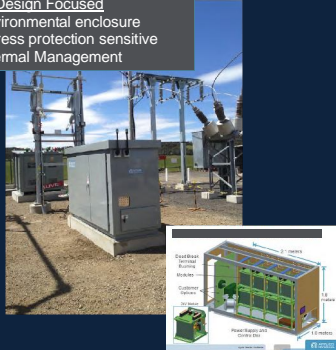
22kV SSFCL N-G System Commissioned – October 2014

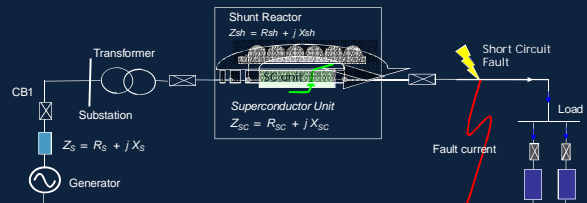
## How an SCFCL works

### Normal operation

- Load current flows through superconducting unit
- SCFCL introduces nearly zero impedance and zero voltage drop

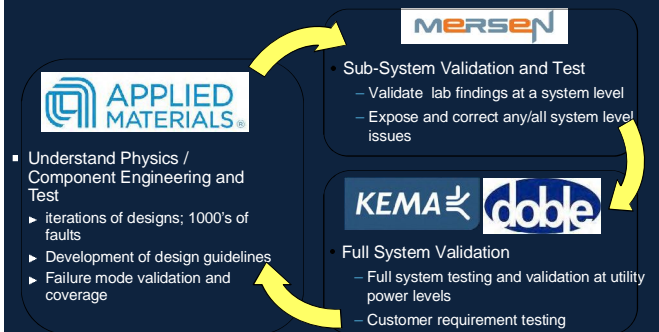
## Testing Methodology

Multiple Labs Enable Fast, Efficient Development and Learning

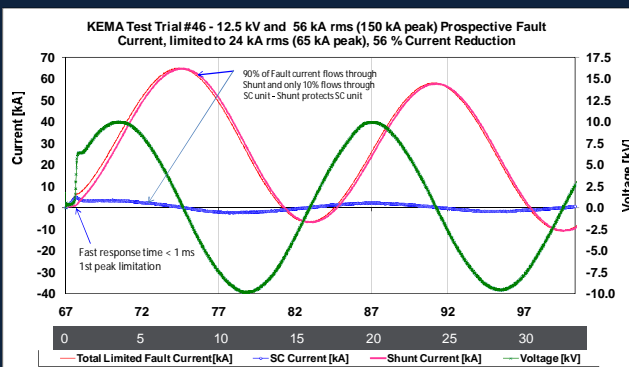
## Actual KEMA Test Results

1st peak response within ~ 1 ms response time.

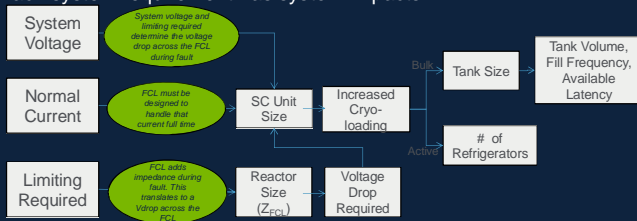
## FCL Design Tradeoffs / Sensitivities

Major Items Influencing System Design are:

1. System Voltage
2. System Normal Current
3. Current Limiting Required

Each system requirement has system impacts:
