Agenda
for
108th PCC Meeting

Eastern Regional Power Committee

AGENDA FOR 108th PROTECTION COORDINATION SUB-COMMITTEE MEETING TO BE HELD ON 16.11.2021 AT 10:30 HOURS

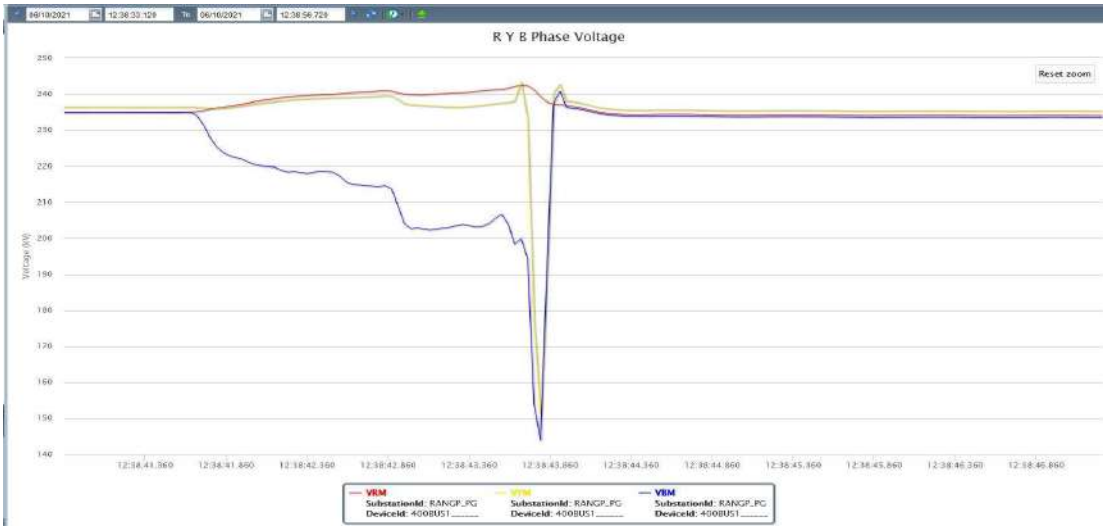
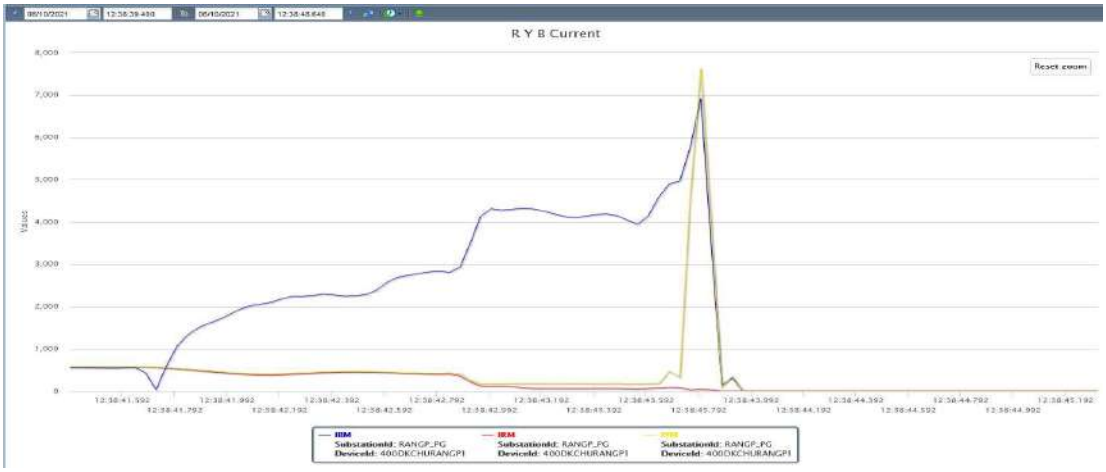
Figure 3: PMU snapshots of 400/220 kV Rangpo S/s

- **Fault was in 400 kV Rangpo-Dikchu line.**
- **Rangpo end:**
  - At Rangpo end, B phase high resistive fault observed, earth fault started and was high for more than 2 seconds with current more than 2 ka still line didn't trip. (Power grid ER-2 to explain)
  - After 2.2 seconds when fault converted to phase to phase and current became more than 5ka it tripped on Distance protection. Total fault clearance time was 2.2 sec.

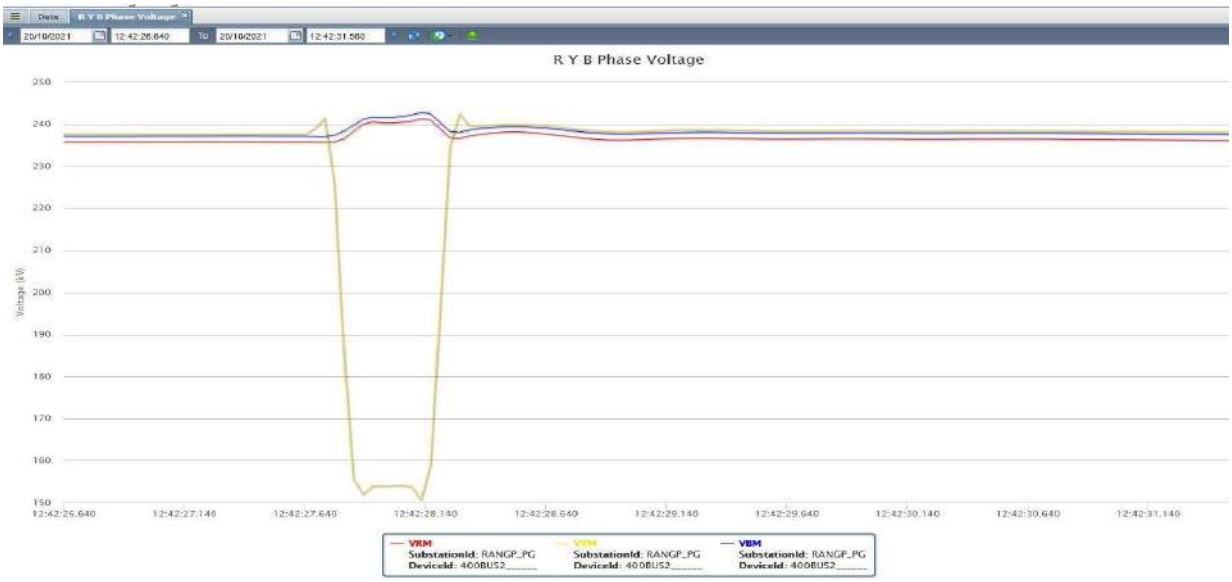
Figure 3: PMU snapshots of 400/220 kV Rangpo S/s

समय	नाम	उप केंद्र 1 रिले संकेत	उप केंद्र 2 रिले संकेत	पीएमयू पर्यवेक्षण
12:38	220 kV Rangpo-Rongnichu-1	Y_N, 6.12 km, 12.89 kA	Y_N Fault	88 kV dip in Y_ph
	220 kV Rangpo-Rongnichu-2	Didn't trip	Y_N, 1.2 kA

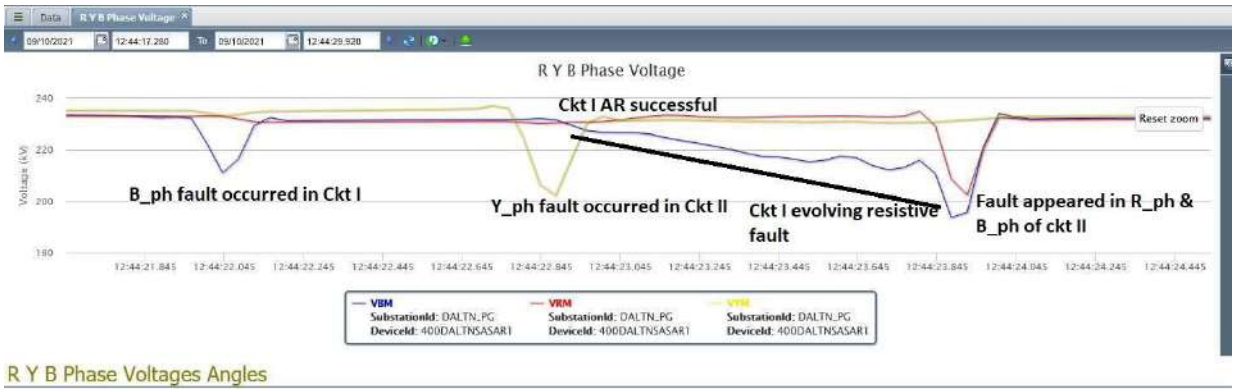
Figure 3: PMU snapshot of 400/220 kV Daltonganj S/s

समय	नाम	उप केंद्र 1 रिले संकेत	उप केंद्र 2 रिले संकेत	पीएमयू पर्यवेक्षण
12:44	220 kV Daltonagnj-Chatra-1	B_N, Z I, 28 km	Didn't trip	22 kV dip in B_ph
	220 kV Daltonagnj-Chatra-2	Y_N, 69 km, 1.3 kA	Didn't trip	31 kV dip in Y_ph

- Voltage induced in both lines after fault clearance is indicative of arcing which persisted till all three phases opened. Root cause of the fault maybe analysed and findings may be shared.

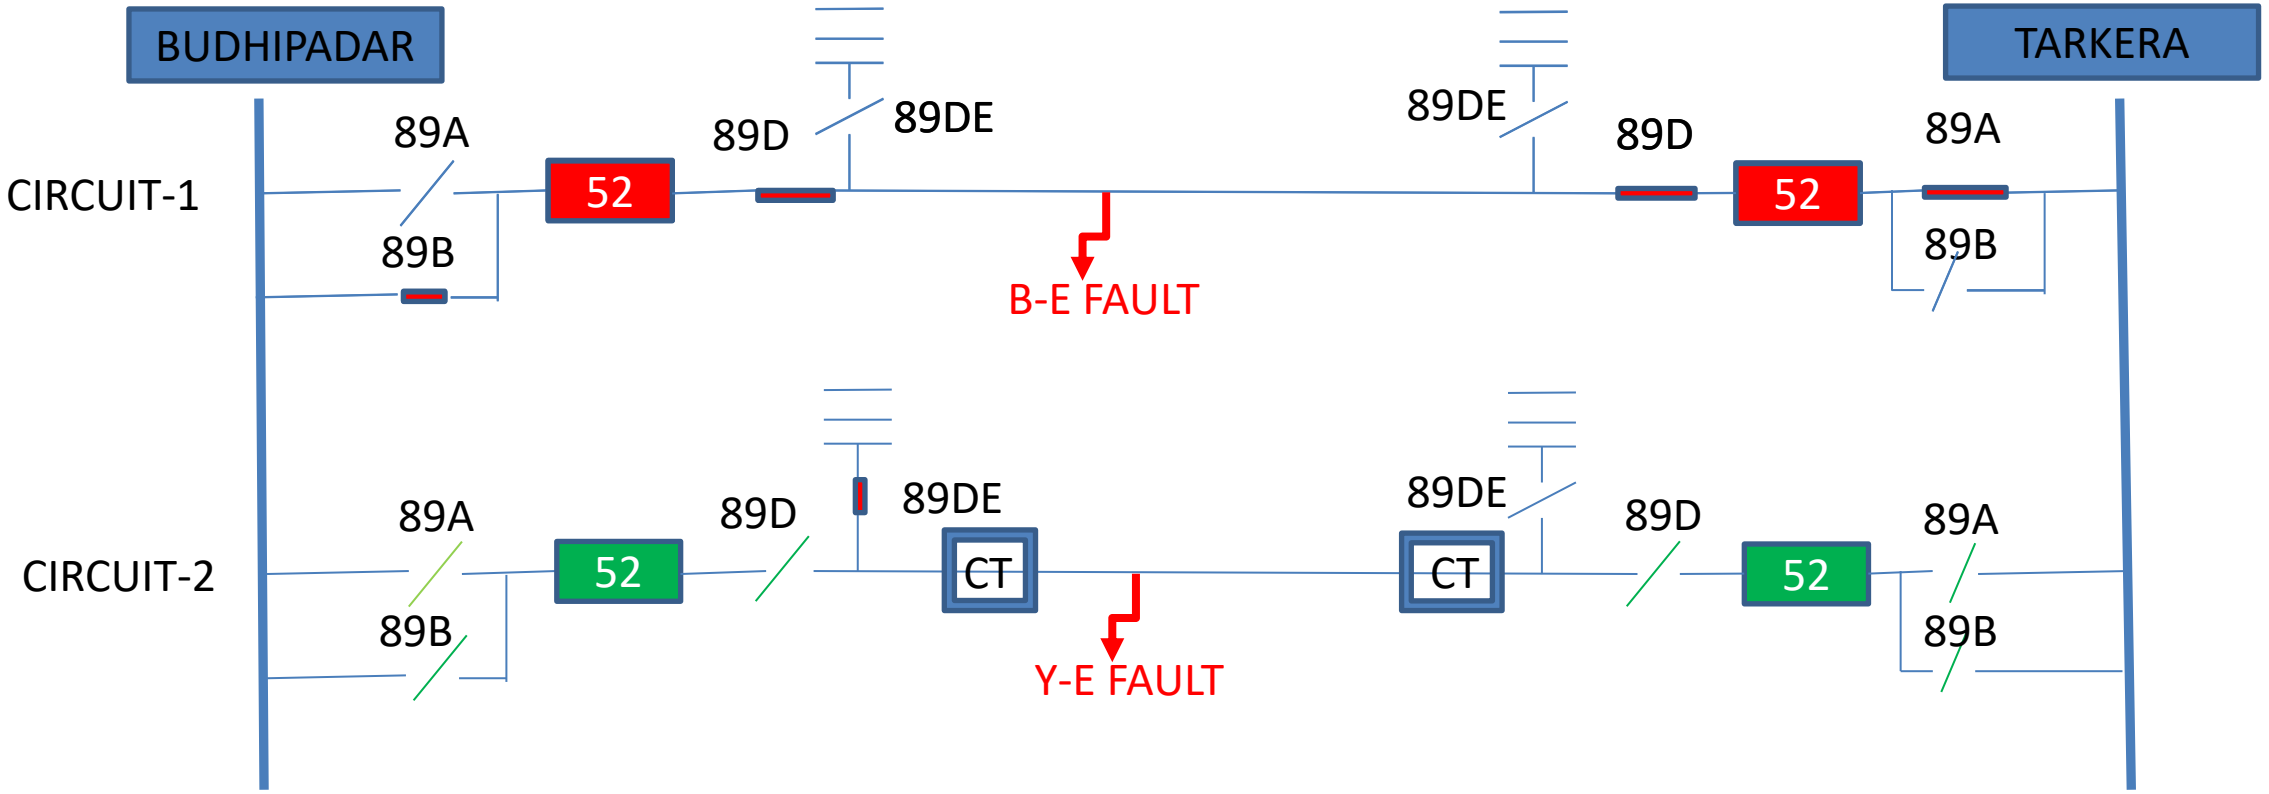
SLD FOR THE TARKERA CKT DURING THE EVENT

1. **The 220KV Budhipadar-Tarkera ckt-2 was charged earlier through 220KV Bus-1. The said feeder was taken shut down at 09.42hrs. At the time of Shutdown the Bus-1 PT selection relay suppose to be reset condition automatically . Due to defect in reset coil of PT selection relay , it was in pickup condition even though the feeder was Shutdown. The Bus PT supply is being used for protection purpose in this feeder due non-availability of line PT so PT was available in the relay.**

3. **The earth switch of 220KV Budhipadar-Tarkera Ckt-2 was in closed condition at Budhipadar end but open condition at Tarkera end . When fault occurs in Ckt-2, the CT at Budhipadr end sensed the fault current as the earth switch was closed. The DP relay of the Budhipadar-Tarkera Ckt-2 actuated due to availability current and voltage. The relay issued a trip command in delayed time due to high resistance nature of fault and master trip relay(86) operated.**

4. **As the master trip relay (86) was in operated condition and current was persisted the LBB relay actuated and the breaker failure protection in Bus bar relay operated for 220KV Bus-1.**

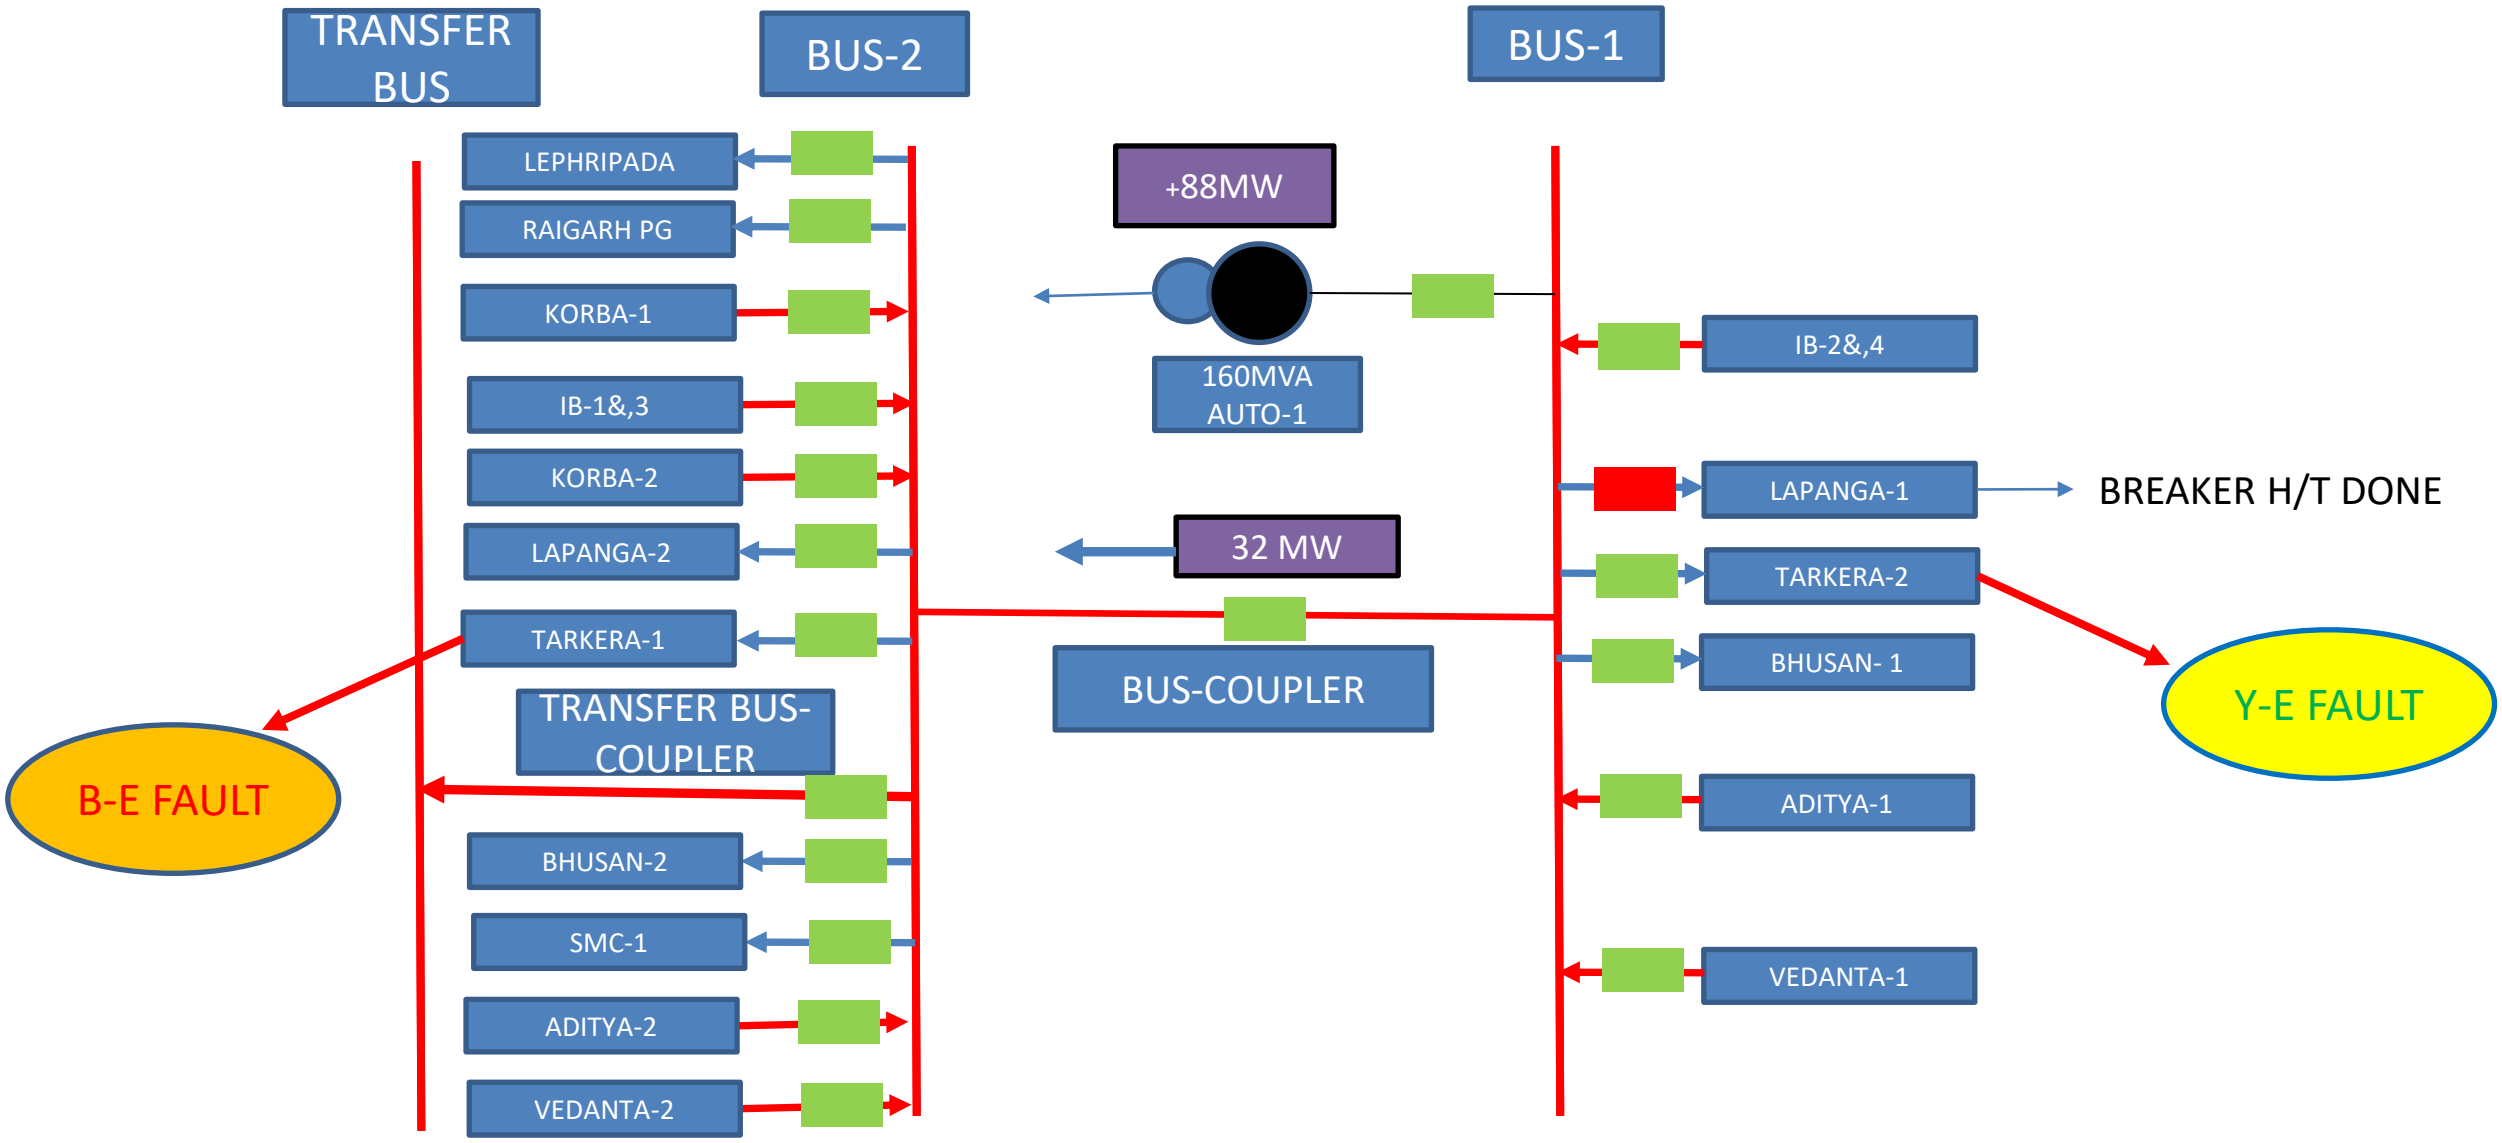
POST-FAULT CONDITION

ALL FEEDERS/TRF IN BUS-1 & BUS-2 TRIPPED, Bus-1(AT-1,IB-2 &4,Lapanga-1, Tarkera-2, Bhusan-1, Aditya-1,Vedanta-1) Bus-2(Lephripada,Raigarh PG,Korba-1, IB-1 & 3,Korba-2Lapanga-2, Tarkera-1, Bhusan-2, SMC-1, Aditya-2, Vedanta-2)

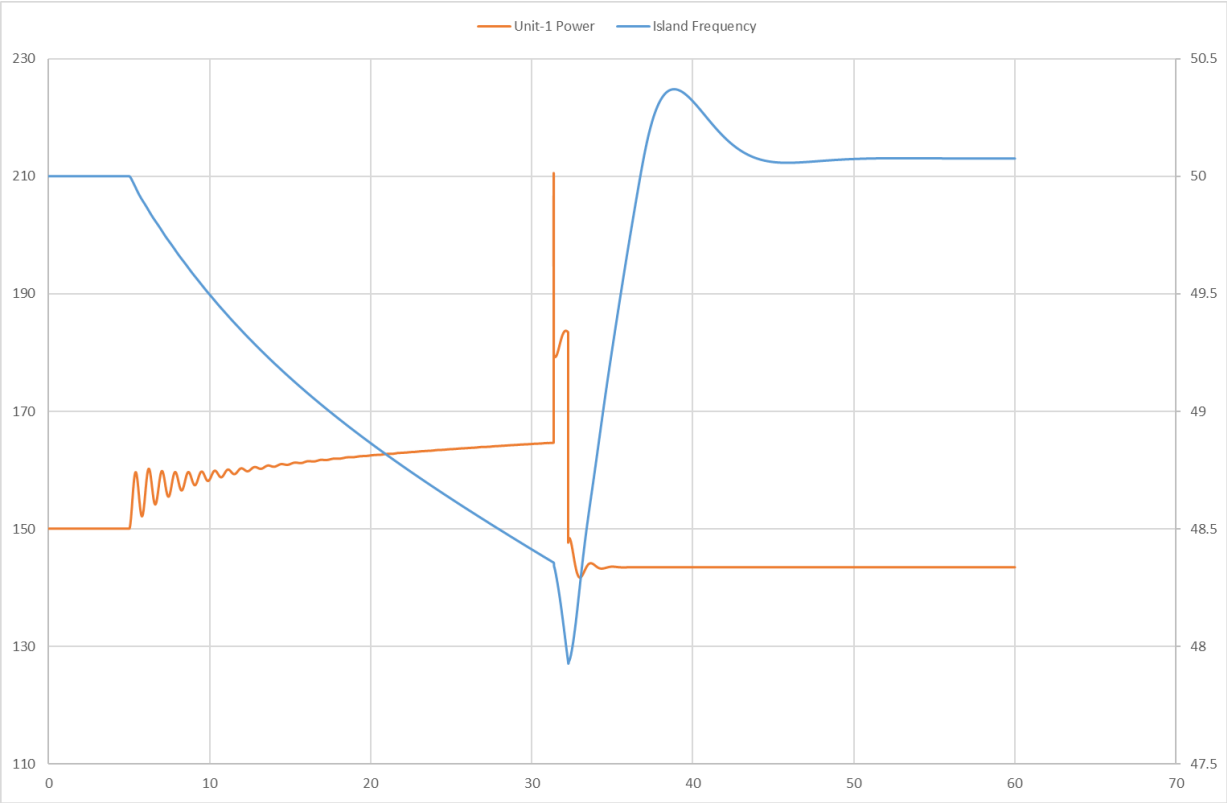
Scenario-1: Maximum generation & Maximum load

1. In max generation max load scenario there is 114 MW surplus generation inside the Island if both unit is considered. However if one unit is considered then the island is 35 Mw deficit.
2. Here one unit inside the island is tripped immediately after island is formed.
3. With this setting island frequency stabilizes around 50.07 Hz

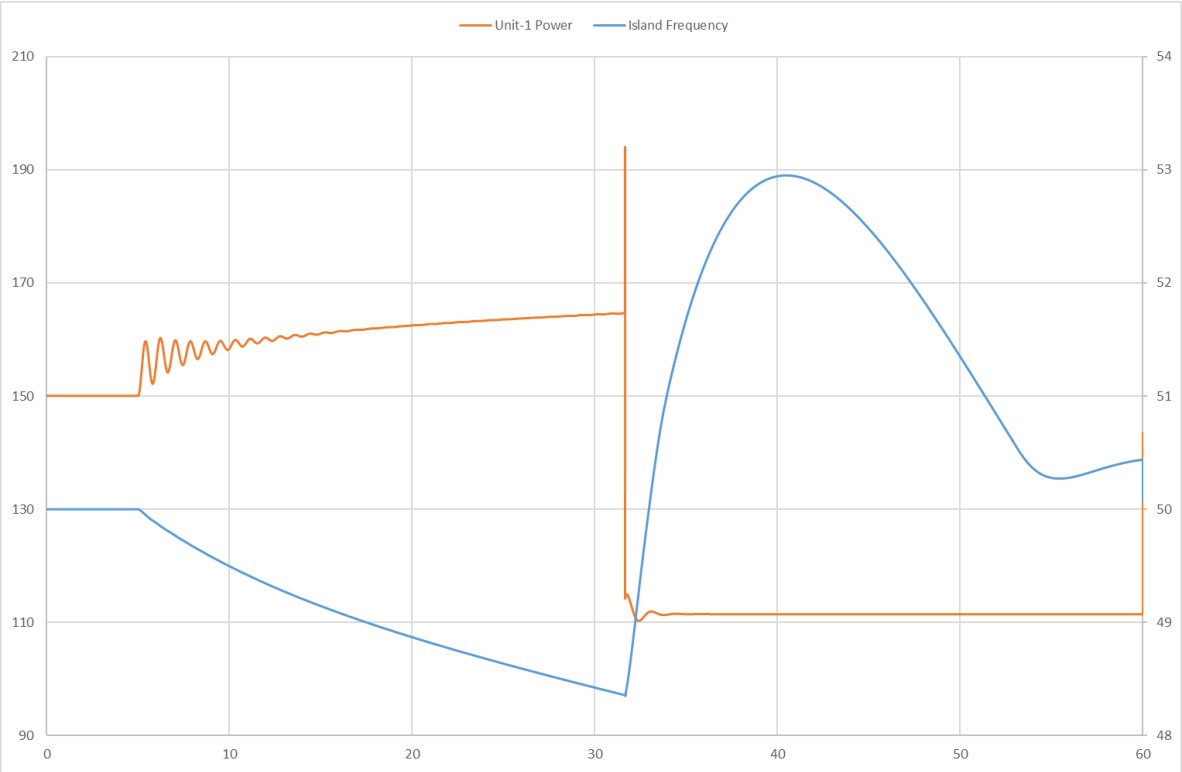
Scenario-2 : Maximum generation & Minimum load

1. In max generation min load scenario there is 190 MW generation surplus inside the Island
2. Therefore after island formation frequency start raising at faster rate, as the inertia of the island is low.
3. One unit is therefore tripped immediately
4. The island is survived with 50.43 Hz frequency.

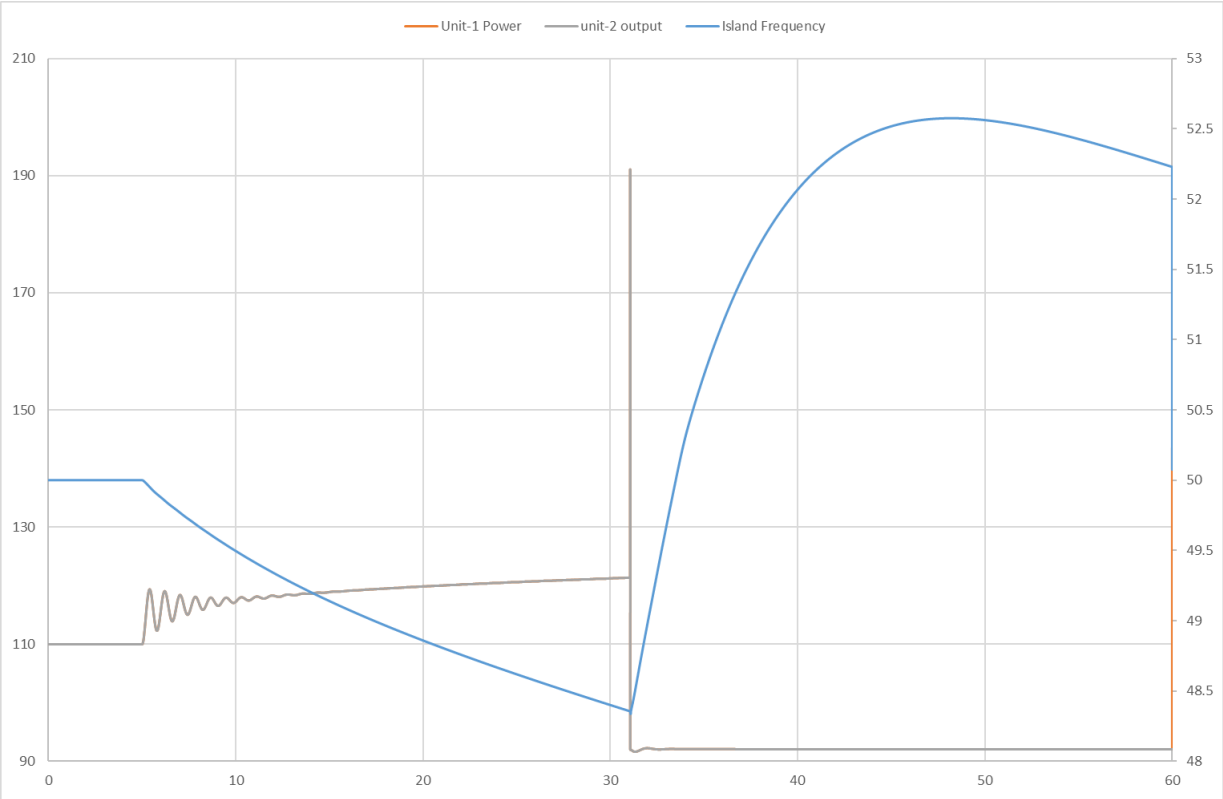
Scenario-3: Minimum generation & Maximum load

1. In min generation max load scenario there is 34 MW generation surplus inside the Island
2. Therefore after island formation frequency start rising fast, as the inertia of the island is low.
3. With this setting finally island frequency stabilizes around 52 Hz.
4. Here Both the unit survived

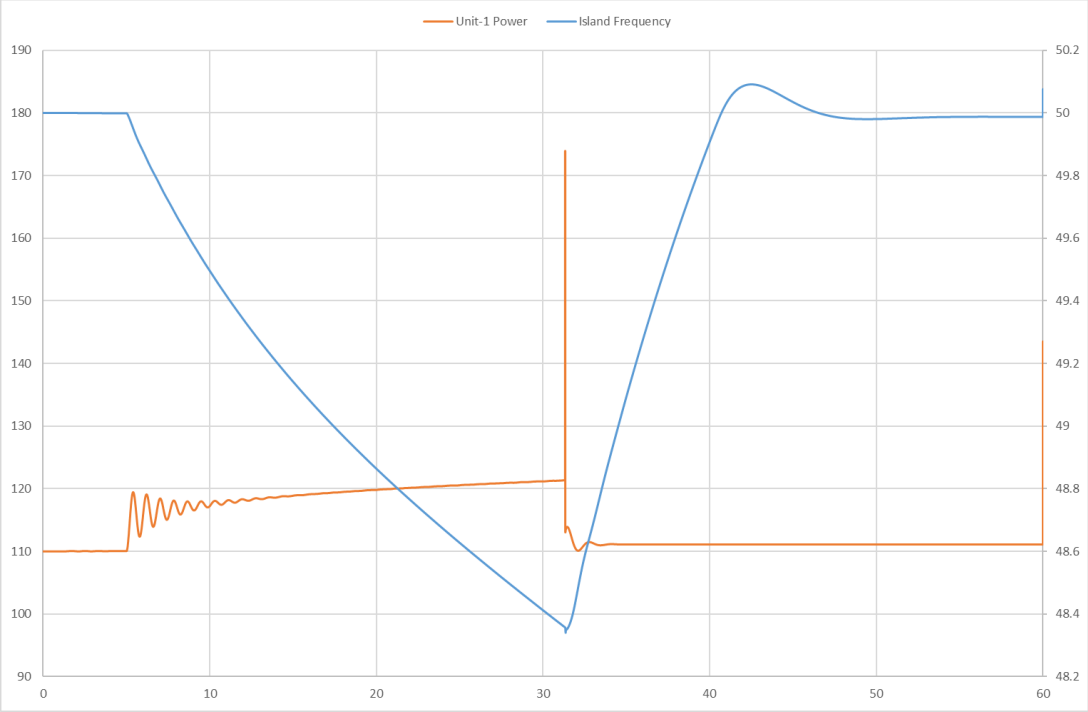
Scenario-4: Minimum generation & Minimum load

In scenario fourth the island is 111 MW generation surplus.

1. In min generation max load scenario there is 111 MW generation surplus
2. Therefore, one unit is tripped and the island is stabilized at 49.98 HZ.
