# Minutes of **65<sup>th</sup> PCC meeting**

# EASTERN REGIONAL POWER COMMITTEE

## MINUTES OF 65<sup>TH</sup> PROTECTION SUB-COMMITTEE MEETING HELD AT ERPC, KOLKATA ON 28.03.2018 (WEDNESDAY) AT 11:00 HOURS

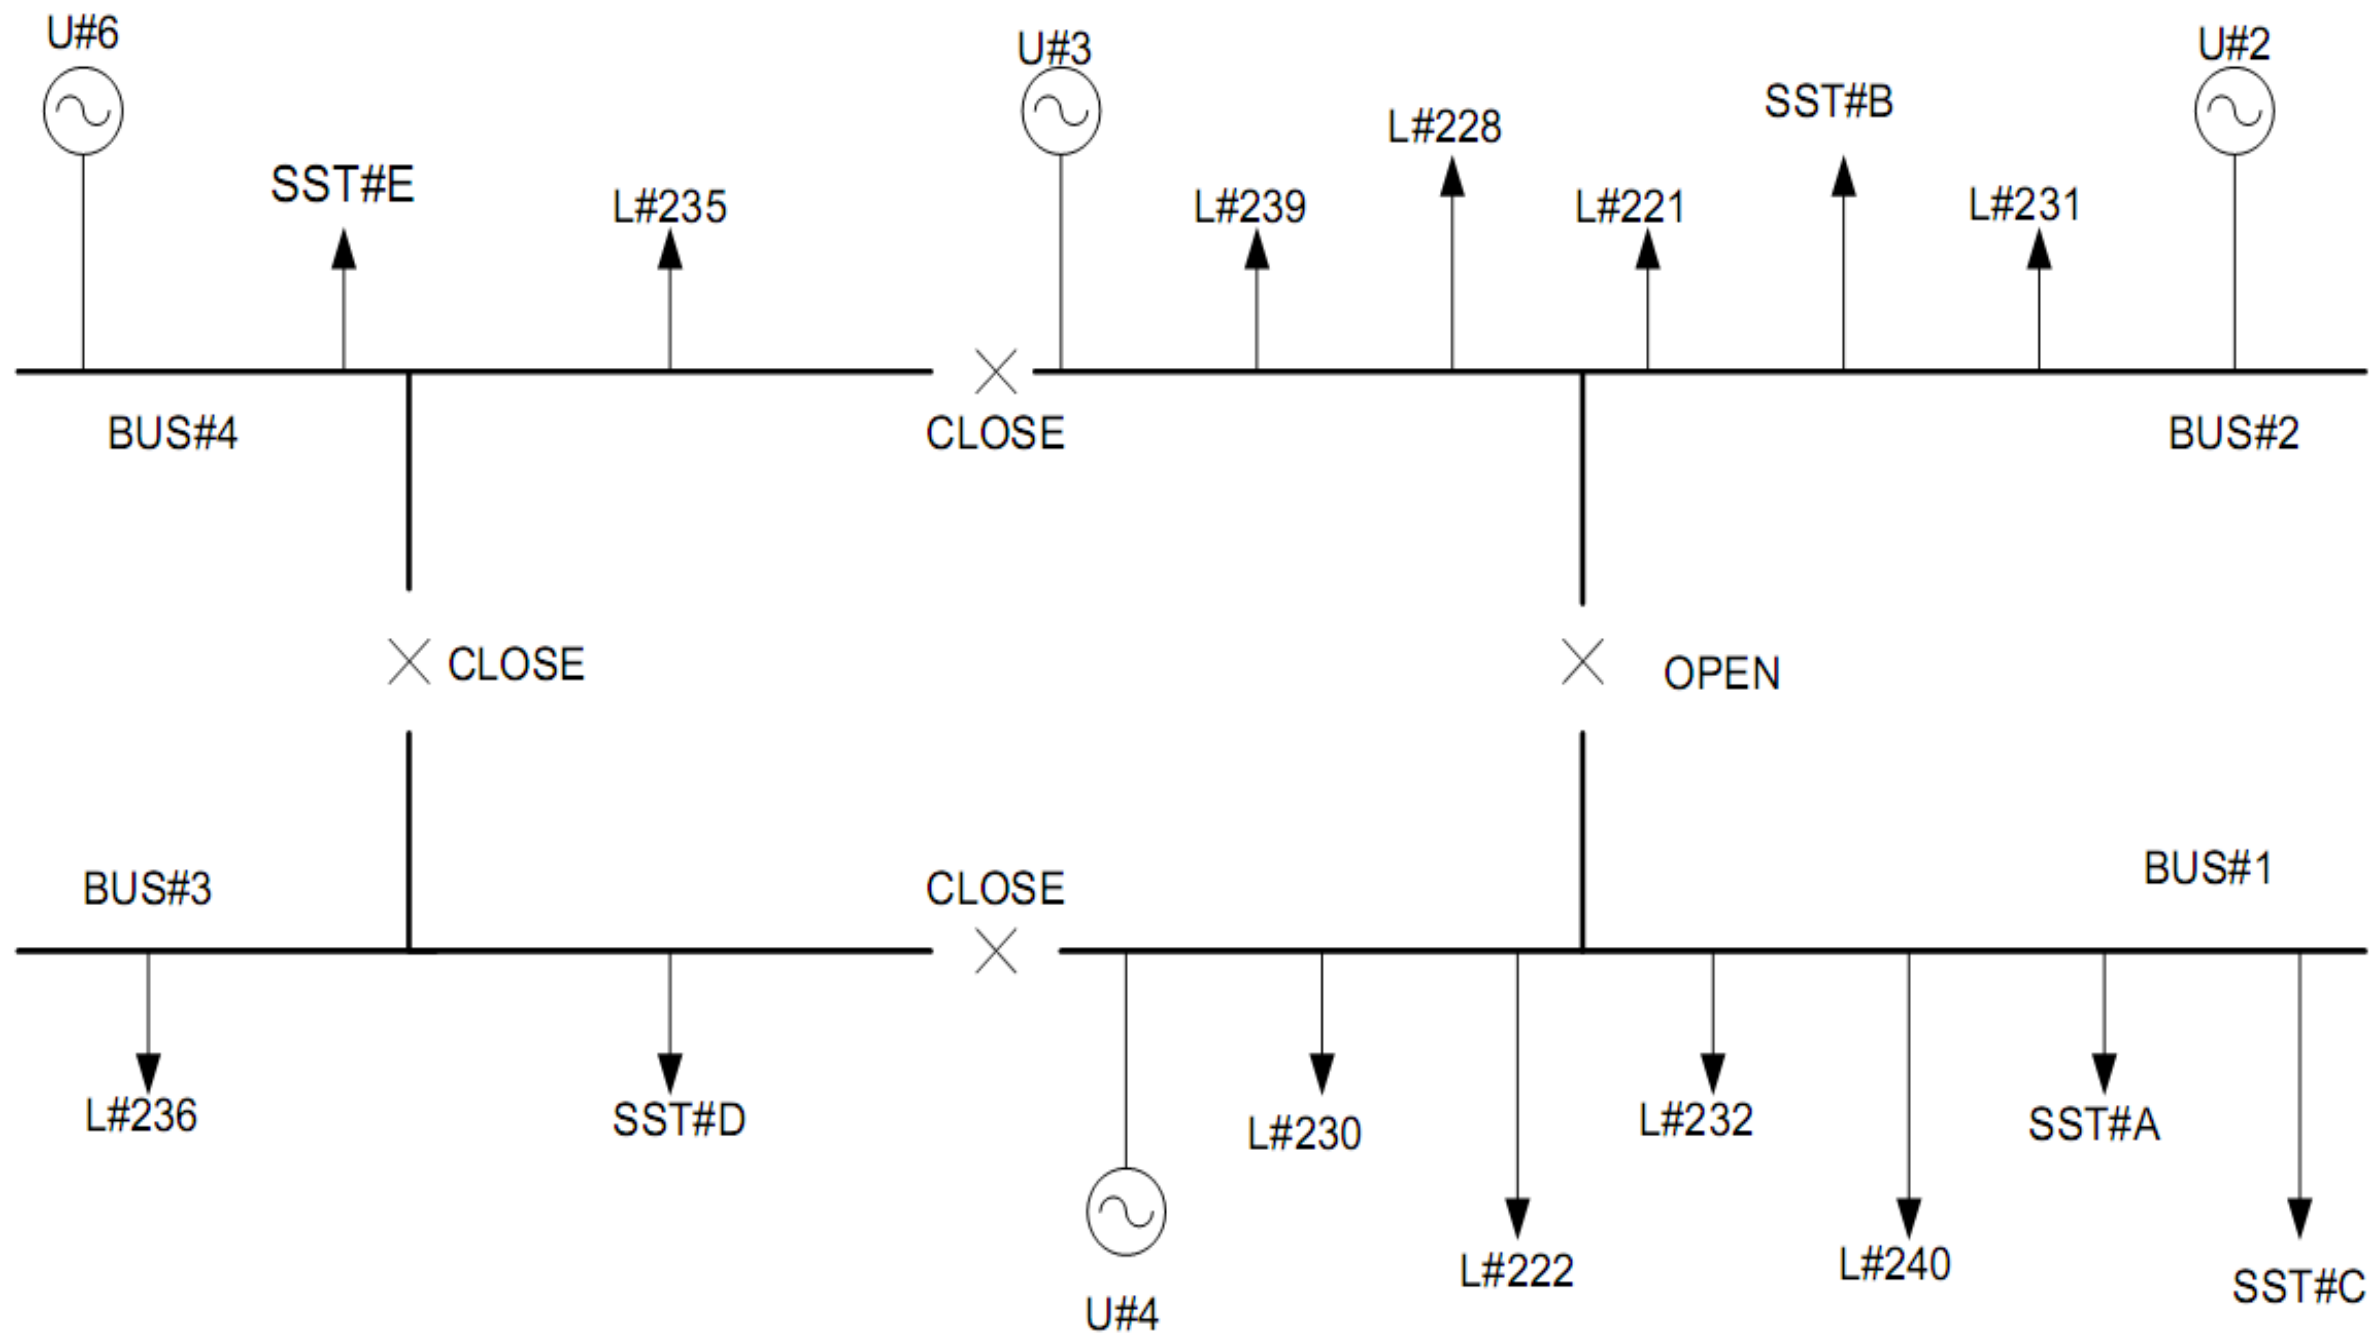
MTPS BUS 1, 2 AND 4  
FAILURE ON 19.02.18 AT  
ABOUT 18:10HRS

- With the failure of Main Bus-1, SST – A which was connected to bus-1 got tripped and led to failure of Emergency Boards of U # 2. It caused failure of AVR Thyristor cooling fan. This initiated Class-A tripping for U#2 which was on Main Bus-2.

- However, Bus section 2-4 Breaker failed to trip due to non operation of Y pole which initiated LBB protection of Bus Section 2-4 and resulted in tripping of all the bays associated with Main Bus-4.

- This ultimately results in failure of Main Bus-1, 2 and 4 causing outage of U # 2, 3 and 6.

- On 19.02.18 at around 18.10 Hrs U#4 was going to be synchronised through Main Bus-1. But, as soon as the Breaker Close pulse was provided, LBB protection operated and all the Bays connected to Main Bus-1 and Bus Section 1-3 Breaker tripped through 96 Relays.
- With the failure of Main Bus-1, SST – A tripped leading to failure of Emergency Boards of U # 2 which caused failure of AVR Thyristor cooling fan. This initiated a Class-A tripping for U#2 which was on Main Bus-2.
- With operation of Class-A Lock-out of U#2, trip pulse was issued to GT#2 Breaker. But GT#2 LBB operated as Y and B-Pole had delayed opening.

DVC added that Bus I & II breakers are 20 years old and they are planning for phase wise replacement.
