Minutes of **68th PCC meeting**

Date: 05.07.2018
Eastern Regional Power Committee
14, Golf Club Road, Tollygunge
Kolkata: 700 033

MINUTES OF 68TH PROTECTION SUB-COMMITTEE MEETING HELD AT ERPC, KOLKATA ON 18.06.2018 (MONDAY) AT 10:30 HOURS

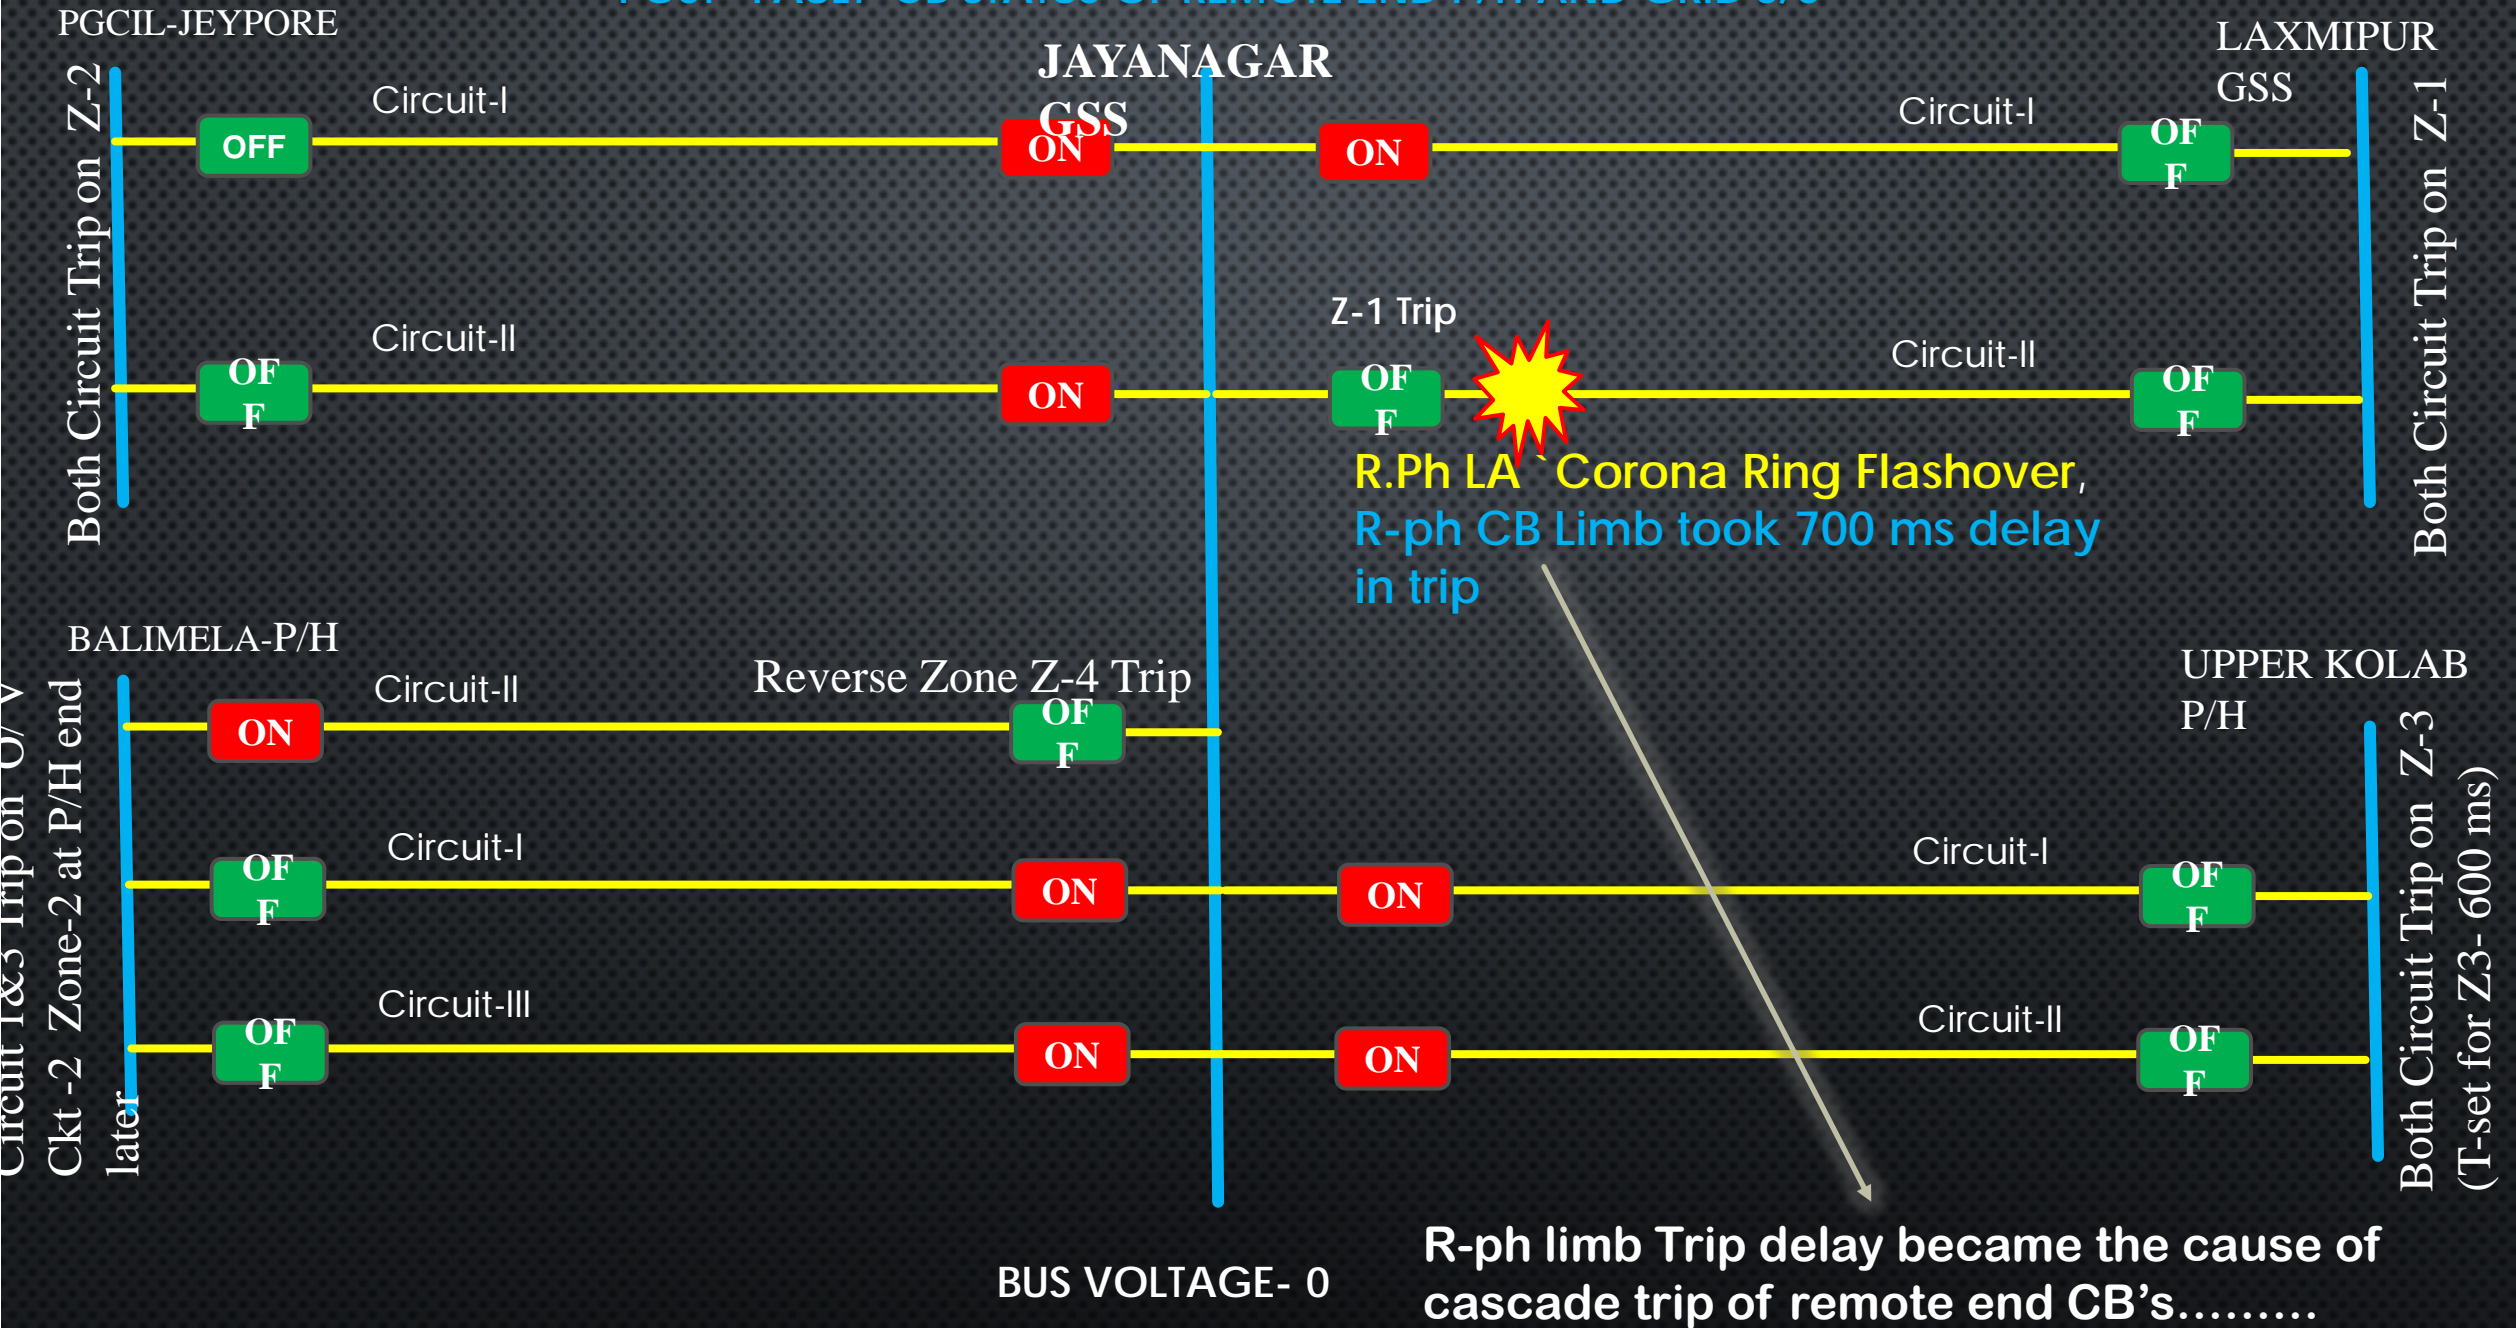
POST-FAULT CB STATUS OF REMOTE END P/H AND GRID S/S

At 16:30:37 Hrs 220KV Laxmipur-1 relays (i.e DP, Zone-1 & Back-up) initiated tripping command for bus side CB & its Tie CB. Instantaneously tie CB and Bus side CB (Y&B-Phase) tripped at Jayanagar GSS, But R-phase limb of bus side CB didn't trip up to 700ms. PDR also operated but R-phase limb didn't trip up to 700ms. During this time SIEMENS make bus-bar Prot./LBB also did not operate & found that the Bus zone-1 of Bus bar Protection scheme is in blocking mode by the Central Unit. Later it was found that Upper Kolab-1 Bay Unit (BU-7) relay not sensing the R-phase current even though balanced current was flowing in the BU, due to which the Central Unit(CU) blocked the Bus-1 diff. protection/LBB.

Cascade situation arised due to 700ms delay in tripping of R-ph limb (i.e Laxmipur-1), so line feeders which were connected to the Jayanagar GSS tripped at remote end.

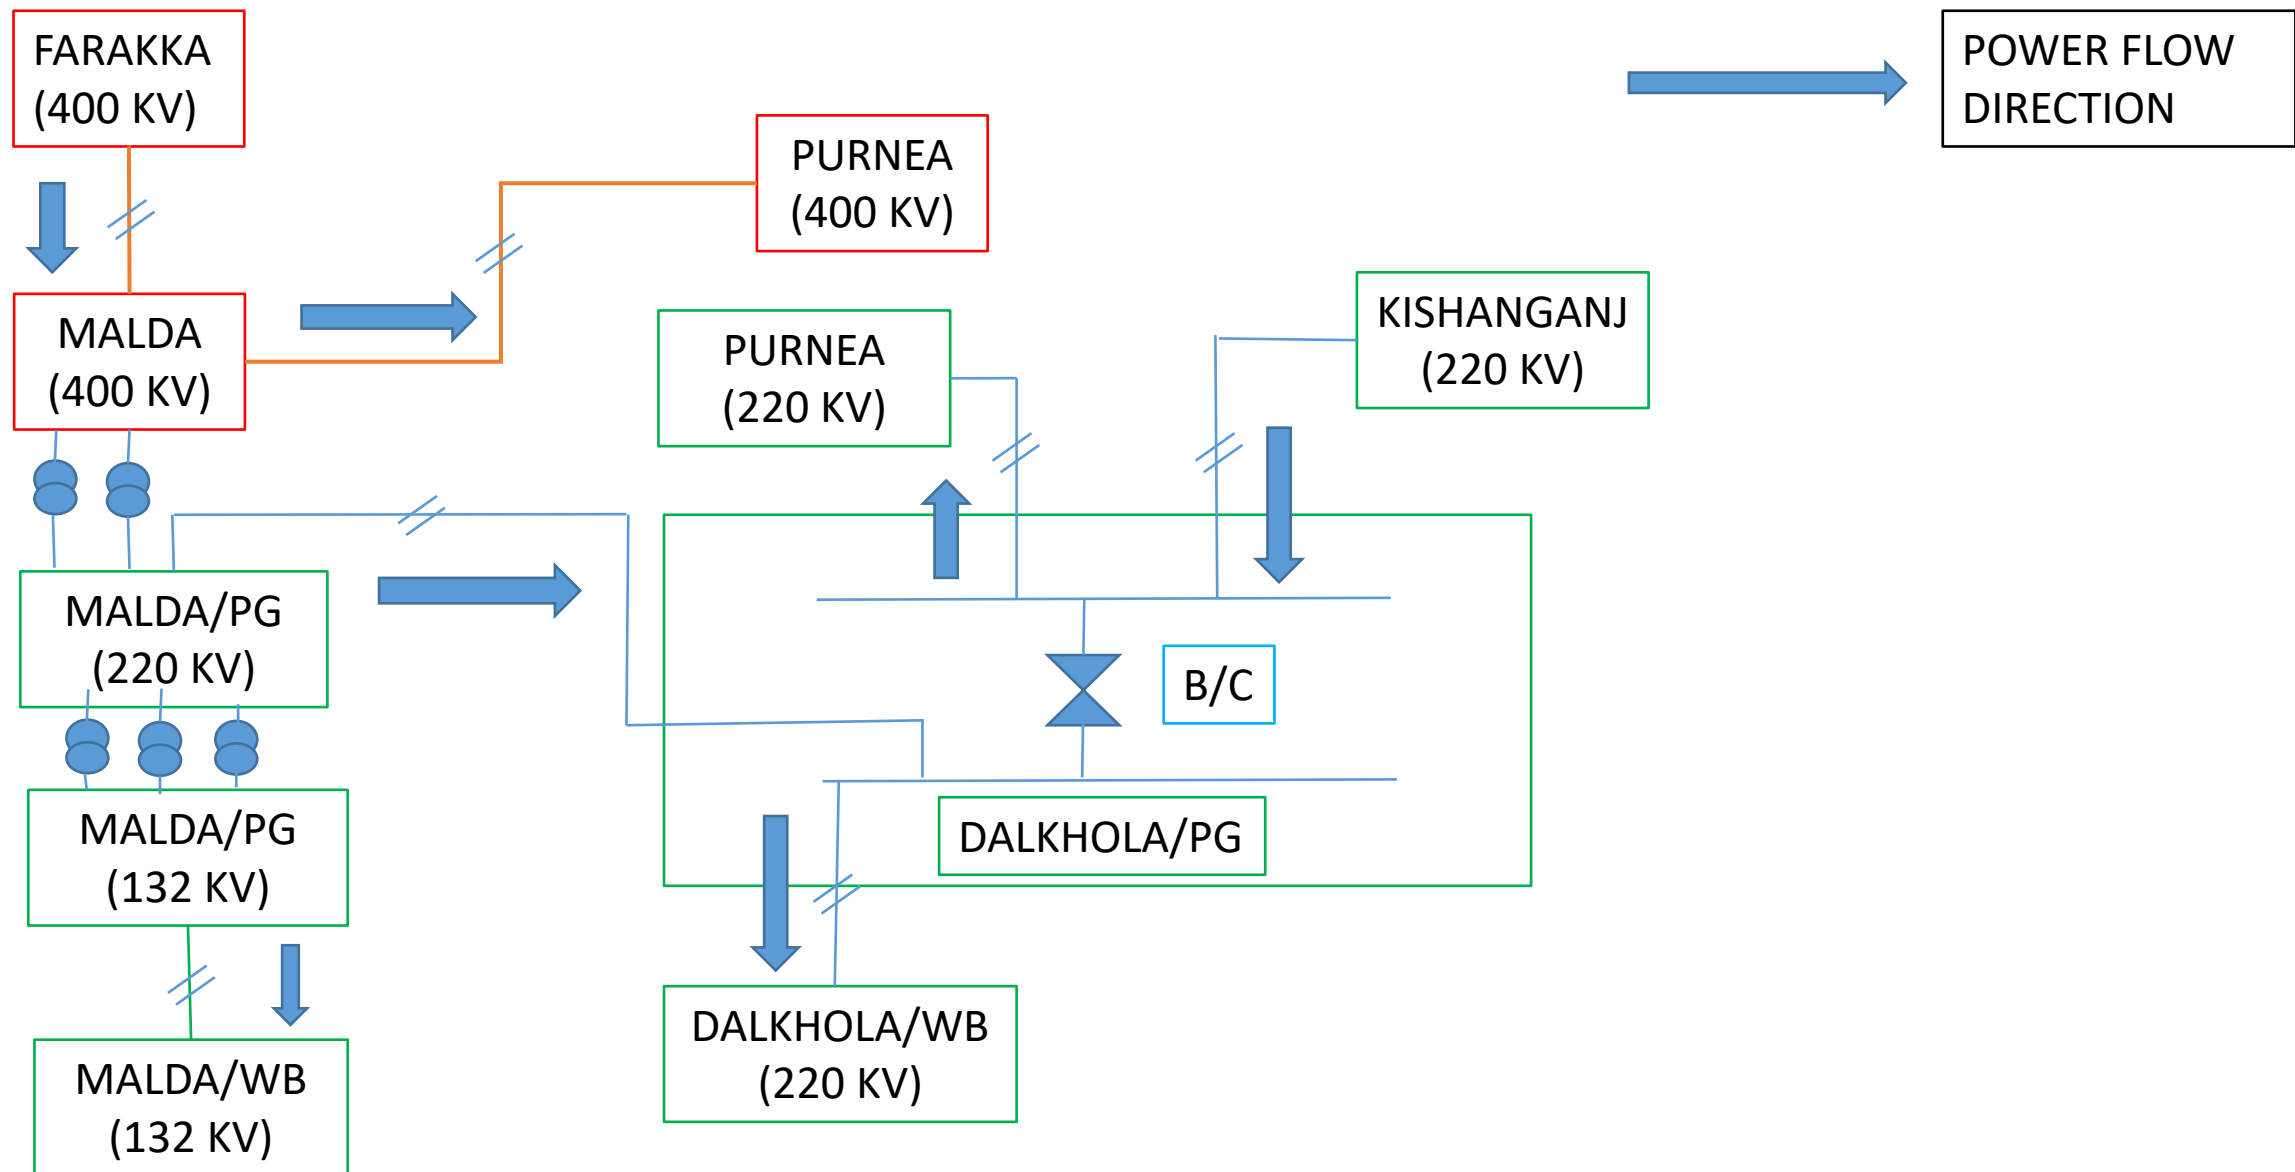
MALDA/DALKHOLA NETWORK DIAGRAM

- 400 KV Bus-I&II tripped at 19:04:21 Hrs. on dated 28.05.2018 at 400 KV Malda substation due to operation of 400KV bus-bar relay.
 - Before that, there was a tripping in 400KV Malda-Purnea Ckt.-II at 19:04:19 Hrs. on dated: 28.05.2018. The relay details: R-N, Ir=4KA, D=65KM, Zone-I, A/R optd. in first fault but again tripped in persistence fault.
-
- 400KV Feeders distribution in 400KV Bus before the incident:
 - Bus-I: 400 KV MLD-PRN Ckt.-I,
400 KV MLD-FRK Ckt.-I,
315 MVA ICT-V
 - Bus-II: 400 KV MLD-PRN Ckt.-II,
400 KV MLD-FRK Ckt.-II,
315 MVA ICT-III

- Annunciation for Bus Coupler CB input Status Monitoring system has been established out side of the Relay to avoid such type incident in future.

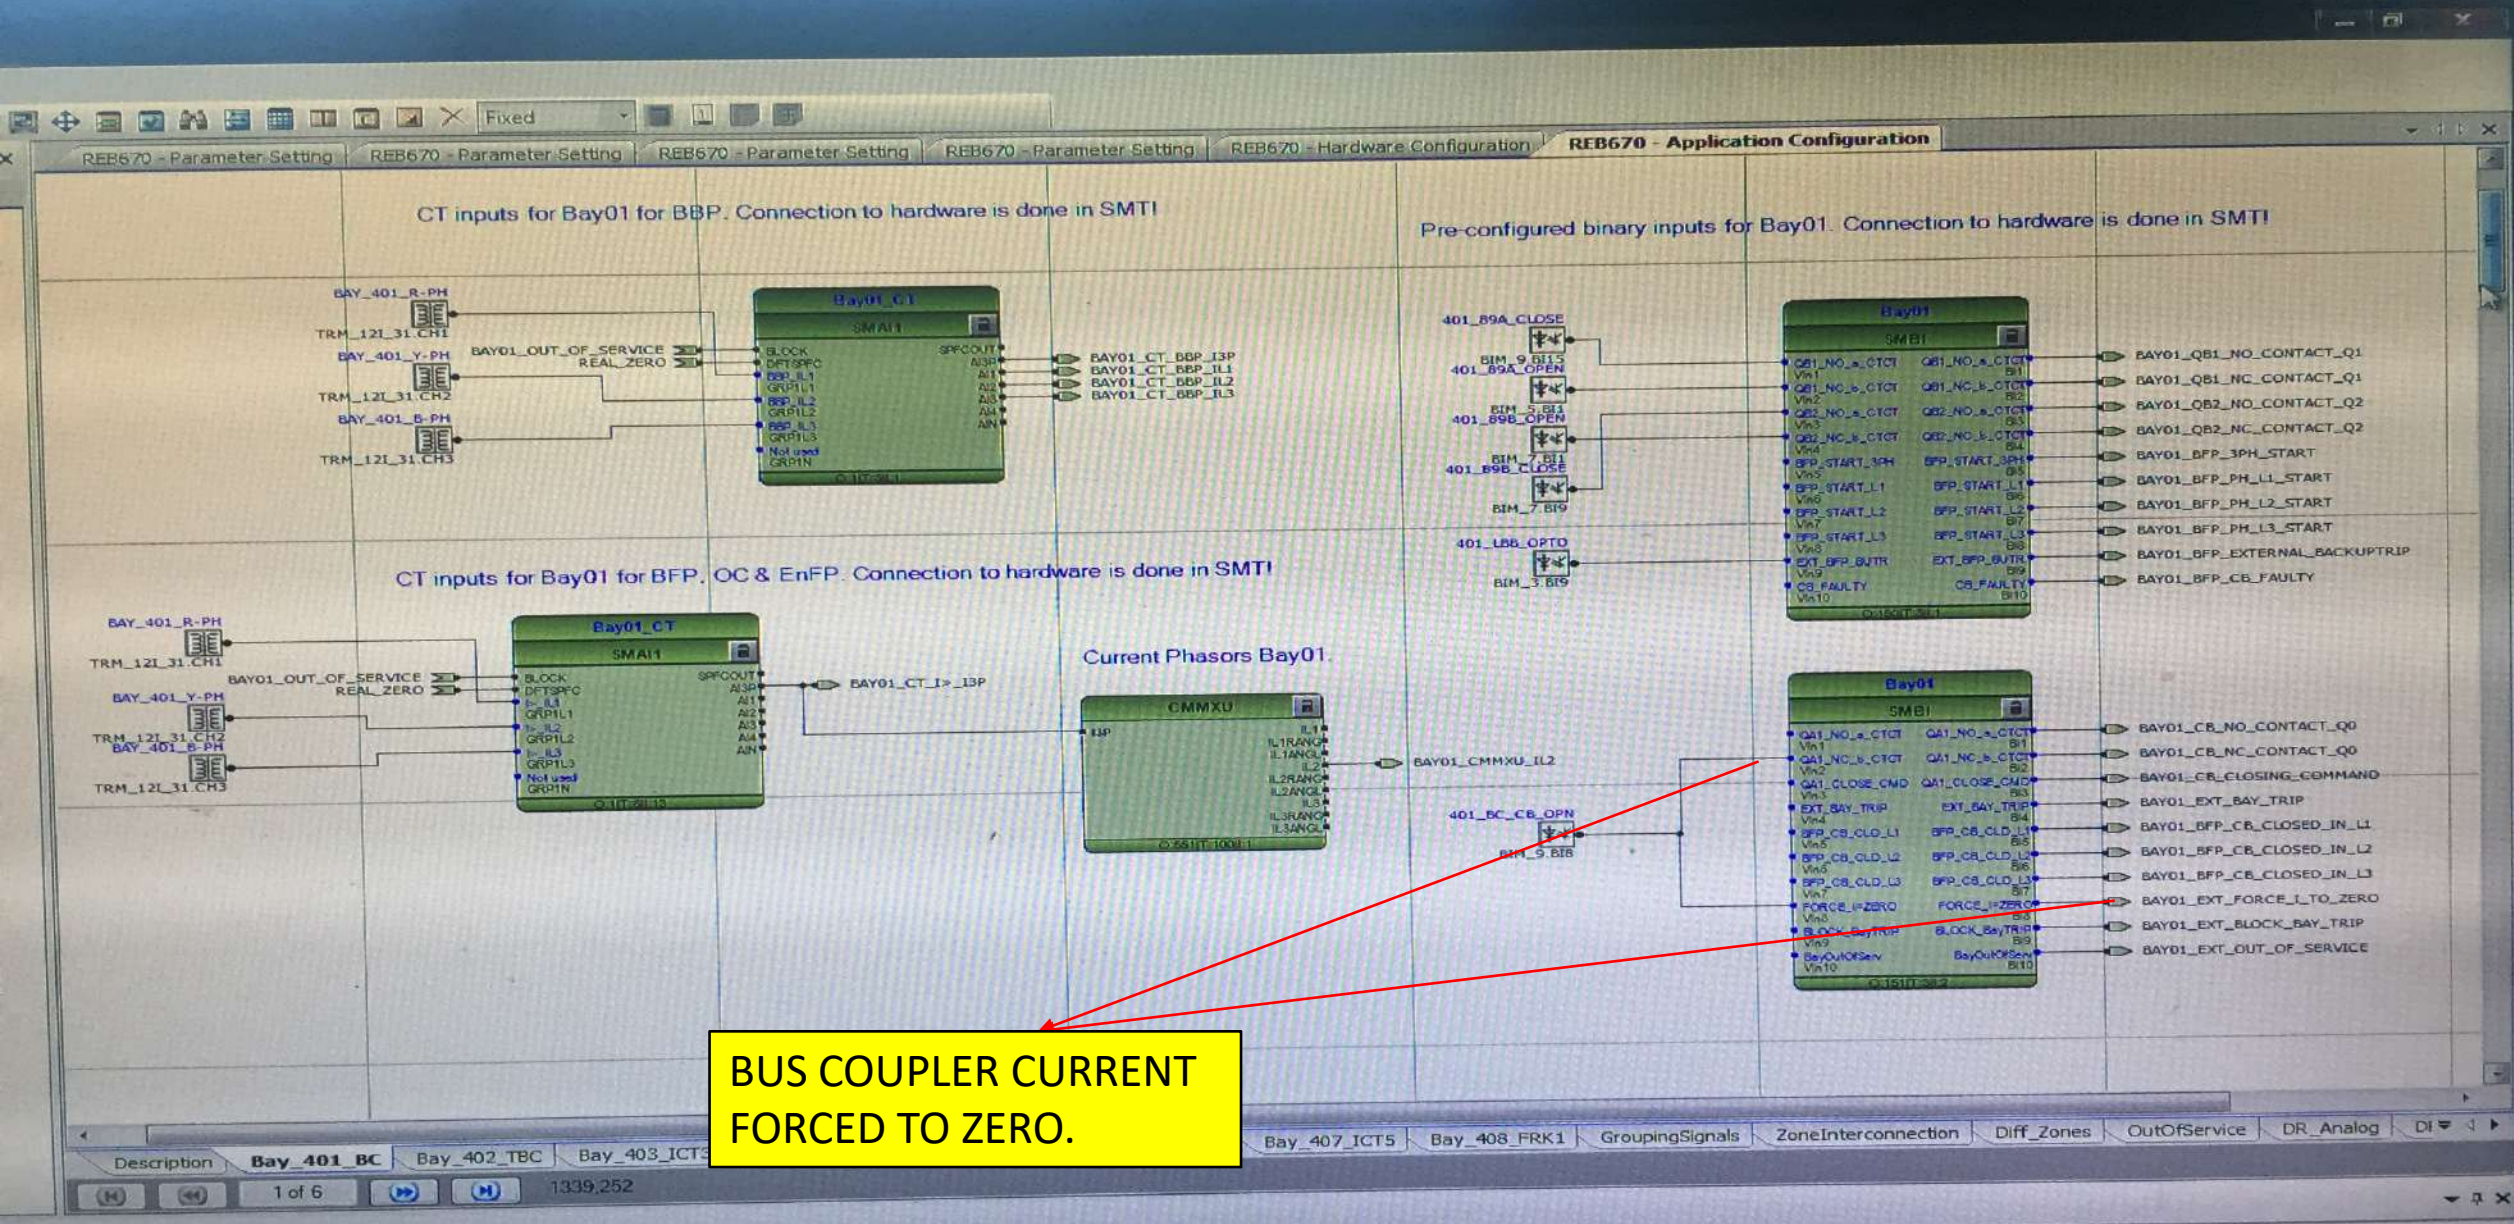
Fault Current Sharing through Bus Coupler During Fault.

Powergrid informed that that 400 KV Malda-Purnea-2 tripped on R-N fault due to persisting fault after auto reclosing. Simultaneously the busbar protection operated at 400kV Malda due to forcing the bus coupler current to zero. After investigation it was found that the specific cable was cut which forcing the bus coupler status as open.
