Minutes of 70th PCC Meeting

Date: 06.09.2018 Eastern Regional Power Committee 14, Golf Club Road, Tollygunge Kolkata: 700 033

MINUTES OF 70TH PROTECTION SUB-COMMITTEE MEETING HELD AT ERPC, KOLKATA ON 21.08.2018 (TUESDAY) AT 10:30 HOURS

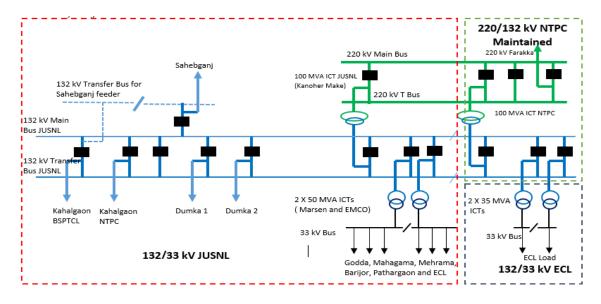
Fig: 220/132/33 kV Lalmatia Substation Single Line Diagram

Substation: Lalmatia substation is having a historical background. The substation was created in around 1989 for catering to the ECL coalmine load. It is 220/132/33 kV substation owned by ECL which was later being maintained by NTPC Farakka. However, subsequently, with the other distribution load coming up, the switchyard was extended by JUSNL with augmentation of 220/132 kV ICT, 132 kV lines and 132/33 kV transformers.

The substation is thus subdivided into two parts out of which one looked after by NTPC Farakka and other by JUSNL. NTPC Farakka is looking after the 220/132 kV switchyard consisting of 220 kV Farakka-Lalmatia ckt and 220/132 kV ICT. While the JUSNL looks after the 220/132 kV ICT 2 (Kanohar Make), 132 kV Kahalgaon(NTPC)-Lalmatia, 132 kV Kahalgaon (BSPTCL)-Lalmatia, 132 kV Kahalgaon (BSPTCL)-Sahebganj, 132 kV Lalmatia-Dumka 1 & 2, 2 X 50 MVA 132/33 kV ICTs and 33 kV switchyard with 6 33 kV feeders (Godda, Mahagama, Patahargaon, Meharama, Barijor and ECL) for JUSNL load. The 132 kV buses maintained by NTPC and JUSNL are coupled and having isolator arrangement decoupling.

The Protection Audit findings are thus subdivided into two parts i.e. One for 220/132 kV NTPC Maintained section and other 132/33 kV JUSNL owned section for this substation.
