Minutes of **71st PCC Meeting**

Date: 08.10.2018
Eastern Regional Power Committee
14, Golf Club Road, Tollygunge
Kolkata: 700 033

EASTERN REGIONAL POWER COMMITTEE

MINUTES OF 71ST PROTECTION SUB-COMMITTEE MEETING HELD AT ERPC, KOLKATA ON 19.09.2018 (WEDNESDAY) AT 10:30 HOURS

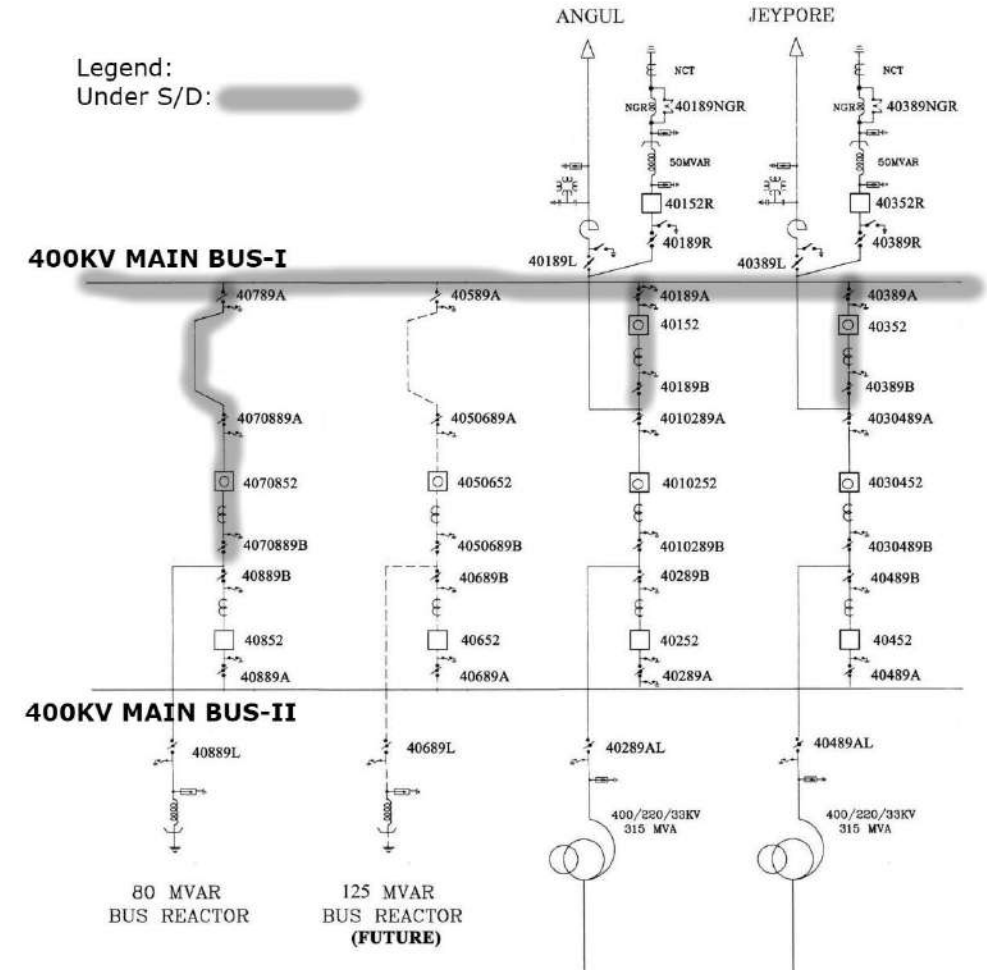
1. Prior to Tripping 400KV BUS-I was under shutdown for Jumpering work for new DIA coming up under 125MVAR Reactor Package.
2. BUS-II Voltage was 404.78KV Frequency: 50.11Hz
3. Loading on ICT-I : -73.29MW, ICT-II: -76.99MW

1. At 18:13Hrs on 21.08.2018 Both ICT-I and ICT-II Tripped on following indications
ICT-I: Buch Trip, OTI Trip, WTI Alarm, Low Oil Flow Alarm, OLTC MOG Alarm.
ICT-II: Buch Trip, OLTC MOG Alarm.
2. Above Tripping from ICT-I and ICT-II Tripped their Main and Tie CBs thereby isolating 400KV Lines from Bus-II. As Bus-I was under S/D, Both 400KV Lines Bolangir-Angul & Bolangir-Jeypore Lines came under hanging position.
3. As seen from the Event Log, the indications were coming and going at the time of tripping, and got reset in few seconds.
4. DC EF Relay was found to be operated at the time of tripping but the same was not resisted in SAS since it was not integrated.
