Minutes of the 1st meeting of the Committee for Analysing the major outages of ISTS elements of Eastern Region held on 13.02.2019 at ERPC Kolkata.

Item No. 1. Outage of 400kV D/C Purnia-Biharsharif line of ENICL.

Item No. 2. Outage of 400kV D/C Patna – Kishanganj line of PGCIL.

Item No. 3. Outage of 400 kV D/C New Ranchi- Chandwa T/L—Powergrid

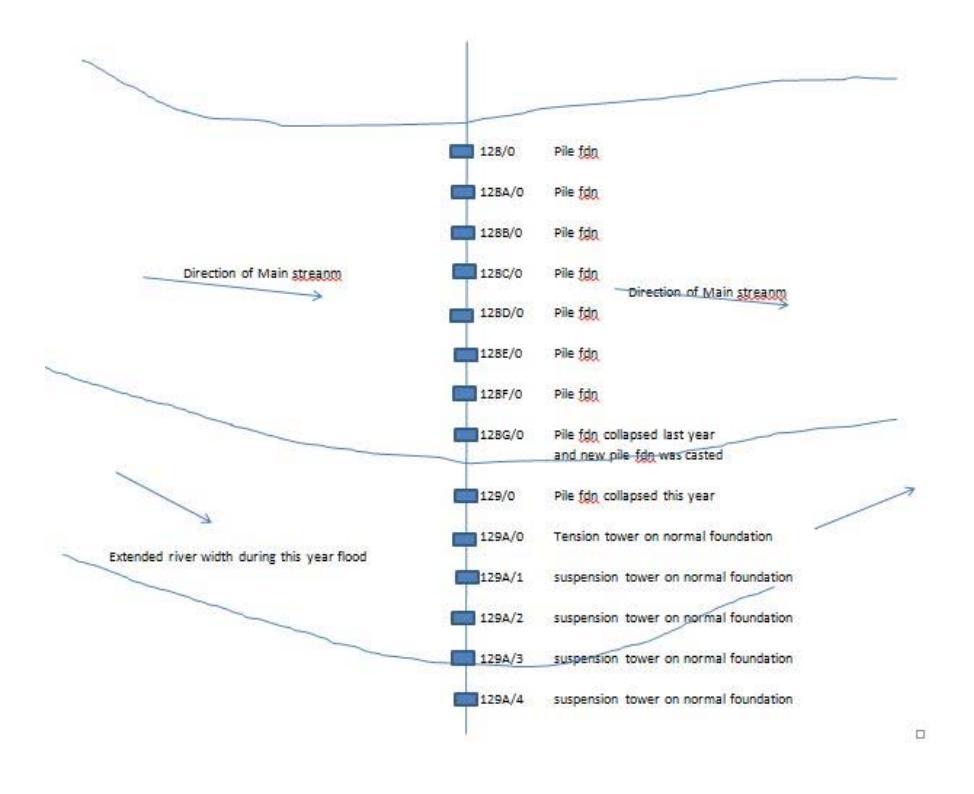
2.1 400 kV D/C (Quad) Patna-Kishanganj transmission line constructed by M/s. EMC Ltd. was commissioned inFeb-2016. There are nine (9) nos. of pile foundations in Ganga River Crossing stretch in this line. Failed tower location no129/0(DD+9) is the last pile foundation location towards Patna side. The pile foundation works for the line was executed by M/s Simplex Ltd. A schematic representation of plan indicating affected location on piles and normal foundation is shown below.

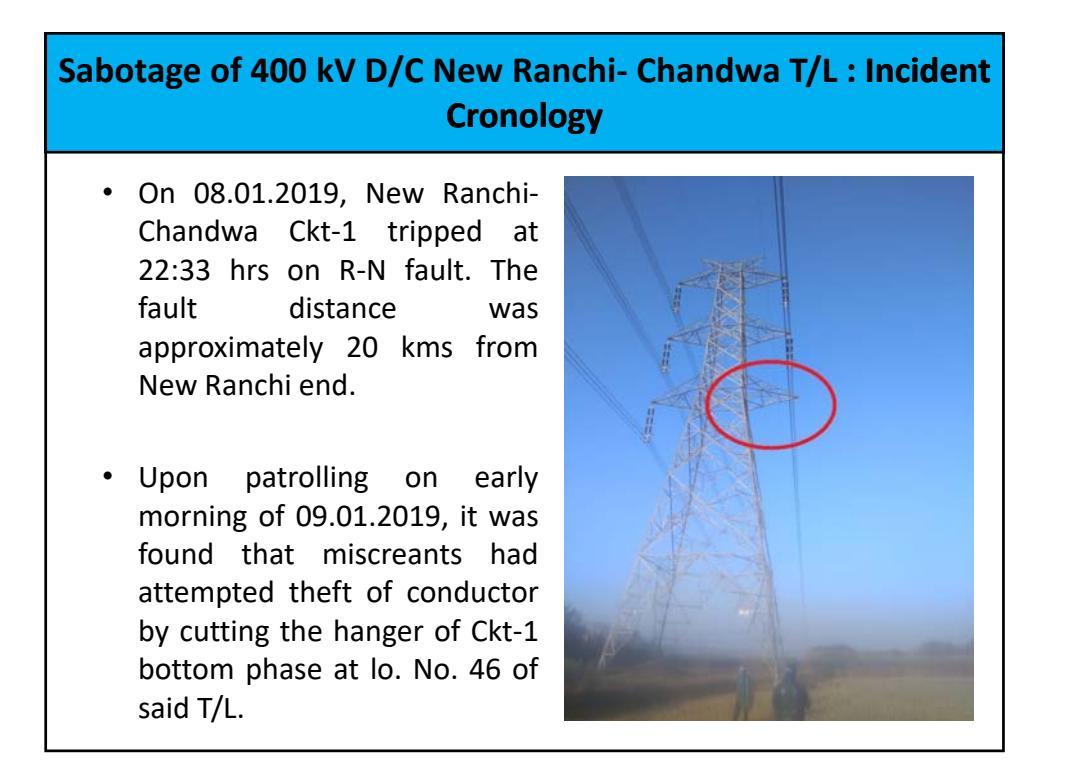
Sabotage of 400 kV D/C New Ranchi- Chandwa T/L : Incident Cronology (contd..)

• It was ascertained that the hanger of the bottom conductor was cut by the miscreants on charged line condition and fall of the same had caused the said tripping.

• The bottom phase insulator string got completely damaged and snapping of the conductors of the bottom phase also happened subsequently.

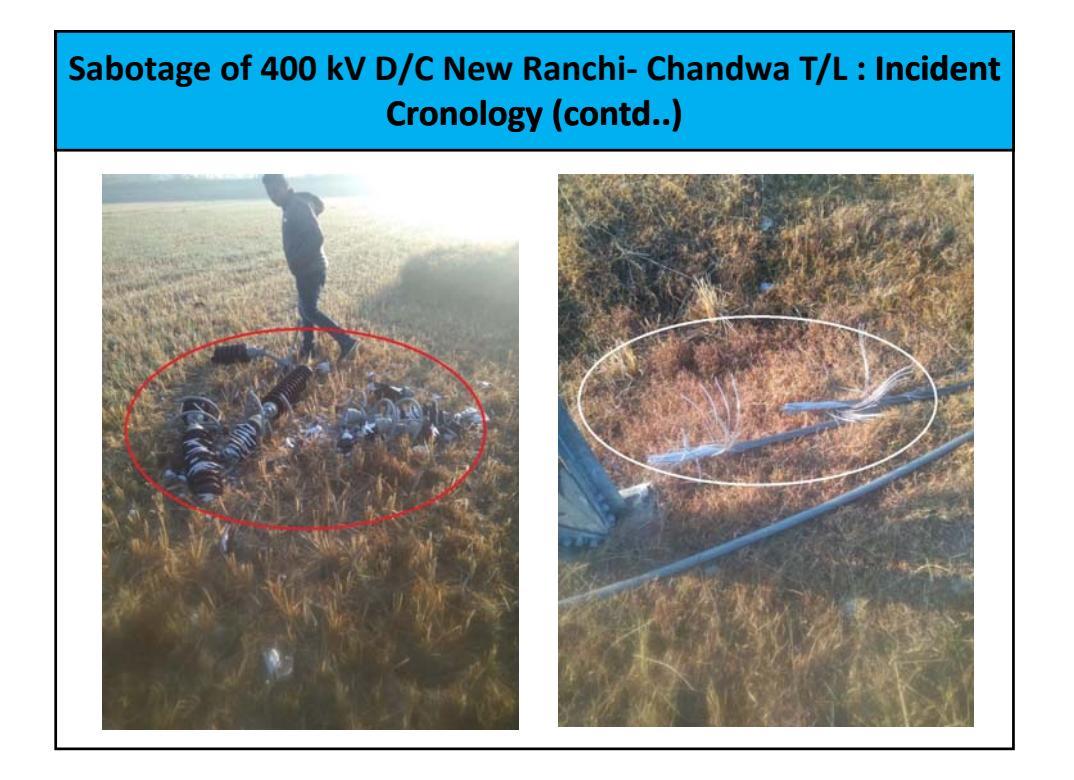
Sabotage of 400 kV D/C New Ranchi- Chandwa T/L : Incident Cronology (contd..)

• The snapping of the bottom phase conductor resulted in causing consequential damage to 10 spans of the bottom phase of the said line.

• However, as the patrolling team reached the site early in the morning, the miscreants could not cause any further damage to the line and fled away.
