Agenda
for
81st PCC Meeting

EASTERN REGIONAL POWER COMMITTEE

AGENDA FOR 81ST PROTECTION SUB-COMMITTEE MEETING TO BE HELD AT ERPC, KOLKATA ON 18.07.2019 (THURSDAY) AT 11:00 HOURS

ITEM NO. B.1: Disturbance at 400 kV Dikchu S/s on 30.06.2019 at 09:55 Hrs.

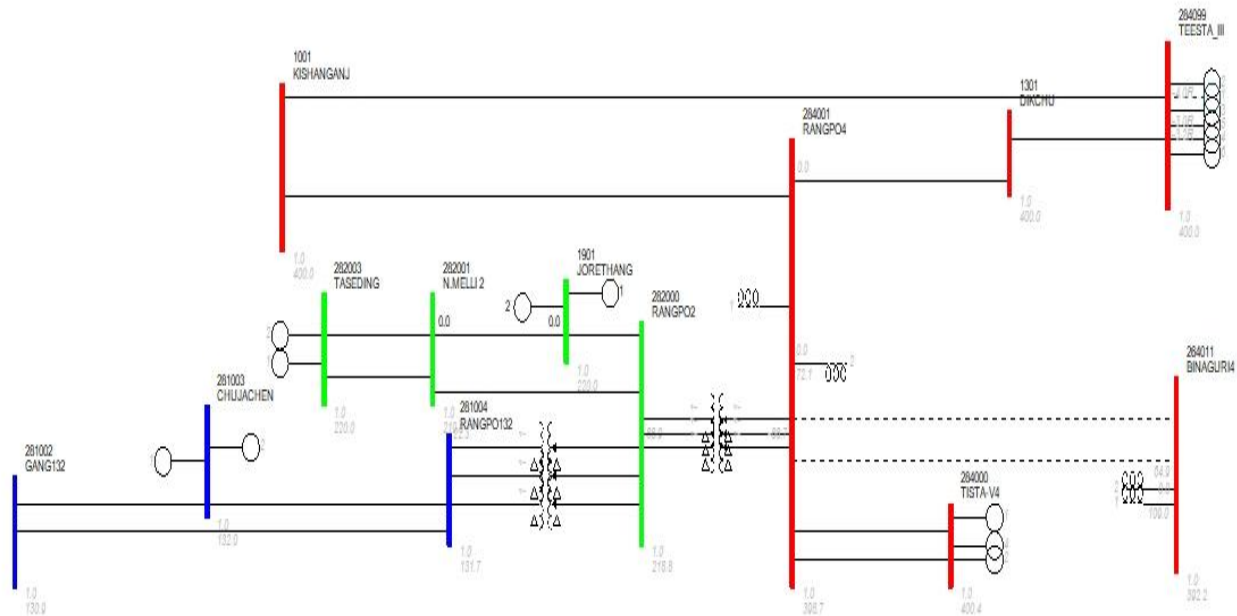
Generation Loss: 241 MW (Dikchu: 106 MW, Jorethang: 80 MW, Chuzachen: 55 MW)

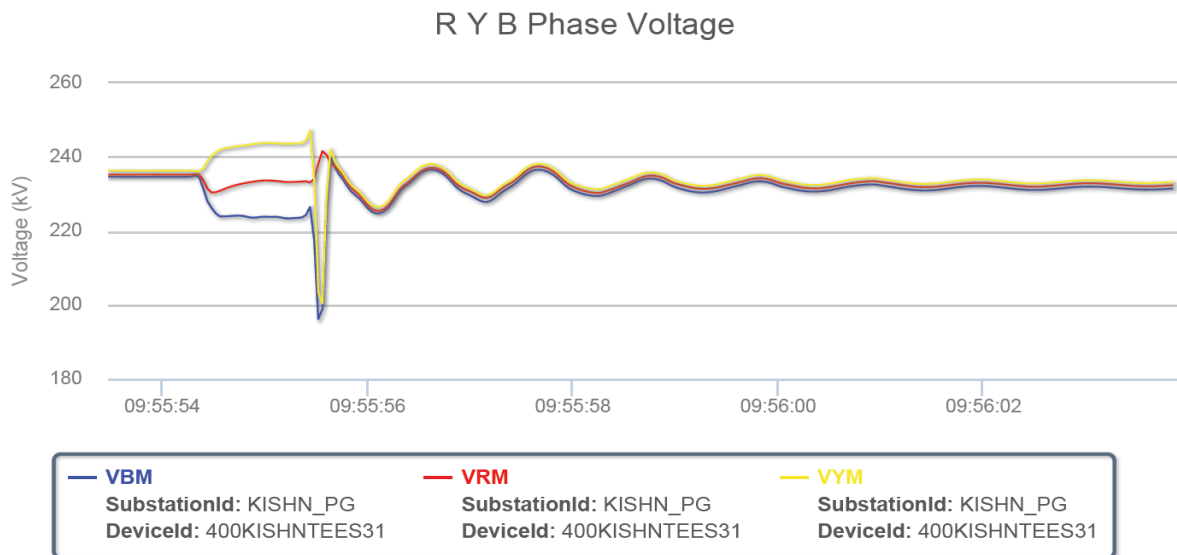
Figure 5: Phase voltage of 400 kV Teesta III Kishanganj line at Kishanganj

In the 400 kV Teesta III Kishanganj Line after transient current settled just above 2000 Amp and stayed there for 50 sec but no SPS operation at Teesta III reported.

Flow of Teesta III –Kishanganj Line remain above 2000 AMP for 1 minute but as per SPS action at Teesta III unit 1 not tripped. Teesta III needs to explain the same. As per PMU data value of the current was 2040 Amp so whether SPS fails to detect the condition or not needs to be confirmed by Teesta III.
