Minutes of 81st PCC Meeting

EASTERN REGIONAL POWER COMMITTEE

MINUTES OF 81ST PROTECTION SUB-COMMITTEE MEETING HELD AT ERPC, KOLKATA ON 18.07.2019 (THURSDAY) AT 11:00 HOURS

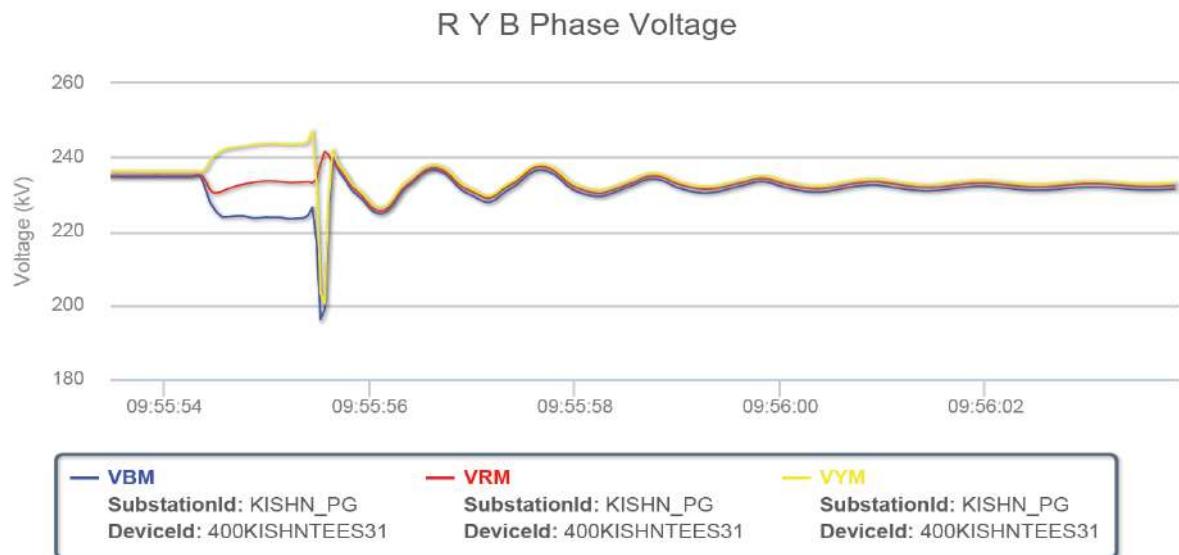
Figure 5: Phase voltage of 400 kV Teesta III Kishanganj line at Kishanganj

In the 400 kV Teesta III Kishanganj Line after transient current settled just above 2000 Amp and stayed there for 50 sec but no SPS operation at Teesta III reported.

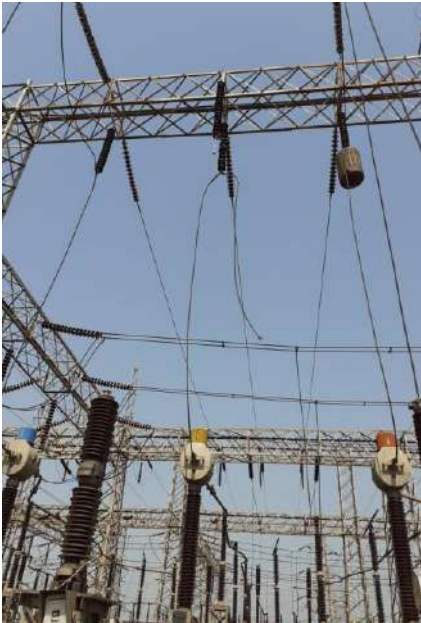
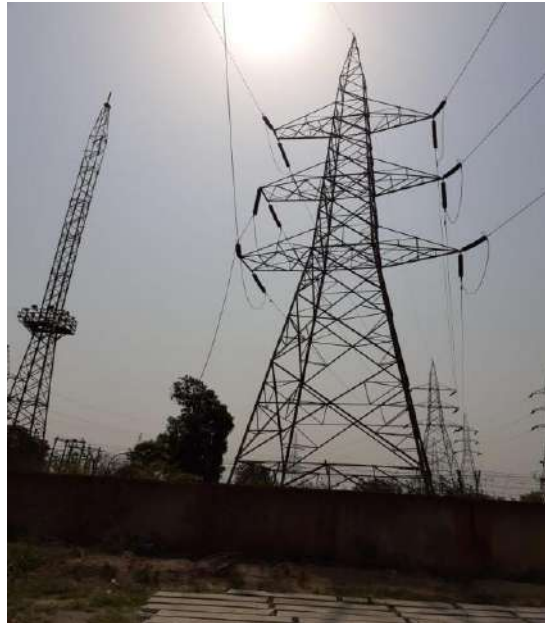
LOCATION OF FAULT POINT

Initially there was a L-L fault in 220 kV Budhipadar-Tarkera-I line near to Tarkera end due to damage of strands in Y & B phase. Tarkera end cleared the fault in zone-1 of distance protection. The relay at 220 kV Budhipadar end operated with Zone-2 of distance protection, but the breakers failed to clear the fault. They informed that further the LBB protection for 220 kV Budhipadar-Tarkera-I also did not operate which resulted in persistence of fault from Budhipadar end.

Date & Time of Occurrence:12.06.19, 00.36 Hrs

OPTCL informed that the damaged jumper & LA have been replaced. They informed that while checking, defects were found in breaker tripping circuit for 220KV Budhipadar-Tarkera-I line, the same had been rectified and the circuit was tested & put into service. They further added that the LBB relay was tested and found faulty. The same has been replaced with a new relay.

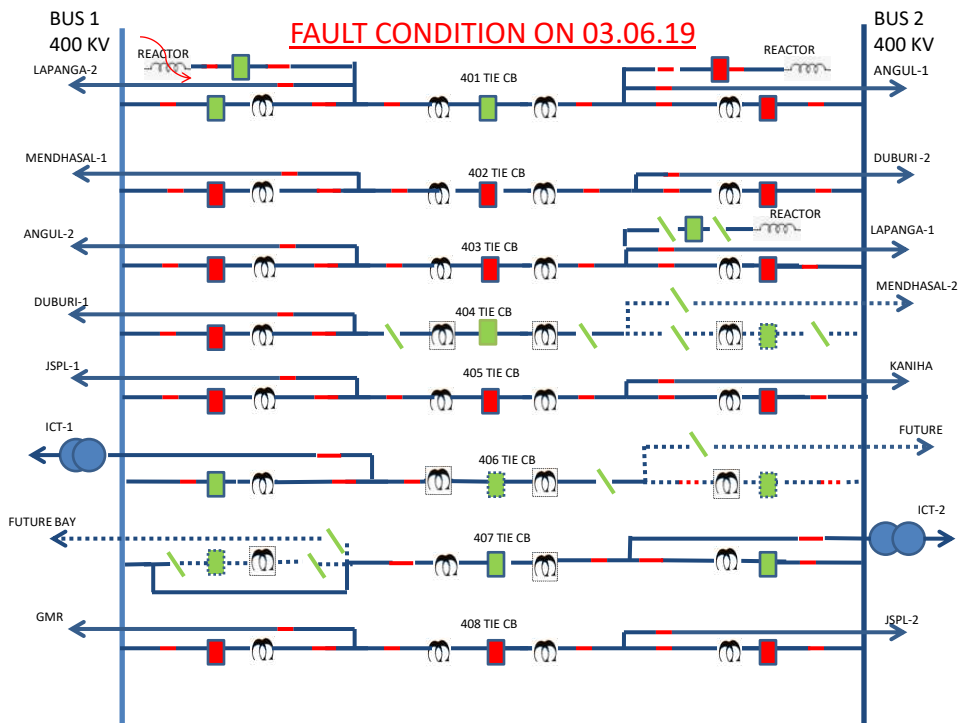
Post Fault Status of 400 KV feeders

OPTCL informed that the fault was due to bursting of B-phase line reactor of 400KV Meramundali-Lapanga-2 line which caused damage to both Y-Phase and B-Phase LAs of the reactor. The line reactor got tripped with relay indication of REF operated.

After detailed analysis of the DRs, PCC observed that before this disturbance occurred, there was a transient fault in 400 kV Meramundali-Lapanga-II line. After the fault occurred, high voltage was observed in Meramundali station which subsequently may have caused the damage of B-phase bushing in the Line reactor.
