Minutes
of
92nd PCC Meeting

MINUTES OF 92ND PROTECTION SUB-COMMITTEE MEETING HELD ON 22.07.2020 AT 10:30 HOURS

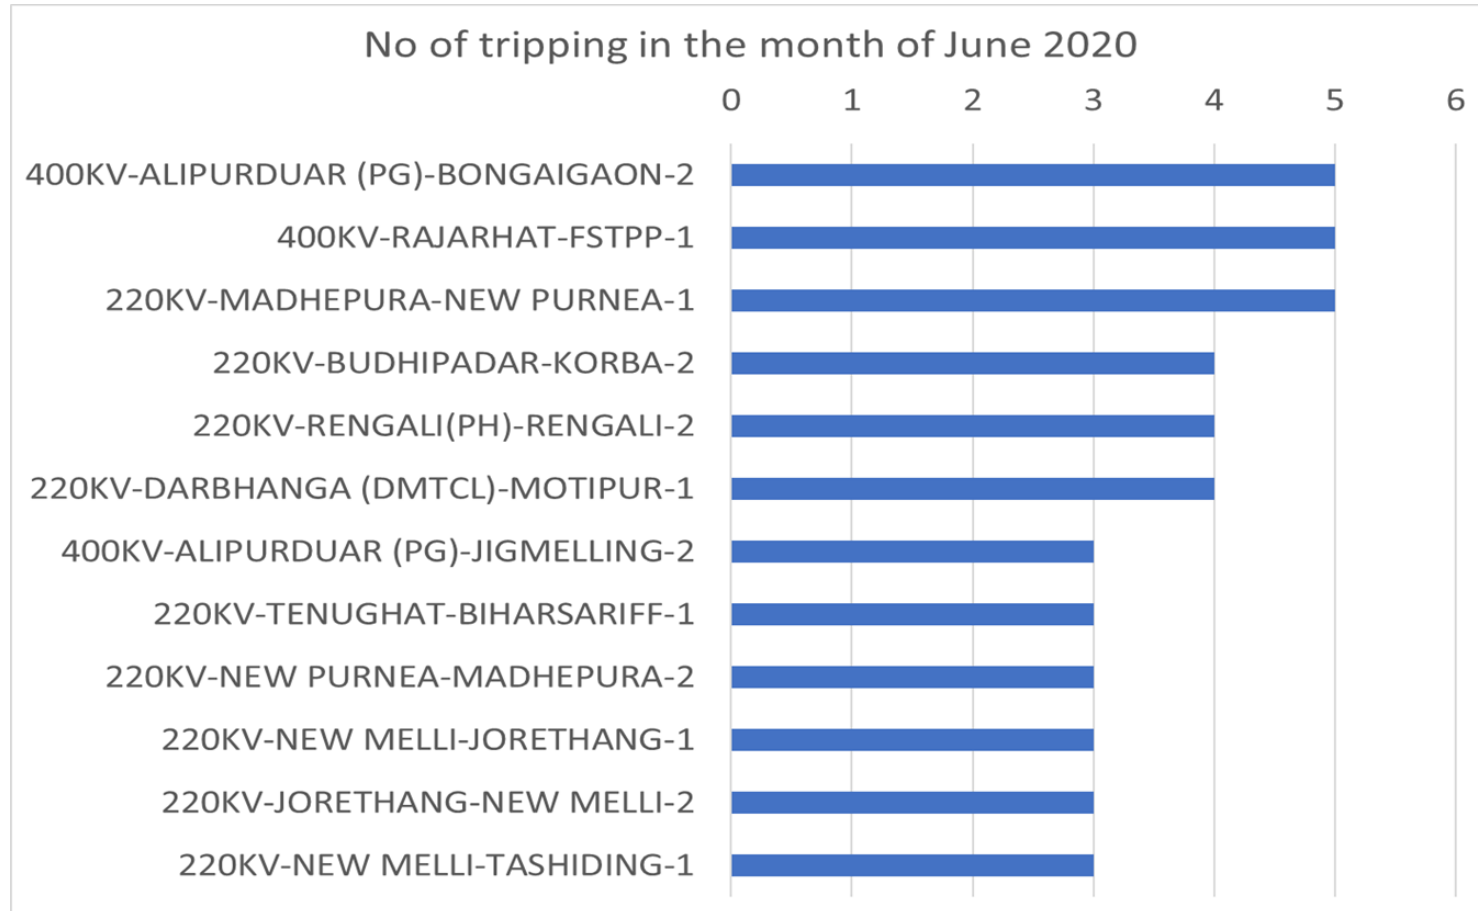
B17 Repeated tripping of same transmission elements

In case of majority tripping, fault found in nearby location.

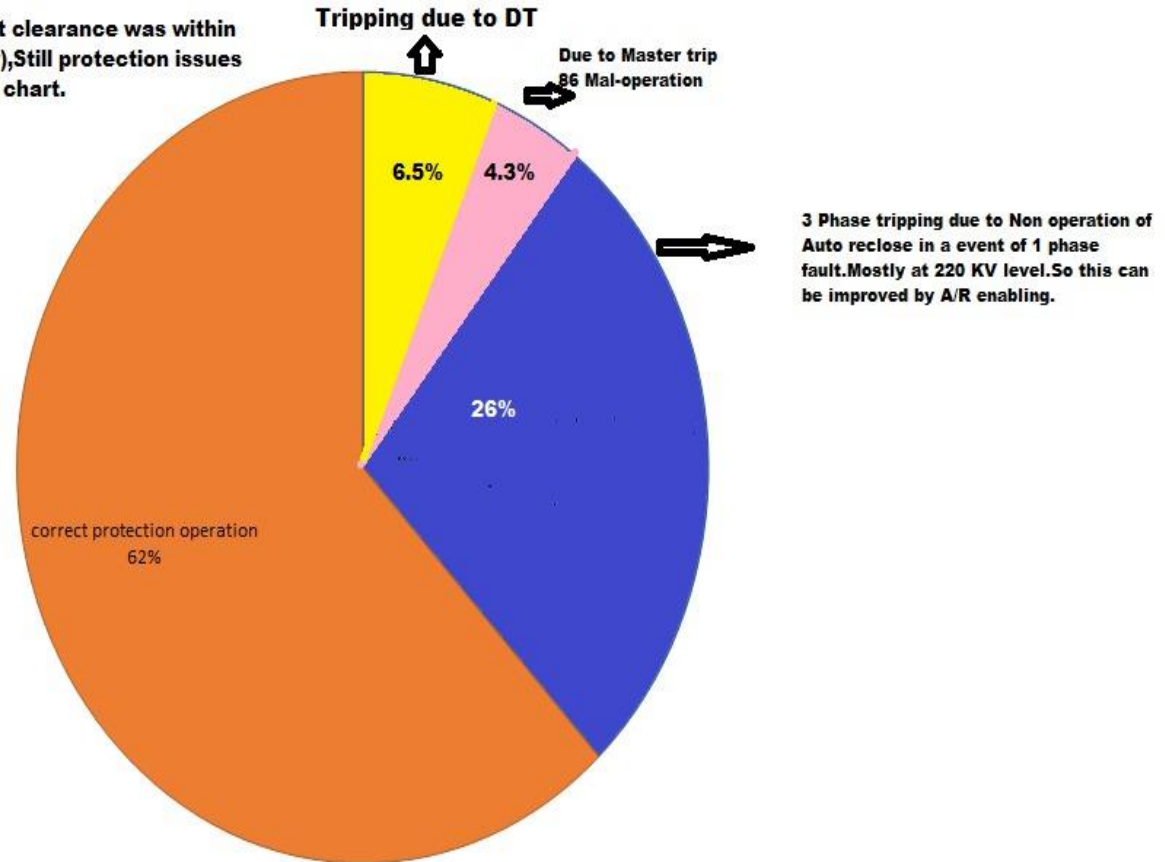
For the cases Where Fault clearance was within 100 ms and 160ms(220 Kv), Still protection issues found as mentioned in the chart.

3 Phase tripping due to Non operation of Auto reclose in a event of 1 phase fault. Mostly at 220 KV level. So this can be improved by A/R enabling.

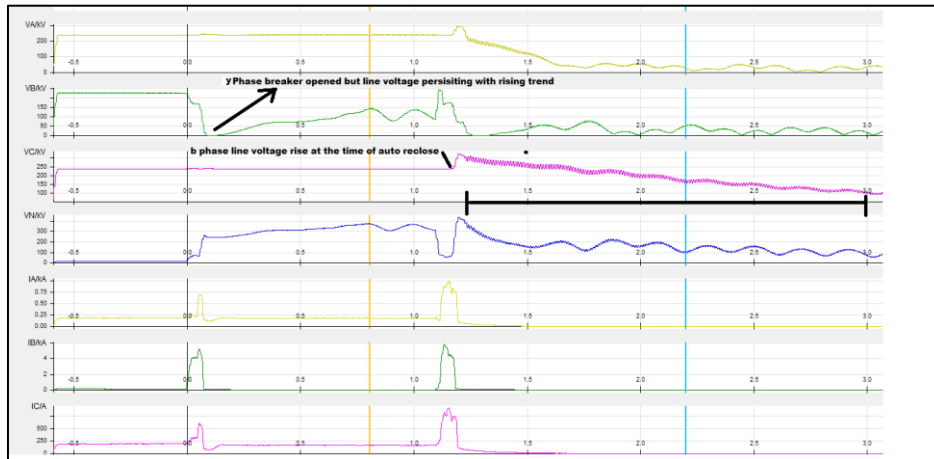
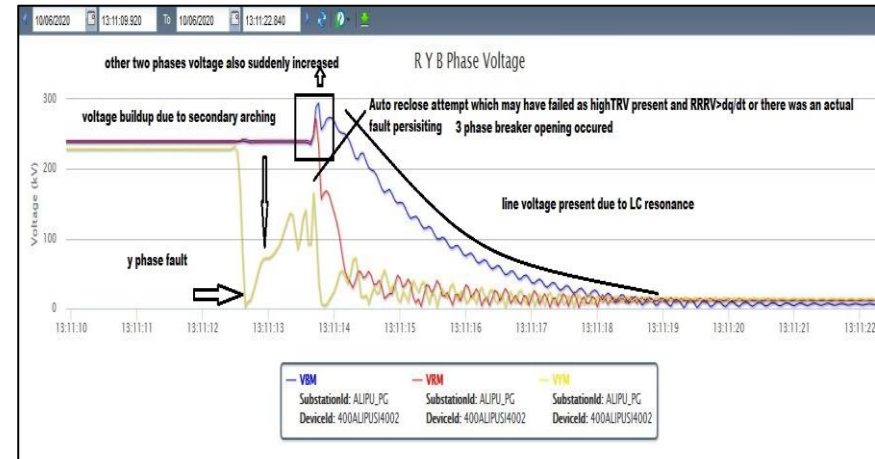
Oscillations are due to exchange of energy between reactor and line capacitance.

This was observed in all the cases with Line reactor attached in report .

With such amount of voltage LC oscillations also started with frequency of 45 Hz approx. As line is compensated more than 85 % ,Line length is 140Km (90 Mvar) , quad moose with 80 Mvar L/R at Patna end .Thus oscillation frequency of LC resonance is coming around 45 Hz which is observed in Dr plot also
