## Eastern Regional Power Committee

### **Minutes of the Meeting on “Total Power Failure in NALCO from 30.09.2021 to 02.10.2021” held on 15<sup>th</sup> February 2021 (Monday) through online MS Teams platform**

**Presentation**  
**on**  
**TOTAL POWER FAILURE**  
**at**  
**NALCO, ANGUL**  
**(30.09.2020-02.10.2020)**

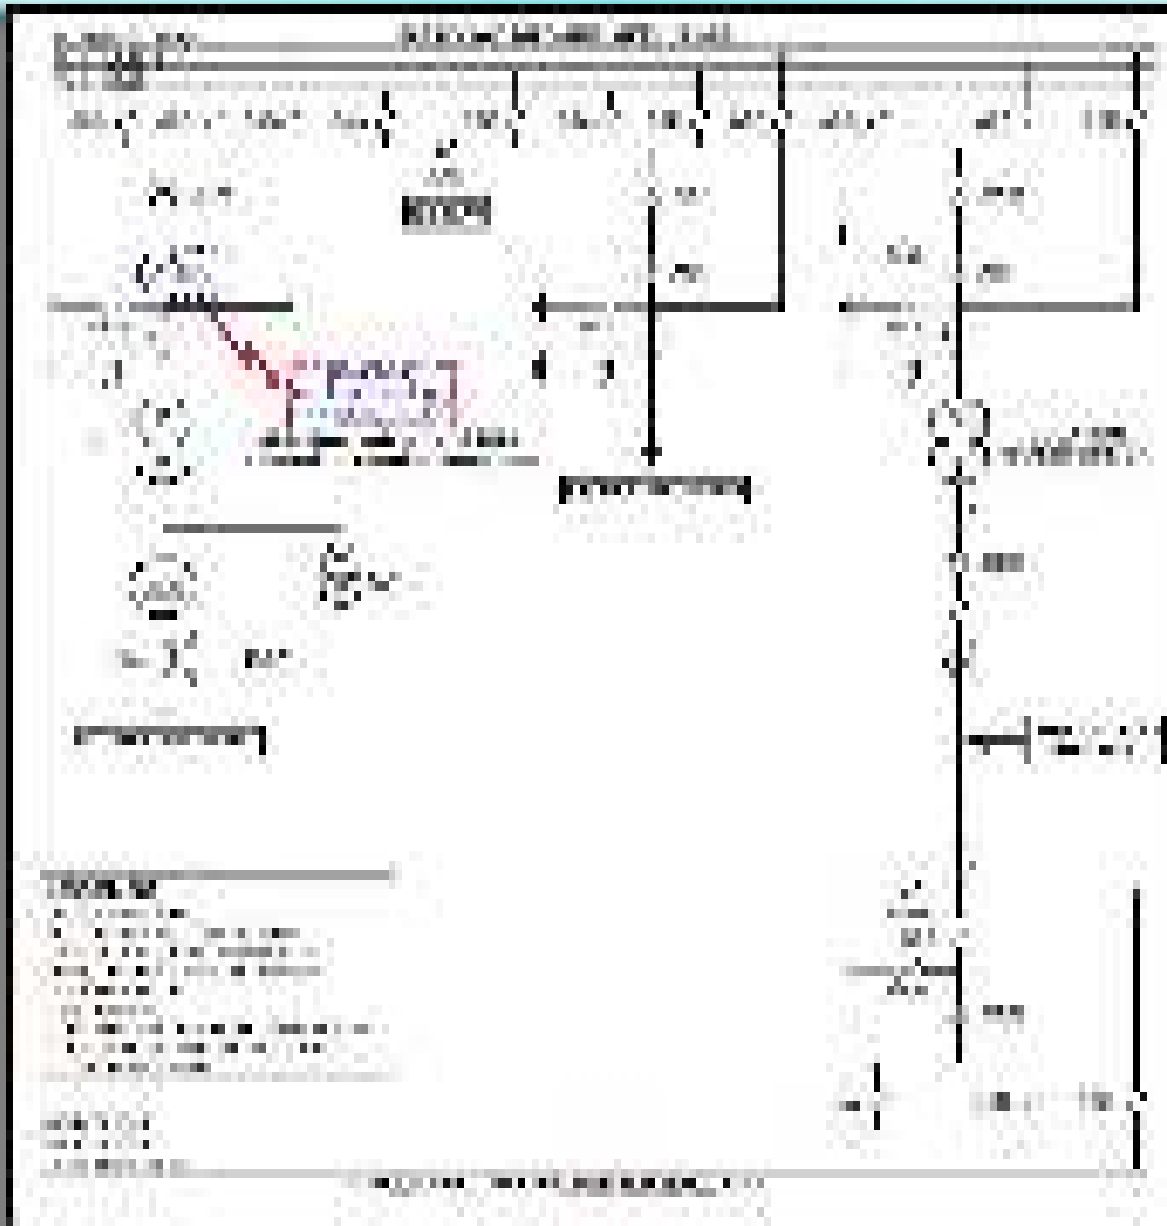
# OBSERVATION DURING THE FAULT:-

- From the current waveform signature of the relays, it is seen that current in all units as well as GRIDCO feeders were normal till 22:36:46.168 Hrs., after which it has increased suddenly. For the present analysis this time is considered as time “t=0” and all timings are calculated on this base.

- Only there is abnormality in current of Unit-4 slightly prior (around 100 mSec) to this time. Hence, it was concluded that fault started in Unit-4. In fact after the incident it was found that the line isolator 89C was in open condition. There were heavy flashover marks on its moving contacts and ‘Y’-phase arcing rod. Hence, it can be concluded that opening of the isolator has initiated the problem.

- As mentioned above the 220 KV isolator 89C of Unit-4 opened automatically. As almost full load current was flowing through it, breaking of the current resulted in heavy flashover and consequential short circuit. This seems to be the root cause of problem leading to subsequent events. As per the interlock provided, the isolator should not open even with a command as long as the GCB is closed. Hence, it was a complete malfunctioning of control circuit of isolator 89 C.

- It was seen that there was moisture ingress in the control panel following heavy rain which occurred prior to the incidence. The presence of moisture in the panel could have short circuited certain portion of control and interlock circuit thereby energising the contactor responsible for opening the isolator.
